# 2021 FACILITY CONDITION SURVEY

Bates Technical College

SURVEY CONDUCTED BY:  
Steve Lewandowski  
State Board for Community  
and Technical Colleges

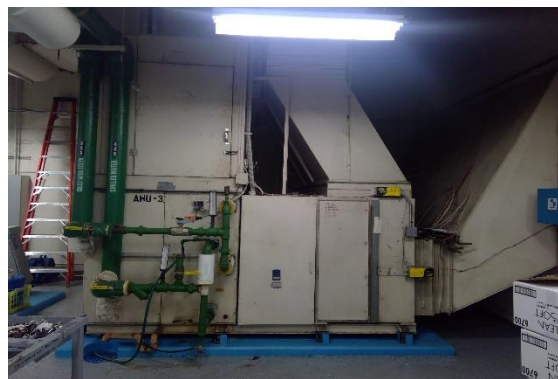
The two HVAC units on the west wing and north wing of the roof and one on the north wing of the first floor are at the end of their useful life. The units have degraded and continually leak. The unit on the first floor should be replaced. The units on the roof should be replaced in the following biennium.

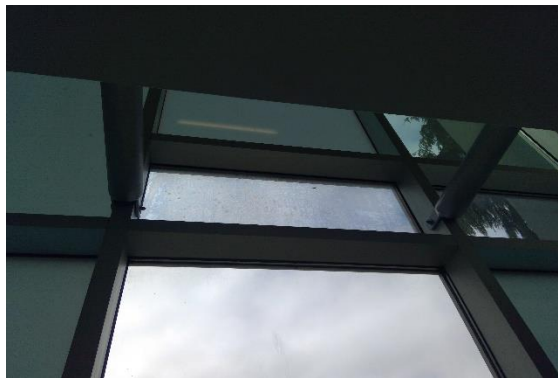
**Deficiency F02**

Several windows in buildings A and C have failed and should be replaced.

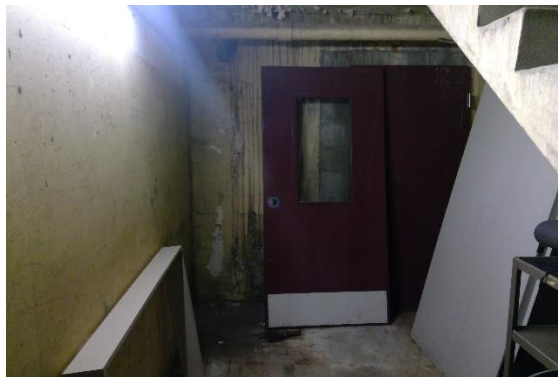
**Deficiency F03**

There is a leak in the west side of the building near room A110B. Water infiltrates through the exterior masonry and has damaged the interior materials. The wall should be repaired to ensure a water-tight condition and the damage should be repaired.

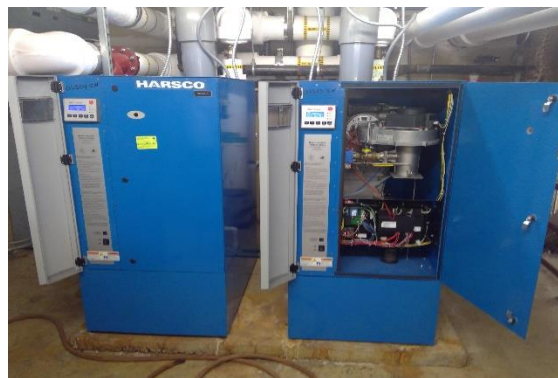
**Deficiency F04**

The boiler controls no longer function and should be replaced.

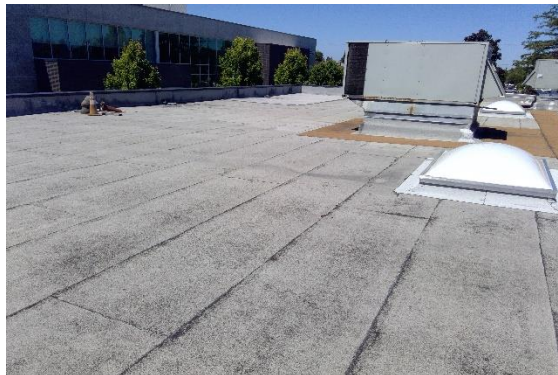
**Deficiency R01**

The roof has degraded and has required many recent repairs to address leaks. The roofing should be re-surfaced to extend its useful life.

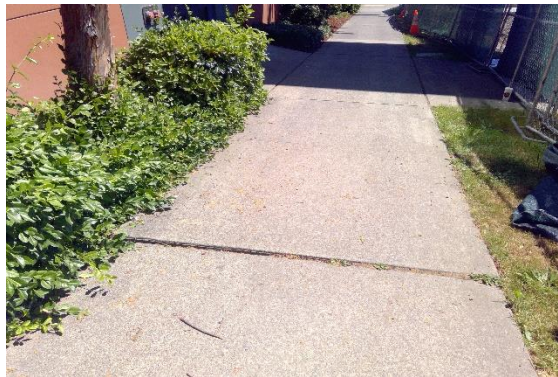
**Deficiency S01**

The pedestrian sidewalks have several locations where the concrete has heaved or is broken. These areas should be replaced. The city requires upgrades to the sidewalk transitions to comply with current ADA standards.

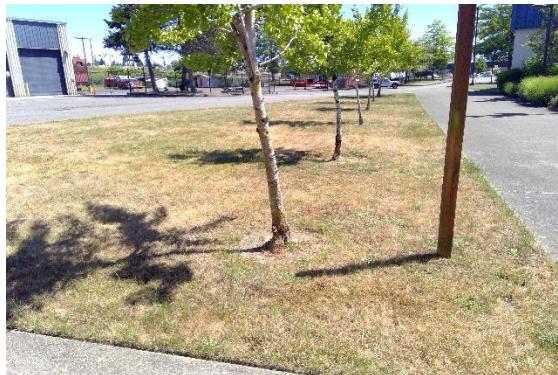
**Deficiency S02**

The irrigation lines have been modified over the years and have degraded. The system has become unreliable and required constant repairs. The lines should be replaced.
