# 2021 FACILITY CONDITION SURVEY

Bellevue College

SURVEY CONDUCTED BY:  
Steve Lewandowski  
State Board for Community  
and Technical Colleges

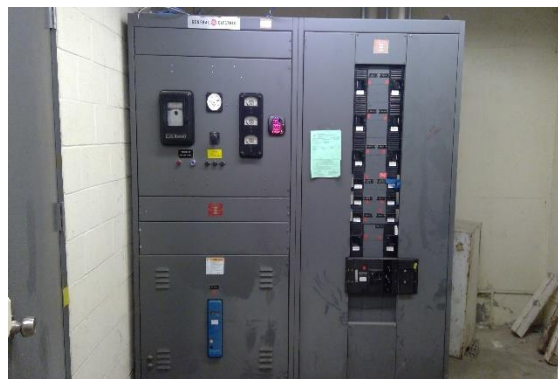
| Deficiency score : $4 \times (15 \times 100\%) + 2 = 62$ |

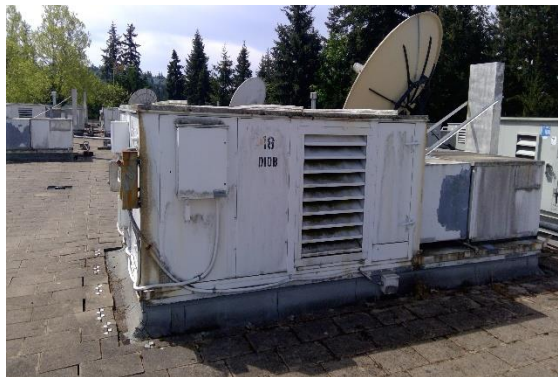
**Deficiency F02**

| Deficiency score : $4 \times ((15 \times 80\%) + (12 \times 20\%)) + 1 = 58.6$ |

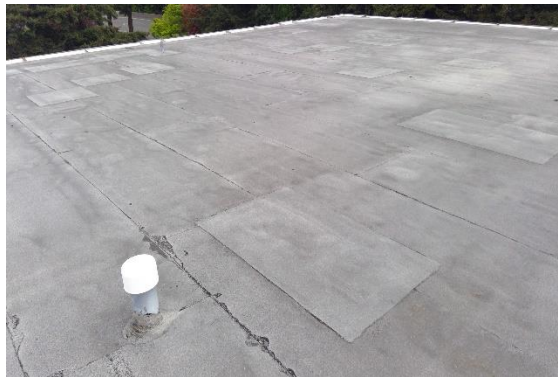
**Deficiency R01**

The roofing currently leaks and has deteriorated. This type of roof can be refreshed and should be repaired with a new top layer and cap sheet to extend its useful life

| Deficiency score : $4 \times (15 \times 100\%) + 0 = 60$ |

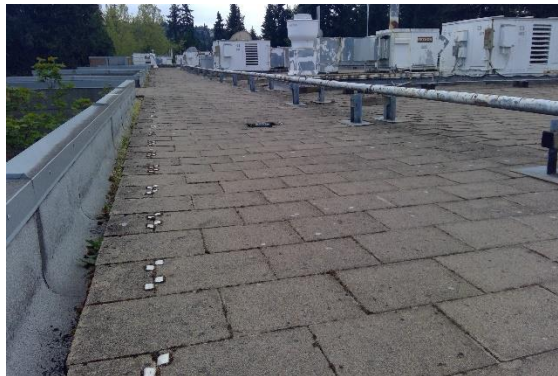
**Deficiency R02**

The roofing has degraded and leaks. The leaks are very difficult to locate because of an added layer of rigid insulation and pavers installed over the roofing. The roofing is near the end of its useful life and should be replaced, however, the roof is large and also has numerous HVAC units that will be affected. Therefore, the roof should be replaced in two phases and should coordinate with the replacement of some of the HVAC units. The south half of the roof should be replaced.

| Deficiency score : $4 \times (15 \times 100\%) + 1 = 61$ |
