# 2021 FACILITY CONDITION SURVEY

Bellingham Technical College

SURVEY CONDUCTED BY:  
Steve Lewandowski  
State Board for Community  
and Technical Colleges

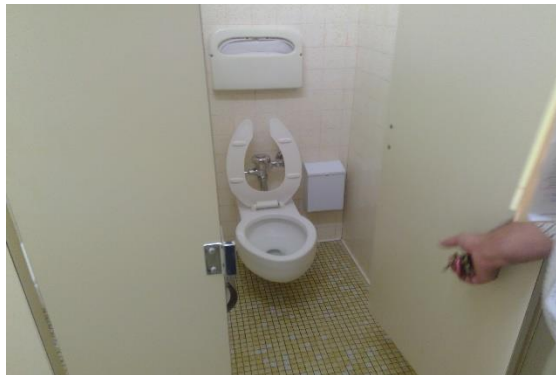
### **Deficiency F01**

The bathroom fixtures and toilet partitions are dated, but still function. These components should continue to be monitored and be replaced in the future

| Deficiency score : $1 \times ((10 \times 60\%) + (5 \times 40\%)) + 2 = 10$ |

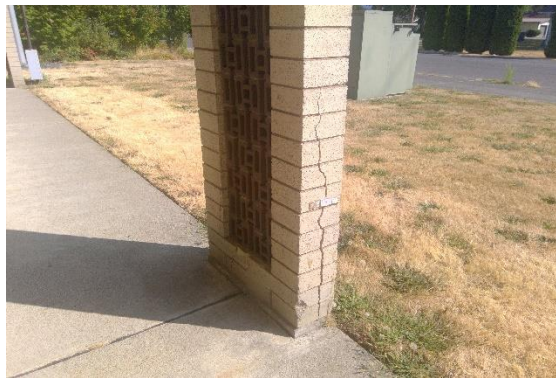
**Deficiency F02**

Multiple locations need masonry repair due to age/wear of the buildings and settling.

| Deficiency score : $4 \times ((15 \times 50\%) + (12 \times 50\%)) + 2 = 56$ |

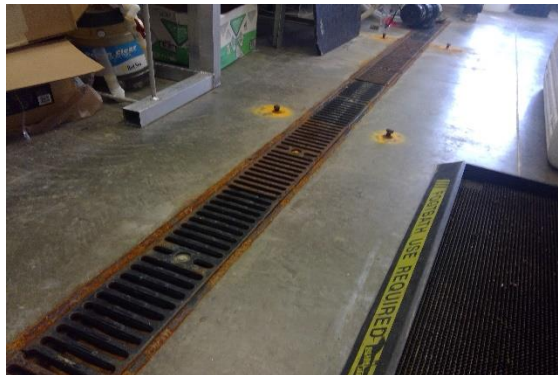
**Deficiency F03**

Saltwater use of Hatchery floor drains has caused premature rusting and deterioration. Need to replace cast iron with suitable floor drain material for both salt and fresh water.

| Deficiency score : $2.5 \times ((12 \times 60\%) + (5 \times 40\%)) + 0 = 23$ |

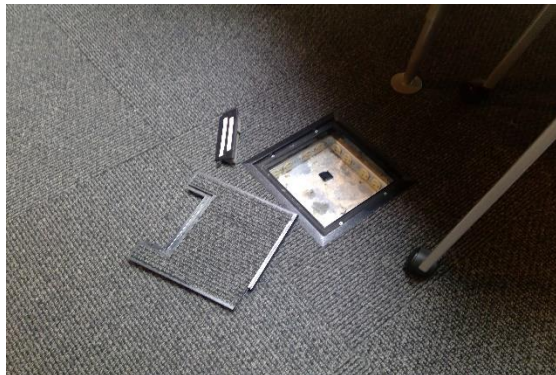
**Deficiency F04**

Plastic covers on electrical floor boxes are failing due to design. Need to replace with metal topped covers.

| Deficiency score : $4 \times ((12 \times 80\%) + (5 \times 20\%)) + 0 = 42.4$ |

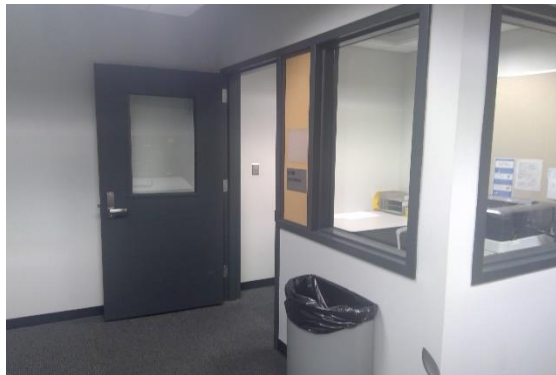
**Deficiency F05**

The settling building has warped many of the door frames. The doors are still in good condition. The frames should be replace.

| Deficiency score : $4 \times ((12 \times 80\%) + (15 \times 20\%)) + 0 = 50.4$ |

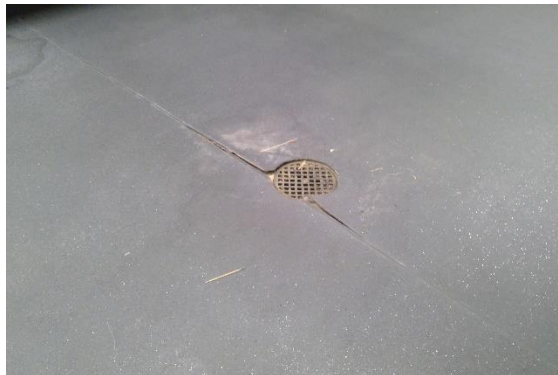
**Deficiency F06**

Several sections of the rubber floor surface have delaminated. Many seams have also failed. These areas should be repaired to maintain a surface that will meet health safety requirements

| Deficiency score : $4 \times ((15 \times 90\%) + (5 \times 10\%)) + 0 = 56$ |

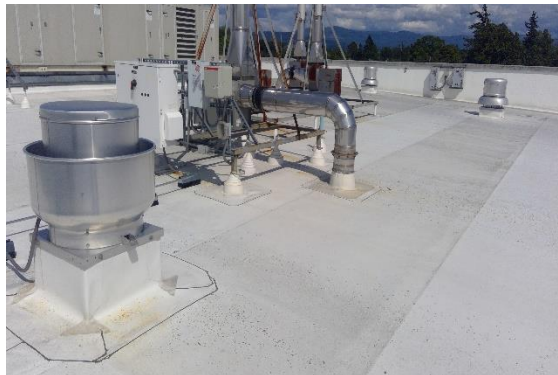
**Deficiency R01**

The roof has leaked in a few areas and the college is concerned about the age. The roof should continue to be monitored and be reconditioned in the future to extend the useful life.

| Deficiency score : $1 \times ((15 \times 70\%) + (12 \times 30\%)) + 0 = 14.1$ |

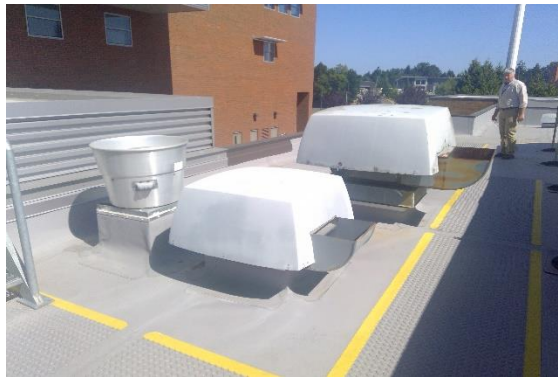
**Deficiency F08**

The exhaust fans are at the end of their useful life. The associated make-up air unit has required prior repairs to maintain function. The exhaust fans are not repairable when they fail. The fans should be replaced.

| Deficiency score : $2.5 \times ((12 \times 60\%) + (15 \times 40\%)) + 2 = 35$ |

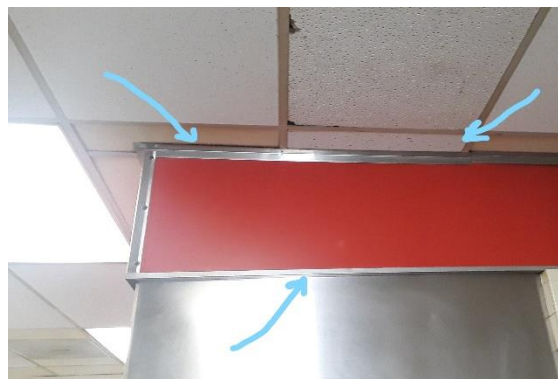
**Deficiency F09**

The hood exhaust fan has degraded. The hood structure is failing and has caused damage to the supporting wall and ceiling. The fans are also unreliable and have been tagged by the local fire department for repairs. The hood should be replaced.

| Deficiency score : $4 \times ((25 \times 80\%) + (12 \times 20\%)) + 2 = 91.6$ |

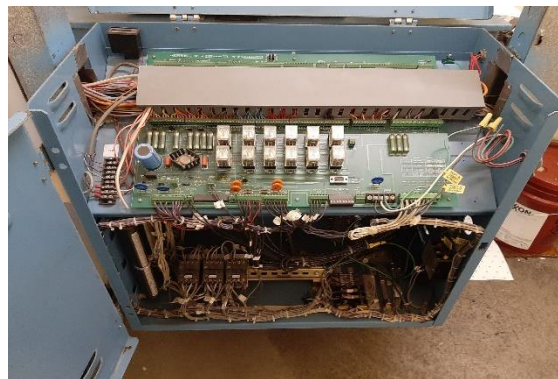
**Deficiency F10**

The college is concerned about the reliability of the elevator controls. The elevator vendor submitted a memo that described how the elevator controls have become obsolete and non-supported. Some control component failures would not be repairable and the elevator would be out of service for an extended period of time. The controls should be modernized to ensure that the elevator remains reliable.

| Deficiency score : $4 \times ((15 \times 70\%) + (20 \times 30\%)) + 1 = 67$ |

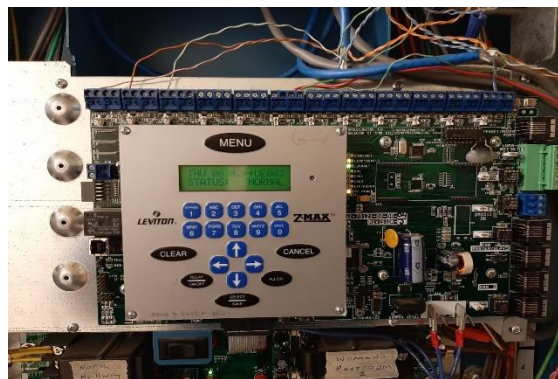
**Deficiency F11**

The lighting controls have become obsolete. Parts are no longer available from the vendor. The controls still function, but the components have been failing and the college has been forced to use all spare components. Since additional components are not available to make repairs, the controls should be replaced to maintain function.

| Deficiency score : $4 \times ((12 \times 80\%) + (15 \times 20\%)) + 0 = 50.4$ |

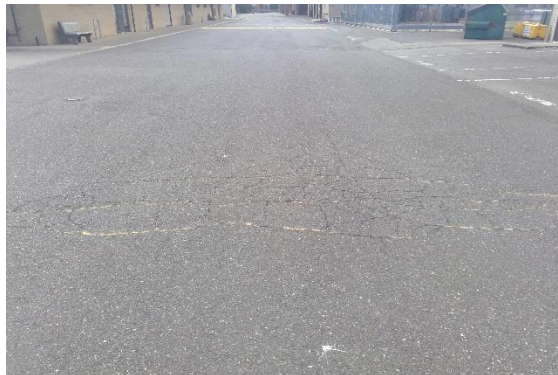
**Deficiency S01**

There are several areas along the fire lane (over utilities) that have settled and cracked. The area is on the north side of campus. These failed areas should be replaced as they become too damaged for emergency use.

| Deficiency score : $4 \times ((25 \times 60\%) + (5 \times 40\%)) + 0 = 68$ |

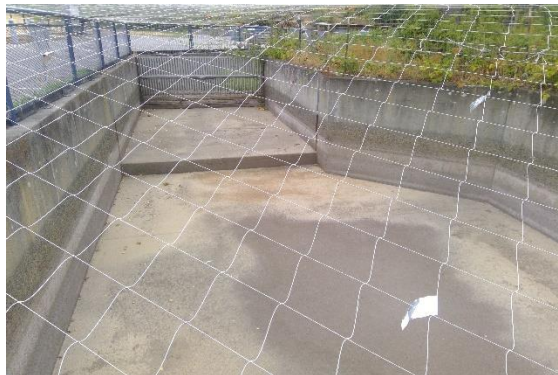
**Deficiency S02**

(4) Hatchery rearing ponds have deteriorating concrete walls that provide growth for unhealthy organisms. Concrete walls need to be resurfaced.

| Deficiency score : Needs study |
