# 2021 FACILITY CONDITION SURVEY

Big Bend Community College

SURVEY CONDUCTED BY:  
Steve Lewandowski  
State Board for Community  
and Technical Colleges

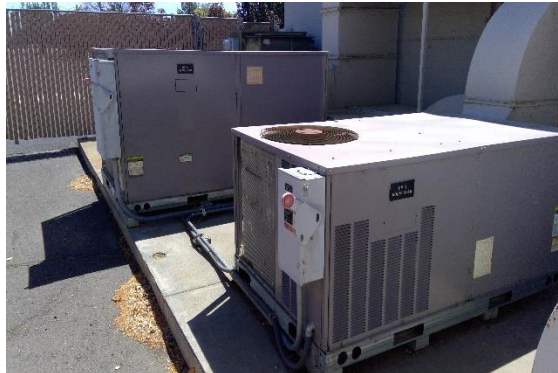
The college is concerned about the age of the two pad-mounted units. The college staff indicated that the level of maintenance is normal. These units should continue to be monitored and be replaced in the future.

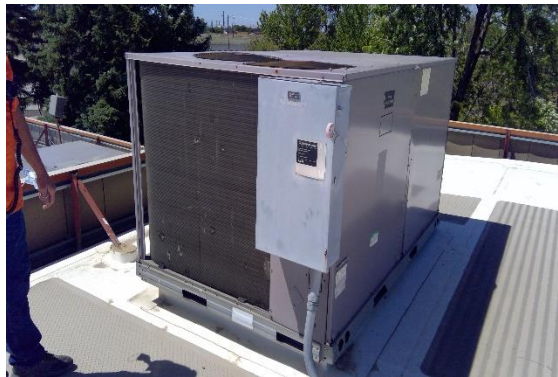
**Deficiency F02**

The two units have required a higher level of maintenance to maintain function. These units are at the end of their useful life and should be replaced.

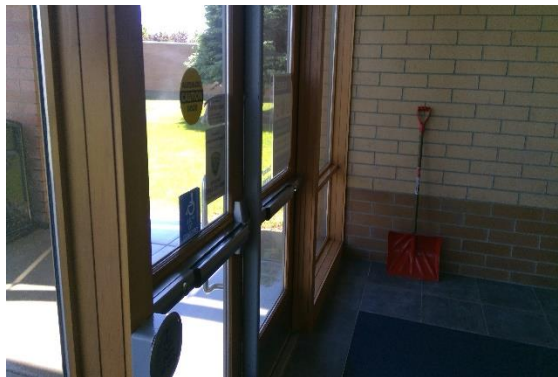
**Deficiency F03**

The entrance storefront systems in building 180 have deteriorated. The door thresholds have warped. The locking mechanisms are unreliable and require regular adjustment. The doors are also failing. The 5 storefront systems and 10 doors should be replaced.

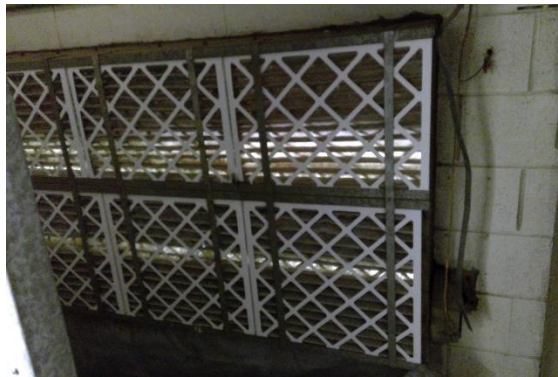
**Deficiency F04**

The two air handlers are near the end of their useful life. The bearings have been repaired multiple times and require constant adjustments. The units should be repaired by replacing the failed louver system and controls.

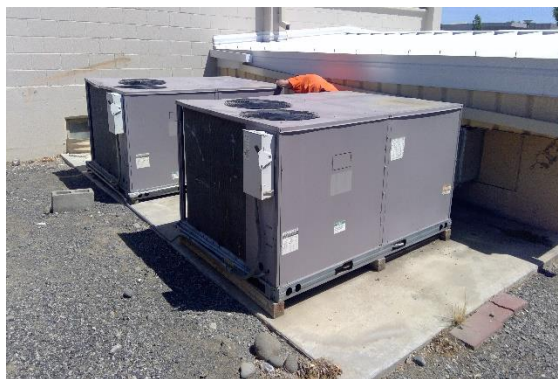
**Deficiency F05**

The two HVAC units that serve the computer server room require significant maintenance to maintain function. The units have become unreliable and are near the end of their useful life. The units should be replaced.

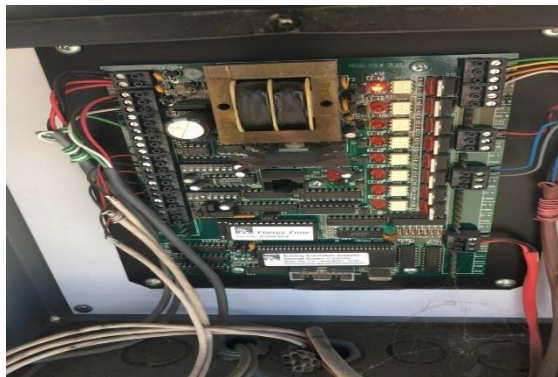
**Deficiency F06**

The mechanical system controls are no longer supported by the vendor and can no longer be used to control equipment. The controls have become more unreliable and should be replaced to maintain the use of the heating and cooling equipment.
