# 2021 FACILITY CONDITION SURVEY

Clark College

SURVEY CONDUCTED BY:  
Steve Lewandowski  
State Board for Community  
and Technical Colleges

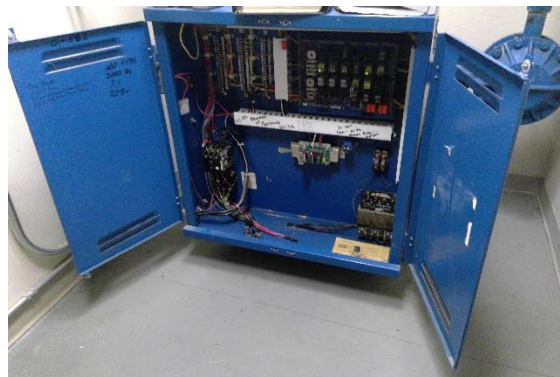
**Deficiency F02**

The college is concerned about the condition of the elevator controls and cab. The elevator should continue to be monitored for future replacement.

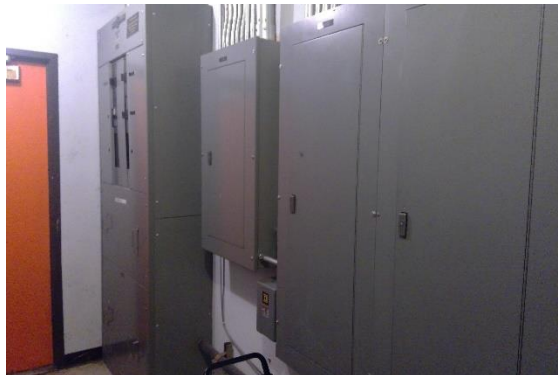
**Deficiency F03**

The college is concerned about the age of the main switchgear and secondary panels. These panels still function and should continue to be monitored for replacement.

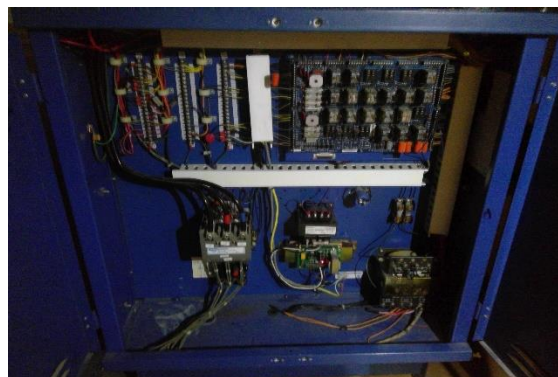
**Deficiency F04**

There are Dover elevators in Anna Pechanic Hall and the Cannell Library. These elevators are now supported by Thyssenkrupp rather than Dover. These elevators are not going to be supported by the vendor after 2024. After that time, these elevators would become non-operational for several months in the event of a failure. If these elevators do not function some program spaces would become inaccessible to students that rely on wheelchairs. The control system that will no longer supported should be replaced to avoid the risk of non-useable elevators.

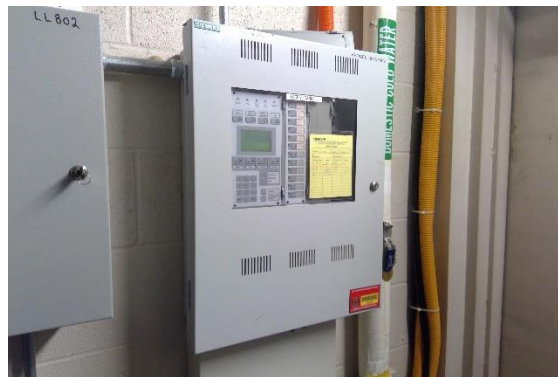
**Deficiency F05**

There are several buildings that have fire alarm panels that are no longer supported by the vendor. These panels should be replaced to ensure that they remain functional and supportable.

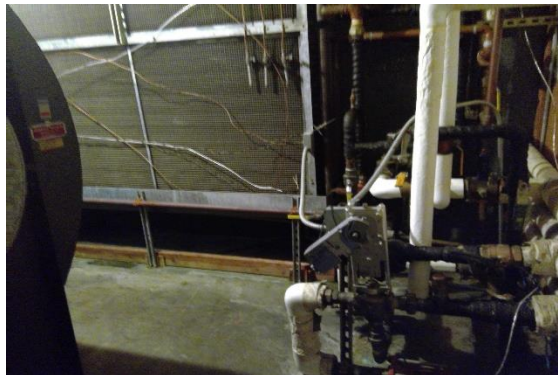
**Deficiency F06**

The air handler supporting the student center that has degraded. The fire dampers no longer function. The college is concerned about the condition of the system.

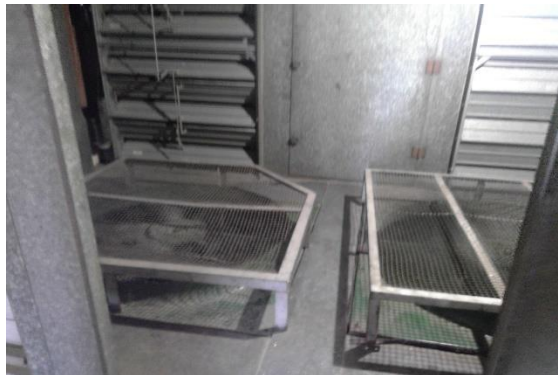
**Deficiency F07**

The air handler has degraded. One of the return air fans has failed. Mixed air damper system no longer functions. The unit should be repaired to extend its useful life.

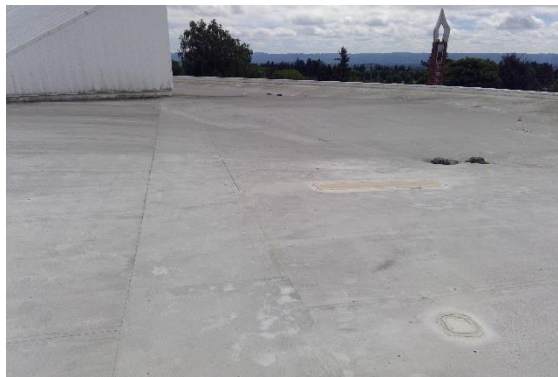
**Deficiency R01**

There are several building roofs that have leaks and show signs of deterioration. The roofing on Facility Services, Joan Stout Hall, Frost Arts Center, Cannell Library & the Columbia Tech Center roofing should be repaired to extend their useful life.
