# 2021 FACILITY CONDITION SURVEY

Clover Park Technical College

SURVEY CONDUCTED BY:  
Steve Lewandowski  
State Board for Community  
and Technical Colleges

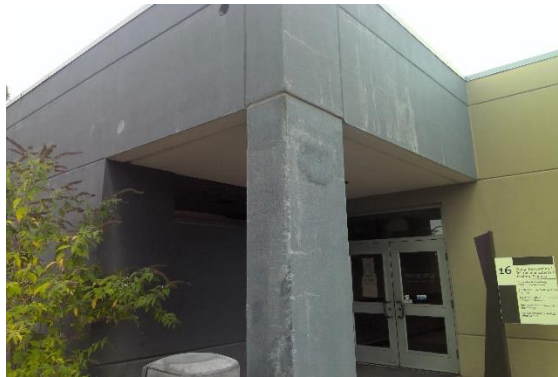
Exterior insulation and stucco finish system is failing in multiple locations and creating water intrusion. Some of the deterioration has been repaired, but additional areas need to be repaired.

| Deficiency score : $4 \times (15 \times 100\%) + 5 = 65$ |

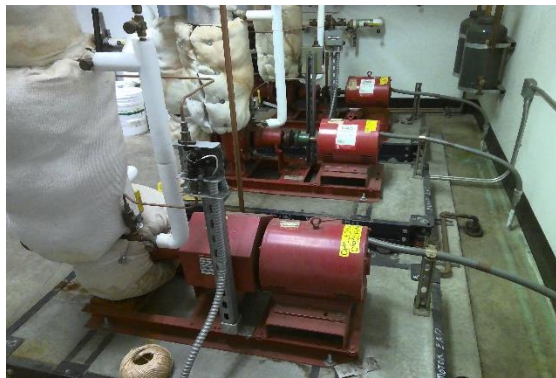
**Deficiency F02**

The circulation pumps for the boiler and chiller needs to be replaced.

| Deficiency score : $4 \times ((15 \times 80\%) + (12 \times 20\%)) + 1 = 58.6$ |

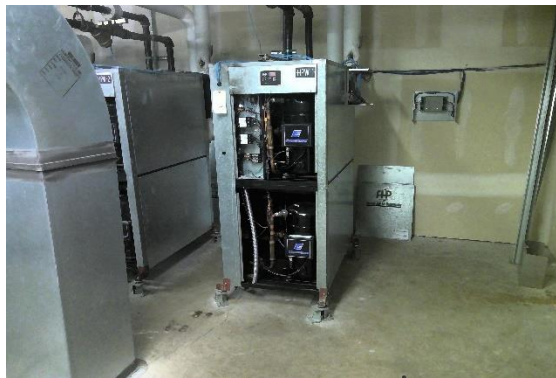
**Deficiency F03**

The refrigerant compressor has failed and needs to be replaced.

| Deficiency score : $4 \times ((15 \times 60\%) + (12 \times 40\%)) + 0 = 55.2$ |

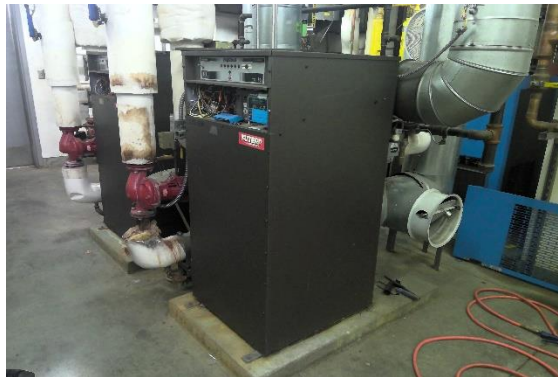
**Deficiency F04**

The boilers are constantly causing trouble alerts. The college has replaced several failed components. The boilers should continue to be monitored for replacement.

| Deficiency score : $2.5 \times (15 \times 100\%) + 1 = 38.5$ |

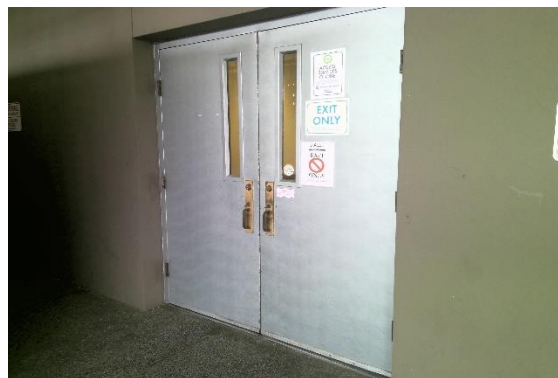
**Deficiency F05**

Multiple exterior doors are failing/broken and need to be replaced.

| Deficiency score : $4 \times ((15 \times 70\%) + (12 \times 30\%)) + 5 = 61.4$ |

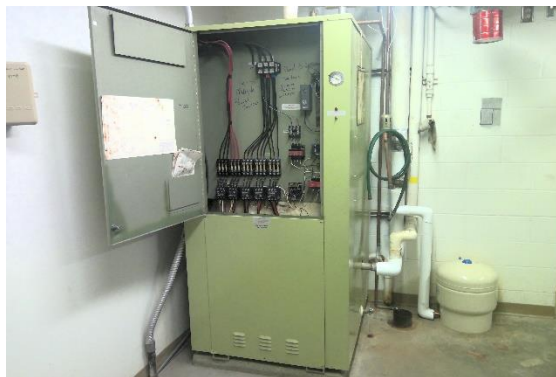
**Deficiency F06**

The college is concerned about the age of the unit. Repairs have not been required and the unit still functions as designed. The unit should be monitored for replacement next biennium.

| Deficiency score : $2.5 \times (15 \times 100\%) + 1 = 38.5$ |

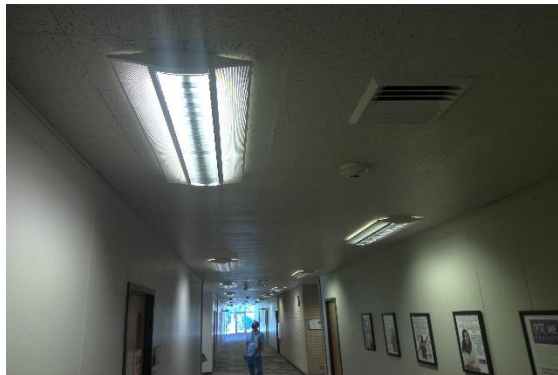
**Deficiency F07**

Lighting fixtures throughout south side of building are outdated and parts no longer available. Many plastic components have broken and cannot be replaced. The fixtures should be replaced.

| Deficiency score : $4 \times ((12 \times 90\%) + (15 \times 10\%)) + 1 = 50.2$ |

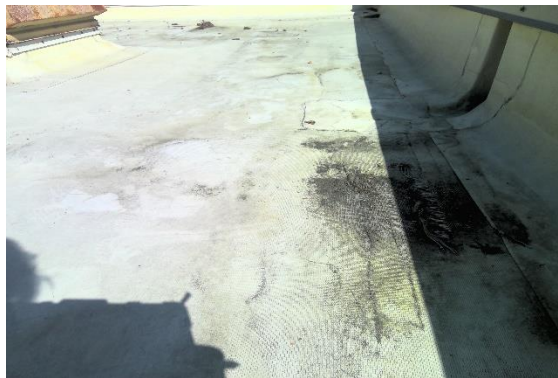
**Deficiency R01**

The two portions of the roof that are TPO are failing and causing water intrusion.

| Deficiency score : $4 \times ((12 \times 70\%) + (15 \times 30\%)) + 1 = 52.6$ |

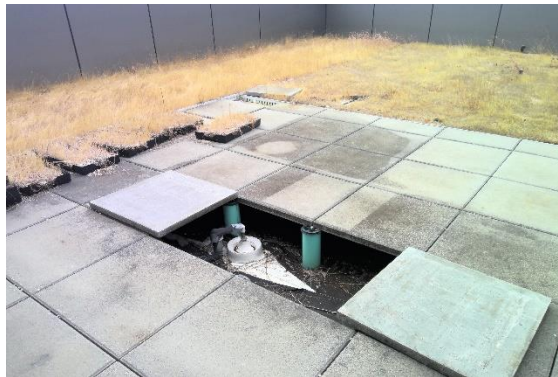
**Deficiency R02**

The "live" roof under the roof garden is failing and causing water intrusion. The roof needs to be peeled up and remapped to repair faulty installation.

| Deficiency score : $4 \times (12 \times 100\%) + 0 = 48$ |

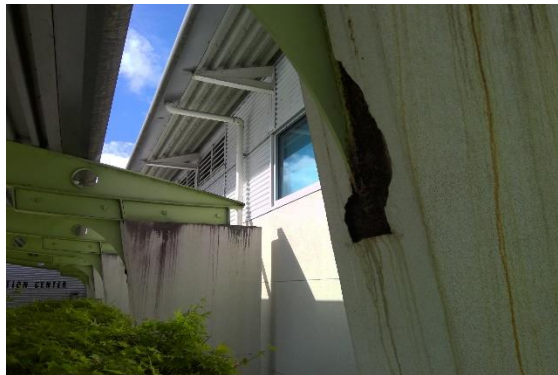
**Deficiency F08**

Front sidewalk cover 'roof' pylon stucco is breaking and chunking out, over rusted support cantilevers. Needs to be repaired structurally.

| Deficiency score : $4 \times (12 \times 100\%) + 1 = 49$ |

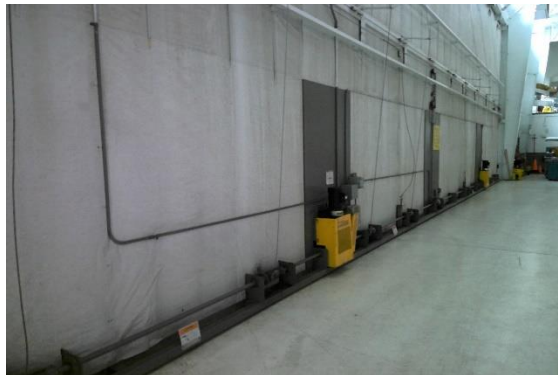
**Deficiency F09**

The hangar doors have required frequent repairs to maintain function. The hardware has failed and should be replaced.

| Deficiency score : $4 \times (15 \times 100\%) + 1 = 61$ |

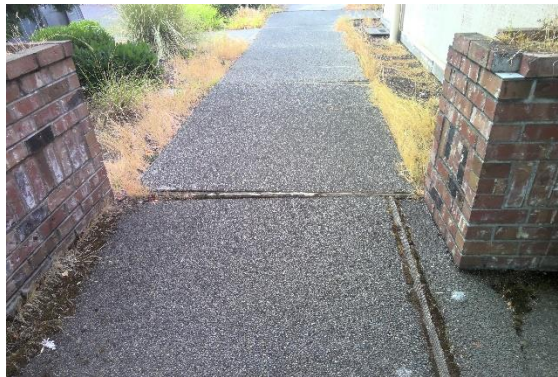
**Deficiency S01**

here are several sections of the pedestrian access paths that have failed due to root infiltration, settling or frost heave. These sections should be replaced.

| Deficiency score : $4 \times ((20 \times 50\%) + (12 \times 50\%)) + 0 = 64$ |
