# 2021 FACILITY CONDITION SURVEY

Columbia Basin College

SURVEY CONDUCTED BY:  
Steve Lewandowski  
State Board for Community  
and Technical Colleges

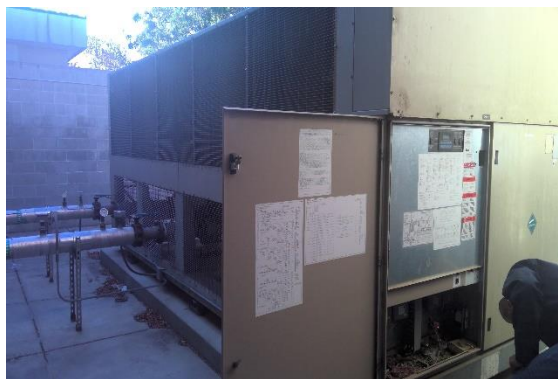
**Deficiency F02**

The college is concerned about the age of the chiller. There are symptoms of some system failure which can be seen as nuisance circuit tripping, but the system just needs to be reset to maintain function. Significant repairs have not been required. The chiller should continue to be monitored for replacement next biennium.

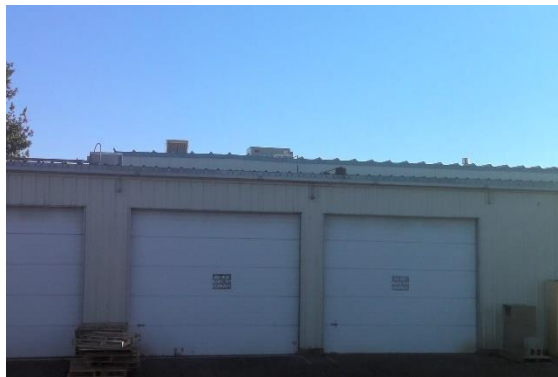
**Deficiency R01**

The roofing fasteners and flashing have degraded, allowing the roof to leak in several locations along the upper roof-to-wall transition. The roof flashing should be repaired and altered to properly protect the building from rain. The roof should also be spot-repaired, where there are leaks due to degraded fasteners or sealants.
