# 2021 FACILITY CONDITION SURVEY

Edmonds Community College

SURVEY CONDUCTED BY:  
Steve Lewandowski  
State Board for Community  
and Technical Colleges

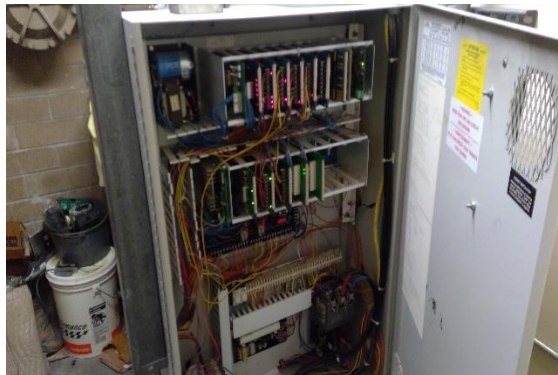
The college is concerned about the age of the equipment. The elevator still functions as designed. The elevator should continue to be monitored and be evaluated for repair need or future replacement.

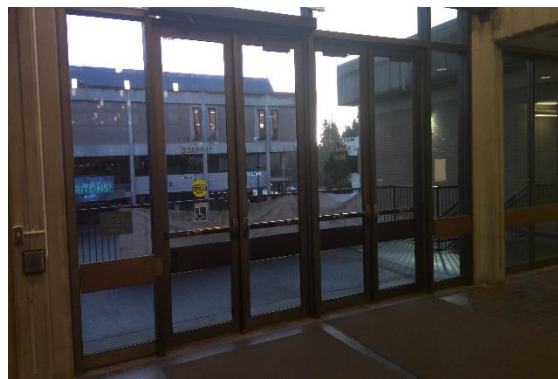
**Deficiency F02**

The college is concerned about the condition of the exterior doors. Some of the doors have small sections of slightly bent trim, but appear to function as designed. One door has an operator that required maintenance. The doors should continue to be monitored for future replacement.

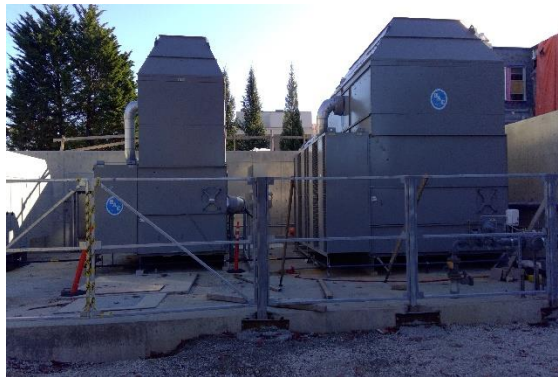
**Deficiency F03**

The cooling towers have been partially reconditioned. Both towers have floats that are no longer reliable. The floats should be replaced.

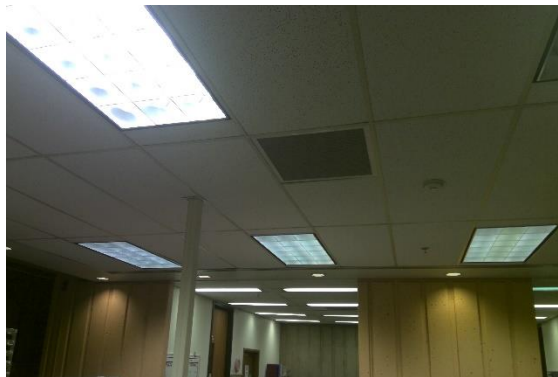
**Deficiency F04**

The variable air volume units are old and no longer function properly. The actuators are failing and make loud clunking sounds. There is asbestos above the ceiling that would need to be abated to work on the units. These units should be replaced and the air plenum should be abated.

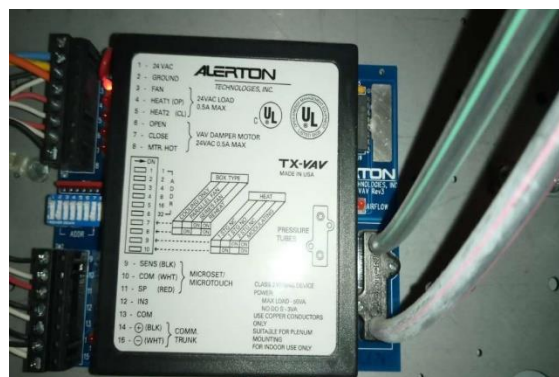
**Deficiency F05**

The college is concerned about the reliability of various HVAC controls. The controls are no longer supported by the vendor and should be replaced. However, the controls still function and could still be repaired using spare parts from another building where similar components will be replaced and retained for parts next biennium. These controls should continue to be monitored and be replaced when spare parts are no longer available to maintain a reliable system.

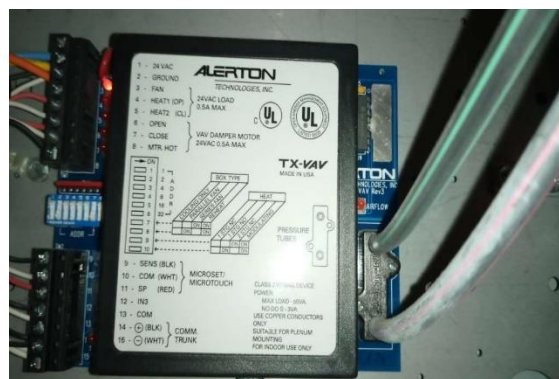
**Deficiency F06**

The college is concerned about the reliability of various HVAC and lighting controls. The controls are no longer supported by the vendor and should be replaced. The working components should be retained used for spare parts for Snohomish Hall and Woodway Hall.

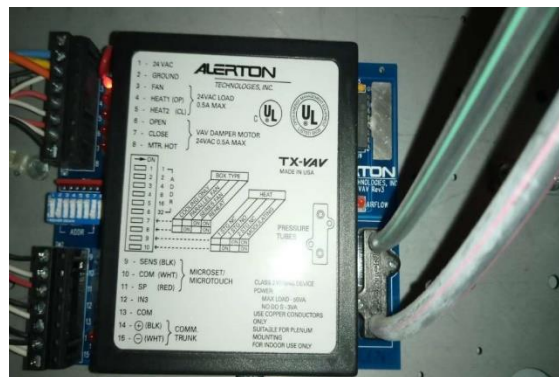
**Deficiency F07**

The college is concerned about the reliability of various HVAC controls. The controls are no longer supported by the vendor and should be replaced. However, the controls still function and could still be repaired using spare parts from another building where similar components will be replaced and retained for parts next biennium. These controls should continue to be monitored and be replaced when spare parts are no longer available to maintain a reliable system.

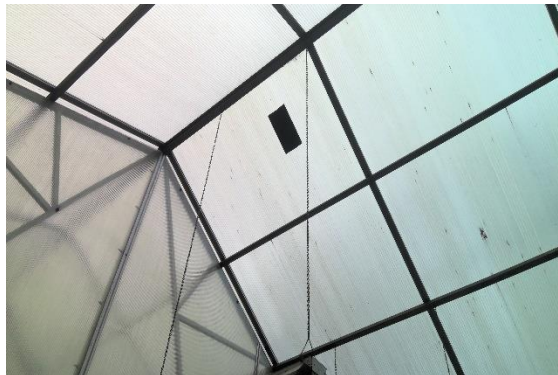
**Deficiency R01**

Greenhouse roof has been damaged repeatedly over the years by both weather and baseballs hit from the adjacent field.

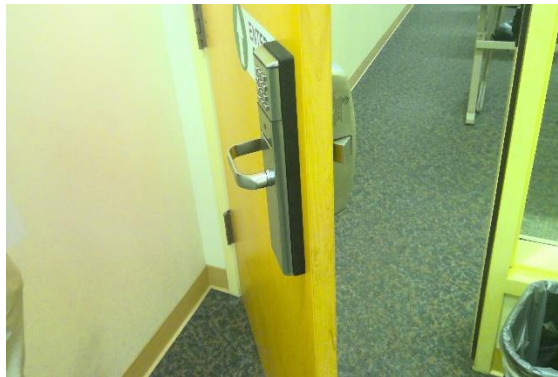
**Deficiency F09**

Replace failing and obsolete electronic door locks and associated doors campus-wide. The locks are no longer supported by the vendor, but most locks appeared to still function. At least one lock was in a failed condition during the survey. There are a few of these units that fail completely every year. The doors have to be modified to house new locks. The 20 locks in the worst condition should be replaced. The old locks should be retained for spare parts.

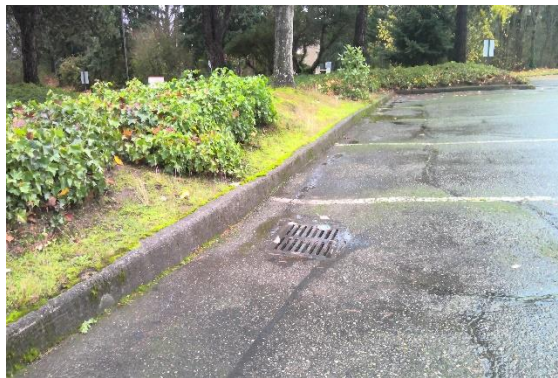
**Deficiency S01**

Replace broken storm sewer lines at multiple locations on campus.
