# 2021 FACILITY CONDITION SURVEY

Everett Community College

SURVEY CONDUCTED BY:  
Steve Lewandowski  
State Board for Community  
and Technical Colleges

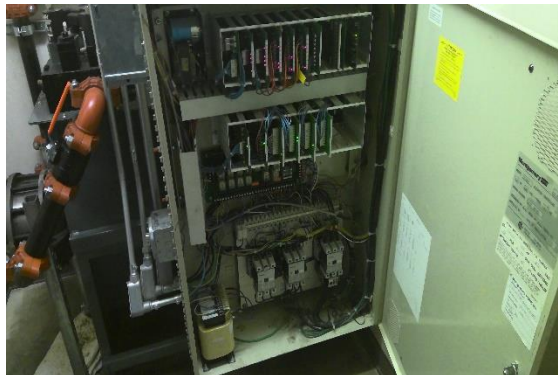
The elevator controls are not reliable and require frequent repairs. The controls should continue to be monitored and be replaced in the future.

| Deficiency score : $1 \times ((10 \times 90\%) + (12 \times 10\%)) + 0 = 10.2$ |

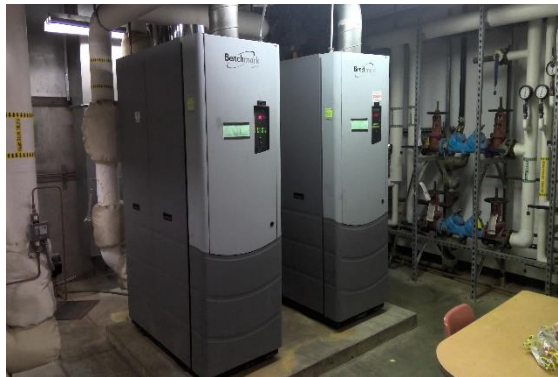
**Deficiency F02**

The boiler controls in the Whitehorse and Greywolf buildings frequently fail by shutting down boilers. The boilers functioned fine during the survey. The college does not have information regarding the reason for failure and are working with the manufacturer to determine the reason for the faults. More information is required to determine the correct repair.

| Deficiency score : Needs study |

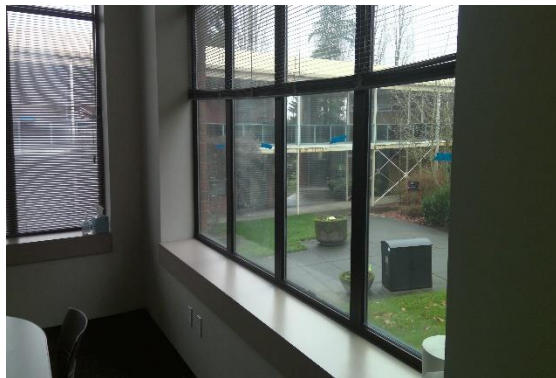
**Deficiency F03**

Many exterior windows have failed. The failed window glazing should be replaced.

| Deficiency score : $4 \times ((12 \times 90\%) + (5 \times 10\%)) + 1 = 46.2$ |

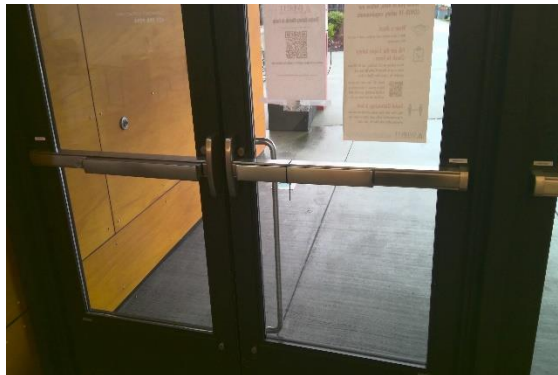
**Deficiency F05**

The emergency door hardware has degraded and no longer functions consistently. At times the hardware does not function and the door will not function. The door hardware should be replaced.

| Deficiency score : $4 \times ((12 \times 70\%) + (20 \times 30\%)) + 0 = 57.6$ |

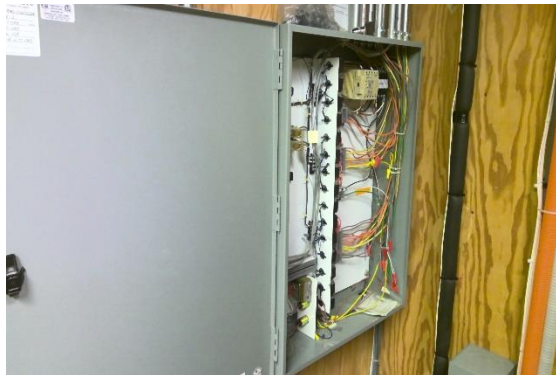
**Deficiency F06**

The lighting controls in Liberty and Shuksan Hall have failed. The panels are no longer supported by the vendor. The controls should be replaced.

| Deficiency score : $4 \times (15 \times 100\%) + 0 = 60$ |

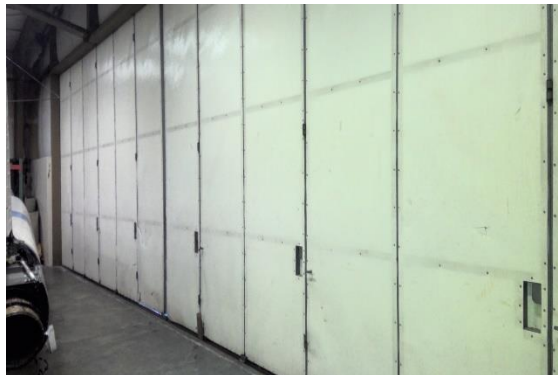
**Deficiency F07**

The hanger doors have degraded. The skin is deteriorated and the hardware has become unreliable. The doors still function and should continue to be monitored for replacement.

| Deficiency score : $4 \times (15 \times 100\%) + 0 = 60$ |

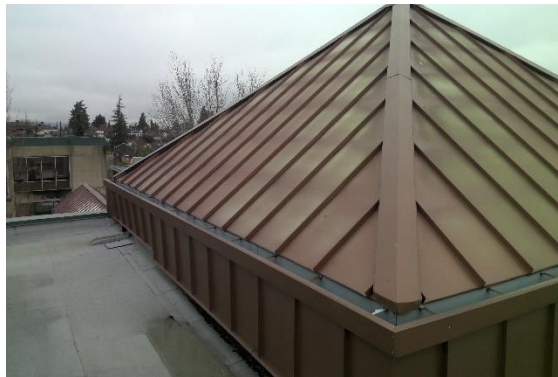
**Deficiency R01**

The roofing finish has degraded. There is also some wind damage from a prior storm event. The roof should be reconditioned to extend its useful life.

| Deficiency score : $4 \times (15 \times 100\%) + 1 = 61$ |

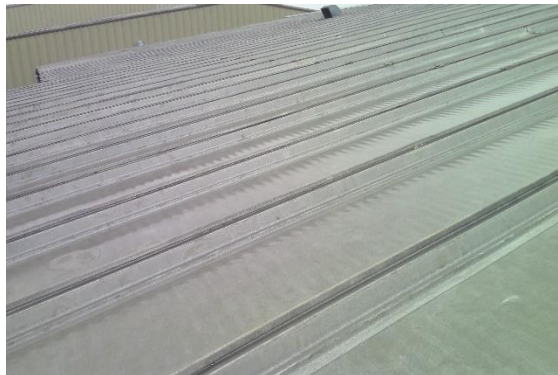
**Deficiency R02**

The roof surface has degraded. There are several leaks at fasteners. The roofing should be reconditioned to extend its useful life.

| Deficiency score : $4 \times ((12 \times 50\%) + (15 \times 50\%)) + 1 = 55$ |

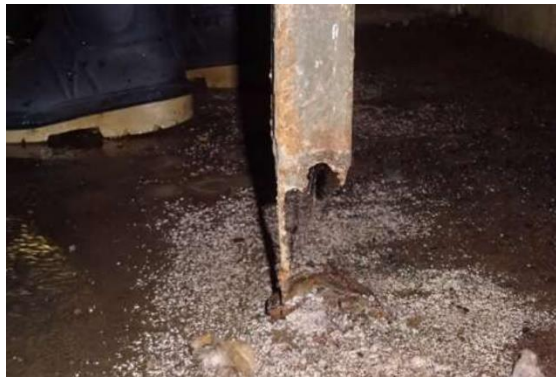
**Deficiency S01**

The utilidor brackets that support electrical and steam system components that have rusted and may fail. These brackets should be replaced or supplemented to make sure that the components are fully supported.

| Deficiency score : $4 \times ((12 \times 80\%) + (15 \times 20\%)) + 0 = 50.4$ |

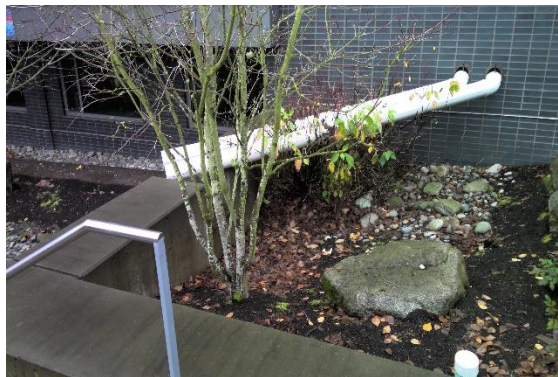
**Deficiency S02**

The storm collection are near the northwest corner of Liberty Hall commonly flood and allows water to penetrate the building foundation. The storm collection area has failed and no longer drains or channels the water correctly. The storm collection are should be repaired to ensure that water drains away from the building

| Deficiency score : $4 \times ((12 \times 80\%) + (15 \times 20\%)) + 0 = 50.4$ |

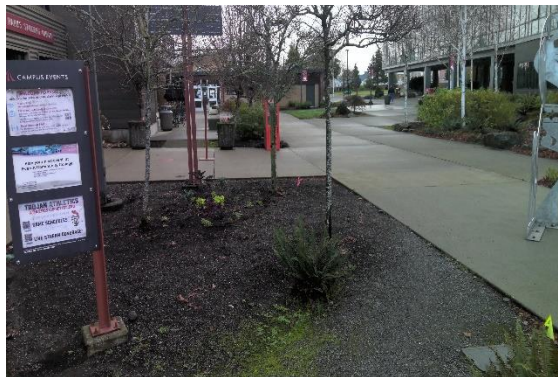
**Deficiency S03**

The water line between Parks student union and Greywolf Hall has deteriorated. There have been several locations where the pipe has ruptured due to deterioration and settling. In the past 20 years there have been four failures in the area that had disrupted campus use. The pipe should be replaced.

| Deficiency score : $4 \times ((15 \times 70\%) + (20 \times 30\%)) + 0 = 66$ |
