# 2021 FACILITY CONDITION SURVEY

Grays Harbor College

SURVEY CONDUCTED BY:  
Steve Lewandowski  
State Board for Community  
and Technical Colleges

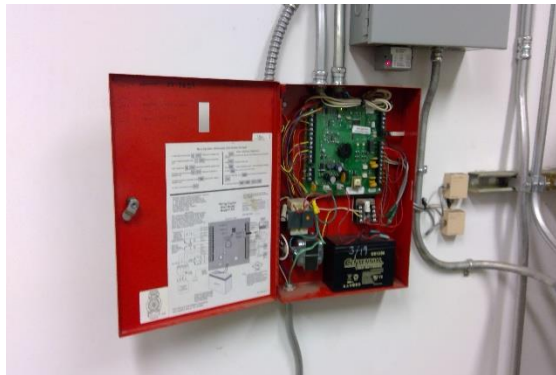
### **Deficiency F01**

The fire alarm panel regularly goes into a trouble alert mode. The panel has to be reset several times per week and is not reliable. The panel should be replaced.

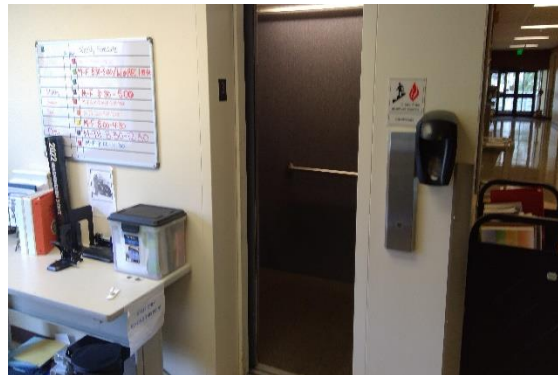
**Deficiency F02**

The elevator car and controls have deteriorated. The frequency of repairs has increased significantly and it has become unreliable. The elevator car and controls should be replaced.

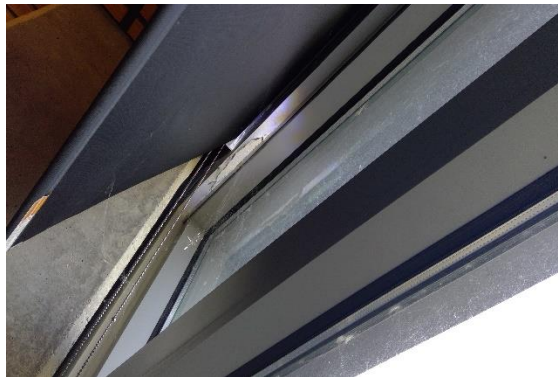
**Deficiency F03**

The windows have leaked for about 6 months, but are fairly new. It was not known if the flashing or sealant has failed. More information is required to determine the appropriate scope of repair.

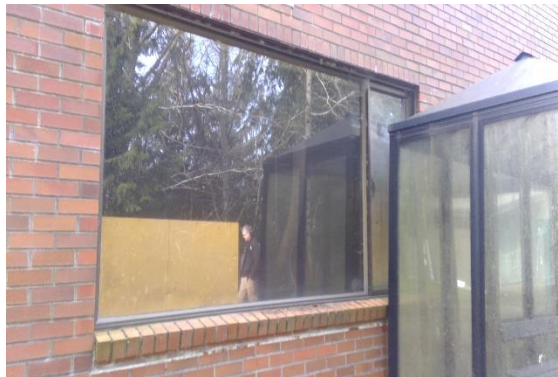
**Deficiency F05**

The aluminum framed windows have deteriorate and failed. Water is allowed to migrate into the building envelope and has caused some minor damage. The windows should be replaced.

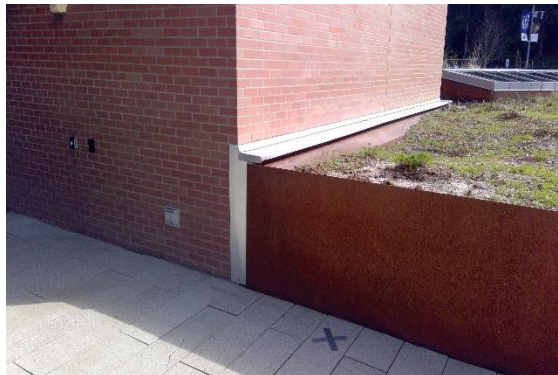
**Deficiency R01**

The green roof is leaking. The college does not know the extent of the failed section of roofing, but know the general location. More information is required to properly determine the scope of repair.

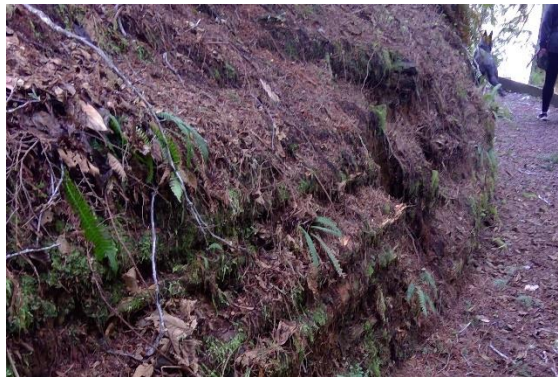
**Deficiency S01**

The wood retaining walls along the pedestrian path to the forestry program outdoor teaching location have rotted and failed. The walls should be replaced.
