# 2021 FACILITY CONDITION SURVEY

Highline College

SURVEY CONDUCTED BY:  
Steve Lewandowski  
State Board for Community  
and Technical Colleges

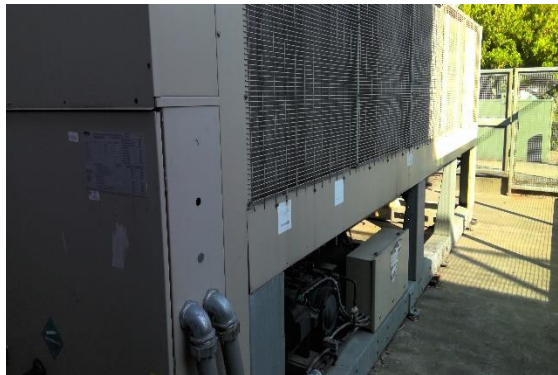
The chiller has exceeded its expected life. The system has become unreliable and the controls are frequently in alarm. The chiller should be replaced.

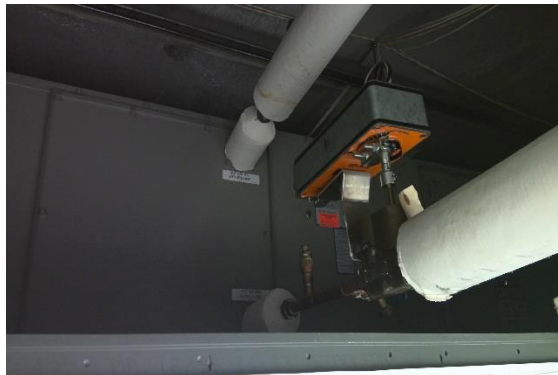
**Deficiency F02**

There are re-heat boxes in buildings 10 and 17 that frequently fail. Th actuators, valves, coils and controls typically fail and require repairs. The units should be repaired to maintain system function.

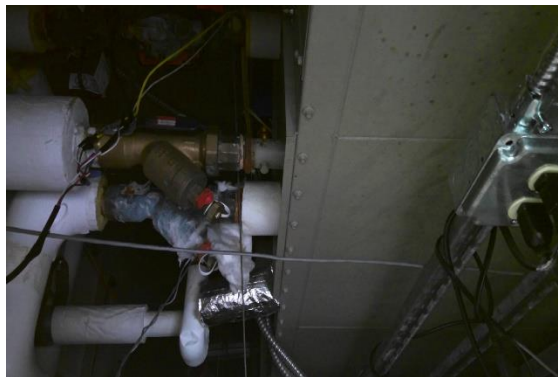
**Deficiency F03**

There are 3 airflow boxes that have become unreliable. The actuators, valves, coils and controls typically fail and require repairs. The units should be repaired to maintain system function. Two boxes have failed and should also be replaced.

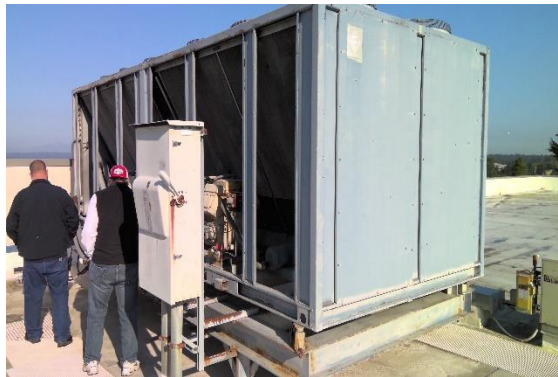
**Deficiency F04**

The older of the two chillers serving the building has become unreliable. The controls are typically in alarm mode and the unit has required a high level of maintenance to maintain function. The chiller should be replaced.

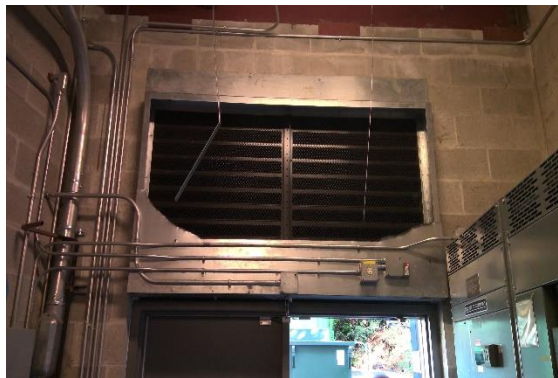
**Deficiency F05**

The exhaust system failed and was removed to allow air flow. The exhaust fan should be replaced.
