# 2021 FACILITY CONDITION SURVEY

Lake Washington Institute of  
Technology

SURVEY CONDUCTED BY:  
Steve Lewandowski  
State Board for Community  
and Technical Colleges

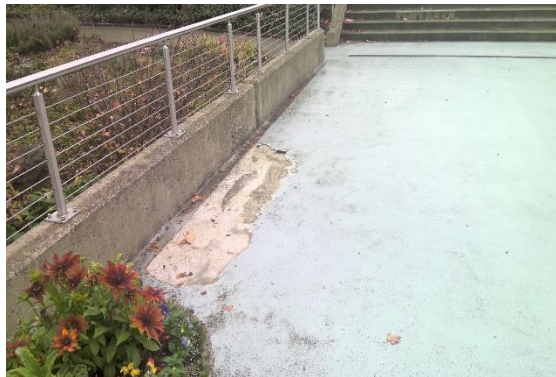
The pedestrian bridge spanning the fire lane from the West Parking Lot to the West Building main entry is showing signs of water leaching from the bridge deck through the structure. However, there is no sign of structural failure. The gutters have failed and the surface has failed in a few places. A prior surface repair has failed. The top surface should be replaced.

| Deficiency score : $4 \times ((15 \times 80\%) + (5 \times 20\%)) + 1 = 53$ |

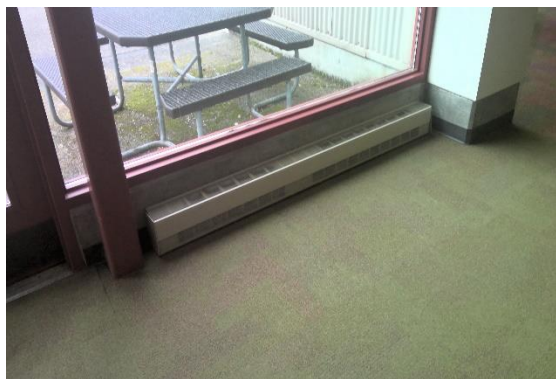
**Deficiency F02**

The college believes that the floor mounted electric radiant heaters have begun failing and indicated that they require significant maintenance. The units counteract the cool air flow from the exterior storefront window wall. The units all were functioning at the time of the survey (and during the prior survey) and should continue to be monitored.

| Deficiency score : $1 \times ((12 \times 70\%) + (5 \times 30\%)) + 1 = 10.9$ |

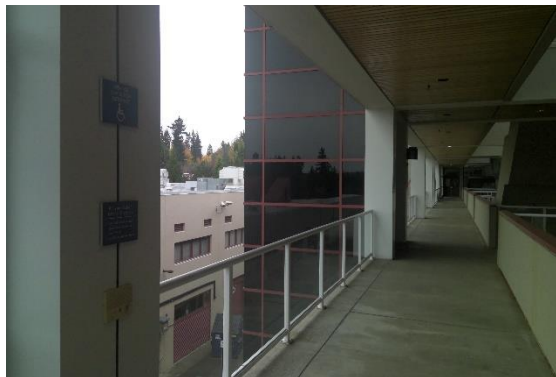
**Deficiency F03**

The design of the building allows water to penetrate into the exterior circulation area. This has caused damage to soffit components. The damage should be repaired. The area should also be enclosed to stop the water infiltration. Without the enclosure, the damage will re-occur. The 1st and 4th floors repairs were funded in the current biennium, but the project had not been completed at the time of the survey. It is not clear how much of the exterior issue can be addressed with current funding. After the project is complete, any remaining exposed portions of the exterior should be evaluated for repairs and correction.

| Deficiency score : $2.5 \times ((15 \times 60\%) + (12 \times 40\%)) + 1 = 35.5$ |

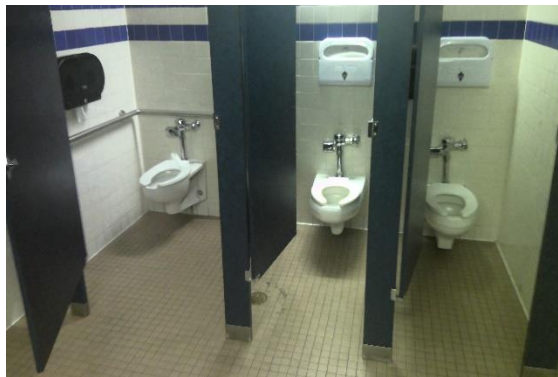
**Deficiency F04**

The toilet anchors have deteriorated and no longer provide the strength to properly seal the toilet to the wall. The college has repaired some of the toilets that have failed. The remaining toilets with this condition should be replaced. The wall behind the toilet and anchoring system should be repaired to fully support the new toilet installation.

| Deficiency score : $4 \times ((15 \times 70\%) + (10 \times 30\%)) + 2 = 56$ |

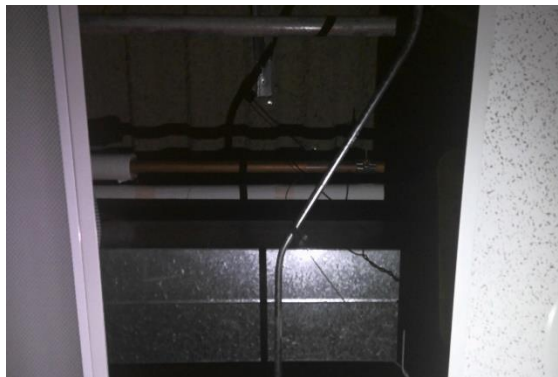
**Deficiency F05**

The domestic hot water circulation pipe is beginning to degrade and leak. The college has been required to patch 4-8 pinhole leaks annually. Additional information is required to determine if the whole system has degraded or if the problem is localized.

| Deficiency score : Needs study |

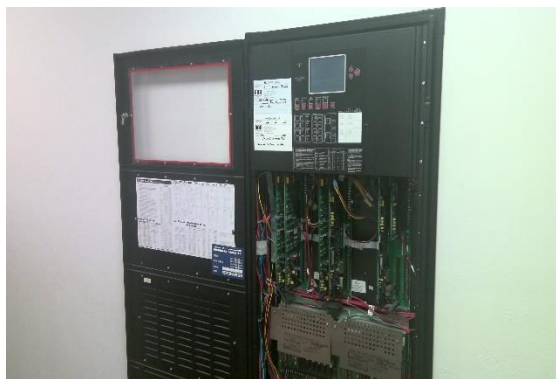
**Deficiency F06**

The college is concerned about the age and reliability of the older fire alarm panels in several buildings. The city fire department has indicated that they have concerns over the reliability of the systems. The system still functions as designed, but the panel is no longer supported by the vendor. The panel should be replaced.

| Deficiency score : $4 \times ((25 \times 70\%) + (12 \times 30\%)) + 0 = 84.4$ |

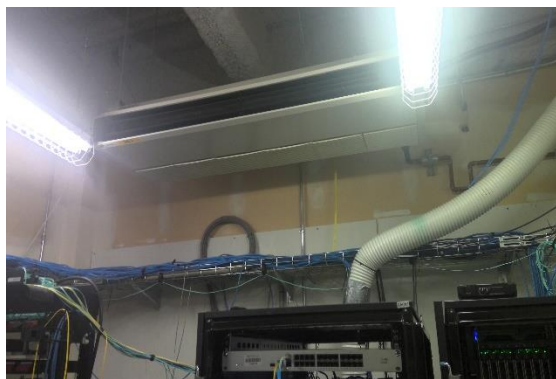
**Deficiency F07**

The main data center is serviced by two cooling units. At least one unit must run continuously in order to keep the data center properly cooled. The college is concerned about the reliability of the units. The least reliable unit should be replaced. The other unit should be monitored for future replacement.

| Deficiency score : $4 \times ((15 \times 90\%) + (12 \times 10\%)) + 1 = 59.8$ |

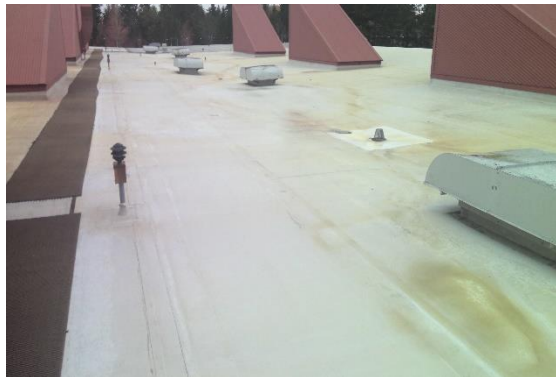
**Deficiency R01**

The roofing on the east wing of the building has areas with leaks. Prior patches and repairs have been made near drains. The main field of the roofing appears to be in good condition. There are localized areas where the roofing skim layer has begun to show. These localized areas should be repaired and re-conditioned. The rest of the east wing roofing should continue to be monitored for reconditioning.

| Deficiency score : $4 \times ((12 \times 70\%) + (15 \times 30\%)) + 2 = 53.6$ |

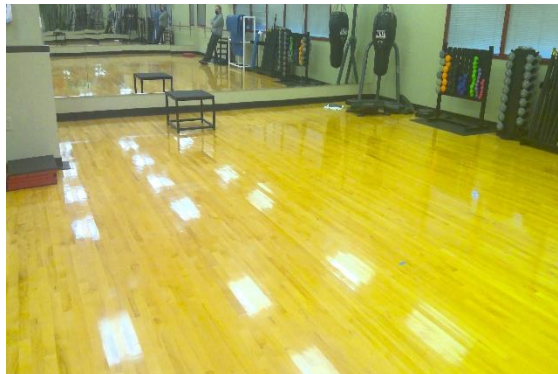
**Deficiency F08**

The wood flooring has warped slightly due to prior exposure to water. The flooring may have buckled due to expansion. It is not known if the buckling could be alleviated by removing some of the flooring along the south wall (or if there is room for the flooring to expand). The flooring condition is worn and it should continue to be monitored for repair or replacement. Additional information is required to determine if the flooring must be replaced due to the exposure to water.

| Deficiency score : $2.5 \times ((12 \times 50\%) + (5 \times 50\%)) + 2 = 23.3$ |

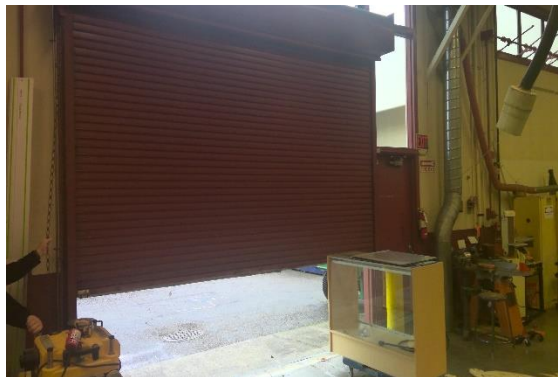
**Deficiency F09**

The overhead doors serving the shop areas and electrical closets are failing. Many of the doors are difficult to operate and have become less reliable. Some of the doors act as smoke or fire barriers. These doors should be replaced.

| Deficiency score : $4 \times ((15 \times 80\%) + (12 \times 20\%)) + 2 = 59.6$ |

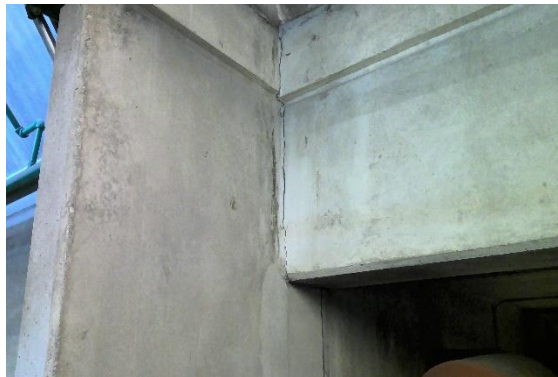
**Deficiency F10**

For several biennia, the college has been concerned about some cracking found in the structural concrete joints near the east entrance to the mechanical "cat walk". It appears that the joint has been repaired in the past. The college did not know if the crack represented any structural failure to the building. Additional information is required to determine if the crack is superficial or if it indicates structural failure.

| Deficiency score : $4 \times ((5 \times 50\%) + (10 \times 50\%)) + 2 = 32$ |

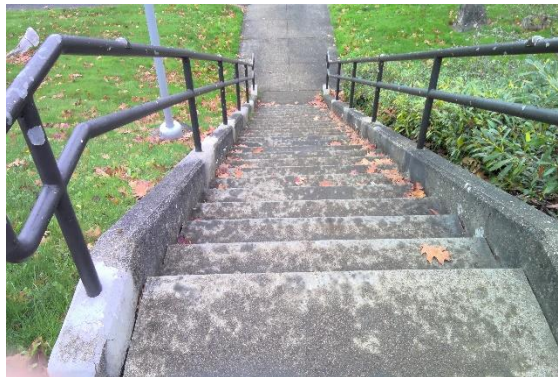
**Deficiency S01**

The college is concerned about the condition of the three concrete stairs on the north and southeast areas of the campus. These stairs are similar to the southwest stairs that have previously failed. The stair rails have all been patched due to spalling concrete. It appeared that some stair treads were cracking due to the effects of moisture intrusion and rebar expansion. The stairs should be replaced.

| Deficiency score : $4 \times ((12 \times 70\%) + (15 \times 30\%)) + 0 = 51.6$ |
