# 2021 FACILITY CONDITION SURVEY

Lower Columbia College

SURVEY CONDUCTED BY:  
Steve Lewandowski  
State Board for Community  
and Technical Colleges

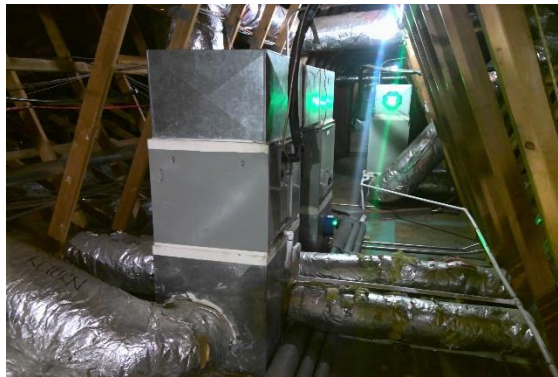
The heat pumps have degraded and are beginning to fail. The level of maintenance has increased and these units should be replaced.

| Deficiency score : $4 \times (15 \times 100\%) + 1 = 61$ |

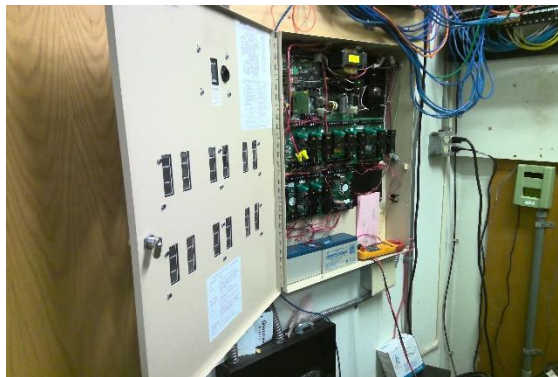
**Deficiency F02**

The fire alarm panel is at the end of its useful life and the college believes that the vendor can no longer support repairs. Additional information is required to confirm this. If the vendor does not support the panel then it should be replaced.

| Deficiency score : Needs study |

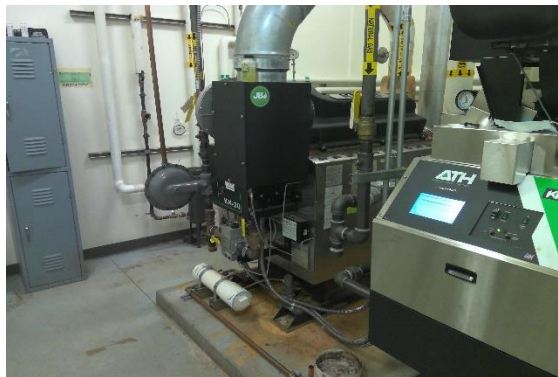
**Deficiency F03**

The college is college is concerned about the remaining life of one of the two boilers serving the building. The other boiler has already failed due to internal corrosion and has been replaced. The remaining boiler is also failing due to the same deterioration. The remaining boiler should be replaced.

| Deficiency score : $4 \times (15 \times 100\%) + 0 = 60$ |

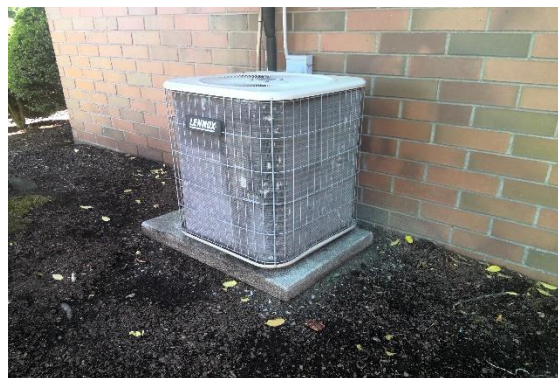
**Deficiency F04**

The split unit heat pump has failed and should be replaced.

| Deficiency score : $4 \times ((12 \times 70\%) + (15 \times 30\%)) + 1 = 52.6$ |

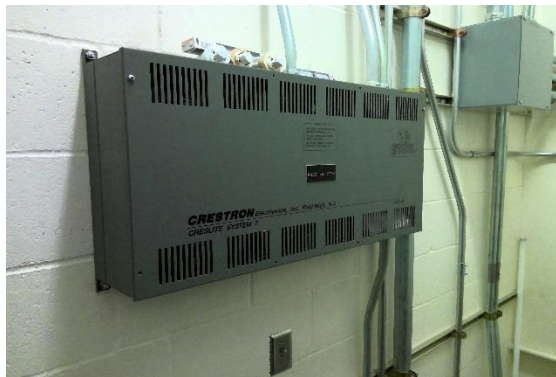
**Deficiency F05**

The lighting controls have failed twice. There is also evidence of wire failure. The system was repaired, but has become unreliable. The system is difficult to fix because there are no local vendors and parts are difficult to find. The wiring and controls should be replaced.

| Deficiency score : $4 \times (15 \times 100\%) + 0 = 60$ |

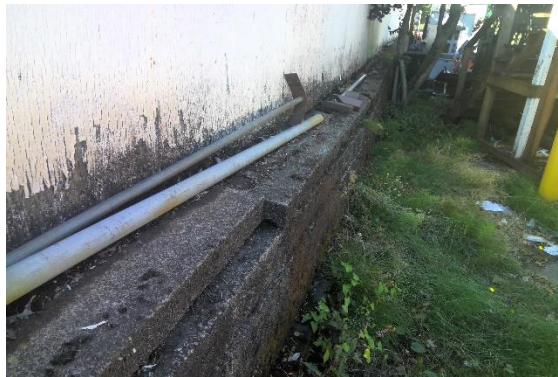
**Deficiency S01**

The retaining wall has failed due to shifting soil. The wall is no longer structurally stable and should be replaced.

| Deficiency score : $4 \times ((12 \times 80\%) + (25 \times 20\%)) + 0 = 58.4$ |

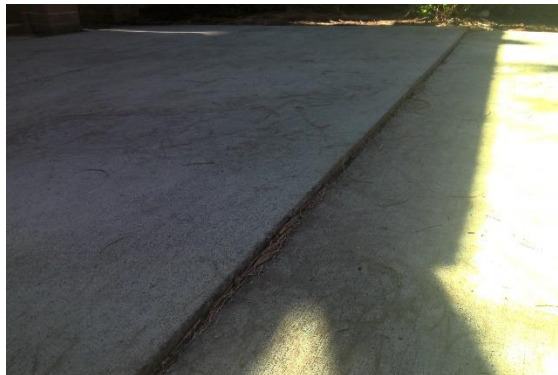
**Deficiency S02**

There are several sections of concrete that heaved, settled or cracked. Some of these areas violate civil rights laws since they no longer meet the ADA standard. These sections should be replaced.

| Deficiency score : $4 \times ((20 \times 70\%) + (5 \times 30\%)) + 0 = 62$ |
