# 2021 FACILITY CONDITION SURVEY

North Seattle College

SURVEY CONDUCTED BY:  
Steve Lewandowski  
State Board for Community  
and Technical Colleges

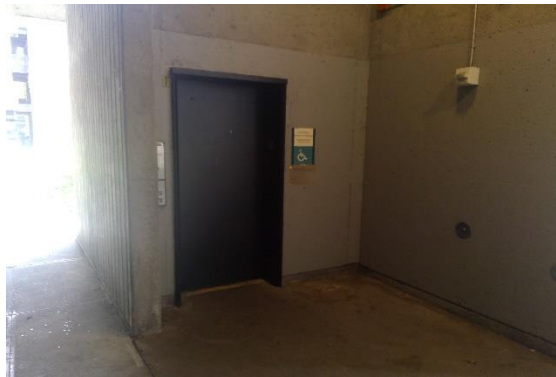
### **Deficiency F01**

The college was concerned that the elevators are requiring more frequent repairs to maintain function. Typically repairs are minor. The controls were replaced 15 years ago. The cabs were in good condition. The elevator lift motors were operating as designed. The elevator components should continue to be monitored for future replacement

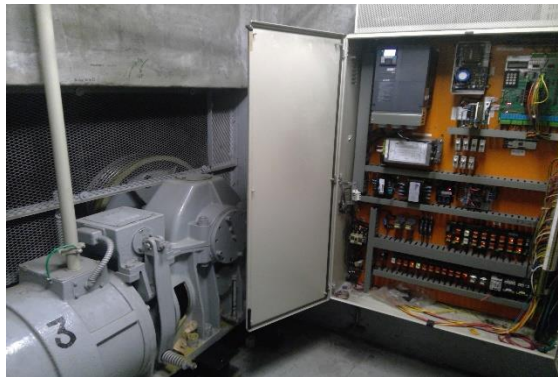
**Deficiency F02**

The elevator located on the west side of the building is exposed to the outside elements. The college was concerned about the number of repairs required to maintain function. Repairs are typically minor. The controls were replaced 15 years ago. The cabs were in good condition. The elevator lift motors were operating as designed. The elevator components should be monitored and be replaced in the future.

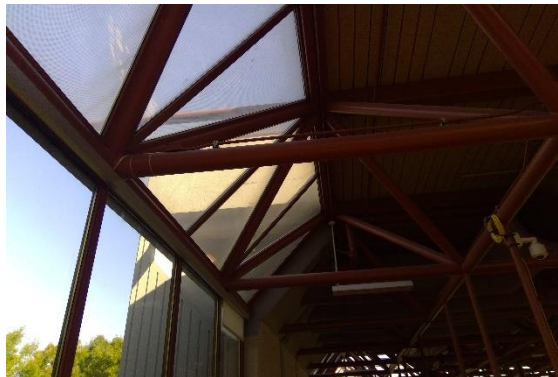
**Deficiency F03**

There are storefront window systems around the upper perimeter of the building that leak. The college believes that there may be a header or seal problem. The leak appeared to come from the roof parapet. The roofing does not wrap up and over the parapet and the cap has overlapping joints rather than standing seam. The roofing should be repaired to extend over the parapet. The parapet cap should be re-sealed to ensure a water tight roof.

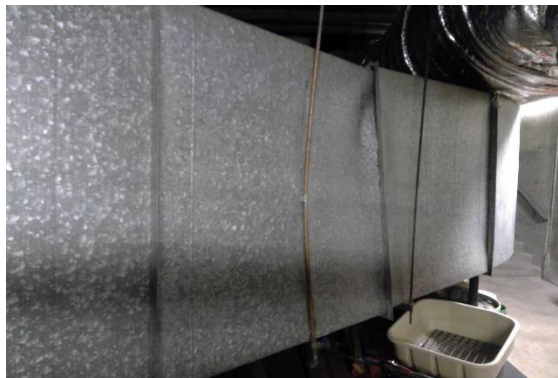
**Deficiency F04**

There is a section of ductwork that has collapsed. This section should be replaced.

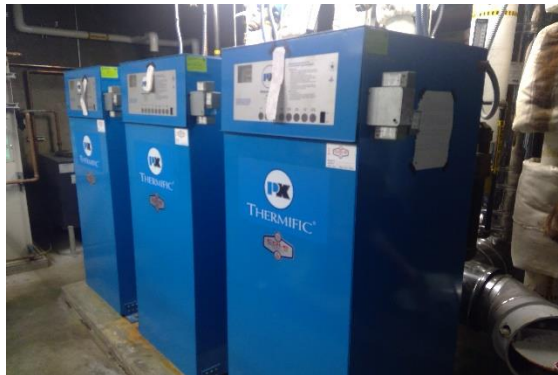
**Deficiency F05**

The college is concerned about the age of the boilers. There has been a higher level of maintenance. The boilers should continue to be monitored for replacements.

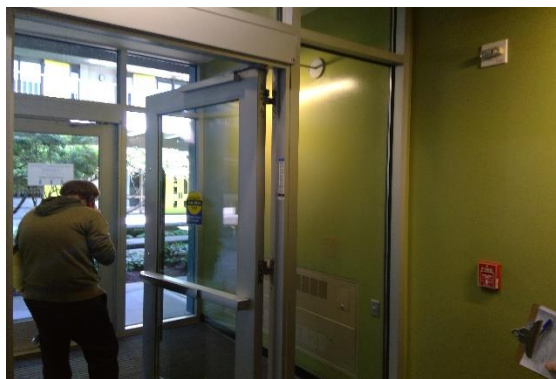
**Deficiency F06**

There are two sets of doors on the east side of the building that show signs of abuse. One door will not close on its own. Additional information is required to determine if the building tenants or the college is responsible for the repair cost. The doors should be replaced.

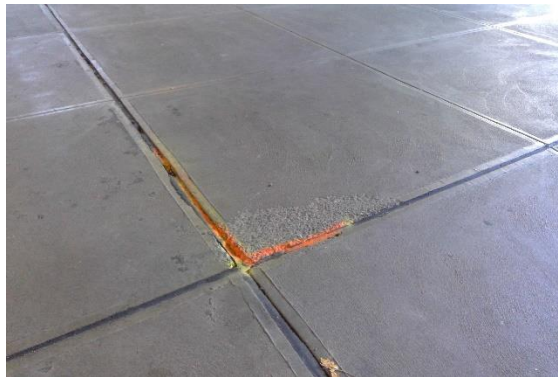
**Deficiency S01**

There are several pedestrian concrete paths that have failed. Some areas have heaved due to roots or settling. These areas should be replaced.

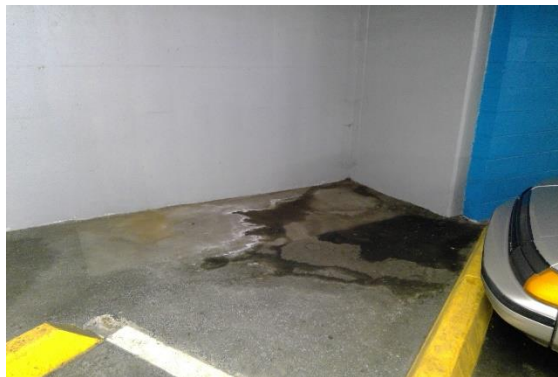
**Deficiency S02**

There is water infiltrating through the parking garage concrete walls on the west side under the instruction building. The college is not sure where the water is coming from. The waterproofing and concrete joints should be repaired to stop the flow of water.

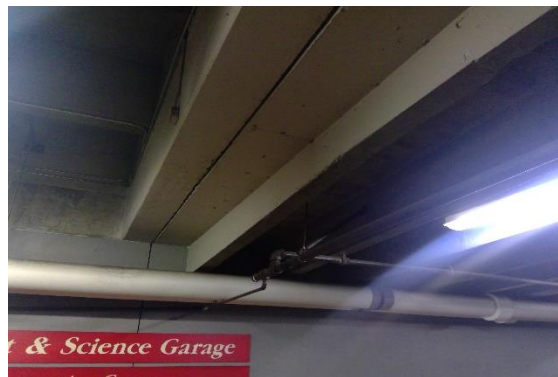
**Deficiency S03**

There are several expansion joints between building foundations and tunnels are leaking. These joints have deteriorated and should be replaced to ensure a water-tight condition.

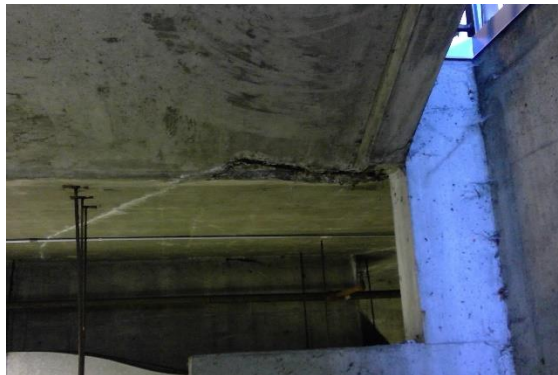
**Deficiency S04**

There are concrete stairs that have degraded due to water infiltration. The rebar has rusted and expanded. Sections of concrete have broken away from the stair. These stairs should be replaced.
