# 2021 FACILITY CONDITION SURVEY

Olympic College

SURVEY CONDUCTED BY:  
Steve Lewandowski  
State Board for Community  
and Technical Colleges

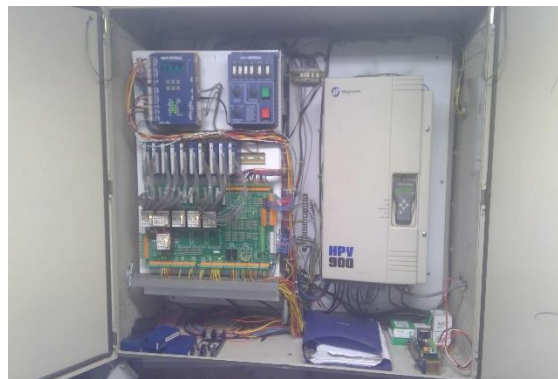
**Deficiency F02**

The 2003 elevator controls require frequent repairs and parts are difficult to find. Additional information from the elevator vendor is required to determine if the components are no longer supportable. Typically elevators can be maintained to function for roughly 45 years. The controls should continue to be monitored and be replaced in the future.

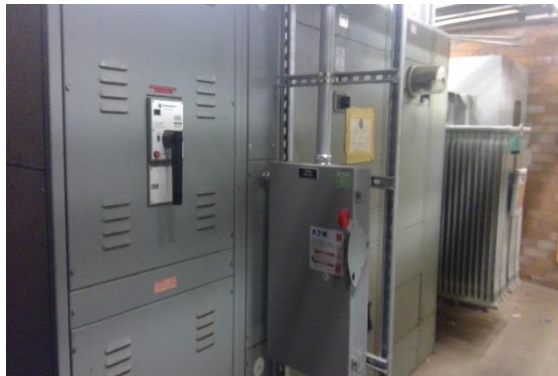
**Deficiency F03**

The college is concerned about the age of the primary disconnect, transformer, secondary distribution and motor control components. The college provided an equipment report that described the age concern, but specific condition was not evaluated. The equipment is still functioning as designed. Additional information and testing is required to justify replacement. Also, the components should be evaluated individually in order to focus on the item(s) in the worst condition. The equipment should continue to be monitored and be replaced in the future.

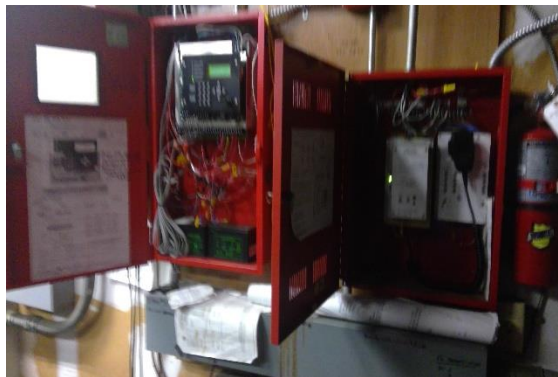
**Deficiency F04**

The fire alarm panel is commonly in warning mode. The system has become unreliable. A letter is required from the vendor that indicates the level of support. If the panel is no longer supported by the vendor, then the panel should be replaced.

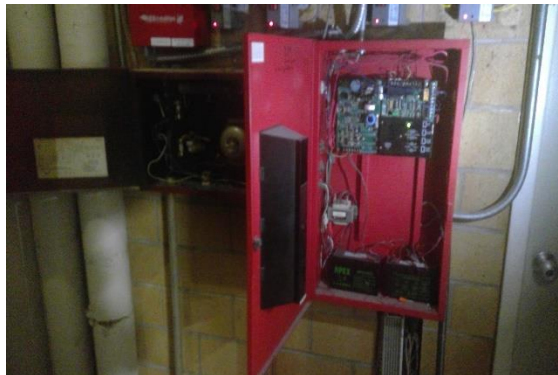
**Deficiency F06**

The college is concerned about the age and reliability of the 28-year-old panel. The panel is past its expected life and should be replaced.

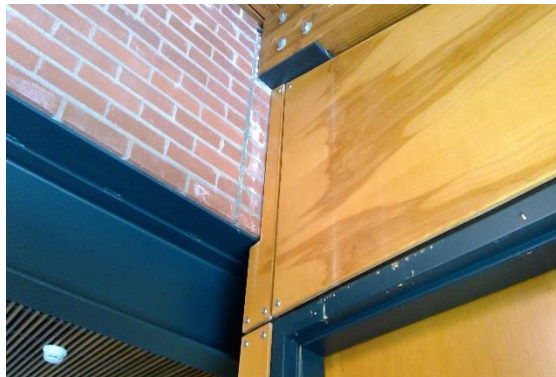
**Deficiency R01**

The building envelope leaks where it meets lower roof. This condition has occurred since the building opened a few years prior to the survey. The gutter system behind the masonry does not function correctly and water penetrates the building. The masonry gutter and flashing should be repaired or modified to ensure a water tight condition.

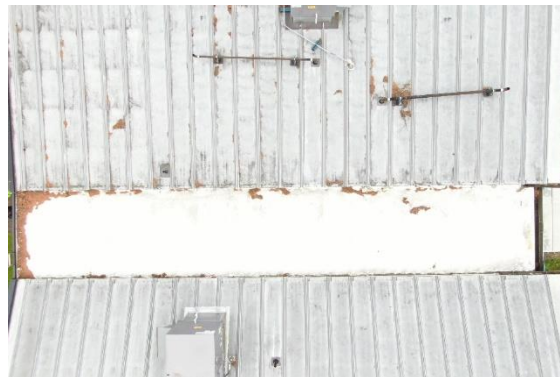
**Deficiency R02**

The college believes that the roofing is in poor condition and leaks. However, the lower section of roofing had been replaced two years earlier. The upper roofing appeared to be in good condition. Other roof penetrations were also modified to address leaks recently. The origin of the leaks is unknown, but are likely due to the low slope roof and inadequate flashing. Prior funding used for this roof issue did not fix the problem. Additional information is required to determine the appropriate scope of work for repairs before funding additional attempts to fix the roofing.

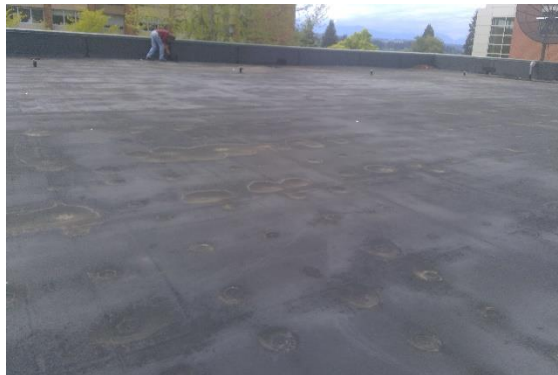
**Deficiency R03**

The EPDM roofing has glued seams that have failed and have been recently repaired. Minor repairs should be completed to extend the life of the roof.

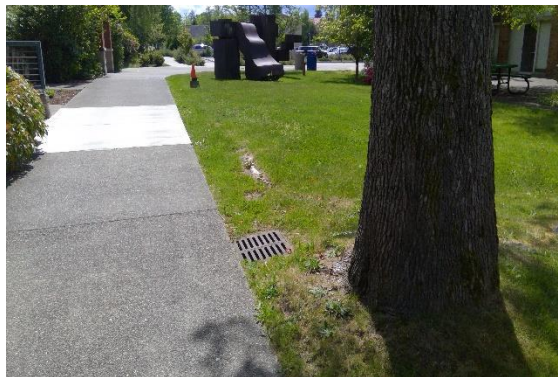
**Deficiency S01**

Repair Underground Utilities near Bldg. 6 (Haselwood Library), Bldg. 5 (CSC) and the Haselwood Library (including the courtyard outside of CSC). The sewer lines have been infiltrated and damaged by tree roots. These sections should be replaced. The college needs to provide additional information to determine the proper scope of work.

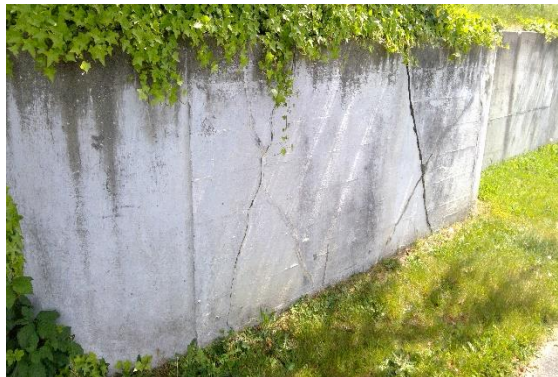
**Deficiency S02**

The college was concerned about the site drainage system along concrete wall on the west perimeter of the campus. Additionally, there is some damage to a small section of the retaining wall in this area. Additional information is required to determine the scope of the problem and to determine the appropriate scope of repair.
