# 2021 FACILITY CONDITION SURVEY

Peninsula College

SURVEY CONDUCTED BY:  
Steve Lewandowski  
State Board for Community  
and Technical Colleges

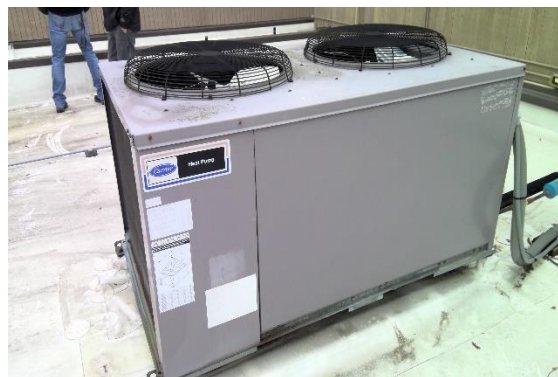
The college is concerned about the age of the two roof mounted heat pumps. The level of maintenance has increased to maintain function. The heat pump in the worst condition should be replaced. Parts should be retained to help extend the life of the other heat pump. The Legislature has not funded buildings used for intercollegiate sports for decades. Additional information is required regarding the use of the building for instructional purposes to justify repairs.

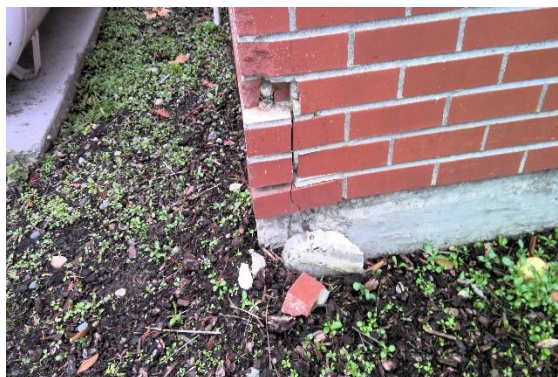
**Deficiency F02**

There are two locations where the masonry has cracked. It is not known if the cracking is due to seismic activity or due to settling, but it should be repaired. Additional information is required to determine if there are instructional classes provided in the building to help justify the repairs. The Legislature has not funded buildings used for intercollegiate sports for decades, however, they have allowed envelope repairs to help maintain prior funded buildings. In order to maintain the integrity of the building envelope, these areas with failing masonry should be repaired.

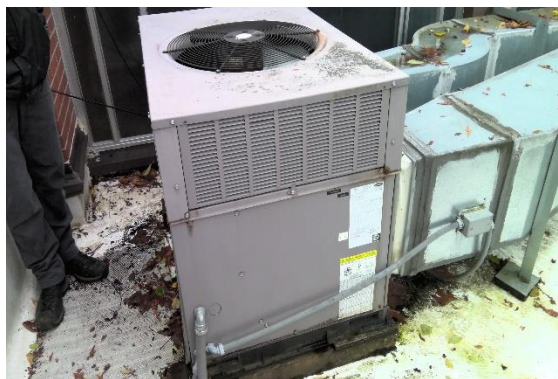
**Deficiency F03**

There are four (2 ton) units that are near the end of their useful life. The units still function, but the college is concerned about the age of the units. Two of the worst units should be replaced. The other two units should continue to be monitored for replacement.

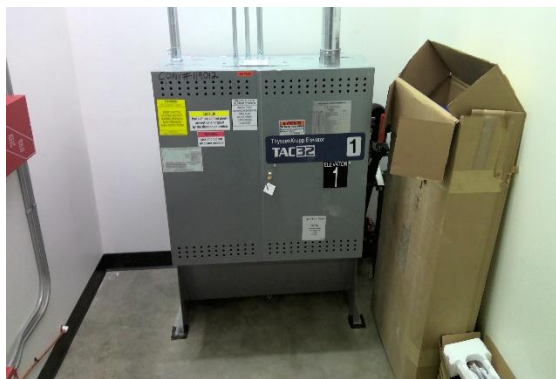
**Deficiency F04**

The college had an elevator service inspection that indicated that there was an oil leak. The elevator is only 4 years old. The college expects to receive a report that describes the issue. The initial finding was leaning towards a pump problem. Additional information is required to determine the scope of work.

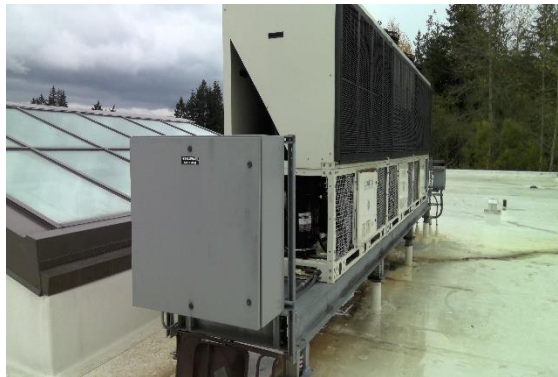
**Deficiency F05**

The large heat pump has required repairs. Three compressors have failed. Outdoor coils have leaked and failed twice. The unit appears to be a lemon product with very poorly manufactured equipment. The college has had recent repairs completed that may solve some of the current problems. The unit should be monitored and be evaluated for replacement next biennium if the repair trend continues.

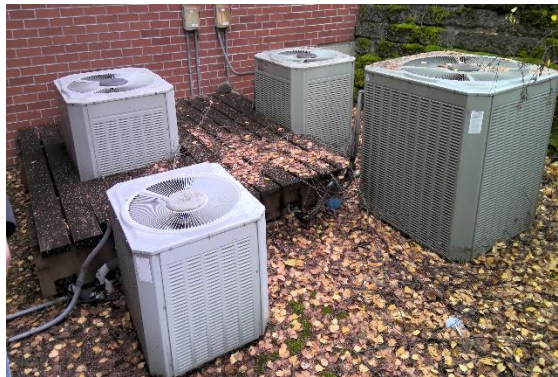
**Deficiency F06**

The heat pumps are at the end of their useful life. The college has had to make more frequent repairs to maintain function. The units should be replaced.
