# 2021 FACILITY CONDITION SURVEY

Pierce College Fort  
Steilacoom

SURVEY CONDUCTED BY:  
Steve Lewandowski  
State Board for Community  
and Technical Colleges

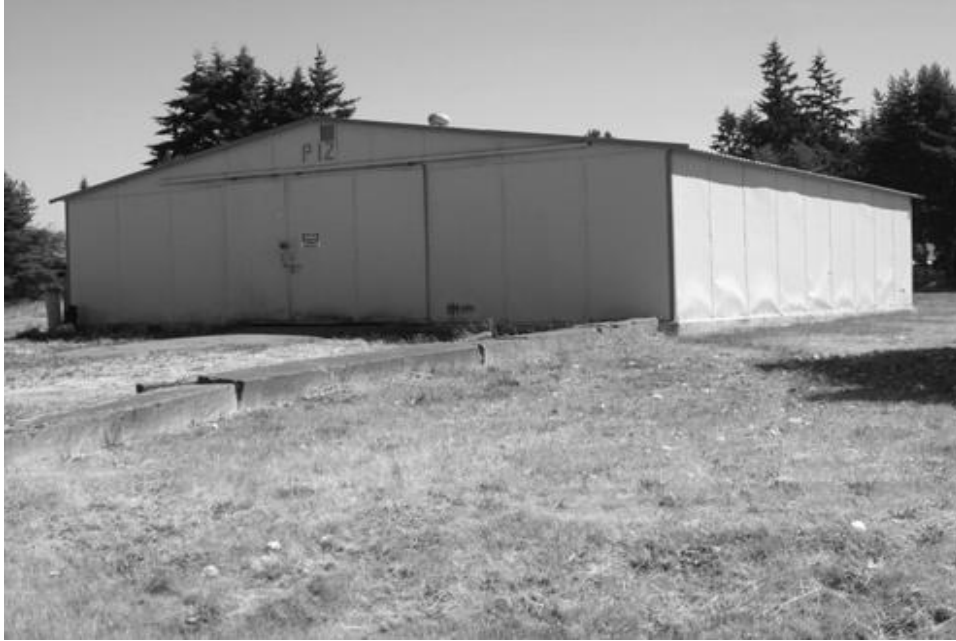
Barn (111-P12)      STATE UFI: A07687      Ft. Steilacoom Campus (111A)  
AREA: 900 SF      BUILT: 1974      REMODELED: No      PREDOMINANT USE: Storage  
CONSTRUCTION TYPE: Light      CRV/SF: \$127      REPLACEMENT VALUE: \$114,300

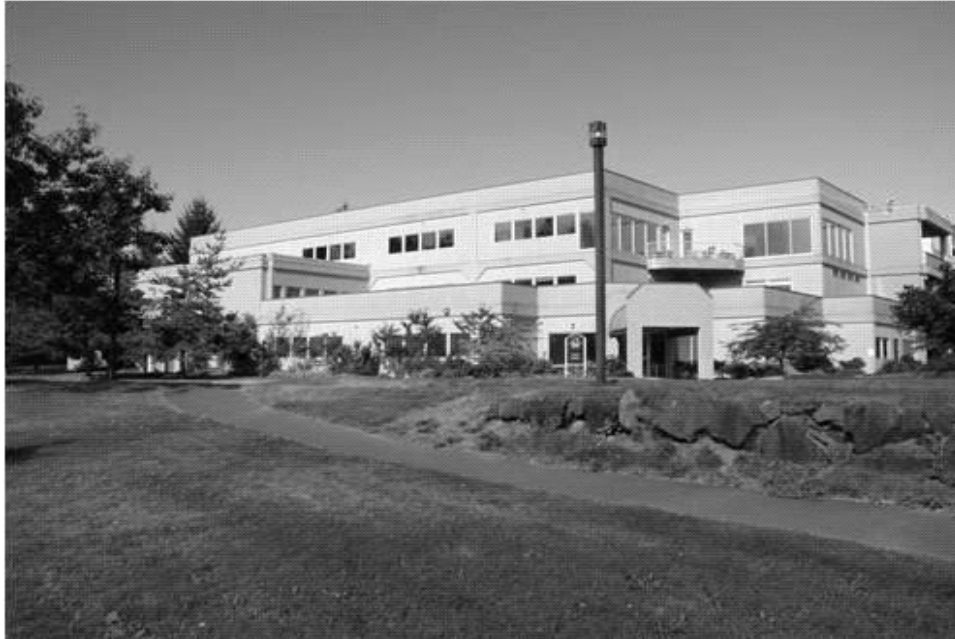
Cascade Bldg (111-S1)      STATE UFI: A08348      Ft. Steilacoom Campus (111A)  
AREA: 247,595 SF      BUILT: 1973      REMODELED: 2009      PREDOMINANT USE: Multi-Use  
CONSTRUCTION TYPE: Heavy      CRV/SF: \$379      REPLACEMENT VALUE: \$93,838,505

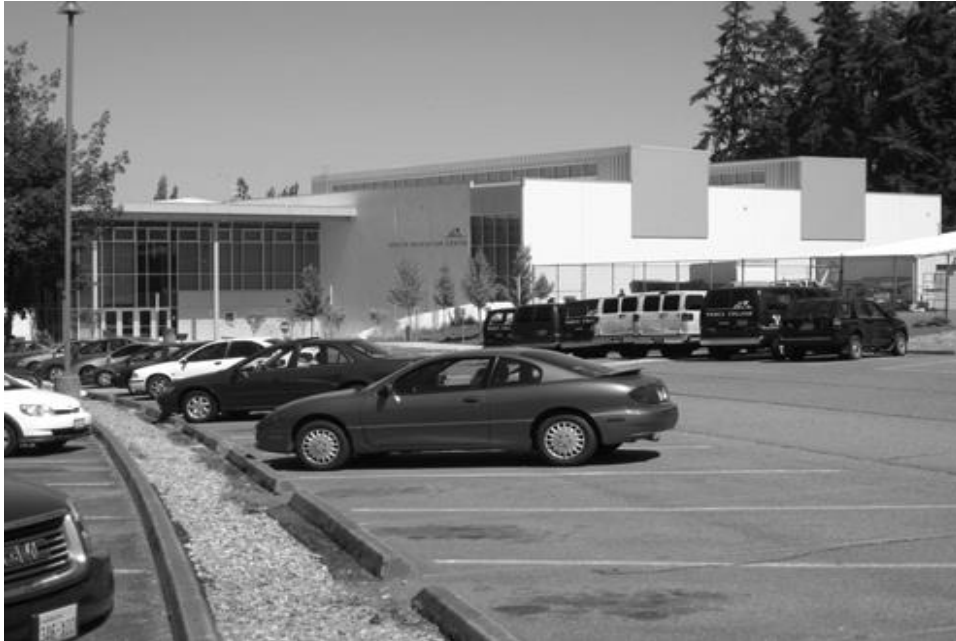
Health Education Cntr (111-S3)      STATE UFI: A03199      Ft. Steilacoom Campus (111A)  
AREA: 45,539 SF      BUILT: 1973      REMODELED: 2007      PREDOMINANT USE: Gymnasium  
CONSTRUCTION TYPE: Heavy      CRV/SF: \$361      REPLACEMENT VALUE: \$16,439,579

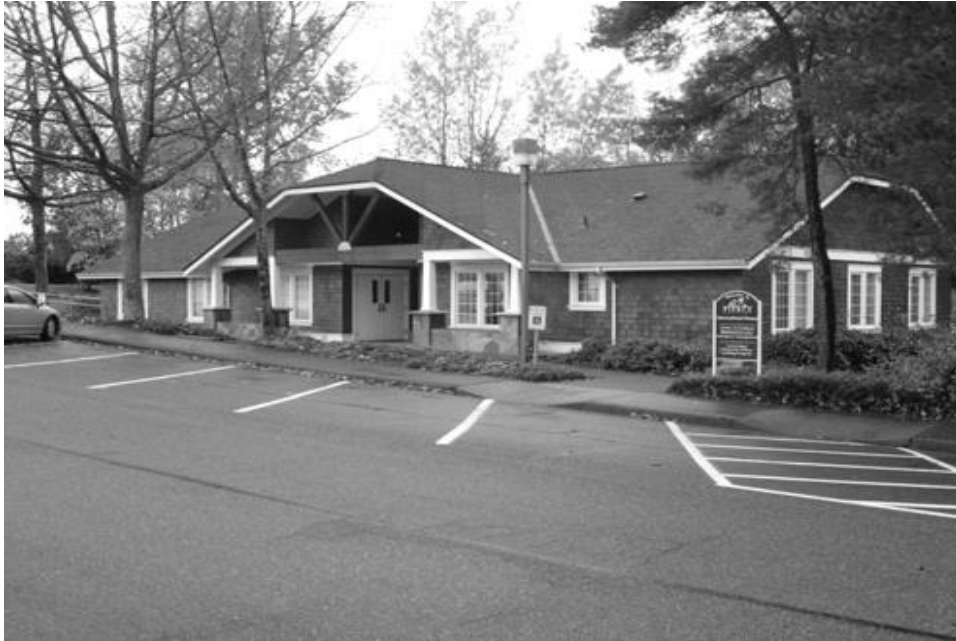
International House (111-S10)      STATE UFI: A01170      Ft. Steilacoom Campus (111A)  
AREA: 2,652 SF      BUILT: 2000      REMODELED: No      PREDOMINANT USE: Administration  
CONSTRUCTION TYPE: Light      CRV/SF: \$253      REPLACEMENT VALUE: \$670,956

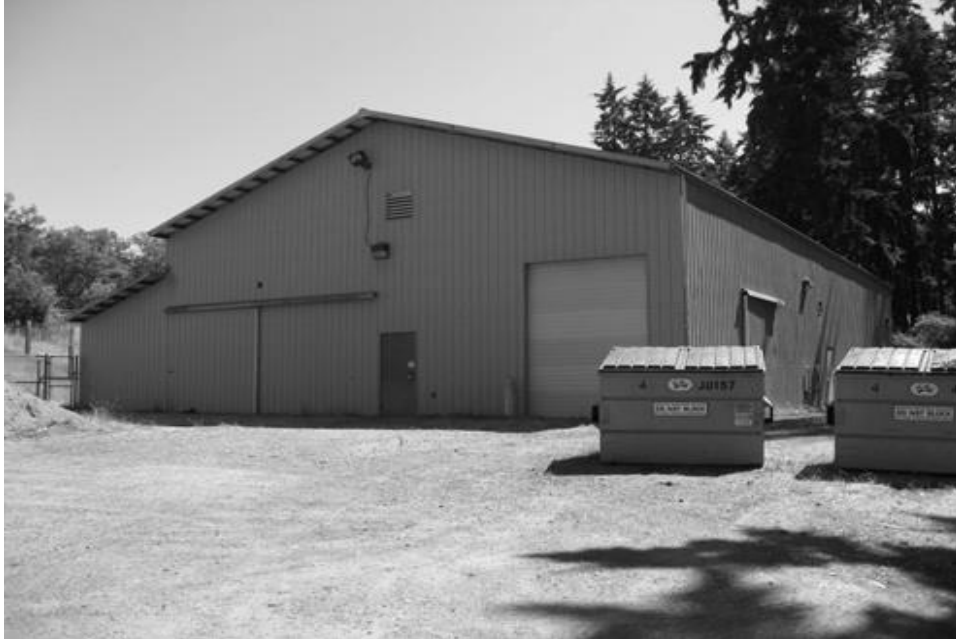
Large Animal Facility (111-S4)      STATE UFI: A07526      Ft. Steilacoom Campus (111A)  
 AREA: 4,800 SF      BUILT: 1992      REMODELED: No      PREDOMINANT USE: Vocational Arts  
 CONSTRUCTION TYPE: Light      CRV/SF: \$222      REPLACEMENT VALUE: \$1,065,600

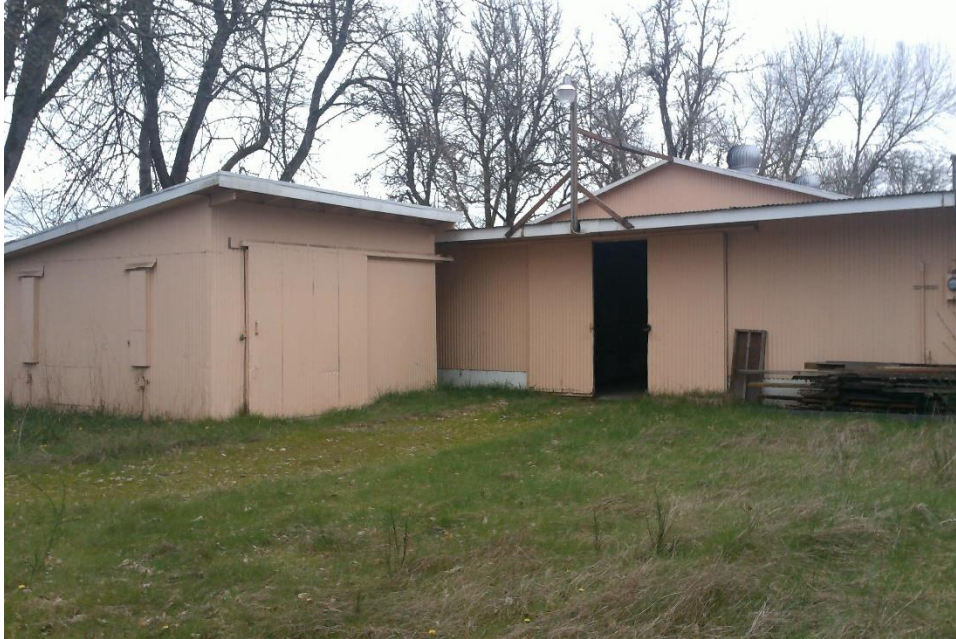
Maintenance (111-P15)      STATE UFI: A07010      Ft. Steilacoom Campus (111A)  
 AREA: 3,264 SF      BUILT: 1957      REMODELED: No      PREDOMINANT USE: Central Storage  
 CONSTRUCTION TYPE: No data      CRV/SF: \$144      REPLACEMENT VALUE: \$470,016

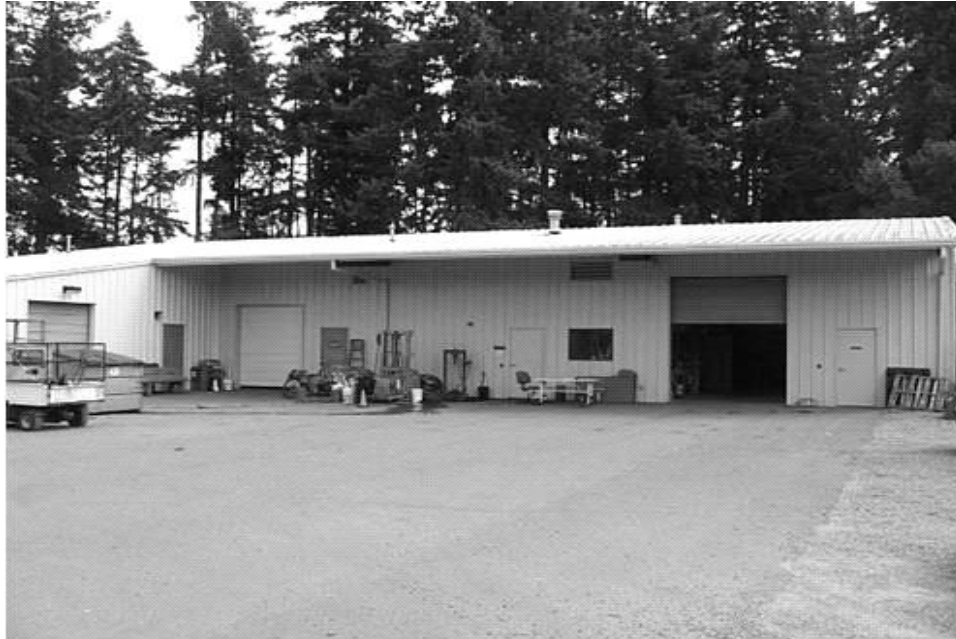
Maintenance Bldg (111-S5)      STATE UFI: A07795      Ft. Steilacoom Campus (111A)  
 AREA: 5,000 SF      BUILT: 1992      REMODELED: No      PREDOMINANT USE: Maintenance  
 CONSTRUCTION TYPE: Medium      CRV/SF: \$222      REPLACEMENT VALUE: \$1,110,000

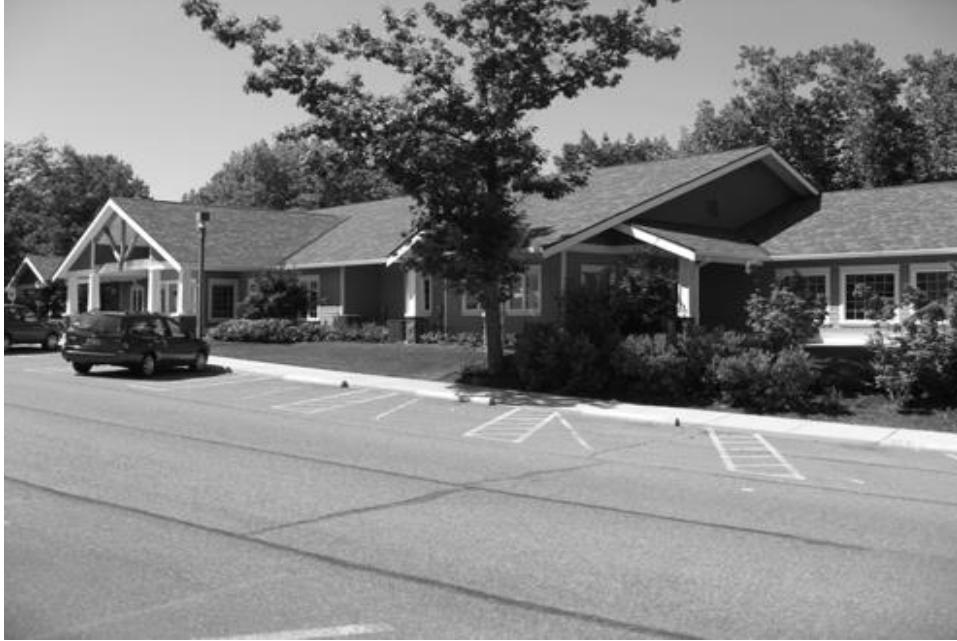
Milgard Child Center (111-S8)      STATE UFI: A02651      Ft. Steilacoom Campus (111A)  
 AREA: 9,900 SF      BUILT: 2005      REMODELED: No      PREDOMINANT USE: Child Care  
 CONSTRUCTION TYPE: Light      CRV/SF: \$253      REPLACEMENT VALUE: \$2,504,700

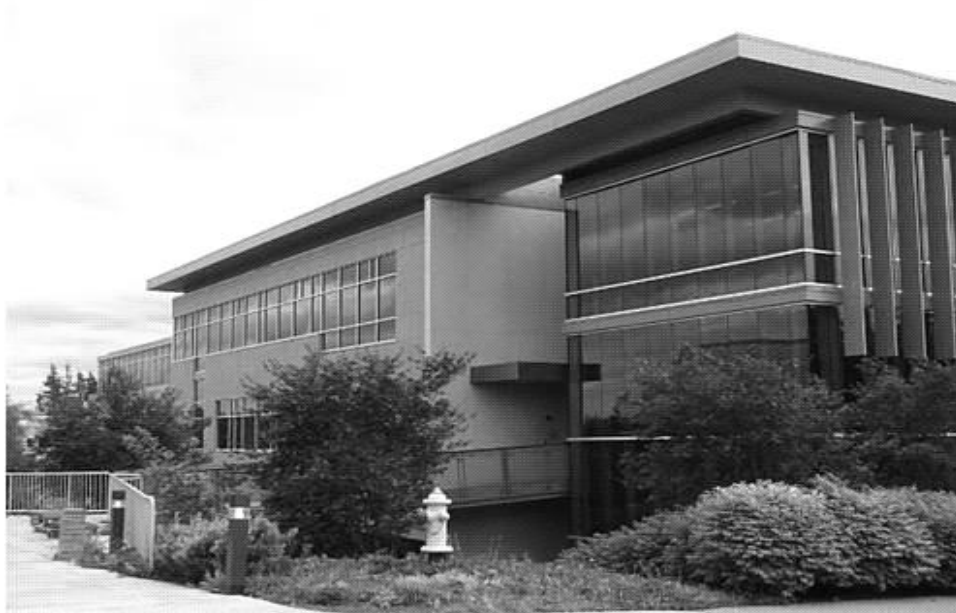
Olympic North Bldg (111-S7)      STATE UFI: A01116      Ft. Steilacoom Campus (111A)  
 AREA: 25,160 SF      BUILT: 2000      REMODELED: No      PREDOMINANT USE: General Classroom  
 CONSTRUCTION TYPE: Heavy      CRV/SF: \$361      REPLACEMENT VALUE: \$9,082,760

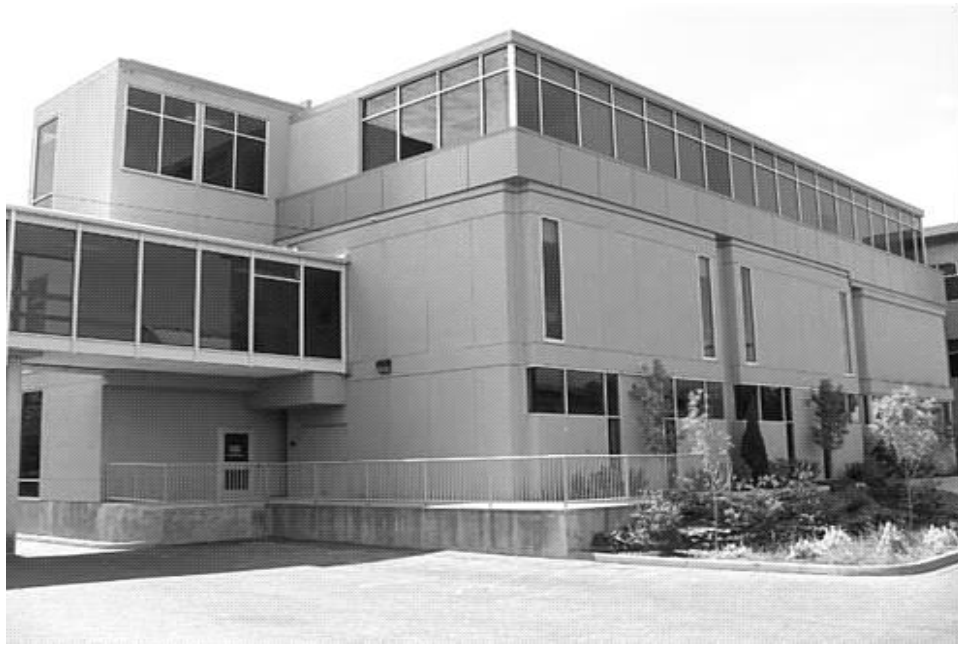
Olympic South Bldg (111-S2)      STATE UFI: A03250      Ft. Steilacoom Campus (111A)  
AREA: 38,800 SF      BUILT: 1976      REMODELED: No      PREDOMINANT USE: General Classroom  
CONSTRUCTION TYPE: Heavy      CRV/SF: \$379      REPLACEMENT VALUE: \$14,705,200

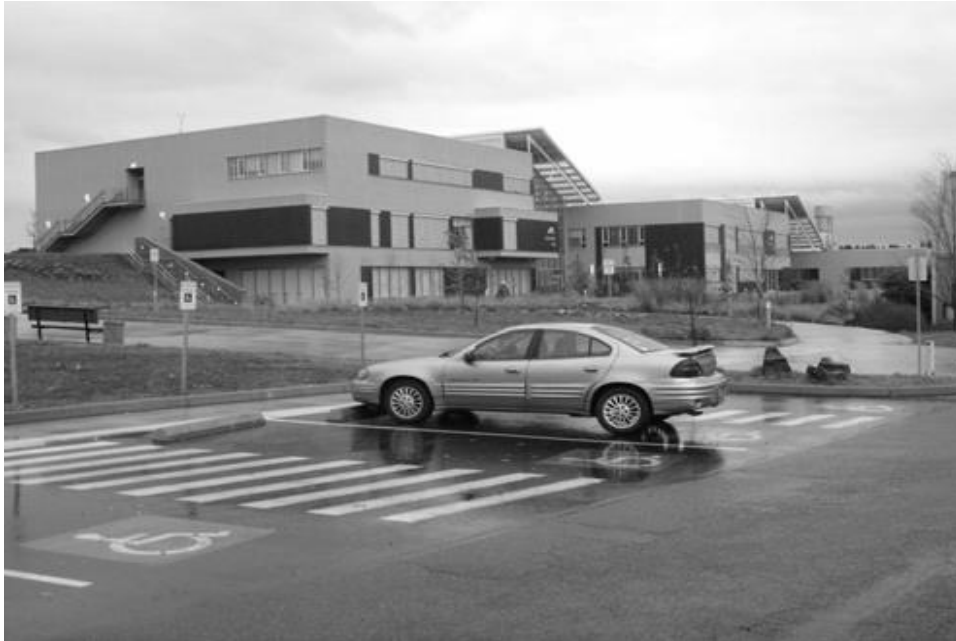
Rainier Building (111-S9)      STATE UFI: A01570      Ft. Steilacoom Campus (111A)  
 AREA: 80,645 SF      BUILT: 2010      REMODELED: No      PREDOMINANT USE: Arts/Science  
 CONSTRUCTION TYPE: Heavy      CRV/SF: \$481      REPLACEMENT VALUE: \$38,790,245

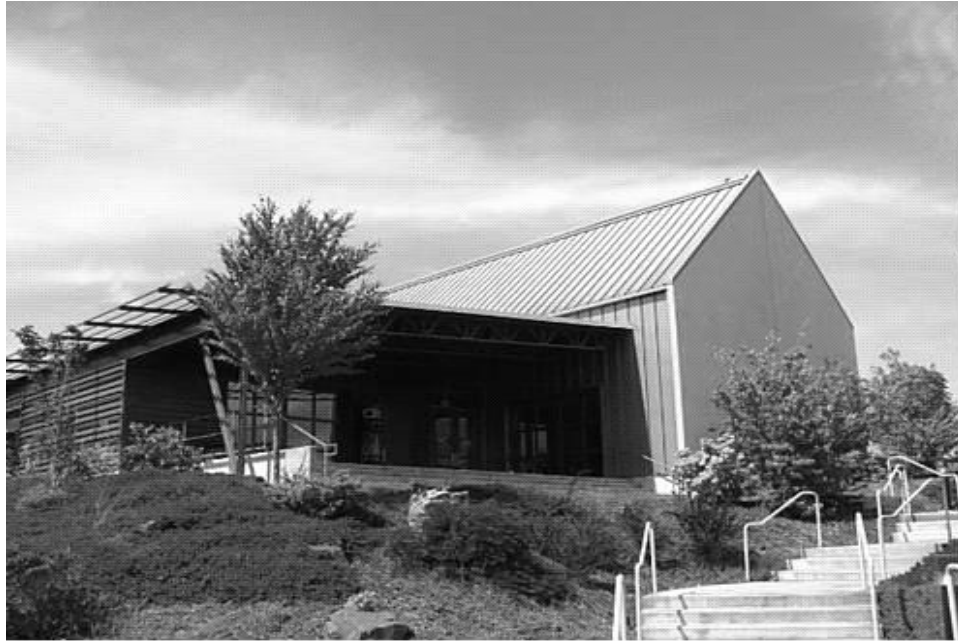
Sunrise Bldg (111-S6)      STATE UFI: A02182      Ft. Steilacoom Campus (111A)  
 AREA: 11,700 SF      BUILT: 1998      REMODELED: No      PREDOMINANT USE: General Classroom  
 CONSTRUCTION TYPE: Medium      CRV/SF: \$361      REPLACEMENT VALUE: \$4,223,700

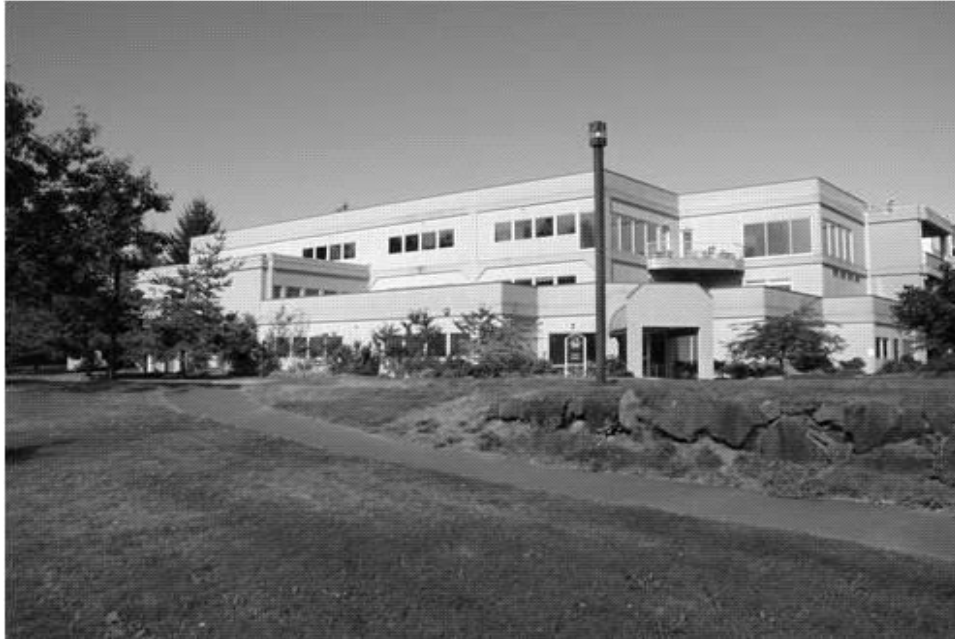
Cascade Bldg (111-S1) - Partial      STATE UFI: A08348      Ft. Steilacoom Campus (111A)  
AREA: 220,00 SF      BUILT: 1973      REMODELED: No data      PREDOMINANT USE: Cascade Bldg (111-S1)  
CONSTRUCTION TYPE: Heavy      CRV/SF: \$0      REPLACEMENT VALUE: \$247595

3rd floor (bookstore) and 5th floor (tutoring, classrooms, international offices & disability services)
