# 2021 FACILITY CONDITION SURVEY

Pierce College Puyallup

SURVEY CONDUCTED BY:  
Steve Lewandowski  
State Board for Community  
and Technical Colleges

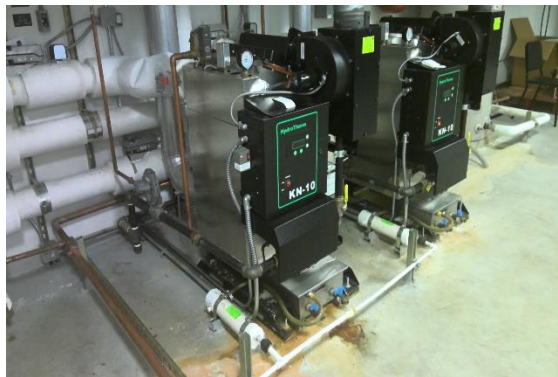
The college is concerned about the condition of the two boilers. The college has replaced the front-end blower/igniter three times on one of the boilers. The college has recently scheduled to recondition the problematic boiler during the current biennium. The boilers should continue to be monitored for repairs or replacement.

| Deficiency score : $2.5 \times ((12 \times 60\%) + (15 \times 40\%)) + 0 = 33$ |

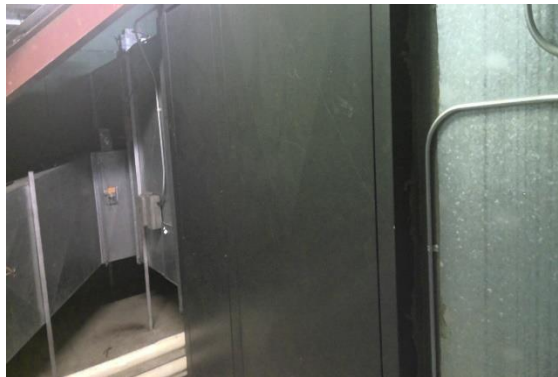
**Deficiency F02**

The three air handlers in the mechanical penthouses have required frequent maintenance to maintain function. All three units still operate as originally designed. Typical repairs have been made to extend their useful life. Two of the units are less reliable and require more attention. These two units should be reconditioned to extend their useful life.

| Deficiency score : $4 \times ((15 \times 80\%) + (12 \times 20\%)) + 1 = 58.6$ |

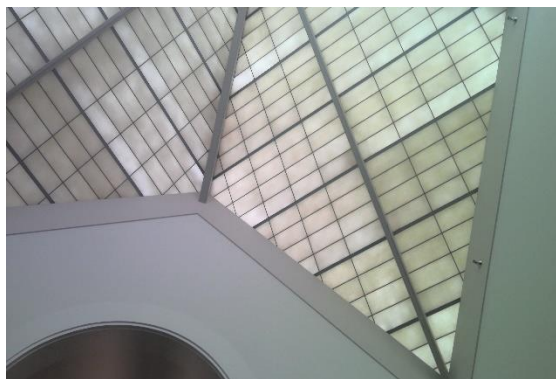
**Deficiency F03**

The college is concerned about the condition of the skylights. There have been more frequent leaks observed. The skylight panels and frames appear to be in good condition, but the seals have failed in some locations. The seals should be replaced.

| Deficiency score : $4 \times (12 \times 100\%) + 1 = 49$ |

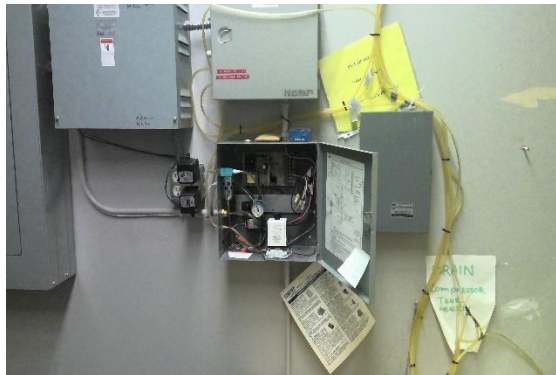
**Deficiency F04**

The pneumatic door operators require a high level of maintenance to maintain function. The lines have become brittle and regularly fail. The system has exceeded its expected useful life and should be replaced.

| Deficiency score : $4 \times ((15 \times 80\%) + (12 \times 20\%)) + 1 = 58.6$ |

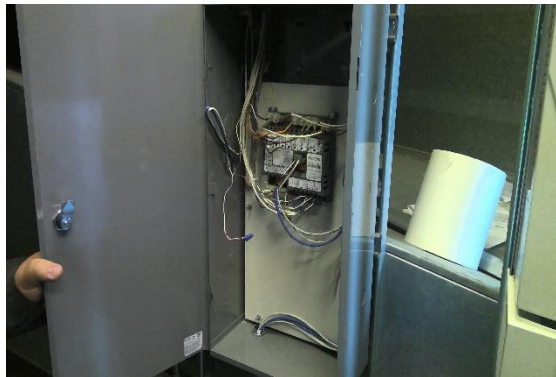
**Deficiency F05**

The college is concerned about the efficiency of the HVAC control modules. The controls still function as designed, but cannot take advantage of newer software that will be installed in the next few years. The college is working on a report to evaluate the controls. Additional information is required to determine if equipment is failing and requires repairs or if this would be considered an improvement rather than a repair.

| Deficiency score : Needs study |

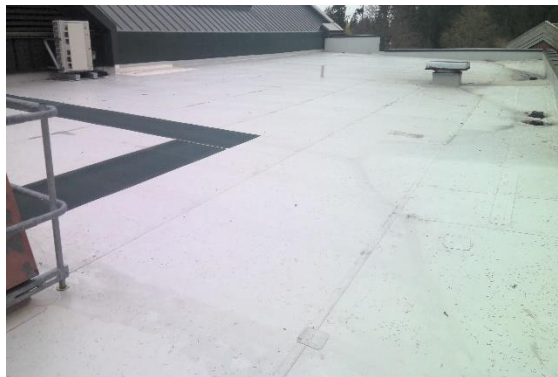
**Deficiency R01**

The college is concerned about the condition of the roofing because of past leaks. Several areas have been patched, however, the main field areas appeared to be in good condition. The roof did not leak at the time of the survey. The roofing should continue to be monitored for future repairs or replacement.

| Deficiency score : $1 \times ((12 \times 70\%) + (15 \times 30\%)) + 1 = 13.9$ |

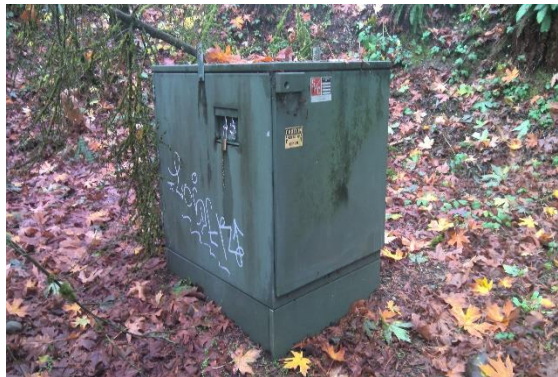
**Deficiency S01**

The college is concerned about the electrical systems that connect to the local utility. Past electrical surges have caused some damage to HVAC equipment on one building and total electrical disruption in another building. The college was not sure what is wrong with the electrical system and were still analyzing the system at the time of the survey. Additional information is required to determine the scope of work required to address the past problems.

| Deficiency score : Needs study |
