# 2021 FACILITY CONDITION SURVEY

Renton Technical College

SURVEY CONDUCTED BY:  
Steve Lewandowski  
State Board for Community  
and Technical Colleges

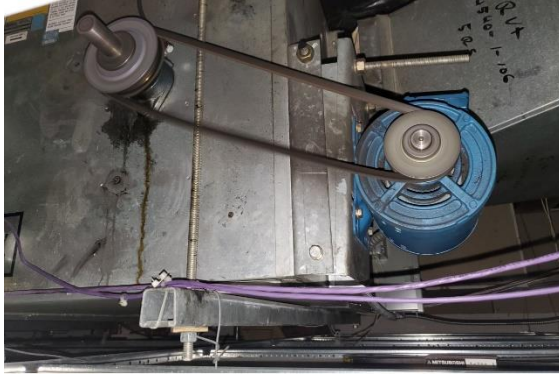
**Deficiency F03**

Several air handling units are near the end of their expected useful life. Some of the components have required some repairs, however, other units are still functioning as designed and have not required repairs. The worst four of these units should be replaced.

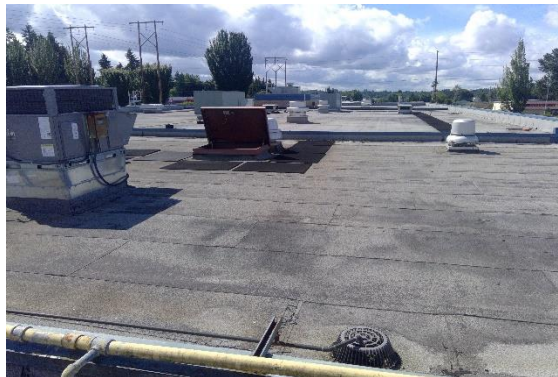
**Deficiency R02**

The roofing has deteriorated. Seams have failed. Rigid insulation has failed. Many leaks have been repaired and continue to emerge. One third of the roof is scheduled to be replaced during the current biennium. The remaining portion of the roofing should also be replaced. The parapet cap flashing should also be replaced.

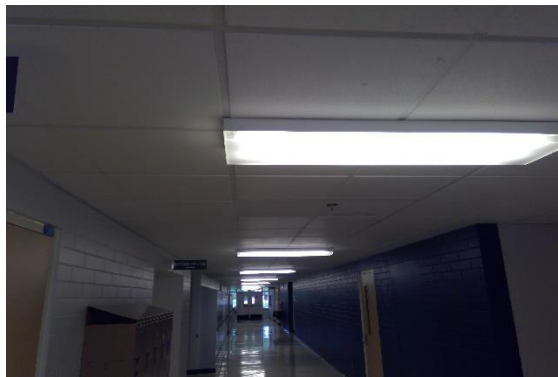
**Deficiency F09**

The fire suppression piping in buildings H, J and L has degraded. Several repairs are required each year on an emergency basis. The college is concerned about the condition of the main trunk line. Additional information is required to determine the extent of the problem and proper scope of repairs.

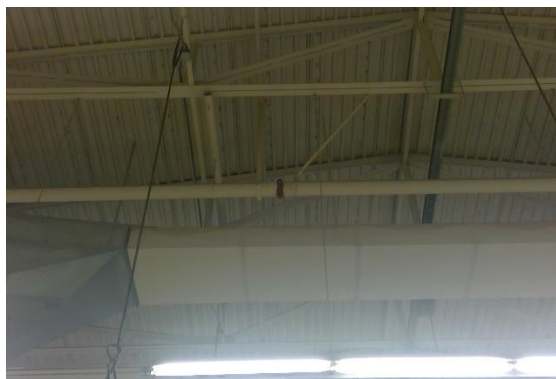
**Deficiency F10**

The college is concerned about the condition of the variable air volume units in the central corridor. The unit dampers are not consistently functioning and the motors are failing. There are three units in this area. The units are near the end of their useful life and should be replaced.

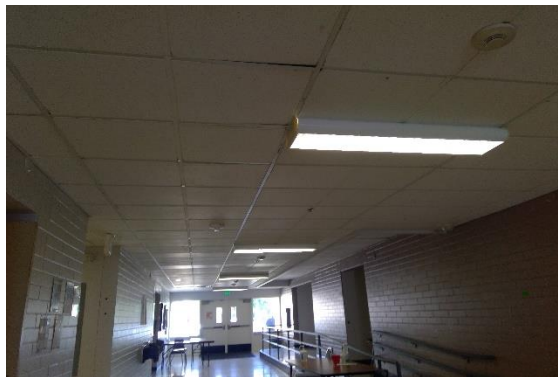
**Deficiency F11**

There are three distinct digital controls systems used to support the main campus buildings. The college is concerned about the unsupported "Lonworks" system in buildings C and H. The college needs to provide some documentation from the vendor that describes the level of support for the system components. If the controls are no longer supported, then they should be replaced.
