# 2021 FACILITY CONDITION SURVEY

Seattle Central College

SURVEY CONDUCTED BY:  
Steve Lewandowski  
State Board for Community  
and Technical Colleges

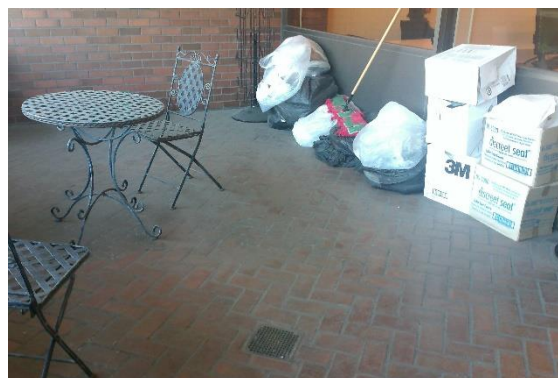
**Deficiency F01**

The college believes that there are three rooftop patios that leak and allow water to penetrate the building envelope. One patio has been funded for repair in prior biennium. The water is damaging the soffits. During the survey, college staff indicated that they had flooded the patios to find the leaks and could not find any. The water infiltration must be occurring in a different location. This has been reviewed over multiple biennia, but supporting information has never been provided to establish the corrective scope of work. Additional information is required to develop an appropriate scope of work.

| Deficiency score : Needs study |

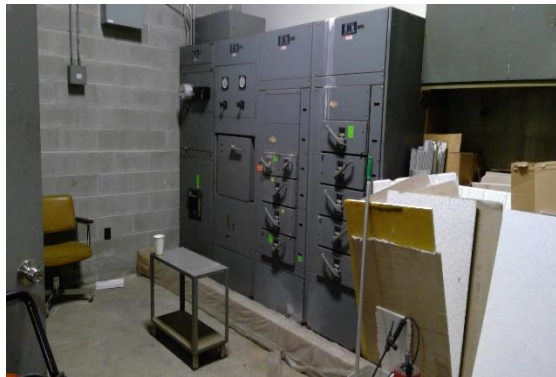
**Deficiency F02**

The main switchgear is over 48 years old and the college is concerned about the age of the equipment. Replacement parts are no longer available, however, the gear still functions as designed. In many cases college switchgear of this type can last more than 50 years. The gear still functions as designed and should continue to be monitored for replacement.

| Deficiency score : $2.5 \times (15 \times 100\%) + 2 = 39.5$ |

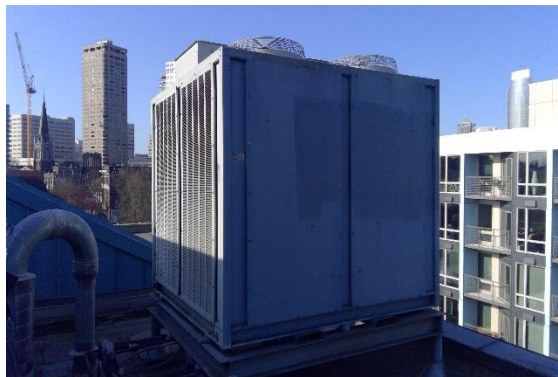
**Deficiency F03**

The college indicated that the rooftop unit (ACCU2) has required a high level of monitoring and repair. Two new compressors and new speed drives were recently installed to extend its useful life by several years. The unit still functions as designed. The unit should continue to be monitored and be replaced in the future.

| Deficiency score : $2.5 \times ((15 \times 50\%) + (12 \times 50\%)) + 1 = 34.8$ |

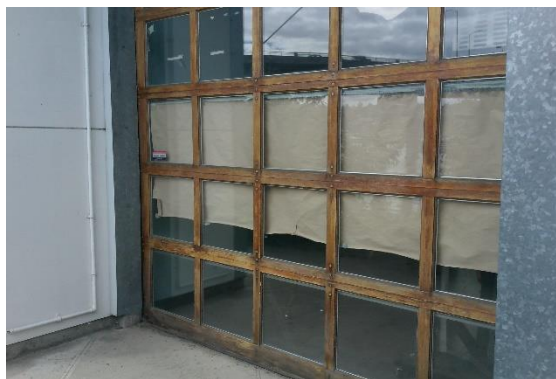
**Deficiency F04**

The wood-framed overhead sectional doors as well as the west window are deteriorating. These doors act as a window since they are not typically used. The wood frames are cracking in many places and should be repaired through typical maintenance to extend their useful life and be replaced in the future.

| Deficiency score : $2.5 \times ((15 \times 80\%) + (5 \times 20\%)) + 2 = 34.5$ |

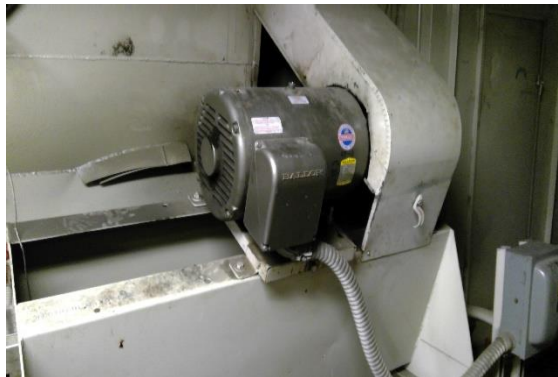
**Deficiency F05**

The return air fans in phase 1 of the building are degrading. The one in the north mechanical tower has recently had a bearing and motor replacement. Both units still function as designed and are built to last longer as long as components are replaced and the system is maintained properly. The units should continue to be monitored and be replaced in the future.

| Deficiency score : $1 \times ((15 \times 70\%) + (10 \times 30\%)) + 2 = 15.5$ |

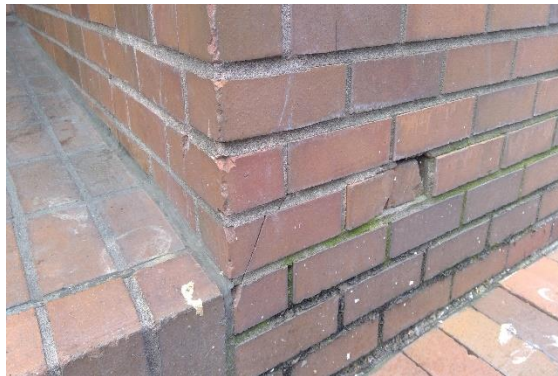
**Deficiency F06**

The exterior masonry has degraded, allowing water to easily penetrate the system. The masonry fasteners have degraded in some areas and the college is concerned that they may fail and allow the masonry to fall away from the wall. The college provided a report that identified that the east and south masonry fasteners have degraded. The areas of masonry over building entrances should be repaired to ensure that they are properly fastened to the building wall and properly supported. The masonry should also be properly sealed to reduce water intrusion in these areas.

| Deficiency score : $4 \times ((20 \times 60\%) + (12 \times 40\%)) + 2 = 69.2$ |

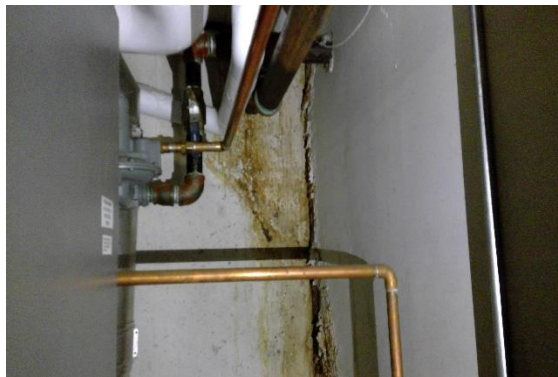
**Deficiency F07**

The planter located on the northeast side of the building allows water to penetrate the basement into a mechanical room next to the boilers. The planter and building concrete exterior should be repaired to stop the water intrusion. The damage to the building should also be repaired.

| Deficiency score : $4 \times (15 \times 100\%) + 1 = 61$ |

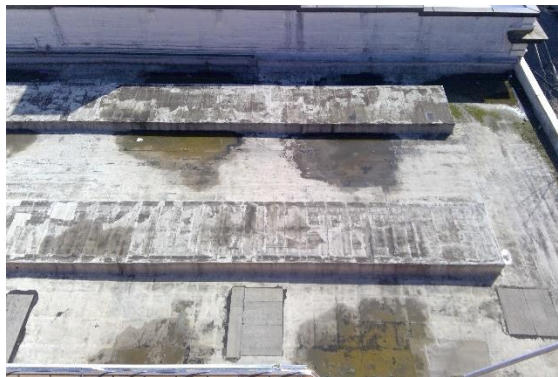
**Deficiency R01**

The roof has deteriorated and the college is concerned about standing water. The roof was resurfaced 18 years ago to extend its useful life and did not have leaks at the time of the survey. The roof is near the end of its useful life and should be considered for replacement next biennium.

| Deficiency score : $2.5 \times (15 \times 100\%) + 1 = 38.5$ |

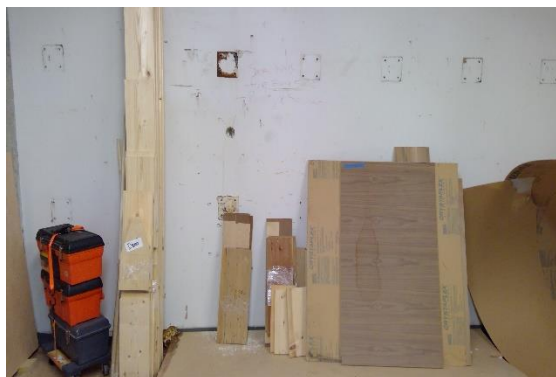
**Deficiency F08**

A below-grade exterior wall has penetrations put in place to support interior an wood support system. Storm water builds up on the soil side of the wall and travels through the penetrations. This water migration has damaged the interior wall. The wall should be repaired to ensure a water-tight system. Failing storm lines, down spouts, tight lines and footing drains in the soil behind the wall should be repaired to pull water away from the building walls and footing.

| Deficiency score : $4 \times ((15 \times 50\%) + (12 \times 50\%)) + 0 = 54$ |

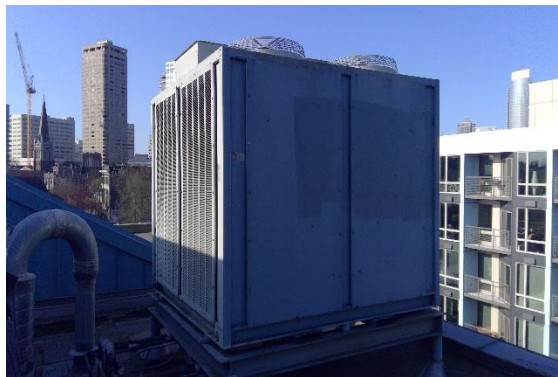
**Deficiency F09**

The DX chiller has required frequent repairs including the replacement of several compressors. The unit has become unreliable. The cost to recondition the unit is more than 50% of the value of a new unit. Therefore the unit should be replaced.

| Deficiency score : $4 \times ((15 \times 70\%) + (12 \times 30\%)) + 2 = 58.4$ |

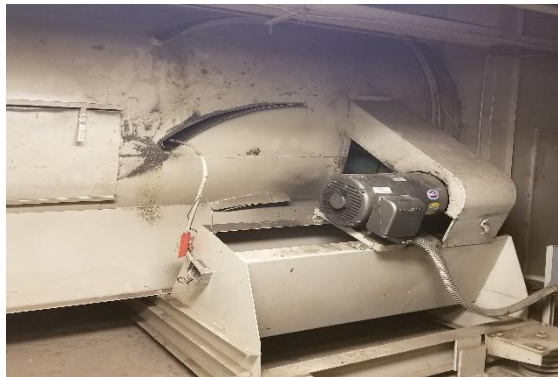
**Deficiency F10**

The supply fan is near the end of its expected life. A recent study completed by a mechanical contractor that commonly completes projects on campus indicated that the fan only has four years of life left. The large fan is no longer available and would need to be replaced with an array of smaller fans. The fan should continue to be monitored and be considered for replacement next biennium.

| Deficiency score : $2.5 \times (15 \times 100\%) + 2 = 39.5$ |

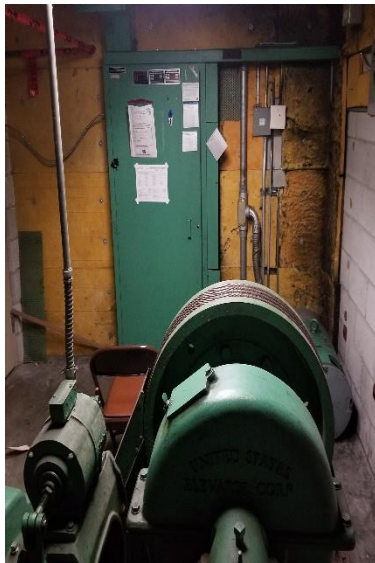
**Deficiency F11**

The college is concerned about the age of the elevator controls. They are near the end of their useful life and should be replaced to ensure the reliability of the elevator.

| Deficiency score : $4 \times ((15 \times 50\%) + (20 \times 50\%)) + 2 = 72$ |

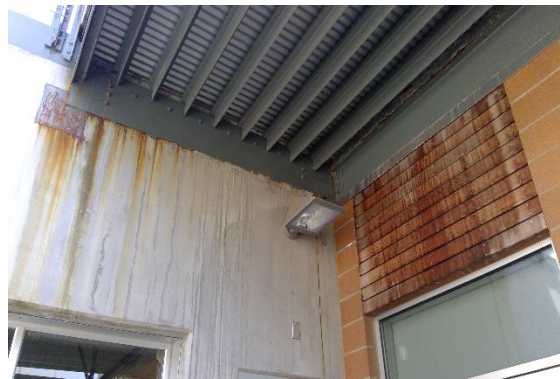
**Deficiency S01**

Water is traveling through the pedestrian walk surface and down to the courtyard level between buildings. The steel is corroded and the concrete has degraded. the upper walk area should be repaired and sealed to top the water penetration. The damage should be repaired.

| Deficiency score : $4 \times ((12 \times 60\%) + (15 \times 40\%)) + 0 = 52.8$ |
