# 2021 FACILITY CONDITION SURVEY

Shoreline Community College

SURVEY CONDUCTED BY:  
Steve Lewandowski  
State Board for Community  
and Technical Colleges

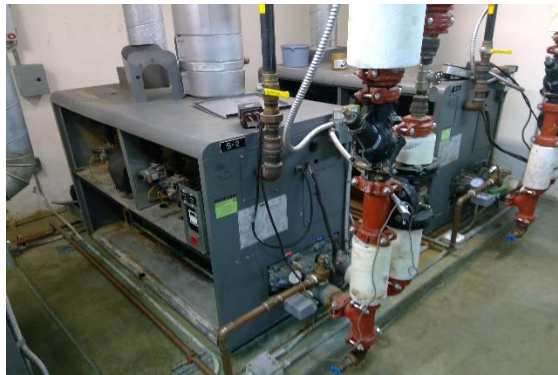
Two of the three boilers are no longer functioning. The fire tubes were cracked and the units appeared to be difficult to repair due to the level of deterioration. These boilers should be replaced.

| Deficiency score : $4 \times ((15 \times 60\%) + (12 \times 40\%)) + 0 = 55.2$ |

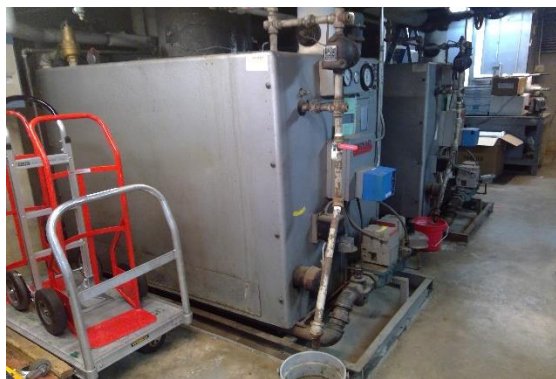
**Deficiency F02**

The original boilers are beyond their expected life and the college is concerned about the reliability of the units. There have been many prior repairs to maintain function, but parts have become difficult to find. These boilers should be replaced.

| Deficiency score : $2.5 \times ((15 \times 60\%) + (12 \times 40\%)) + 2 = 36.5$ |

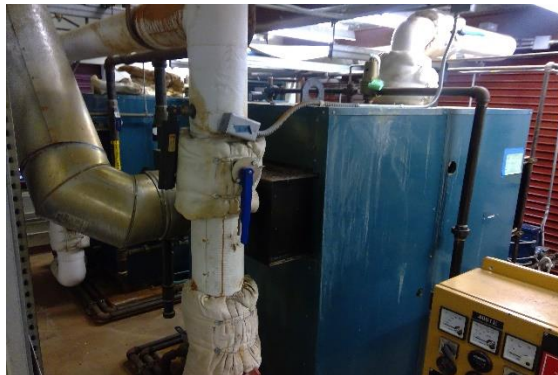
**Deficiency F03**

The two boilers serving the building have prior leaks and rust. These units are near the end of their useful life, but still function as designed. These boilers should continue to be monitored for future replacement.

| Deficiency score : $2.5 \times ((12 \times 50\%) + (15 \times 50\%)) + 1 = 34.8$ |

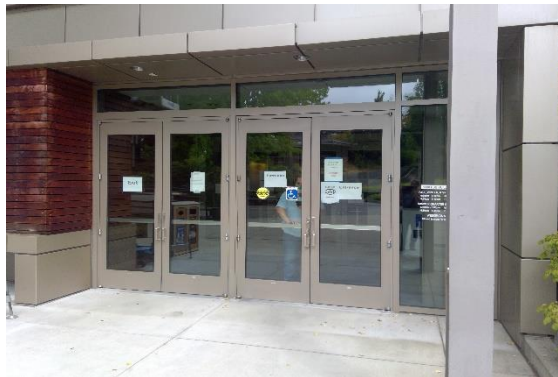
**Deficiency F04**

There are four door operators on building 4000 that have become unreliable. The college has attempted to repair these operators and was unsuccessful at finding a repair solution. The operators should be replaced. There are also several doors on building 9000 that have degraded where the door hardware no functions correctly. These doors should be repaired to regain full function.

| Deficiency score : $4 \times ((12 \times 70\%) + (20 \times 30\%)) + 0 = 57.6$ |

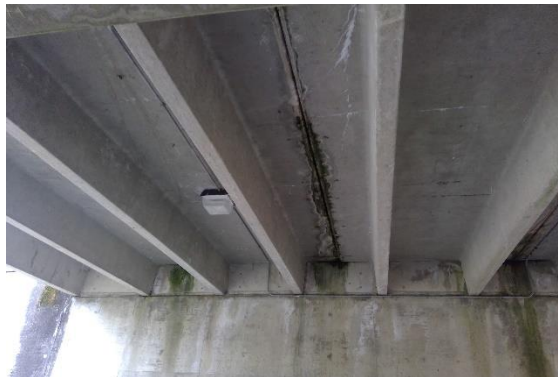
**Deficiency F05**

There is water migrating through the concrete pedestrian access bridge at the 3000 building. The structure has not been compromised, but the concrete should be properly sealed to stop the water from further degrading the concrete structure. The same thing is occurring at a shear wall near the elevator at the 2900 building. Both of these concrete systems should be repaired and properly sealed to make them water-tight.

| Deficiency score : $4 \times ((12 \times 60\%) + (15 \times 40\%)) + 0 = 52.8$ |

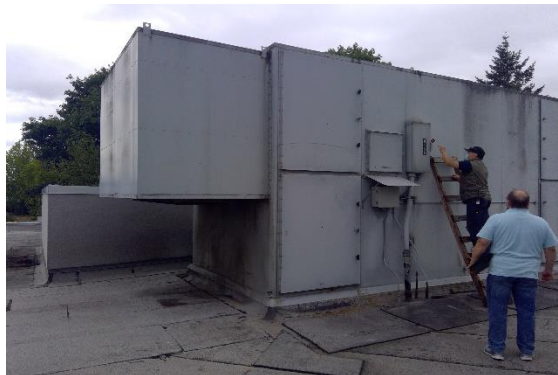
**Deficiency F06**

The two air handlers have required a high level of maintenance. Several repairs have been completed to maintain function. Parts are difficult to find. These units should be repaired to extend their useful life.

| Deficiency score : $4 \times ((15 \times 50\%) + (12 \times 50\%)) + 1 = 55$ |

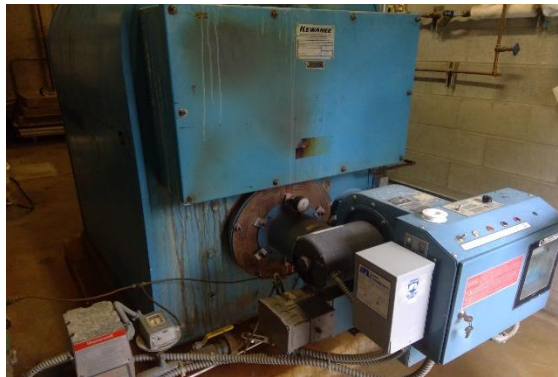
**Deficiency F07**

The college is concerned about the age of the boiler. The circulation pumps leak. The boiler and pump are at the end of their expected life and should be replaced.

| Deficiency score : $4 \times ((15 \times 60\%) + (12 \times 40\%)) + 1 = 56.2$ |

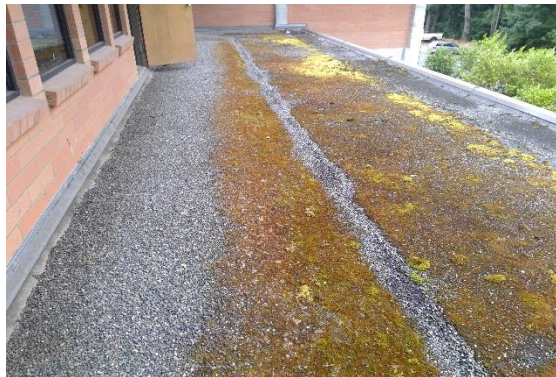
**Deficiency R01**

The college is concerned about the condition of the two lower roofs and the upper south section of roofing. The college is also concerned about the condition of the sheet metal flashing and trim. There are leaks near the north parapet on the upper roof. These roofs are near the end of their useful life and should be repaired and reconditioned to extend their useful life.

| Deficiency score : $4 \times ((15 \times 70\%) + (12 \times 30\%)) + 5 = 61.4$ |

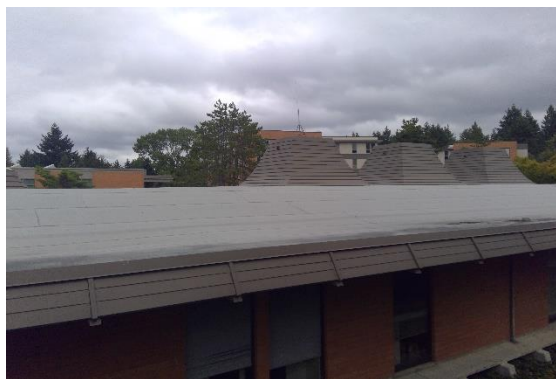
**Deficiency R02**

There are fourteen buildings with roofs that are in various levels of degraded condition. These buildings have roof leaks, poorly functioning drainage systems and damaged soffits. The roofs should be repaired to ensure water-tight envelopes. The prior water damage should be repaired.

| Deficiency score : $4 \times ((12 \times 70\%) + (15 \times 30\%)) + 0 = 51.6$ |

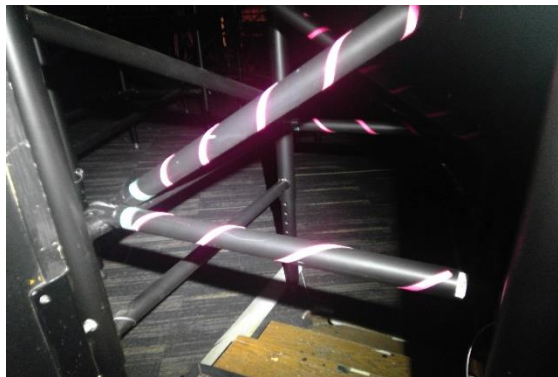
**Deficiency F08**

The orchestra pit floods during storm events. This is likely due to hydraulic pressure below the pit slab. The college has installed an enhanced footing drain system to address the issue, but the flooding still occurs. The foundation drainage system should be repaired to stop water from entering the orchestra pit.

| Deficiency score : $4 \times ((10 \times 70\%) + (15 \times 30\%)) + 2 = 48$ |
