# 2021 FACILITY CONDITION SURVEY

Skagit Valley College

SURVEY CONDUCTED BY:  
Steve Lewandowski  
State Board for Community  
and Technical Colleges

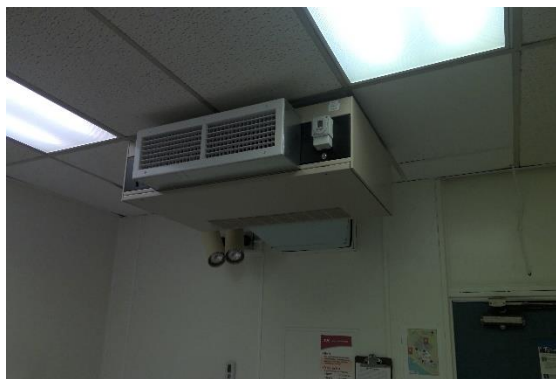
**Deficiency F07**

| Deficiency score : $4 \times ((15 \times 70\%) + (12 \times 30\%)) + 5 = 61.4$ |

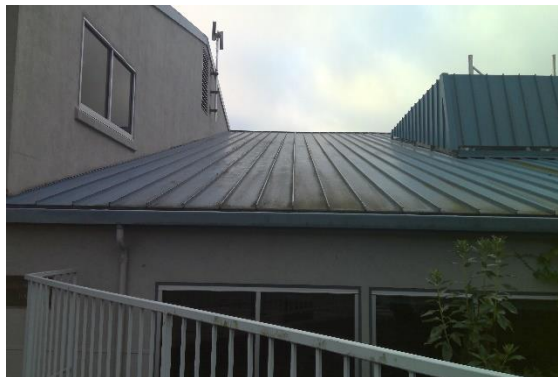
**Deficiency R01**

| Deficiency score : $2.5 \times ((12 \times 70\%) + (15 \times 30\%)) + 1 = 33.3$ |

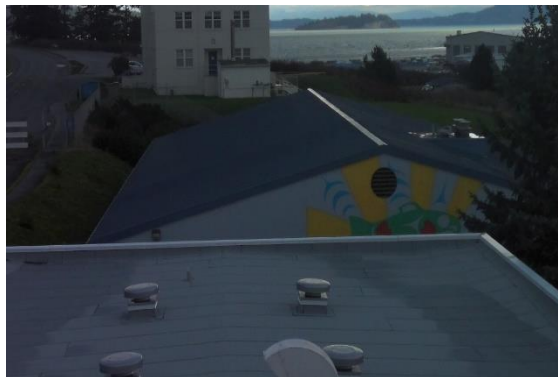
**Deficiency R02**

| Deficiency score : $4 \times ((15 \times 70\%) + (5 \times 30\%)) + 5 = 53$ |

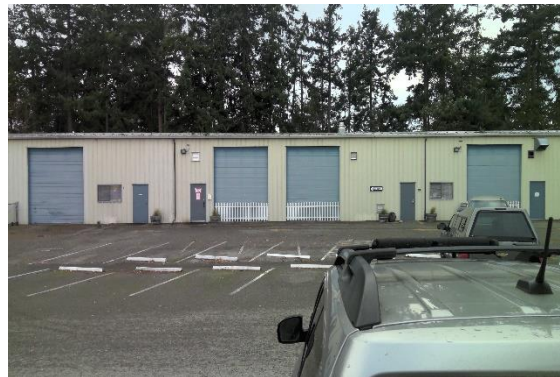
**Deficiency R03**

| Deficiency score : Needs study |

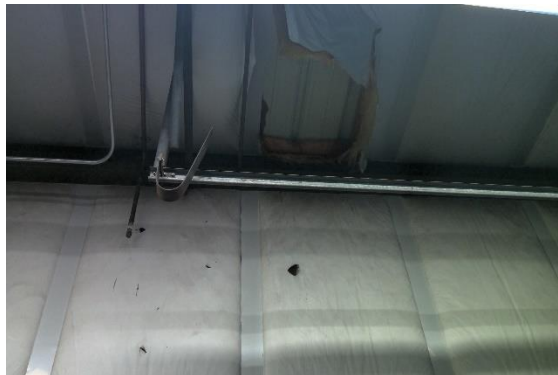
**Deficiency R04**

| Deficiency score : $2.5 \times (15 \times 100\%) + 5 = 42.5$ |
