# 2021 FACILITY CONDITION SURVEY

South Puget Sound  
Community College

SURVEY CONDUCTED BY:  
Steve Lewandowski  
State Board for Community  
and Technical Colleges

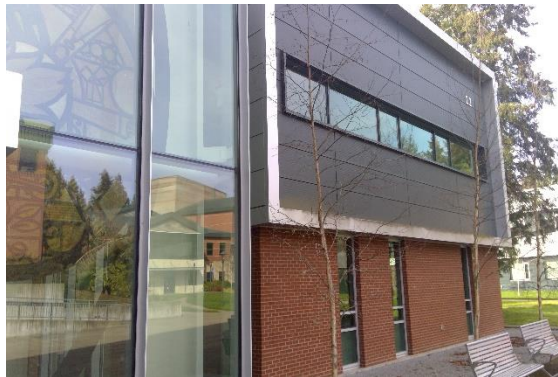
The window headers leak and allow water to infiltrate the building envelope. The windows should be flashed and sealed to provide a water-tight envelope. The interior damage should be repaired.

| Deficiency score : $4 \times ((15 \times 80\%) + (12 \times 20\%)) + 0 = 57.6$ |

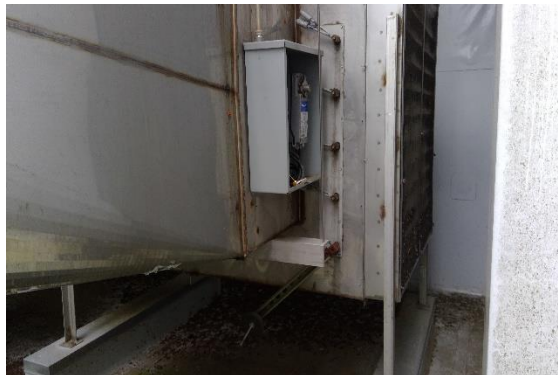
**Deficiency F02**

The two exhaust fans damper motor assemblies are failing and have become unreliable. The damper systems should be replaced.

| Deficiency score : $4 \times ((12 \times 50\%) + (15 \times 50\%)) + 0 = 54$ |

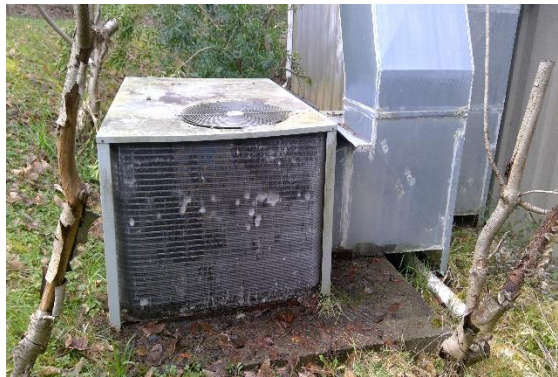
**Deficiency F03**

The heat pump located behind the building on a pad is near the end of its useful life. The pump has required several repairs in the last few years and has become less reliable. The heat pump should be replaced.

| Deficiency score : $4 \times ((10 \times 60\%) + (15 \times 40\%)) + 5 = 53$ |

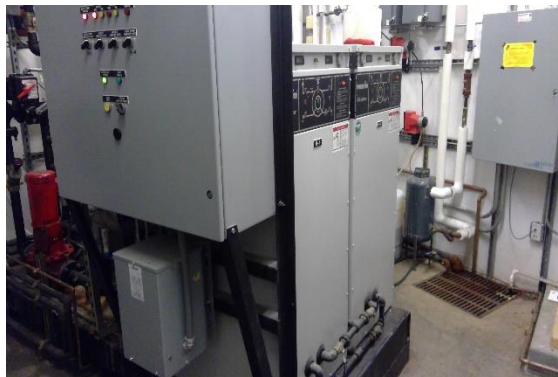
**Deficiency F04**

The two boilers are near the end of their useful life, but still function as designed. There has not been a significant increase in maintenance required to sustain operation of the boilers. The boilers are still maintainable and should be replaced in the next biennium.

| Deficiency score : $2.5 \times ((12 \times 50\%) + (15 \times 50\%)) + 1 = 34.8$ |

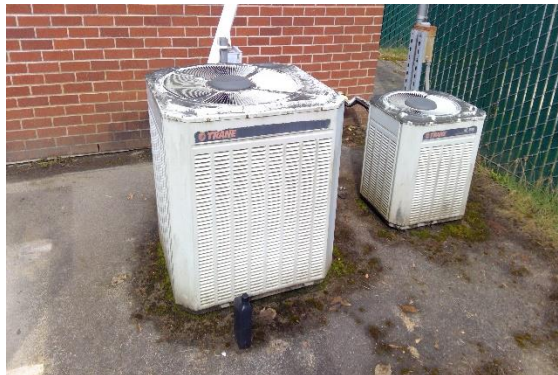
**Deficiency F05**

The pad mounted heat pumps on the south side of the building are unreliable and at the end of their service life. Maintenance has increased. The 1 ton, 3 ton and 5-ton heat pumps should be replaced.

| Deficiency score : $4 \times (15 \times 100\%) + 1 = 61$ |

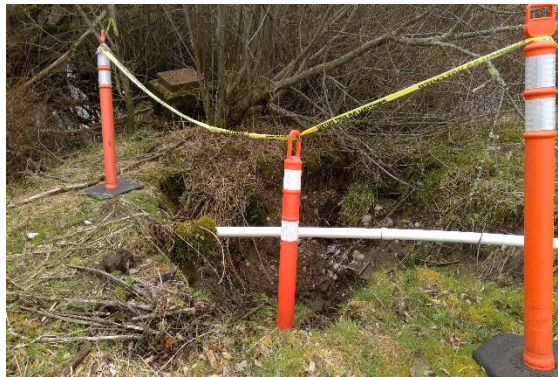
**Deficiency S01**

A sink hole has emerged near the soccer field on the south east of campus. It is not clear what is causing the sink hole or what the scope of work will be to repair the damage, but this erosion should be repaired.

| Deficiency score : $4 \times ((15 \times 60\%) + (12 \times 40\%)) + 0 = 55.2$ |

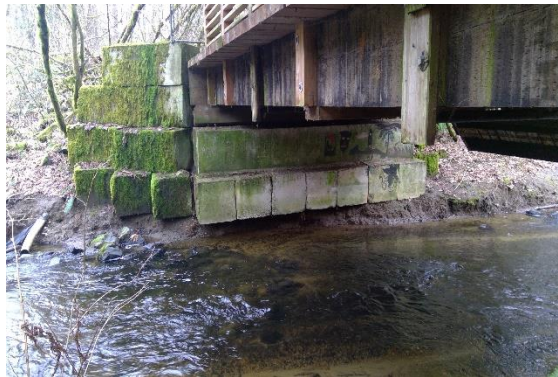
**Deficiency S02**

The creek has eroded the bridge foundation around the NE abutments. The bridge is no longer safe to use. The foundation should be repaired to regain use of the pedestrian bridge.

| Deficiency score : $4 \times ((25 \times 70\%) + (15 \times 30\%)) + 0 = 88$ |
