# 2021 FACILITY CONDITION SURVEY

South Seattle College

SURVEY CONDUCTED BY:  
Steve Lewandowski  
State Board for Community  
and Technical Colleges

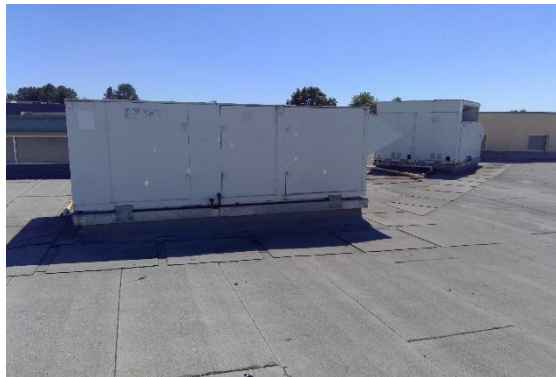
**Deficiency F01**

There are several HVAC units on the roof that are near the end of their useful life. There are four 10 Ton units. Some of the heat exchanger tubes have been repaired. The level of maintenance has become more frequent. The worst two 10-ton units are currently funded for replacement. The two smaller units should continue to be monitored for replacement.

| Deficiency score : $2.5 \times ((15 \times 70\%) + (12 \times 30\%)) + 2 = 37.3$ |

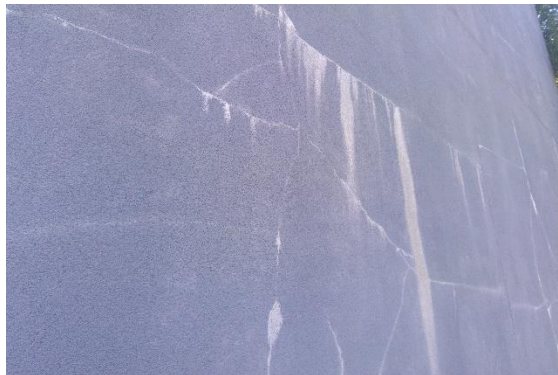
**Deficiency F02**

The stucco on the north and east walls of the auditorium have developed cracks. These cracks should be repaired.

| Deficiency score : $4 \times ((12 \times 70\%) + (15 \times 30\%)) + 1 = 52.6$ |

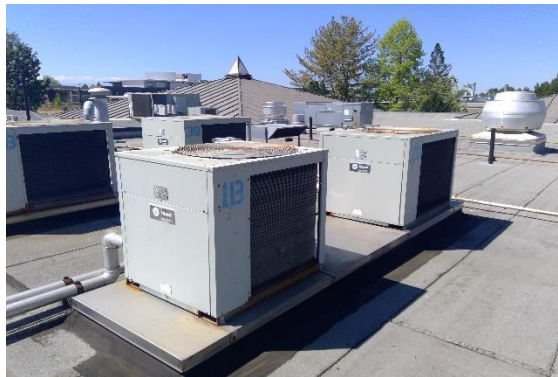
**Deficiency F03**

The three 10-ton units are near the end of their useful life. One of the units no longer functions due to a failed compressor. These units should be replaced.

| Deficiency score : $4 \times ((15 \times 60\%) + (12 \times 40\%)) + 2 = 57.2$ |

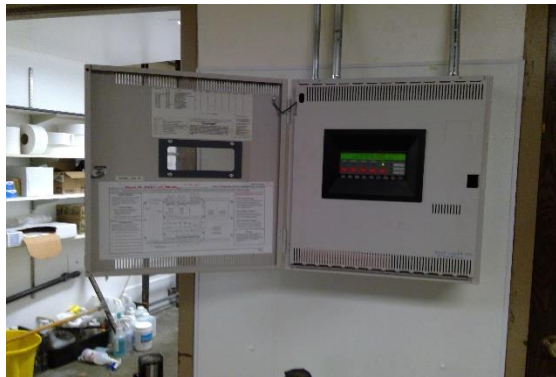
**Deficiency F04**

The college is concerned about the age of the fire alarm panels in Olympic Hall, Culinary Arts Building, Jerry Barockey Center and Robert Smith Buildings. It was not known if these older systems were still supported by the vendor. If they are no longer supported, then they should be replaced. A memo describing the level of support is required to justify replacement.

| Deficiency score : Needs study |

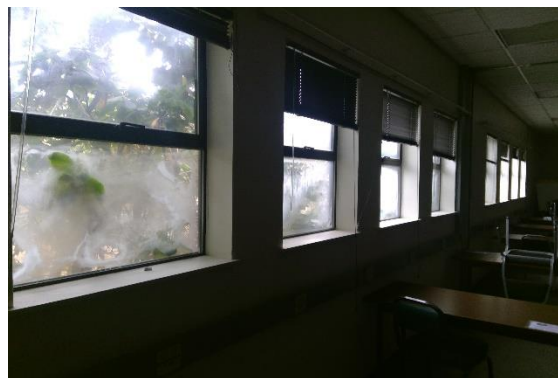
**Deficiency F05**

Several windows have failed in multiple buildings. These failed windows should be replaced.

| Deficiency score : $4 \times ((15 \times 90\%) + (5 \times 10\%)) + 0 = 56$ |

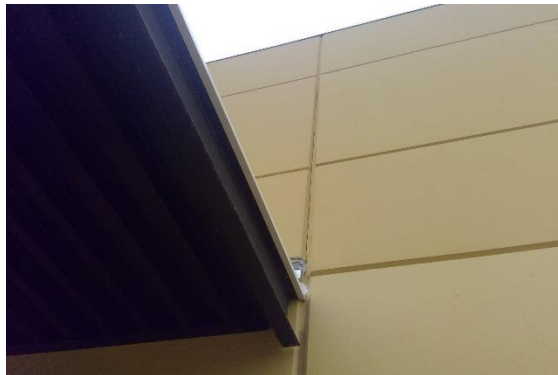
**Deficiency F06**

Several of the concrete panel joints have failed. These joints should be replaced to ensure a water-tight envelope.

| Deficiency score : $4 \times (12 \times 100\%) + 0 = 48$ |

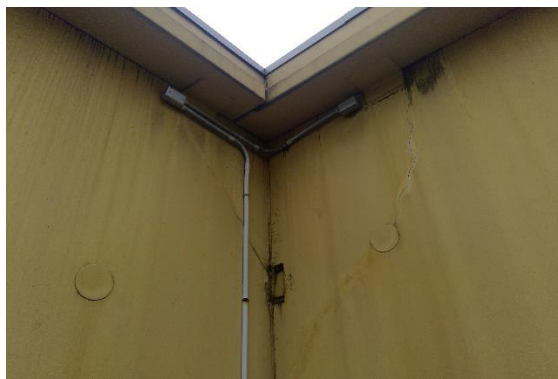
**Deficiency F07**

The top corner of two tilt-up concrete panels display a crack that appears to possibly be the result of structural failure. Additional information is required to determine the appropriate scope of work required to repair the panels.

| Deficiency score : Needs study |

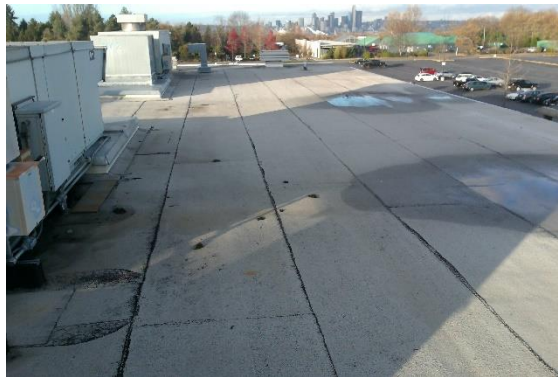
**Deficiency R01**

The roofing has had a few leaks, but the surface appeared to be in good condition. The roofing should continue to be monitored and be replaced in the future.

| Deficiency score : $2.5 \times ((15 \times 70\%) + (12 \times 30\%)) + 2 = 37.3$ |

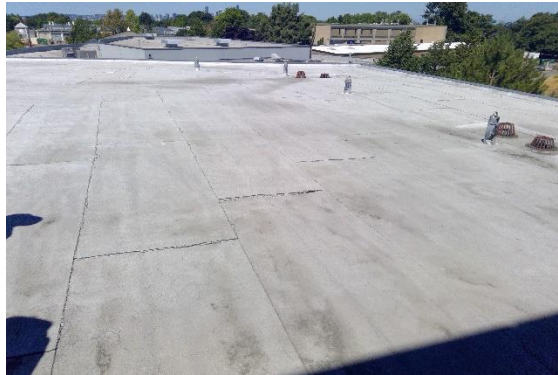
**Deficiency R02**

The roofing has deteriorated and started cracking on the surface. The roofing should be re-surfaced to extend its useful life.

| Deficiency score : $4 \times ((15 \times 90\%) + (12 \times 10\%)) + 1 = 59.8$ |

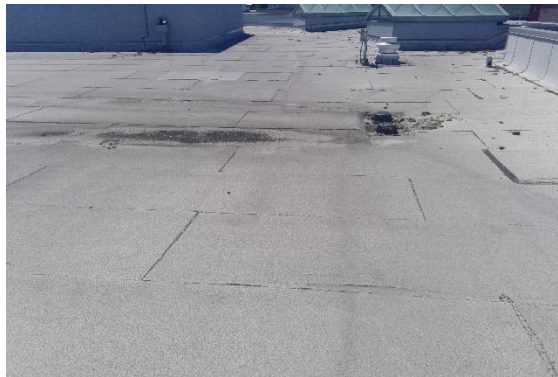
**Deficiency R03**

The roofing has degraded. There are multiple bubbles and some delamination of the top layer. The roofing should be re-conditioned to extend its useful life.

| Deficiency score : $2.5 \times ((15 \times 70\%) + (12 \times 30\%)) + 1 = 36.3$ |

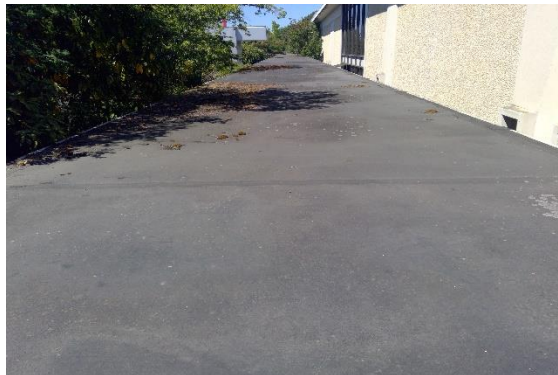
**Deficiency S01**

The roofing on the covered walkway has deteriorated. There are no current leaks, but the roofing should be replaced.

| Deficiency score : $2.5 \times ((15 \times 50\%) + (12 \times 50\%)) + 0 = 33.8$ |

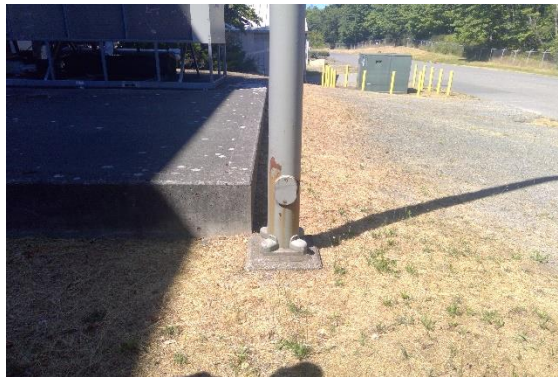
**Deficiency S02**

The light poles along the east emergency access road have rusted out. One has even fallen over due to the rust. These poles should be replaced.

| Deficiency score : $4 \times ((15 \times 70\%) + (25 \times 30\%)) + 0 = 72$ |
