2021 FACILITY CONDITION SURVEY

Spokane Falls Community
College

SURVEY CONDUCTED BY:
Steve Lewandowski
State Board for Community
and Technical Colleges

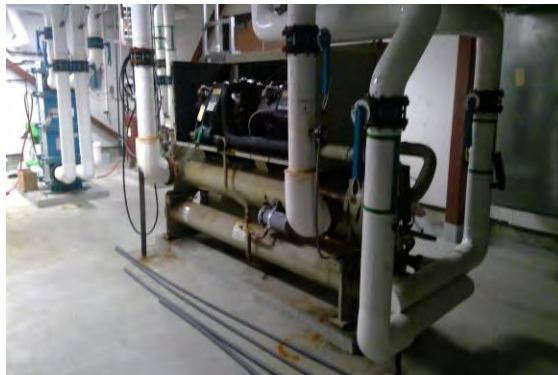
Deficiency F01

The chiller system (chiller, cooling tower, pumps, piping, tanks) have required a higher level of maintenance to maintain function. The chiller is at the end of its useful life and should be replaced.

Scoring priority category 1 : System Use (score = 15)
Category 1 percentage : 60 %
Scoring priority category 2 : High Repair/Repl. Cost (score = 12)
Category 2 percentage : 40 %
Project construction estimate (MACC): \$650,000
Total project estimate (including soft costs): \$920,000
Additional points based on building condition: 0
Deficiency score : $4 \times ((15 \times 60\%) + (12 \times 40\%)) + 0 = 55.2$

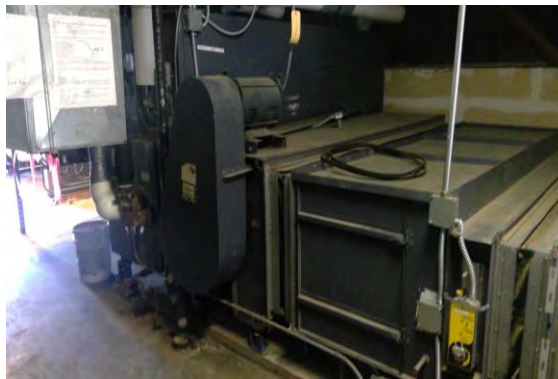
Deficiency F02

Two multi-zoned HVAC units in the rooftop penthouse still function as designed. Maintenance levels have been normal, but they are difficult to access and challenging to maintain. These units should continue to be monitored and be replaced in the future.

Estimated remaining life (years) : (No Data)
Estimated average life expectancy (years) : 20
Scoring priority category 1 : System Use (scoring weight=15)
Category 1 percentage : 50 %
Scoring priority category 2 : High Repair/Repl. Cost (scoring weight=12)
Category 2 percentage : 50 %
Project construction estimate (MACC): \$500,000
Total project estimate (including soft costs): \$708,000
Additional points based on building condition: 0
Deficiency score : $2.5 \times ((15 \times 50\%) + (12 \times 50\%)) + 0 = 33.8$

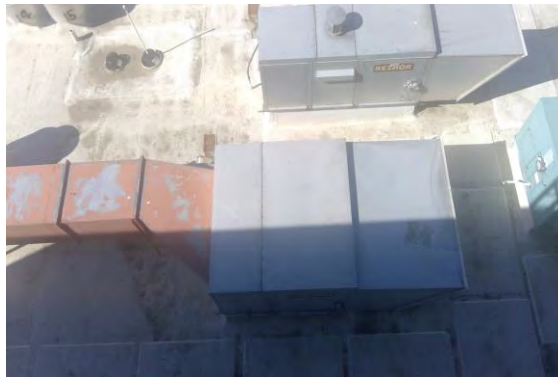
Deficiency F03

The make-up air handler unit has required recent repairs, but still functions as designed. The unit is nearing the end of its useful life. The units should be monitored for future replacement.

Scoring priority category 1 : High Repair/Repl. Cost (scoring weight=12)
Category 1 percentage : 80 %
Scoring priority category 2 : System Use (scoring weight=15)
Category 2 percentage : 20 %
Project construction estimate (MACC): \$200,000
Total project estimate (including soft costs): \$283,000
Additional points based on building condition: 0
Deficiency score : $2.5 \times ((12 \times 80\%) + (15 \times 20\%)) + 0 = 31.5$

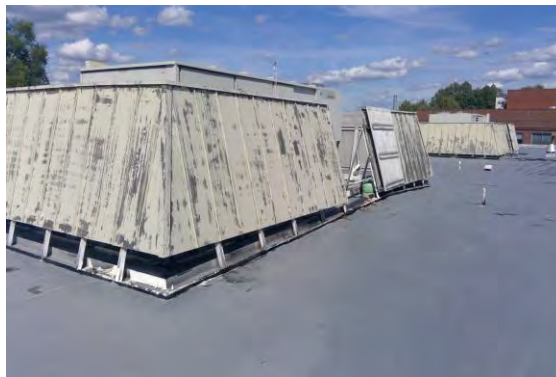
Deficiency F04

The three multi-zone air handler units on the roof top have required recent repairs. Parts are difficult to find due to the age of units. There are potential health and safety risks due to the cracked heat exchanger in one of the units. The unit in the worst condition should be replaced.

Estimated remaining life (years) : 3
Estimated average life expectancy (years) : 25
Scoring priority category 1 : High Repair/Repl. Cost (scoring weight=12)
Category 1 percentage : 60 %
Scoring priority category 2 : System Use (scoring weight=15)
Category 2 percentage : 40 %
Project construction estimate (MACC): \$250,000
Total project estimate (including soft costs): \$354,000
Additional points based on building condition: 0
Deficiency score : $4 \times ((12 \times 60\%) + (15 \times 40\%)) + 0 = 52.8$

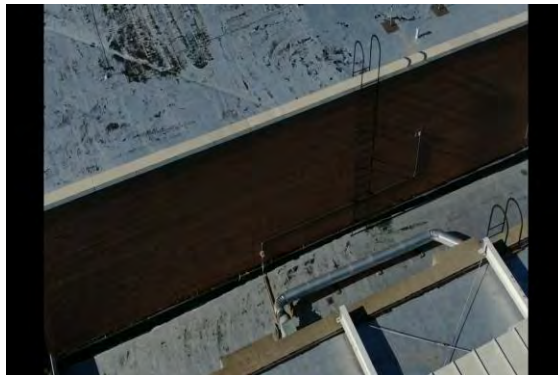
Deficiency R01

The lower section of built-up roofing has deteriorated. Previous leaks have been repaired. The roofing should be reconditioned to extend its useful life.

Category 1 percentage : 70 %
Scoring priority category 2 : System Use (scoring weight=15)
Category 2 percentage : 30 %
Project construction estimate (MACC): \$30,000
Total project estimate (including soft costs): \$42,000
Additional points based on building condition: 0
Deficiency score : $4 \times ((12 \times 70\%) + (15 \times 30\%)) + 0 = 51.6$

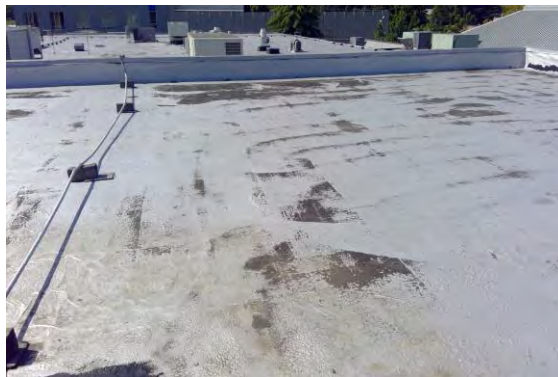
Deficiency R02

The roofing on the building addition and penthouse has required recent repairs, but does not leak. Most of the roofing appeared to be weathered, but most field areas were in fair condition. The roofing should be re-conditioned in the future to extend its useful life.

Estimated average life expectancy (years) : 25
Scoring priority category 1 : System Use (scoring weight=15)
Category 1 percentage : 60 %
Scoring priority category 2 : High Repair/Repl. Cost (scoring weight=12)
Category 2 percentage : 40 %
Project construction estimate (MACC): \$500,000
Total project estimate (including soft costs): \$708,000
Additional points based on building condition: 0
Deficiency score : $2.5 \times ((15 \times 60\%) + (12 \times 40\%)) + 0 = 34.5$

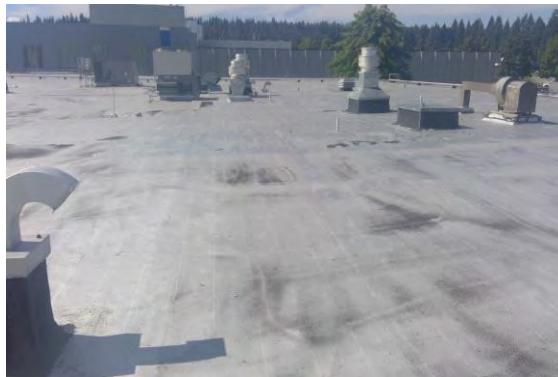
Deficiency R03

The roof has been leaking in a few small areas. The reflective coating has cracked and become weathered. Cracks are starting to become evident in the roofing felt layers. Some maintenance coating is required to extend the useful life of the roofing. The roof should be reconditioned in the future to extend it's useful life.

Estimated remaining life (years) : 5
Estimated average life expectancy (years) : 20
Scoring priority category 1 : High Repair/Repl. Cost (scoring weight=12)
Category 1 percentage : 70 %
Scoring priority category 2 : System Use (scoring weight=15)
Category 2 percentage : 30 %
Project construction estimate (MACC): \$413,000
Total project estimate (including soft costs): \$584,000
Additional points based on building condition: 0
Deficiency score : $2.5 \times ((12 \times 70\%) + (15 \times 30\%)) + 0 = 32.3$

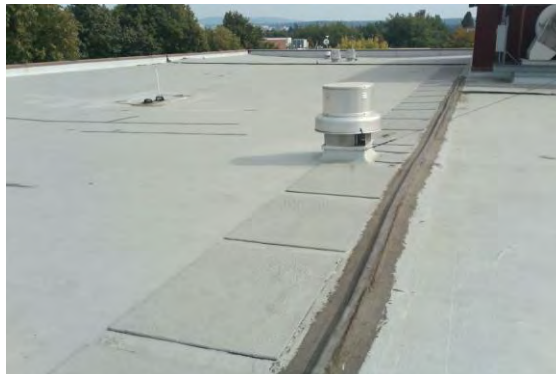
Deficiency R04

The UV coating on the main upper section of built-up roof is starting to peel slightly. The UV coating still adequately protects the roofing and cracks have been repaired in some areas. This upper roof should continue to be monitored and repaired or replaced in the future. The lower section of roofing appeared to be in worse condition with significant UV coating deterioration and prior repairs. The lower section should be reviewed for replacement next biennium.

Recommended funding schedule : Fund in Next Biennium (scoring weight=2.5)
Estimated remaining life (years) : 5
Estimated average life expectancy (years) : 25
Scoring priority category 1 : System Use (scoring weight=15)
Category 1 percentage : 100 %
Scoring priority category 2 : High Repair/Repl. Cost (scoring weight=12)
Category 2 percentage : 0 %
Project construction estimate (MACC): \$525,000
Total project estimate (including soft costs): \$743,000
Additional points based on building condition: 0
Deficiency score : $2.5 \times (15 \times 100\%) + 0 = 37.5$

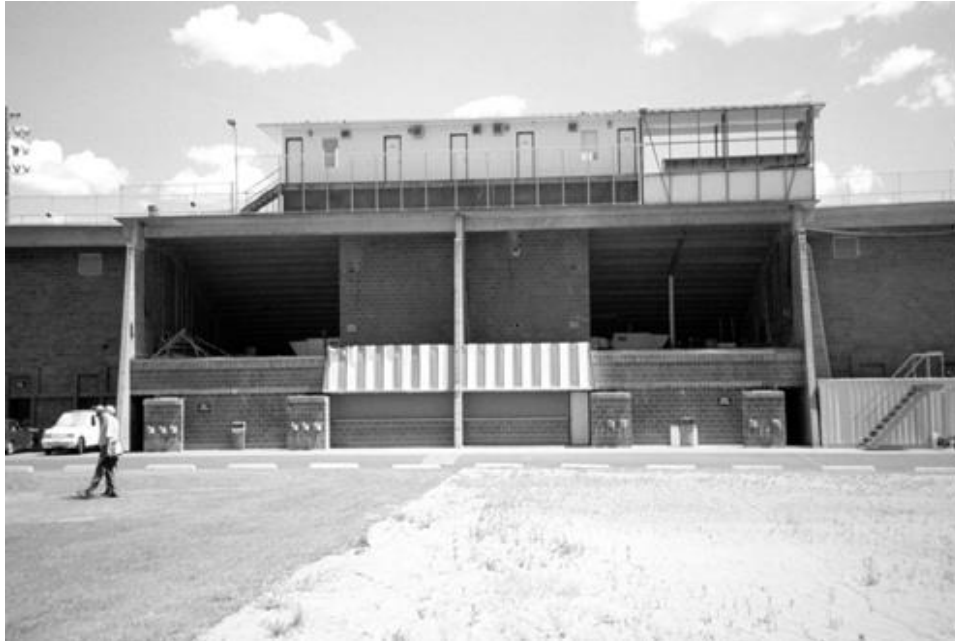
P.E. Annex (172-13) STATE UFI: A01742 Main Campus (172A)
AREA: 18,687 SF BUILT: 1970 REMODELED: 2013 PREDOMINANT USE: PE Programs
CONSTRUCTION TYPE: Medium CRV/SF: \$335 REPLACEMENT VALUE: \$6,260,145

Primary Systems			
COMPONENT:	Structure	RATING: 3 x WEIGHT: 8.7 =	SCORE: 26.1
Some cracking evident but does not likely affect structural integrity; Visible defects apparent but are non-structural			
COMMENTS:	CMU/Concrete; random cracking throughout		
COMPONENT:	Exterior Closure	RATING: 3 x WEIGHT: 8.7 =	SCORE: 26.1
Sound and weatherproof but with some deterioration evident			
COMMENTS:	CMU walls		
COMPONENT:	Roofing	RATING: 5 x WEIGHT: 10.9 =	SCORE: 54.5
Leaking and deterioration is to point where new roof is required			
COMMENTS:	Concrete bleachers form roof of structure; extensive joint leaks and cracking

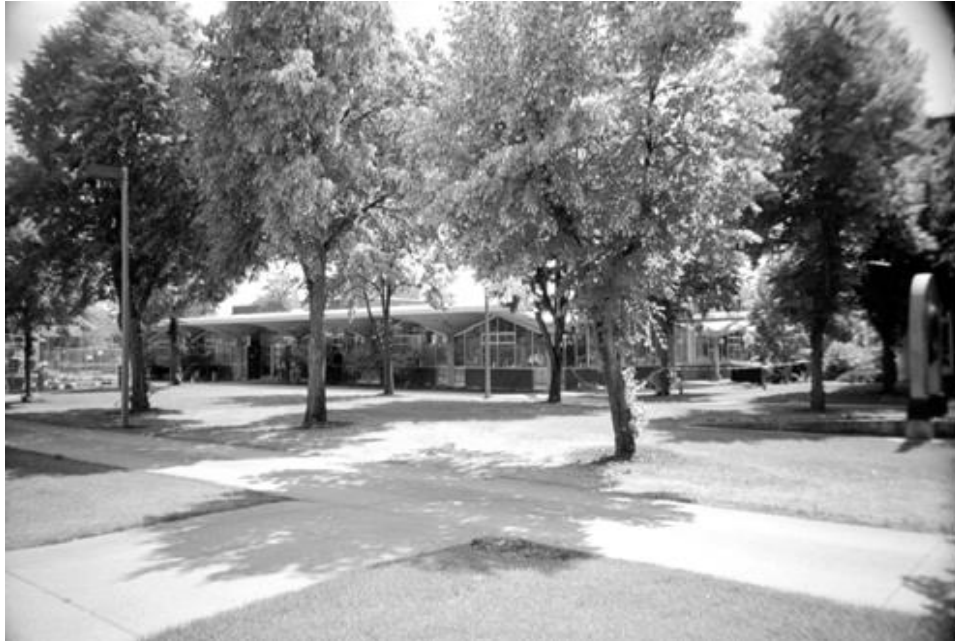
Fine Arts (172-6) STATE UFI: A06505 Main Campus (172A)
 AREA: 24,873 SF BUILT: 1965 REMODELED: No PREDOMINANT USE: Visual Arts
 CONSTRUCTION TYPE: Medium CRV/SF: \$379 REPLACEMENT VALUE: \$9,426,867

Primary Systems			
COMPONENT:	Structure	RATING: 3 x WEIGHT: 8.3 =	SCORE: 25
Some cracking evident but does not likely affect structural integrity; Visible defects apparent but are non-structural			
COMMENTS:	Concrete column; concrete; steel; brick; some structural concerns		
COMPONENT:	Exterior Closure	RATING: 3 x WEIGHT: 8.3 =	SCORE: 25
Sound and weatherproof but with some deterioration evident			
COMMENTS:	Brick and CMU; window walls; stucco/plaster; energy inefficient closure		
COMPONENT:	Roofing	RATING: 2 x WEIGHT: 10.4 =	SCORE: 20.9
Majority of roofing and flashing appear sound, but a small portion of roofing shows deterioration where maintenance or minor repair needed			
COMMENTS:	Foam roof; repaired/replaced in 2004, but high maintenance; standing seam metal; recoat 2016

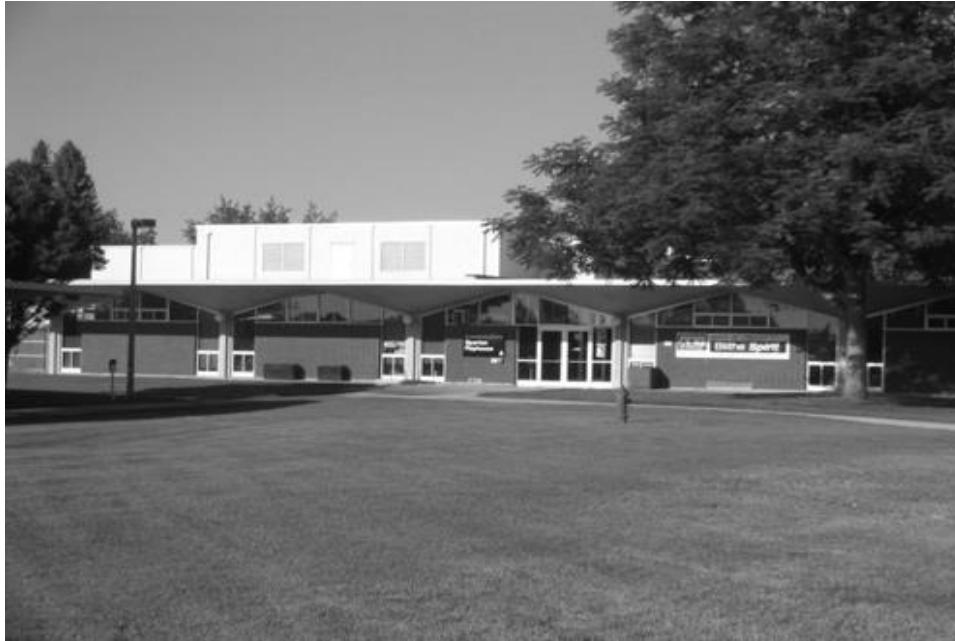
Humanities (172-5) STATE UFI: A06764 Main Campus (172A)
AREA: 29,597 SF BUILT: 1965 REMODELED: No PREDOMINANT USE: Performing Arts
CONSTRUCTION TYPE: Medium CRV/SF: \$404 REPLACEMENT VALUE: \$11,957,188

Primary Systems			
COMPONENT:	Structure	RATING: 3 x WEIGHT: 8.3 =	SCORE: 25
Some cracking evident but does not likely affect structural integrity; Visible defects apparent but are non-structural			
COMMENTS:	Concrete columns and roof; concrete; CMU; steel		
COMPONENT:	Exterior Closure	RATING: 3 x WEIGHT: 8.3 =	SCORE: 25
Sound and weatherproof but with some deterioration evident			
COMMENTS:	Brick; CMU; window walls; stucco/plaster		
COMPONENT:	Roofing	RATING: 3 x WEIGHT: 10.4 =	SCORE: 31.3
Some deterioration is evident in membrane and flashings; maintenance or minor repair is needed			
COMMENTS:	Foam hyperbolic roof; high maintenance; TPO single-ply; mineral capsheet BUR; BUR w UV coat

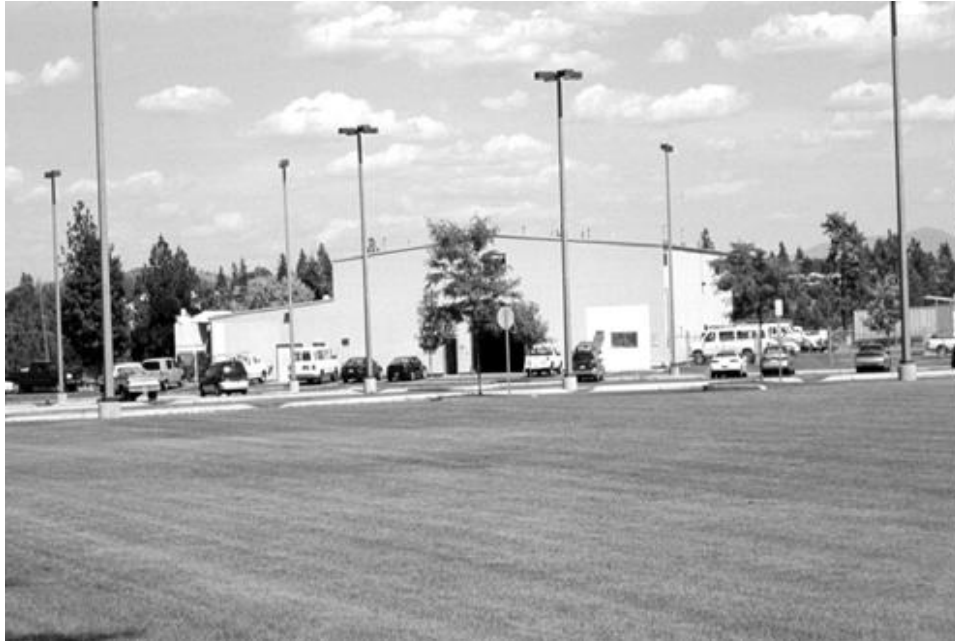
Maintenance (172-10) STATE UFI: A04693 Main Campus (172A)
AREA: 17,452 SF BUILT: 1943 REMODELED: 2009 PREDOMINANT USE: Maintenance
CONSTRUCTION TYPE: Light CRV/SF: \$335 REPLACEMENT VALUE: \$5,846,420

Primary Systems			
COMPONENT:	Structure	RATING: 2 x WEIGHT: 8.3 =	SCORE: 16.7
Minor cracks evident in a small portion of the structure			
COMMENTS:	Wood framed; concrete slab has numerous cracks		
COMPONENT:	Exterior Closure	RATING: 2 x WEIGHT: 8.3 =	SCORE: 16.7
Weatherproof exterior, but generally appears poorly maintained			
COMMENTS:	Metal wall panels		
COMPONENT:	Roofing	RATING: 1 x WEIGHT: 10.4 =	SCORE: 10.4
Flashing and penetrations appear sound and membrane appears water- tight; drainage is positive and there are overflow scuppers			
COMMENTS:	New metal coated roof in 2002

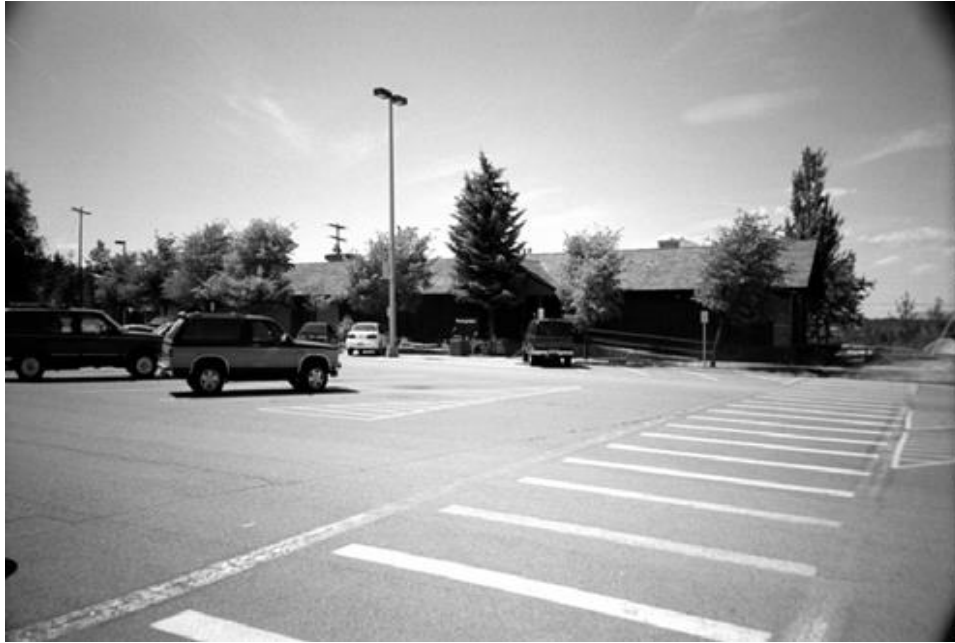
Photography (172-11) STATE UFI: A09540 Main Campus (172A)
 AREA: 10,401 SF BUILT: 1930 REMODELED: 1987 PREDOMINANT USE: Visual Arts
 CONSTRUCTION TYPE: Medium CRV/SF: \$379 REPLACEMENT VALUE: \$3,941,979

Primary Systems			
COMPONENT:	Structure	RATING: 5 x WEIGHT: 8.3 =	SCORE: 41.7
Visible settlement and potential structural failure; potential safety hazard Structural defects apparent in superstructure			
COMMENTS:	Slump stone and CMU construction; wood and metal roof deck		
COMPONENT:	Exterior Closure	RATING: 3 x WEIGHT: 8.3 =	SCORE: 25
Sound and weatherproof but with some deterioration evident			
COMMENTS:	Wood siding over CMU; slump stone on original portion of building		
COMPONENT:	Roofing	RATING: 3 x WEIGHT: 10.4 =	SCORE: 31.3
Some deterioration is evident in membrane and flashings; maintenance or minor repair is needed			
COMMENTS:	New BUR in 2003 on original portion; finish is worn off Cemwood mansard shingles
