2021 FACILITY CONDITION SURVEY

Tacoma Community College

SURVEY CONDUCTED BY:
Steve Lewandowski
State Board for Community
and Technical Colleges

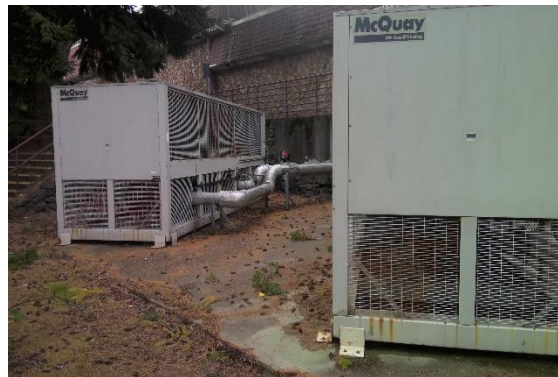
Deficiency F02

These chillers are near the end of their expected life. The units are exhibiting some rust and minor structural failures in several places. There are periodic refrigerant leaks occurring where the circuit passes through a structural steel member. Due to poor design, this steel section of welded piping is deteriorated to the point that refrigerant is leaking through the wall of the pipe. This is a structural component of the chiller framework and would be cost prohibitive to properly replace even if the components were still available. The chillers appear to still function as designed (despite the leaking) and should be replaced in the near future to avoid possible program disruptions.

Recommended funding schedule : Fund in Next Biennium (scoring weight=2.5)
Estimated average life expectancy (years) : 25
Scoring priority category 1 : System Use (scoring weight=15)
Category 1 percentage : 70 %
Scoring priority category 2 : High Repair/Repl. Cost (scoring weight=12)
Category 2 percentage : 30 %
Project construction estimate (MACC): \$460,000
Total project estimate (including soft costs): \$652,000
Additional points based on building condition: 1
Deficiency score : $2.5 \times ((15 \times 70\%) + (12 \times 30\%)) + 1 = 36.3$

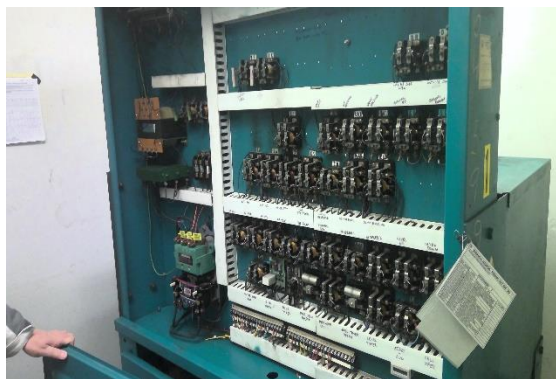
Deficiency F03

The Dover elevator will no longer be supported in the near future due to the recent acquisition by another manufacturer. Replacement parts will no longer be available and repairs may take months due to lack of parts and support. Since at least one of these pairs of Dover elevators is required to meet accessibility standards and remain reliable, the elevator controls for one elevator should be modernized to ensure that reliability is maintained. The remaining elevator should be modernized in the future.

Recommended funding schedule : Immediate (scoring weight=4)
Estimated remaining life (years) : 3
Estimated average life expectancy (years) : 40
Scoring priority category 1 : System Use (scoring weight=15)
Category 1 percentage : 100 %
Scoring priority category 2 : High Repair/Repl. Cost (scoring weight=12)
Category 2 percentage : 0 %
Project construction estimate (MACC): \$95,000
Total project estimate (including soft costs): \$134,000
Additional points based on building condition: 1
Deficiency score : $4 \times (15 \times 100\%) + 1 = 61$

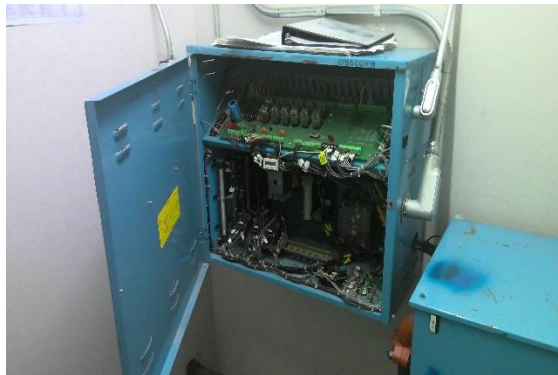
Deficiency F04

The college believes that this elevator is no longer supported by the vendor and that repairs are no longer possible. Additional information from the vendor is required to verify this condition and to support modernization.

Estimated average life expectancy (years) : 40
Scoring priority category 1 : System Use (scoring weight=15)
Category 1 percentage : 70 %
Scoring priority category 2 : High Repair/Repl. Cost (scoring weight=12)
Category 2 percentage : 30 %
Project construction estimate (MACC): \$106,000
Total project estimate (including soft costs): \$150,000
Additional points based on building condition: 1
Deficiency score : Needs study

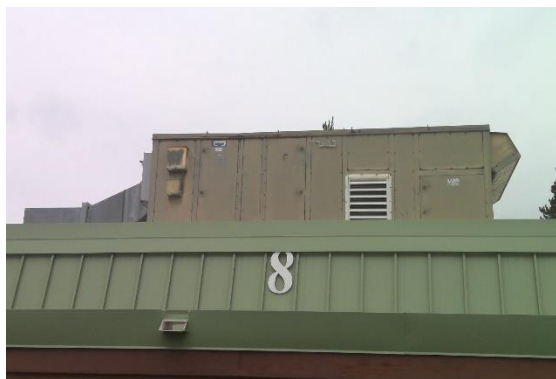
Deficiency F05

The air handler has reached the end of its useful life and is showing signs of structural fatigue. This college plans to replace this building as part of the next major project. The unit should continue to be maintained and repaired to extend its useful life until the building is demolished.

Estimated remaining life (years) : 5
Estimated average life expectancy (years) : 20
Scoring priority category 1 : High Repair/Repl. Cost (scoring weight=12)
Category 1 percentage : 60 %
Scoring priority category 2 : System Use (scoring weight=15)
Category 2 percentage : 40 %
Project construction estimate (MACC): \$85,000
Total project estimate (including soft costs): \$120,000
Additional points based on building condition: 2
Deficiency score : $2.5 \times ((12 \times 60\%) + (15 \times 40\%)) + 2 = 35$

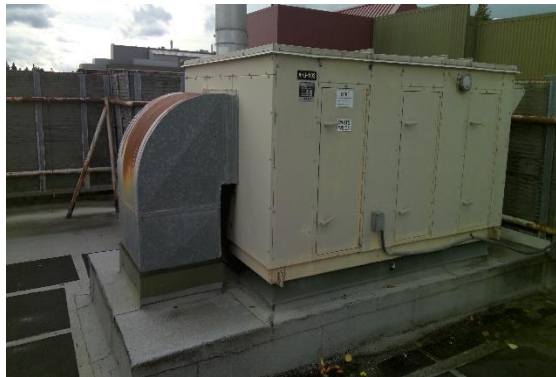
Deficiency F06

Five air handlers are near the end of their useful life and are showing signs of structural fatigue. The units appeared to have varying levels of degradation and the staff indicated varying levels of maintenance requirements. The three air handlers in the worst condition should be replaced. The remaining two units should be monitored for future replacement.

Recommended funding schedule : Immediate (scoring weight=4)
Estimated remaining life (years) : 3
Estimated average life expectancy (years) : 20
Scoring priority category 1 : System Use (scoring weight=15)
Category 1 percentage : 70 %
Scoring priority category 2 : High Operating Cost (scoring weight=10)
Category 2 percentage : 30 %
Project construction estimate (MACC): \$180,000
Total project estimate (including soft costs): \$255,000
Additional points based on building condition: 1
Deficiency score : $4 \times ((15 \times 70\%) + (10 \times 30\%)) + 1 = 55$

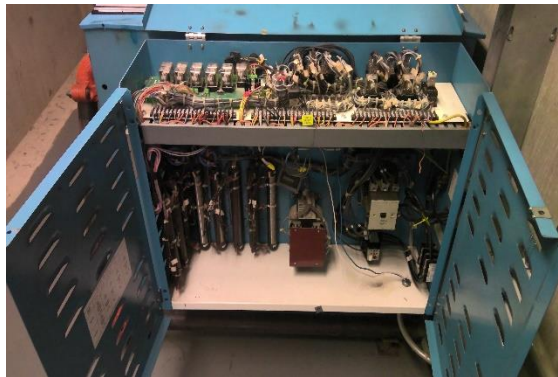
Deficiency F07

The college believes that this elevator is no longer supported by the vendor and that repairs are no longer possible. Additional information from the vendor is required to verify this condition and to support modernization.

Estimated average life expectancy (years) : 40
Scoring priority category 1 : System Use (scoring weight=15)
Category 1 percentage : 90 %
Scoring priority category 2 : High Repair/Repl. Cost (scoring weight=12)
Category 2 percentage : 10 %
Project construction estimate (MACC): \$123,000
Total project estimate (including soft costs): \$174,000
Additional points based on building condition: 1
Deficiency score : Needs study

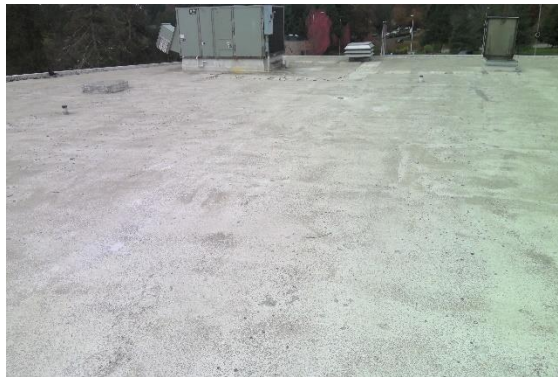
Deficiency R01

The roofing has reached the end of its useful life. Prior reconditioning materials have also failed. Some water damage has occurred. The roofing should be replaced and the damage should be repaired.

Scoring priority category 1 : System Use (scoring weight=15)
Category 1 percentage : 70 %
Scoring priority category 2 : High Repair/Repl. Cost (scoring weight=12)
Category 2 percentage : 30 %
Project construction estimate (MACC): \$218,000
Total project estimate (including soft costs): \$309,000
Additional points based on building condition: 5
Deficiency score : $4 \times ((15 \times 70\%) + (12 \times 30\%)) + 5 = 61.4$

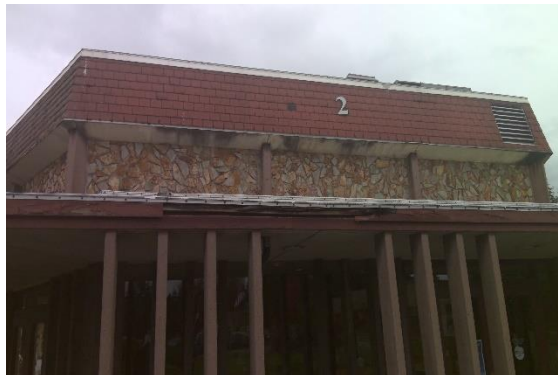
Deficiency R02

The asbestos mansard roof siding shingles are failing. The roofing should be covered with metal panels like other buildings on campus.

Scoring priority category 2 : High Repair/Repl. Cost (scoring weight=12)
Category 2 percentage : 30 %
Project construction estimate (MACC): \$100,000
Total project estimate (including soft costs): \$141,000
Additional points based on building condition: 5
Deficiency score : $4 \times ((15 \times 70\%) + (12 \times 30\%)) + 5 = 61.4$

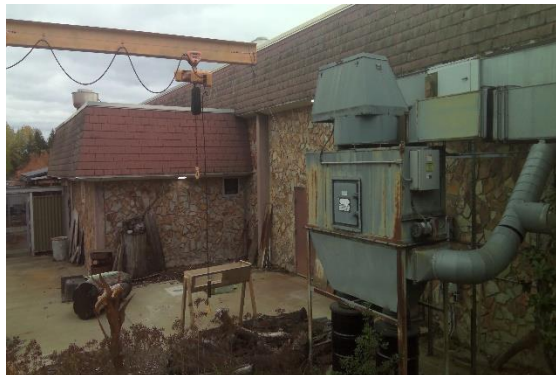
Deficiency R03

The asbestos mansard roof siding shingles are beginning to fail. Minor repairs are required to extend its useful life. The roofing should be covered with metal panels like other buildings on campus.

Scoring priority category 1 : High Repair/Repl. Cost (scoring weight=12)
Category 1 percentage : 60 %
Scoring priority category 2 : System Use (scoring weight=15)
Category 2 percentage : 40 %
Project construction estimate (MACC): \$150,000
Total project estimate (including soft costs): \$212,000
Additional points based on building condition: 5
Deficiency score : $2.5 \times ((12 \times 60\%) + (15 \times 40\%)) + 5 = 38$

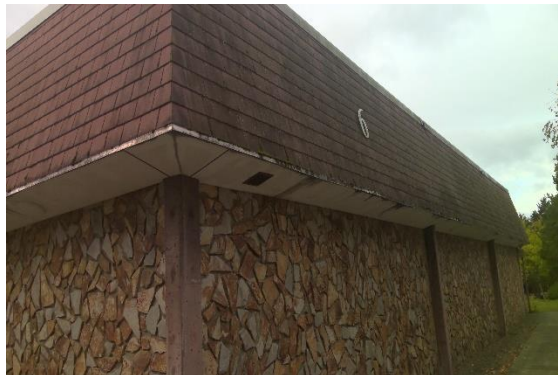
Deficiency R04

The asbestos mansard roof siding shingles are beginning to fail. Minor repairs are required to extend its useful life. The roofing should be covered with metal panels like other buildings on campus.

Category 1 percentage : 70 %
Scoring priority category 2 : System Use (scoring weight=15)
Category 2 percentage : 30 %
Project construction estimate (MACC): \$120,000
Total project estimate (including soft costs): \$170,000
Additional points based on building condition: 2
Deficiency score : $2.5 \times ((12 \times 70\%) + (15 \times 30\%)) + 2 = 34.3$

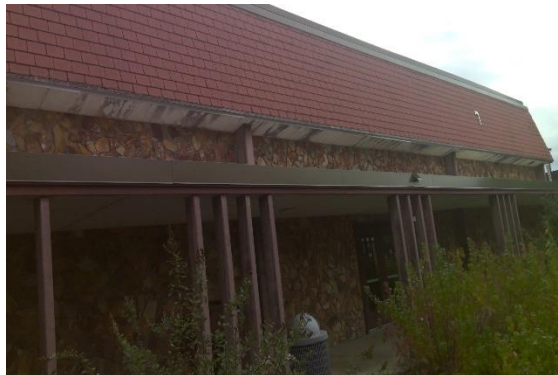
Deficiency R05

The asbestos mansard roof siding shingles are beginning to fail. Minor repairs are required to extend its useful life. The roofing should be covered with metal panels like other buildings on campus.

Category 1 percentage : 60 %
Scoring priority category 2 : System Use (scoring weight=15)
Category 2 percentage : 40 %
Project construction estimate (MACC): \$400,000
Total project estimate (including soft costs): \$567,000
Additional points based on building condition: 1
Deficiency score : $2.5 \times ((12 \times 60\%) + (15 \times 40\%)) + 1 = 34$

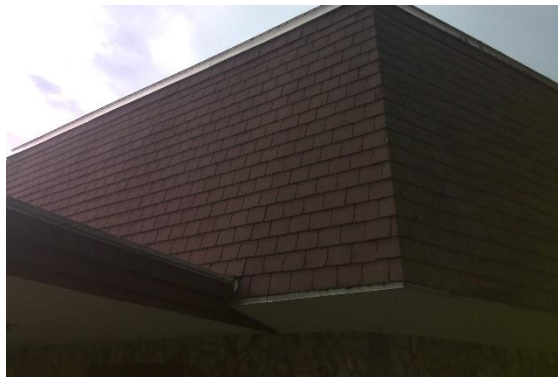
Deficiency R06

The asbestos mansard roof siding shingles are beginning to fail, but there are no known leaks. Minor repairs are required to extend its useful life. The roofing should be covered with metal panels like other buildings on campus.

Scoring priority category 1 : System Use (scoring weight=15)
Category 1 percentage : 70 %
Scoring priority category 2 : High Repair/Repl. Cost (scoring weight=12)
Category 2 percentage : 30 %
Project construction estimate (MACC): \$282,000
Total project estimate (including soft costs): \$400,000
Additional points based on building condition: 2
Deficiency score : $1 \times ((15 \times 70\%) + (12 \times 30\%)) + 2 = 16.1$

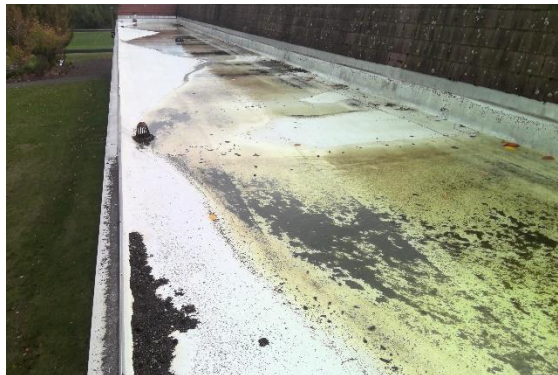
Deficiency R07

The roof system has exceeded its useful life and is deteriorating rapidly. Moisture testing indicates that the wooden overhangs will also need replacing.

Category 1 percentage : 70 %
Scoring priority category 2 : High Repair/Repl. Cost (scoring weight=12)
Category 2 percentage : 30 %
Project construction estimate (MACC): \$305,000
Total project estimate (including soft costs): \$432,000
Additional points based on building condition: 5
Deficiency score : $4 \times ((15 \times 70\%) + (12 \times 30\%)) + 5 = 61.4$

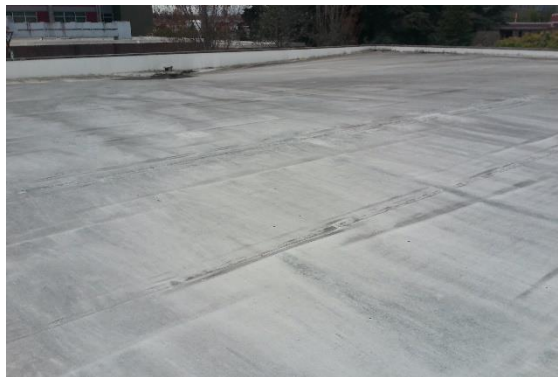
Deficiency R08

The roof system has exceeded its useful life and is deteriorating rapidly. Moisture testing indicates that some of the insulation has been saturated and must also be replaced. The roofing should be replaced and the areas of failed insulation should also be replaced.

Estimated remaining life (years) : 3
Estimated average life expectancy (years) : 20
Scoring priority category 1 : System Use (scoring weight=15)
Category 1 percentage : 70 %
Scoring priority category 2 : High Repair/Repl. Cost (scoring weight=12)
Category 2 percentage : 30 %
Project construction estimate (MACC): \$345,000
Total project estimate (including soft costs): \$489,000
Additional points based on building condition: 1
Deficiency score : $4 \times ((15 \times 70\%) + (12 \times 30\%)) + 1 = 57.4$

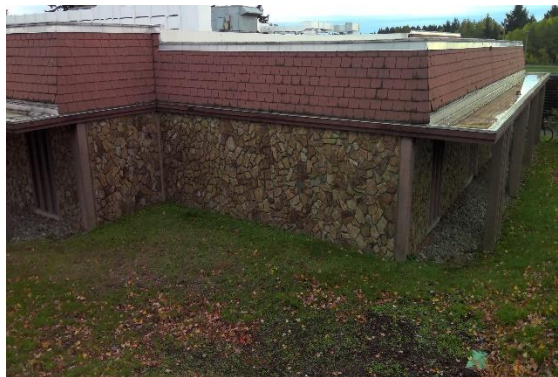
Deficiency R09

The asbestos mansard roof siding shingles are failing. The roofing should be replaced, however, this building is planned to be demolished with the next major project. The roofing should continue to be monitored for leaks and be repaired using maintenance methods until the building is demolished.

Estimated remaining life (years) : 9
Estimated average life expectancy (years) : 20
Scoring priority category 1 : System Use (scoring weight=15)
Category 1 percentage : 60 %
Scoring priority category 2 : High Repair/Repl. Cost (scoring weight=12)
Category 2 percentage : 40 %
Project construction estimate (MACC): \$455,000
Total project estimate (including soft costs): \$645,000
Additional points based on building condition: 5
Deficiency score : $1 \times ((15 \times 60\%) + (12 \times 40\%)) + 5 = 18.8$

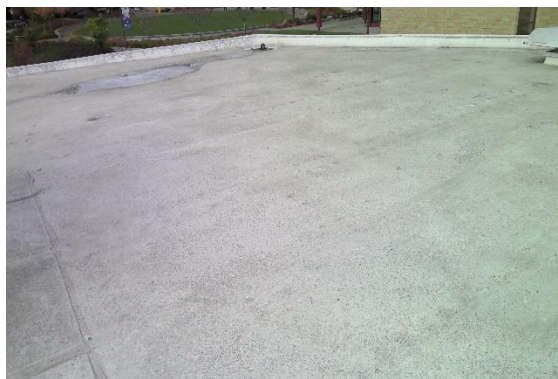
Deficiency R10

The roofing has deteriorated and is near the end of its useful life. The roofing should be reconditioned, however, this building is planned to be demolished with the next major project. The roofing should continue to be monitored for leaks and be repaired using maintenance methods until the building is demolished.

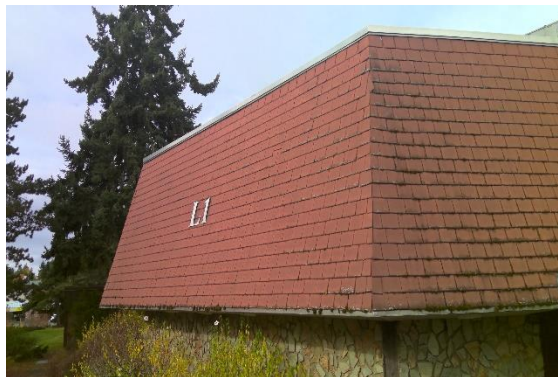
Deficiency R11

The asbestos mansard roof siding shingles are failing. The roofing should be replaced, however, this building is planned to be demolished with the next major project. The roofing should continue to be monitored for leaks and be repaired using maintenance methods until the building is demolished.

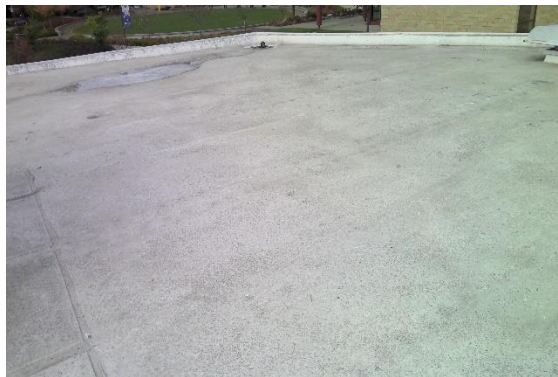
Deficiency R12

The roofing has deteriorated and is near the end of its useful life. The roofing should be reconditioned, however, this building is planned to be demolished with the next major project. The roofing should continue to be monitored for leaks and be repaired using maintenance methods until the building is demolished.

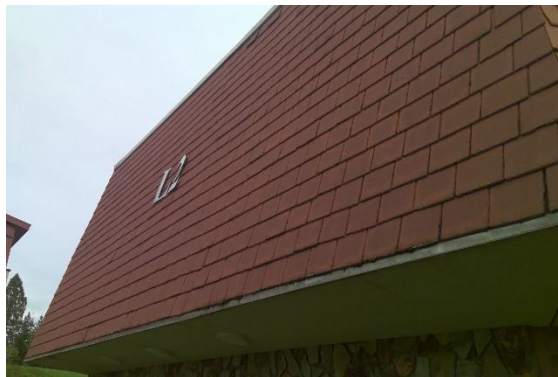
Deficiency R13

The asbestos mansard roof siding shingles are failing. The roofing should be replaced, however, this building is planned to be demolished with the next major project. The roofing should continue to be monitored for leaks and be repaired using maintenance methods until the building is demolished.
