# 2021 FACILITY CONDITION SURVEY

Whatcom Community College

SURVEY CONDUCTED BY:  
Steve Lewandowski  
State Board for Community  
and Technical Colleges

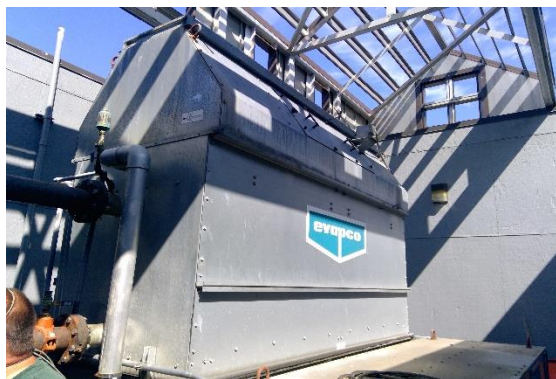
The cooling tower is rusting out due to weather and age. Once the water reservoir is rusted through, the cooling tower will have reached its end of life. The tower should continue to be monitored for future replacement.

| Deficiency score : $2.5 \times ((15 \times 50\%) + (12 \times 50\%)) + 1 = 34.8$ |

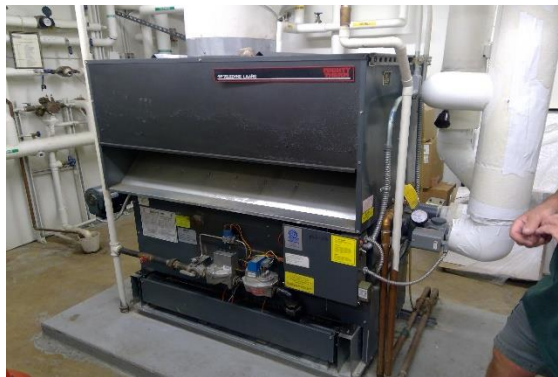
**Deficiency F02**

The boiler is near the end of its useful life. The heat exchanger has been replaced two times and is starting to fail again. The sheet metal cabinet is becoming increasingly damaged and warped by the heat as is the control wiring and components. The burners are also extremely deteriorated. The boiler should be replaced.

| Deficiency score : $4 \times ((15 \times 70\%) + (12 \times 30\%)) + 1 = 57.4$ |

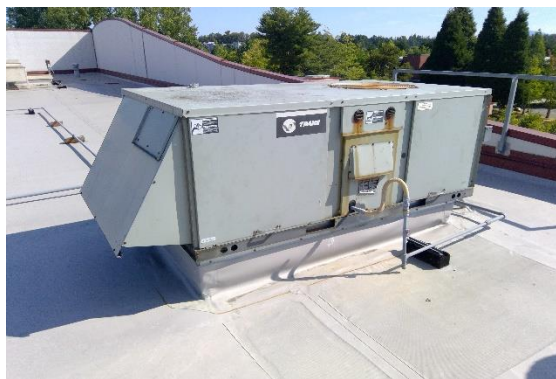
**Deficiency F03**

The HVAC units are showing sign of age. The college staff indicated that they are having problems with water intrusion through the sheet metal cabinets. Some of the control boards have failed. These units should be replaced.

| Deficiency score : $4 \times ((15 \times 60\%) + (10 \times 40\%)) + 1 = 53$ |

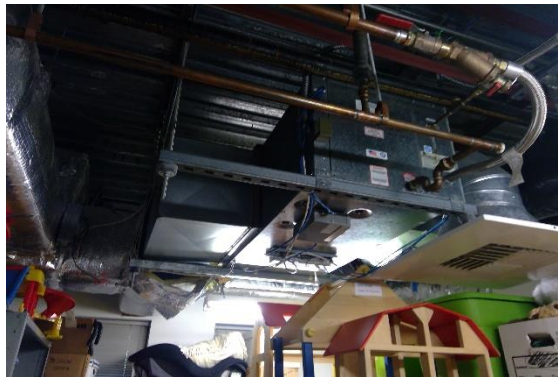
**Deficiency F04**

The heat pumps serving this building have deteriorated. Eight of the units in the worst condition were funded for replacement in the prior biennium. There are 22 original units remaining in varying degrees of deterioration. The next eight units in the worst condition should be replaced. The other remaining units should continue to be monitored for future replacement.

| Deficiency score : $4 \times ((12 \times 80\%) + (15 \times 20\%)) + 1 = 51.4$ |

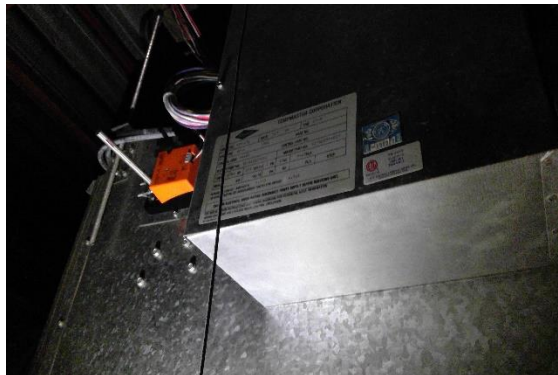
**Deficiency F05**

The variable air volume heat boxes installed in multiple buildings have derogated. Each box has varying needs for repairs (motor, damper, control valve failures). The worst 40 units should be repaired.

| Deficiency score : $4 \times ((12 \times 50\%) + (15 \times 50\%)) + 1 = 55$ |

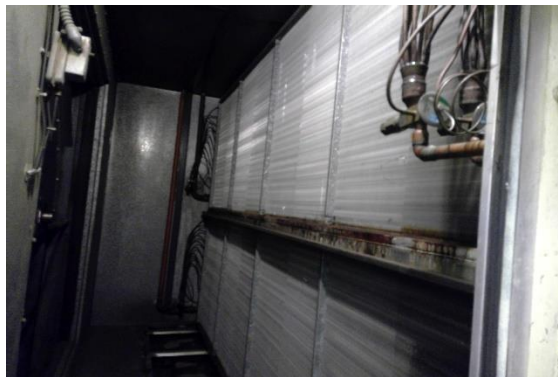
**Deficiency F06**

The college is concerned about the age of the air handler. Staff indicated that there are reoccurring issues with refrigerant leaks and replacement parts are becoming more difficult to find. The unit appeared to be in good condition, but required maintenance. The unit should continue to be monitored for repair or replacement.

| Deficiency score : $2.5 \times ((12 \times 60\%) + (15 \times 40\%)) + 1 = 34$ |

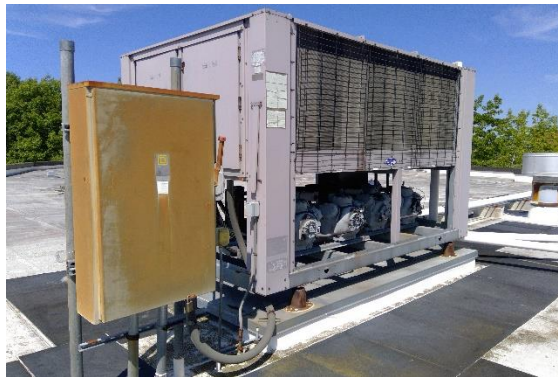
**Deficiency F07**

The college was concerned about the age of the cooling coils in the HVAC unit. One of the compressors has failed. The coils and related condensing components should be replaced to extend the life of the unit.

| Deficiency score : $4 \times ((15 \times 70\%) + (12 \times 30\%)) + 1 = 57.4$ |

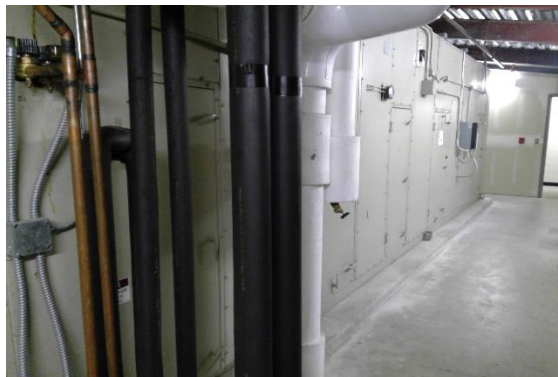
**Deficiency F08**

The college is concerned about the age of the air handler. Staff indicated that two variable frequency drives had failed and the return fan need to be rebuilt to return it to normal operation. The unit appeared to be in good working order and should continue to be monitored for repair or replacement.

| Deficiency score : $1 \times ((12 \times 60\%) + (15 \times 40\%)) + 1 = 14.2$ |

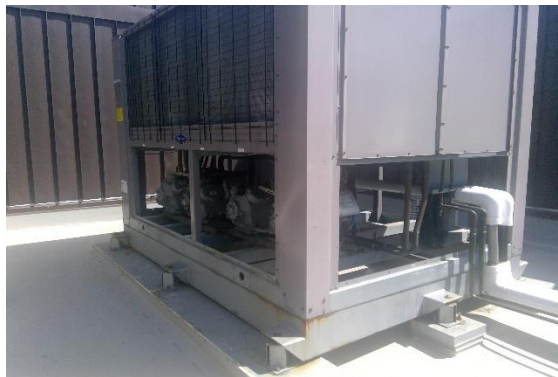
**Deficiency F09**

The college was concerned about electrical issues due to equipment vibration. The staff also indicated that there were fan reliability issues as well as refrigerant leaks, however, the unit appeared to be in good condition and should be monitored for repair or replacement.

| Deficiency score : $1 \times ((12 \times 60\%) + (15 \times 40\%)) + 1 = 14.2$ |

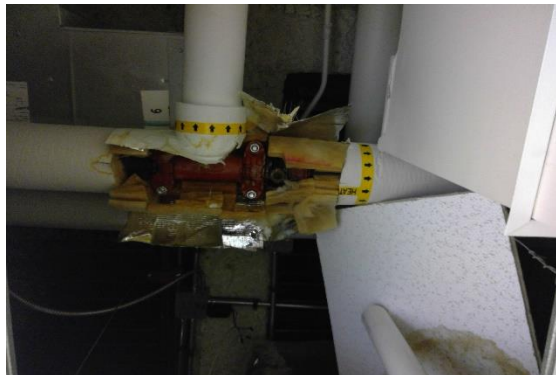
**Deficiency F10**

There are many leaking Victaulic fittings throughout the heating water loop. These fittings should be replaced to maintain a water-tight system.

| Deficiency score : $4 \times ((12 \times 70\%) + (15 \times 30\%)) + 0 = 51.6$ |

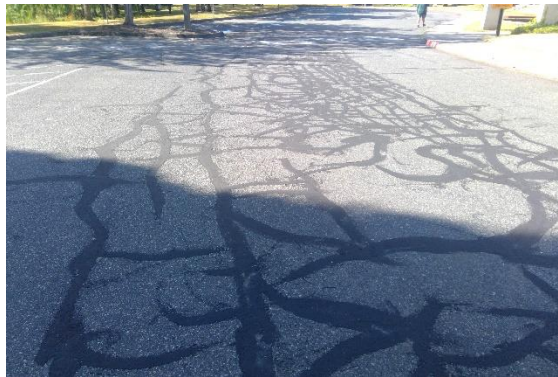
**Deficiency S01**

The emergency access road has failed in several areas. The deteriorated surface will lead to subgrade failure. These areas should be repaired.

| Deficiency score : $4 \times ((25 \times 50\%) + (5 \times 50\%)) + 0 = 60$ |

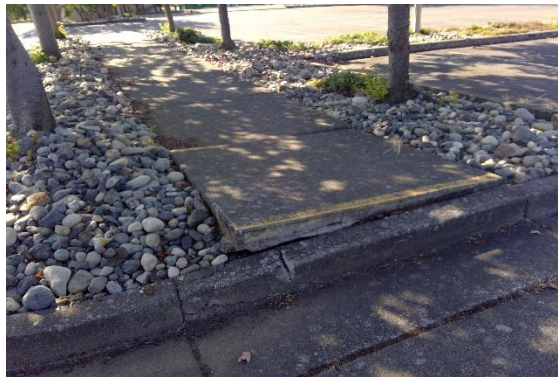
**Deficiency S02**

There are several concrete paths that have failed due to frost heave, root intrusion or movement. Many areas create an accessibility standard violation. These areas should be replaced.

| Deficiency score : $4 \times ((20 \times 50\%) + (12 \times 50\%)) + 0 = 64$ |

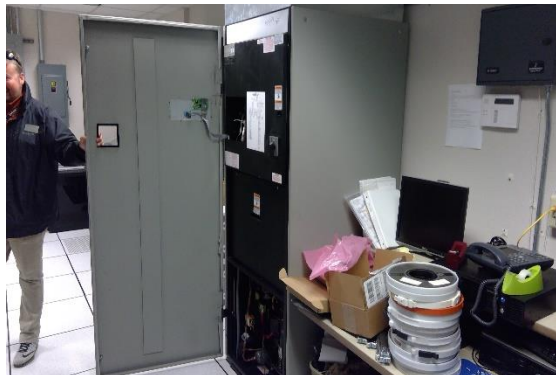
**Deficiency F14**

One of the HVAC units serving the main server room is near the end of its useful life. The adjacent lead-lag unit has already been replaced. The remaining unit should be replaced to ensure proper cooling is not disrupted.

| Deficiency score : $4 \times ((15 \times 60\%) + (10 \times 40\%)) + 1 = 53$ |

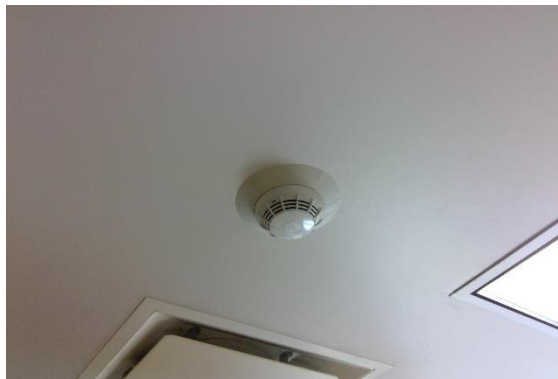
**Deficiency F15**

Many smoke detectors are beginning to fail in several buildings. These detectors cannot function as a system when newer detectors are installed due to communication issues. The smoke detectors of this type should be replaced to ensure that the entire system functions to protect the building and inhabitants.

| Deficiency score : $4 \times ((25 \times 60\%) + (12 \times 40\%)) + 0 = 79.2$ |

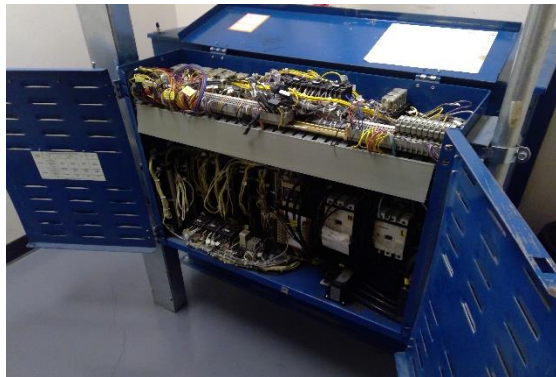
**Deficiency F16**

The Otis elevator controls are no longer supported by the manufacturer or vendor. The vendor has provided documentation that indicates that the elevator would possibly be out of service for an extended period in the case of equipment failure since parts would no longer be available. Since this is the only elevator serving the building, this would create an accessibility violation. The elevator should be modernized to ensure reliable use is not disrupted.

| Deficiency score : $4 \times ((20 \times 50\%) + (12 \times 50\%)) + 1 = 65$ |

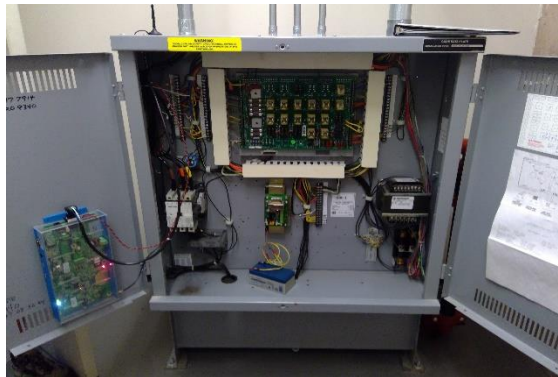
**Deficiency F17**

The Dover elevator controls are no longer supported by the manufacturer or vendor. The vendor has provided documentation that indicates that the elevator would possibly be out of service for an extended period in the case of equipment failure since parts would no longer be available. Since this is the only elevator serving the building, this would create an accessibility violation. The elevator should be modernized to ensure reliable use is not disrupted.

| Deficiency score : $4 \times ((20 \times 50\%) + (15 \times 50\%)) + 1 = 71$ |
