2021 FACILITY CONDITION SURVEY

Yakima Valley College

SURVEY CONDUCTED BY:
Steve Lewandowski
State Board for Community
and Technical Colleges

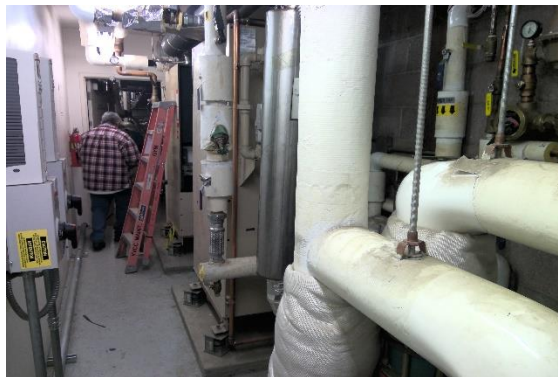
Deficiency F04

The college is concerned about the age of the boilers. They still function as designed, but have required more frequent repairs to maintain function. These boilers should continue to be monitored and be reviewed for replacement next biennium.

Estimated remaining life (years) : 5
Estimated average life expectancy (years) : 20
Scoring priority category 1 : System Use (scoring weight=15)
Category 1 percentage : 70 %
Scoring priority category 2 : High Repair/Repl. Cost (scoring weight=12)
Category 2 percentage : 30 %
Project construction estimate (MACC): \$160,000
Total project estimate (including soft costs): \$223,000
Additional points based on building condition: 5
Deficiency score : $2.5 \times ((15 \times 70\%) + (12 \times 30\%)) + 5 = 40.3$

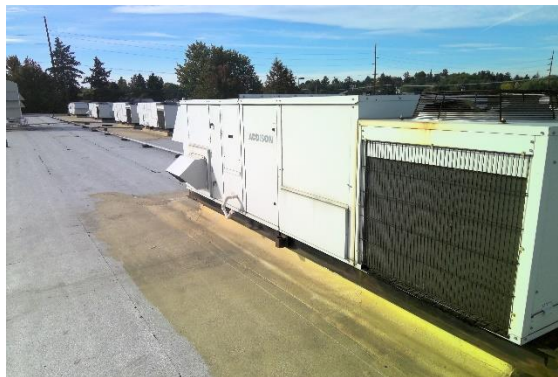
Deficiency F10

These college is concerned about the two air handlers serving the building. One unit has failed. Both units are beyond their expected life and should be replaced.

Category 1 percentage : 80 %
Scoring priority category 2 : High Repair/Repl. Cost (scoring weight=12)
Category 2 percentage : 20 %
Project construction estimate (MACC): \$70,000
Total project estimate (including soft costs): \$97,000
Additional points based on building condition: 0
Deficiency score : $4 \times ((15 \times 80\%) + (12 \times 20\%)) + 0 = 57.6$

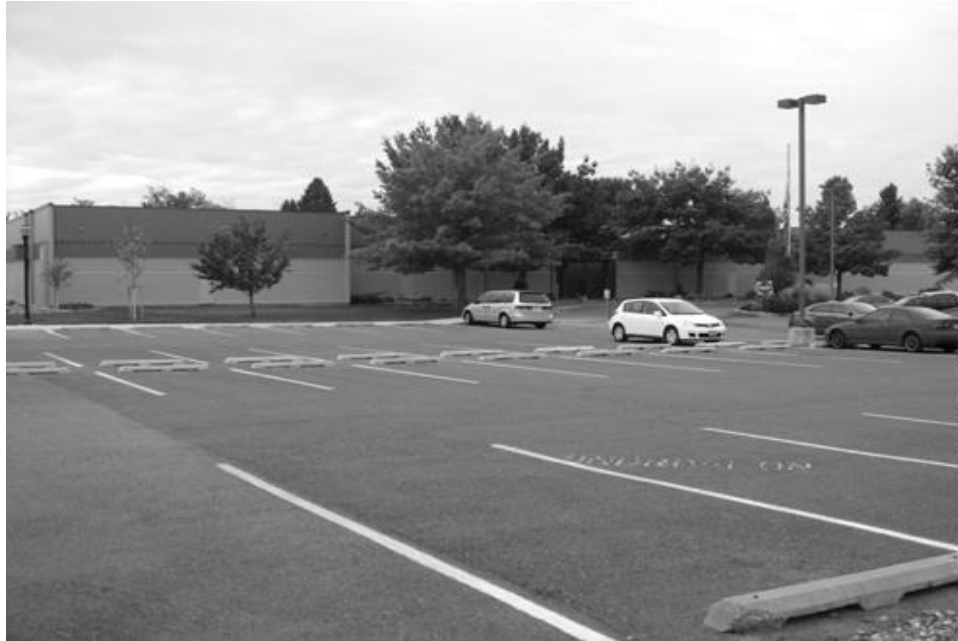
Grandview Center (160-046) STATE UFI: A01507 Grandview Campus (160B)
AREA: 27,738 SF BUILT: 1990 REMODELED: No PREDOMINANT USE: General Classroom
CONSTRUCTION TYPE: Heavy CRV/SF: \$361 REPLACEMENT VALUE: \$10,013,418

Primary Systems			
COMPONENT:	Structure	RATING: 1 x WEIGHT: 8.3 =	SCORE: 8.3
No signs of settlement or cracking, no abrupt vertical changes Columns, bearing walls and roof structure appears sound/free of defects			
COMMENTS:	Steel frame structure		
COMPONENT:	Exterior Closure	RATING: 1 x WEIGHT: 8.3 =	SCORE: 8.3
Weatherproof, tight, well-maintained exterior walls, doors, windows/finishes			
COMMENTS:	Stucco; metal panels; aluminum window walls		
COMPONENT:	Roofing	RATING: 2 x WEIGHT: 10.4 =	SCORE: 20.9
Majority of roofing and flashing appear sound, but a small portion of roofing shows deterioration where maintenance or minor repair needed			
COMMENTS:	Modified bitumen with UV coat; skylight

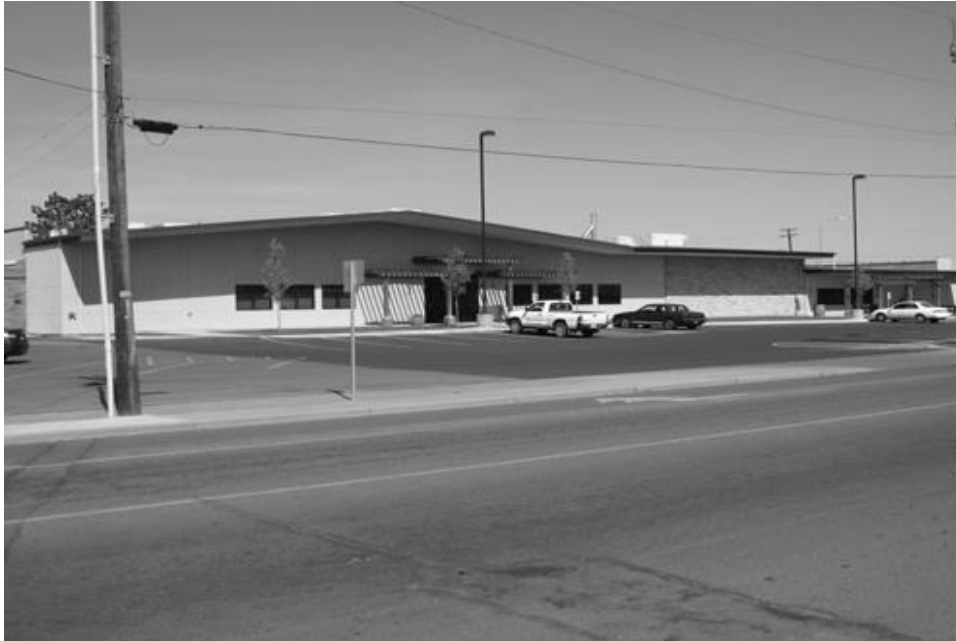
Workforce Education Center (160-051) STATE UFI: A08651 Grandview Campus (160B)
AREA: 25,888 SF BUILT: 1962 REMODELED: 2007 PREDOMINANT USE: Vocational Arts
CONSTRUCTION TYPE: Medium CRV/SF: \$379 REPLACEMENT VALUE: \$9,811,552

Primary Systems			
COMPONENT:	Structure	RATING: 1 x WEIGHT: 8.3 = SCORE: 8.3	
No signs of settlement or cracking, no abrupt vertical changes Columns, bearing walls and roof structure appears sound/free of defects			
COMMENTS:	Wood frame w steel columns		
COMPONENT:	Exterior Closure	RATING: 1 x WEIGHT: 8.3 = SCORE: 8.3	
Weatherproof, tight, well-maintained exterior walls, doors, windows/finishes			
COMMENTS:	CMU, stucco; random cut split faced sandstone block		
COMPONENT:	Roofing	RATING: 1 x WEIGHT: 10.4 = SCORE: 10.4	
Flashing and penetrations appear sound and membrane appears water- tight; drainage is positive and there are overflow scuppers			
COMMENTS:	Mineral surfaced torch down cap sheet membrane

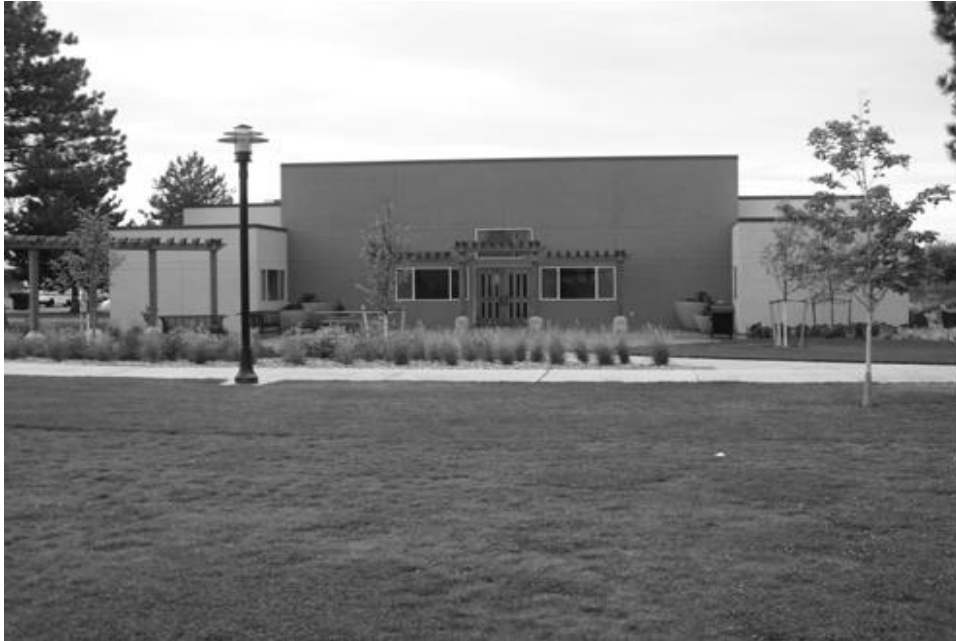
Grandview Activity Center (160-052) STATE UFI: A10610 Grandview Campus (160B)
AREA: 5,170 SF BUILT: 1988 REMODELED: 2012 PREDOMINANT USE: Student Center
CONSTRUCTION TYPE: Medium CRV/SF: \$222 REPLACEMENT VALUE: \$1,147,740

Primary Systems			
COMPONENT:	Structure	RATING: 1 x WEIGHT: 8.3 =	SCORE: 8.3
No signs of settlement or cracking, no abrupt vertical changes Columns, bearing walls and roof structure appears sound/free of defects			
COMMENTS:	Wood frame		
COMPONENT:	Exterior Closure	RATING: 1 x WEIGHT: 8.3 =	SCORE: 8.3
Weatherproof, tight, well-maintained exterior walls, doors, windows/finishes			
COMMENTS:	Stucco		
COMPONENT:	Roofing	RATING: 2 x WEIGHT: 10.4 =	SCORE: 20.9
Majority of roofing and flashing appear sound, but a small portion of roofing shows deterioration where maintenance or minor repair needed			
COMMENTS:	TPO single-ply

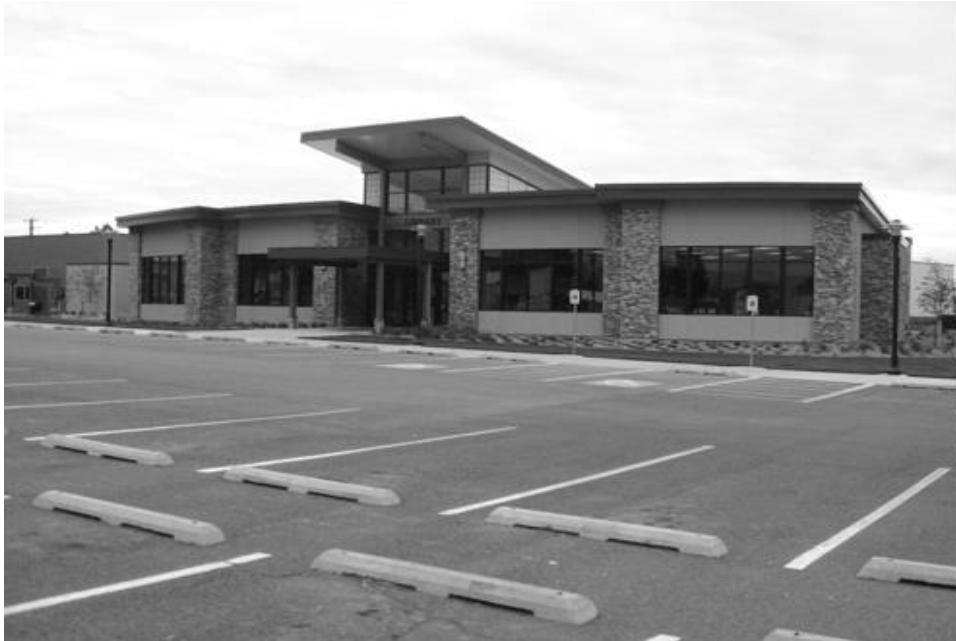
Grandview Library (160-055) STATE UFI: A10922 Grandview Campus (160B)
AREA: 12,144 SF BUILT: 2011 REMODELED: No PREDOMINANT USE: Library
CONSTRUCTION TYPE: Medium CRV/SF: \$317 REPLACEMENT VALUE: \$3,849,648

Primary Systems			
COMPONENT:	Structure	RATING: 1 x WEIGHT: 8.3 =	SCORE: 8.3
No signs of settlement or cracking, no abrupt vertical changes Columns, bearing walls and roof structure appears sound/free of defects			
COMMENTS:	Wood beam and frame; concrete		
COMPONENT:	Exterior Closure	RATING: 1 x WEIGHT: 8.3 =	SCORE: 8.3
Weatherproof, tight, well-maintained exterior walls, doors, windows/finishes			
COMMENTS:	Stucco; split-rock; metal soffits		
COMPONENT:	Roofing	RATING: 1 x WEIGHT: 10.4 =	SCORE: 10.4
Flashing and penetrations appear sound and membrane appears water- tight; drainage is positive and there are overflow scuppers			
COMMENTS:	TPO single-ply

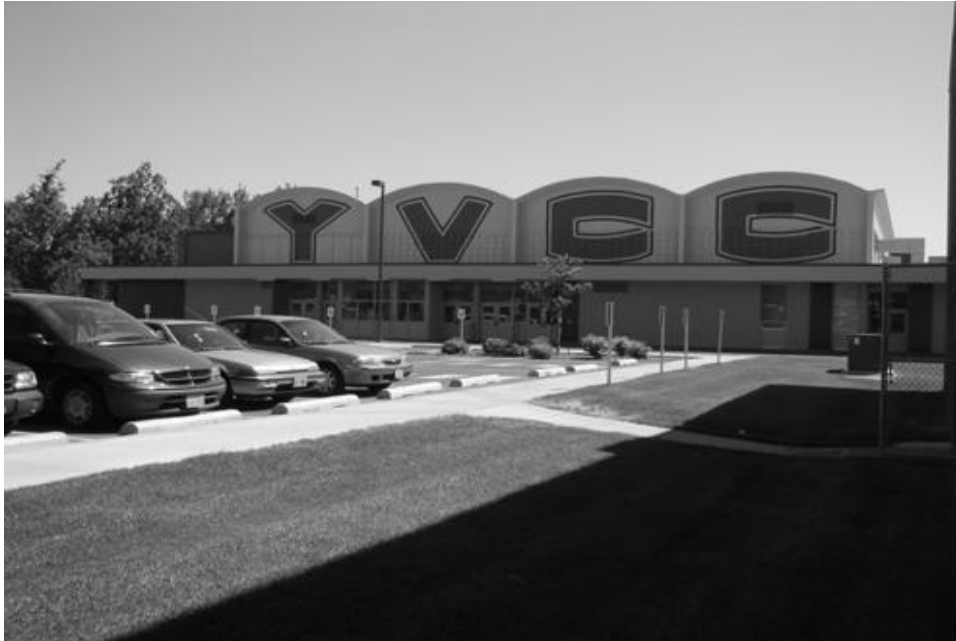
Sherar Gym (160-006) STATE UFI: A01980 Main Campus (160A)
AREA: 35,699 SF BUILT: 1957 REMODELED: No PREDOMINANT USE: Gymnasium
CONSTRUCTION TYPE: Medium CRV/SF: \$335 REPLACEMENT VALUE: \$11,959,165

Primary Systems			
COMPONENT:	Structure	RATING: 3 x WEIGHT: 8.3 =	SCORE: 25
Some cracking evident but does not likely affect structural integrity; Visible defects apparent but are non-structural			
COMMENTS:	Concrete and CMU; minor column deterioration; some seismic issues		
COMPONENT:	Exterior Closure	RATING: 1 x WEIGHT: 8.3 =	SCORE: 8.3
Weatherproof, tight, well-maintained exterior walls, doors, windows/finishes			
COMMENTS:	CMU; three side have been overlaid w dryvit; brick; wood fascia		
COMPONENT:	Roofing	RATING: 2 x WEIGHT: 10.4 =	SCORE: 20.9
Majority of roofing and flashing appear sound, but a small portion of roofing shows deterioration where maintenance or minor repair needed			
COMMENTS:	Mineral surfaced cap sheet; BUR with UV coating; new UV coat IN 04

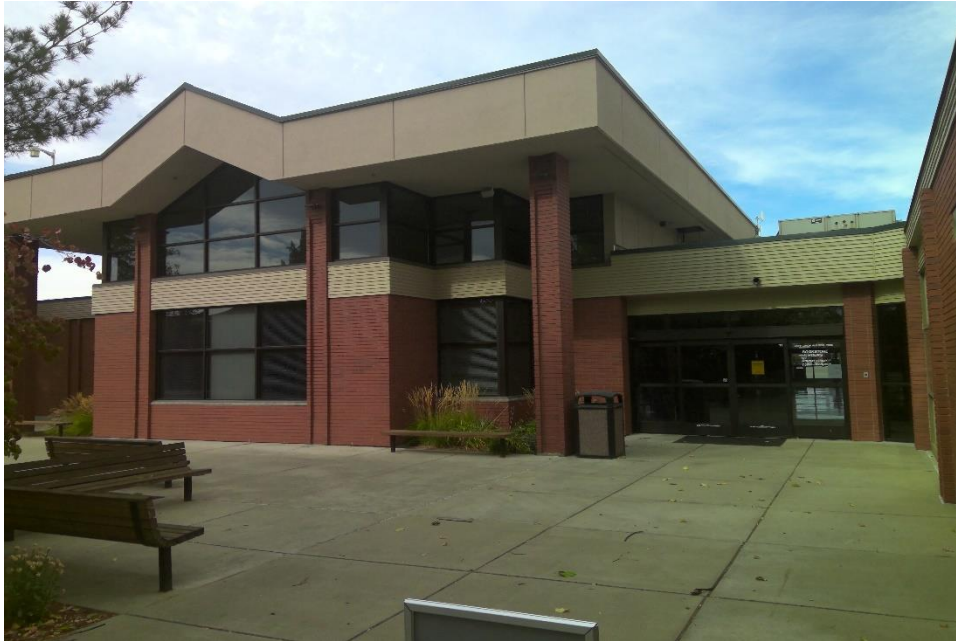
Hopf Union Building (160-009) STATE UFI: A03561 Main Campus (160A)
AREA: 26,497 SF BUILT: 1957 REMODELED: 2001 PREDOMINANT USE: Student Center
CONSTRUCTION TYPE: Medium CRV/SF: \$376 REPLACEMENT VALUE: \$9,962,872

Primary Systems			
COMPONENT:	Structure	RATING: 1 x WEIGHT: 8.3 =	SCORE: 8.3
No signs of settlement or cracking, no abrupt vertical changes Columns, bearing walls and roof structure appears sound/free of defects			
COMMENTS:	Concrete and brick; steel columns		
COMPONENT:	Exterior Closure	RATING: 1 x WEIGHT: 8.3 =	SCORE: 8.3
Weatherproof, tight, well-maintained exterior walls, doors, windows/finishes			
COMMENTS:	Brick; wood fascia		
COMPONENT:	Roofing	RATING: 3 x WEIGHT: 10.4 =	SCORE: 31.3
Some deterioration is evident in membrane and flashings; maintenance or minor repair is needed			
COMMENTS:	BUR-parapet/curb lap seal tape peeling; 3-tab asphalt shingles; skylights; Repairs funded 21-23

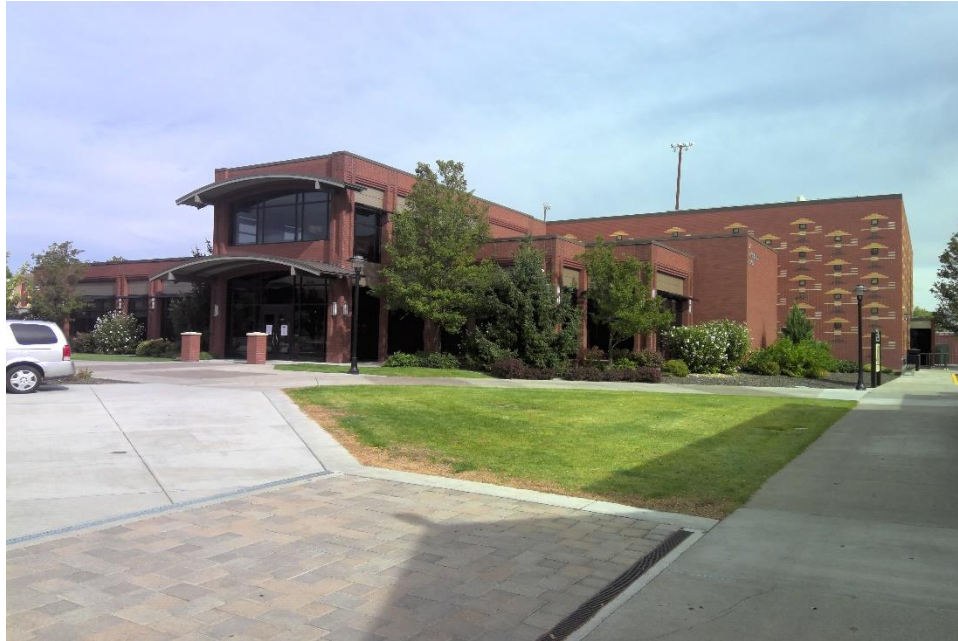
Raymond Hall Library (160-007) STATE UFI: A03586 Main Campus (160A)
 AREA: 28,255 SF BUILT: 1966 REMODELED: 2009 PREDOMINANT USE: Library
 CONSTRUCTION TYPE: Heavy CRV/SF: \$361 REPLACEMENT VALUE: \$10,200,055

Primary Systems			
COMPONENT:	Structure	RATING: 1 x WEIGHT: 8 =	SCORE: 8
No signs of settlement or cracking, no abrupt vertical changes Columns, bearing walls and roof structure appears sound/free of defects			
COMMENTS:	Brick, concrete, and structural steel		
COMPONENT:	Exterior Closure	RATING: 1 x WEIGHT: 8 =	SCORE: 8
Weatherproof, tight, well-maintained exterior walls, doors, windows/finishes			
COMMENTS:	Brick		
COMPONENT:	Roofing	RATING: 1 x WEIGHT: 10 =	SCORE: 10
Flashing and penetrations appear sound and membrane appears water- tight; drainage is positive and there are overflow scuppers			
COMMENTS:	BUR 2011 on older section; granular surfaced torch-down on addition

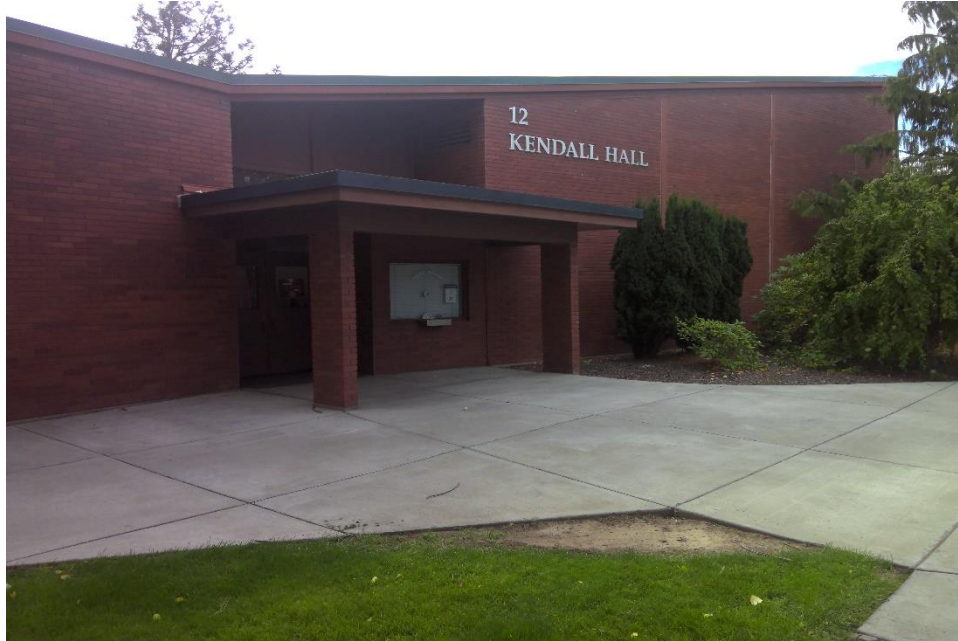
Kendall Hall (160-012) STATE UFI: A03623 Main Campus (160A)
AREA: 16,486 SF BUILT: 1961 REMODELED: No PREDOMINANT USE: Performing Arts
CONSTRUCTION TYPE: Medium CRV/SF: \$404 REPLACEMENT VALUE: \$6,660,344

Primary Systems			
COMPONENT:	Structure	RATING: 1 x WEIGHT: 8.3 =	SCORE: 8.3
No signs of settlement or cracking, no abrupt vertical changes Columns, bearing walls and roof structure appears sound/free of defects			
COMMENTS:	Brick; concrete; steel framing		
COMPONENT:	Exterior Closure	RATING: 3 x WEIGHT: 8.3 =	SCORE: 25
Sound and weatherproof but with some deterioration evident			
COMMENTS:	Brick and CMU		
COMPONENT:	Roofing	RATING: 2 x WEIGHT: 10.4 =	SCORE: 20.9
Majority of roofing and flashing appear sound, but a small portion of roofing shows deterioration where maintenance or minor repair needed			
COMMENTS:	Modified bitumen with UV coating; new roof in 2006

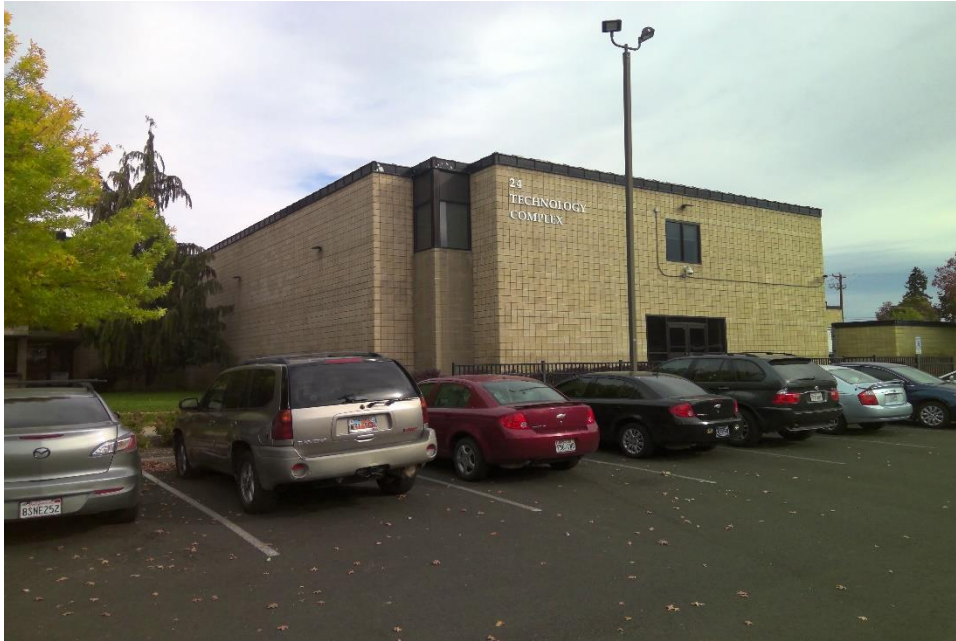
Technology Complex (160-017) STATE UFI: A04110 Main Campus (160A)
AREA: 48,140 SF BUILT: 1975 REMODELED: 2001 PREDOMINANT USE: Vocational Arts
CONSTRUCTION TYPE: Heavy CRV/SF: \$379 REPLACEMENT VALUE: \$18,245,060

Primary Systems			
COMPONENT:	Structure	RATING: 1 x WEIGHT: 8 =	SCORE: 8
No signs of settlement or cracking, no abrupt vertical changes Columns, bearing walls and roof structure appears sound/free of defects			
COMMENTS:	Concrete; CMU; steel framing		
COMPONENT:	Exterior Closure	RATING: 1 x WEIGHT: 8 =	SCORE: 8
Weatherproof, tight, well-maintained exterior walls, doors, windows/finishes			
COMMENTS:	CMU		
COMPONENT:	Roofing	RATING: 3 x WEIGHT: 10 =	SCORE: 30
Some deterioration is evident in membrane and flashings; maintenance or minor repair is needed			
COMMENTS:	Mineral surfaced cap sheet-needs minor repair of blisters

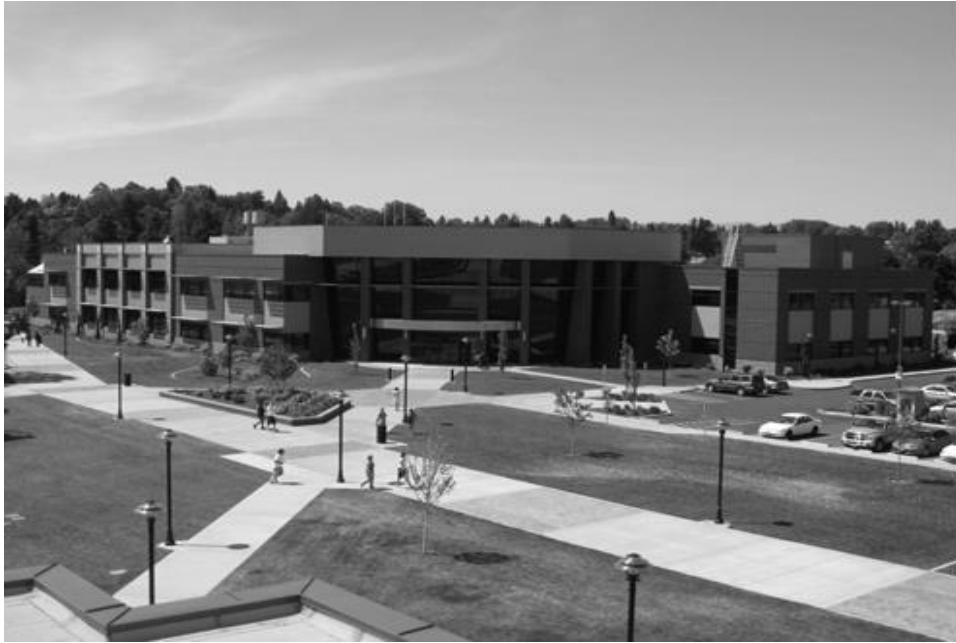
Glenn Anthon Hall (160-026) STATE UFI: A04522 Main Campus (160A)
AREA: 102,941 SF BUILT: 2007 REMODELED: No PREDOMINANT USE: General Classroom
CONSTRUCTION TYPE: Heavy CRV/SF: \$361 REPLACEMENT VALUE: \$37,161,701

Primary Systems			
COMPONENT:	Structure	RATING: 1 x WEIGHT: 8.4 = SCORE: 8.4	
No signs of settlement or cracking, no abrupt vertical changes Columns, bearing walls and roof structure appears sound/free of defects			
COMMENTS:	Steel frame and concrete		
COMPONENT:	Exterior Closure	RATING: 1 x WEIGHT: 8.4 = SCORE: 8.4	
Weatherproof, tight, well-maintained exterior walls, doors, windows/finishes			
COMMENTS:	Concrete; brick; stucco		
COMPONENT:	Roofing	RATING: 1 x WEIGHT: 10.5 = SCORE: 10.5	
Flashing and penetrations appear sound and membrane appears water- tight; drainage is positive and there are overflow scuppers			
COMMENTS:	Built-up roof membrane with mineral surfaced cap sheet
