2023 FACILITY CONDITION SURVEY

Bates Technical College

SURVEY CONDUCTED BY:
Steve Lewandowski
State Board for Community
and Technical Colleges

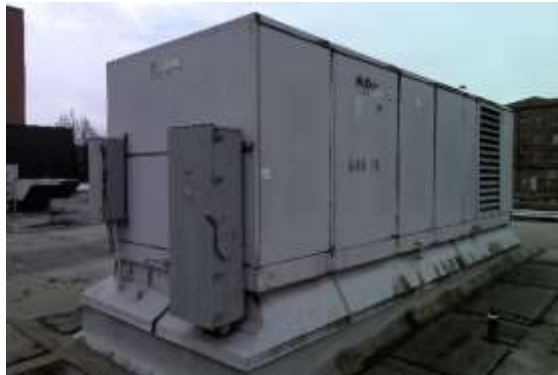
The two HVAC units have had failing coils, dampers and burner components. These units should be replaced.

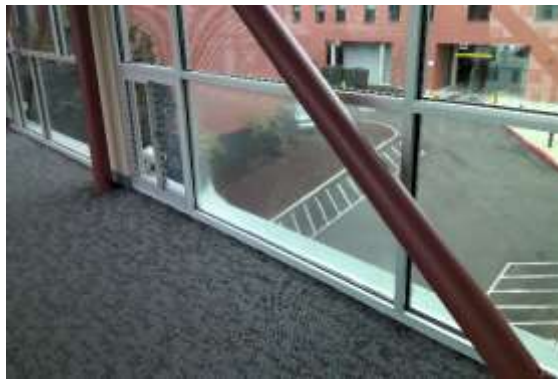
Deficiency F02

Several windows in multiple buildings have failed or have become damaged due to vandalism. Some windows have allowed water to penetrate the building envelope and have caused damage. These windows should be replaced and the damage should be repaired.

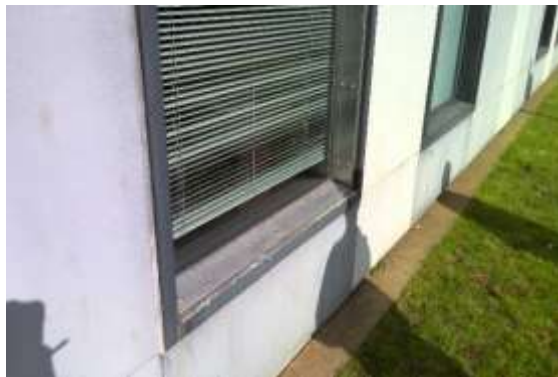
Deficiency F03

The hollow metal frames of several windows in buildings A, B and D have allowed water to infiltrate the building envelopes. Some of these windows have allowed water to penetrate the building envelope and cause damage. These windows should be replaced and the damage should be repaired.

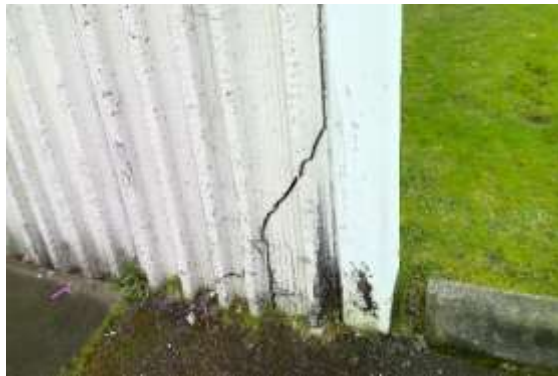
Deficiency F04

A section of the tilt-up exterior wall has failed due to settling or a previous seismic event. The stucco finish on one side of the concrete has also failed. The extent of the failure is not evident based on visual observation, but this portion of the structural concrete and applied stucco finish should be repaired. Additional information is required to determine if the scope of work extends to other portions of the wall or to the footing.

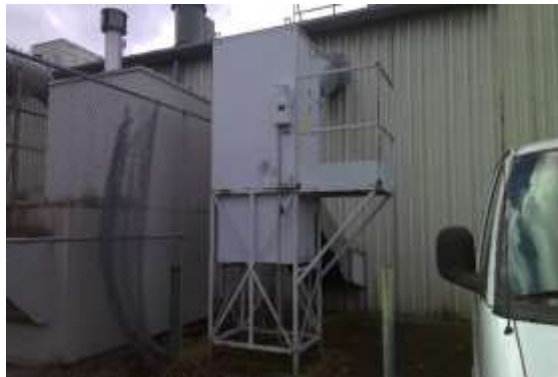
Deficiency F05

The HVAC units have exceeded their expected life and have become less reliable. Parts are difficult to obtain. Four of the units were recently replaced. Three of the remaining four units should be replaced. One remaining unit only serves the space occupied by the union shop program and does not qualify for capital funds because this space is leased to the apprenticeship program outside of the college.

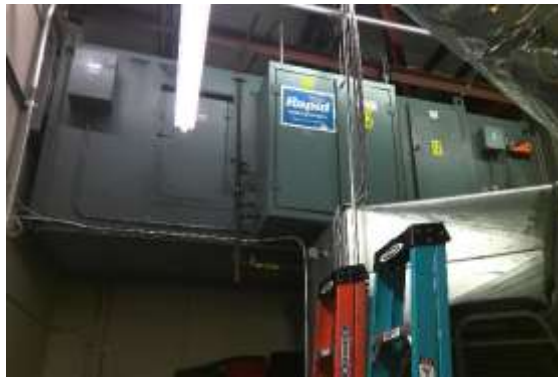
Deficiency F06

The air handler has become less reliable. The college is not able to repair the unit because parts are no longer available. The unit still functions and should be reconditioned to extend its useful life.

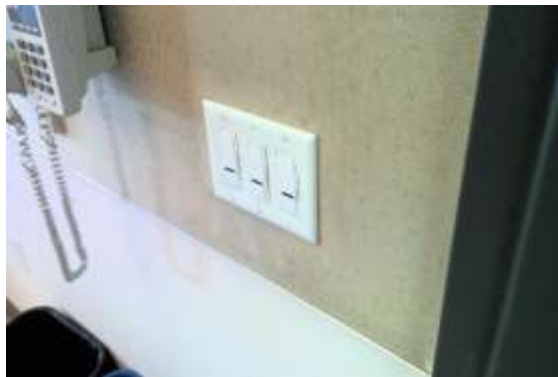
Deficiency F07

The lighting controls serving the whole building are becoming obsolete. Parts are difficult to obtain and the system is difficult to program when fixtures are replaced or repaired. The system should be monitored for future replacement when it becomes less usable.

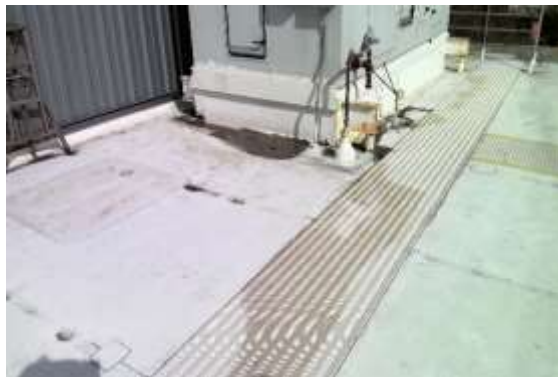
Deficiency R01

The roofing has developed leaks near the east portion of the building above the cabinet making program. The college did not know where the source of the leak was located. Additional information is required to determine the appropriate repair.

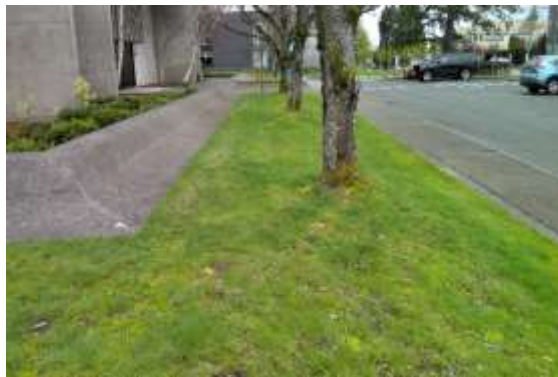
Deficiency S01

The irrigation system on the north and east side of the KBTC building has failed. The controls no longer function as well. Prior construction efforts destroyed some of the pipe. The system has also degraded due to age. The system should be replaced.

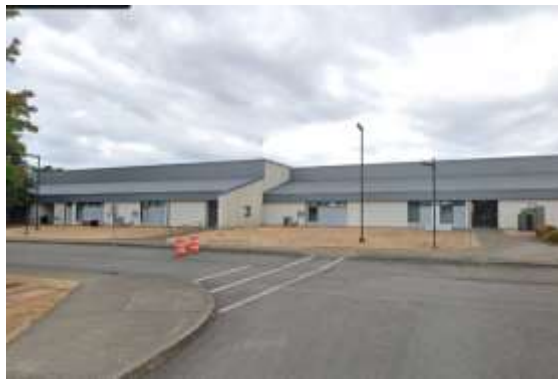
Deficiency S02

The irrigation system has degraded due to age and prior site activities. The system partially functions and has become unreliable. The system is located near the west and south perimeter of building B. The system should be replaced.

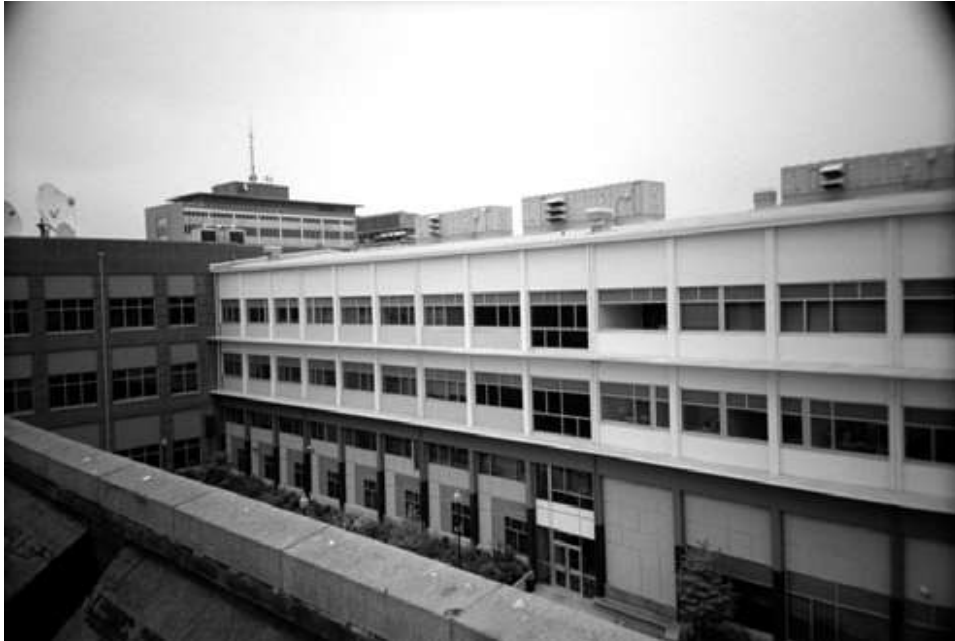
D.C. Main Bldg. - Bldg. A (280-001E) STATE UFI: A03217 Downtown Campus (280A)
AREA: 175,669 SF BUILT: 1945 REMODELED: 1999 PREDOMINANT USE: Mixed Use
CONSTRUCTION TYPE: Heavy CRV/SF: \$395 REPLACEMENT VALUE: \$69,389,255

Primary Systems			
COMPONENT:	Structure	RATING: 1 x WEIGHT: 8 =	SCORE: 8
No signs of settlement or cracking, no abrupt vertical changes Columns, bearing walls and roof structure appears sound/free of defects			
COMMENTS:	Concrete post and beam		
COMPONENT:	Exterior Closure	RATING: 3 x WEIGHT: 8 =	SCORE: 24
Sound and weatherproof but with some physical deterioration evident			
COMMENTS:	Stucco and brick veneer		
COMPONENT:	Roofing	RATING: 2 x WEIGHT: 10 =	SCORE: 20
Majority of roofing and flashing appear sound, but a small portion of roofing shows deterioration where maintenance or minor repair needed			
COMMENTS:	BUR w mineral-surfaced cap sheet; granulation shedding

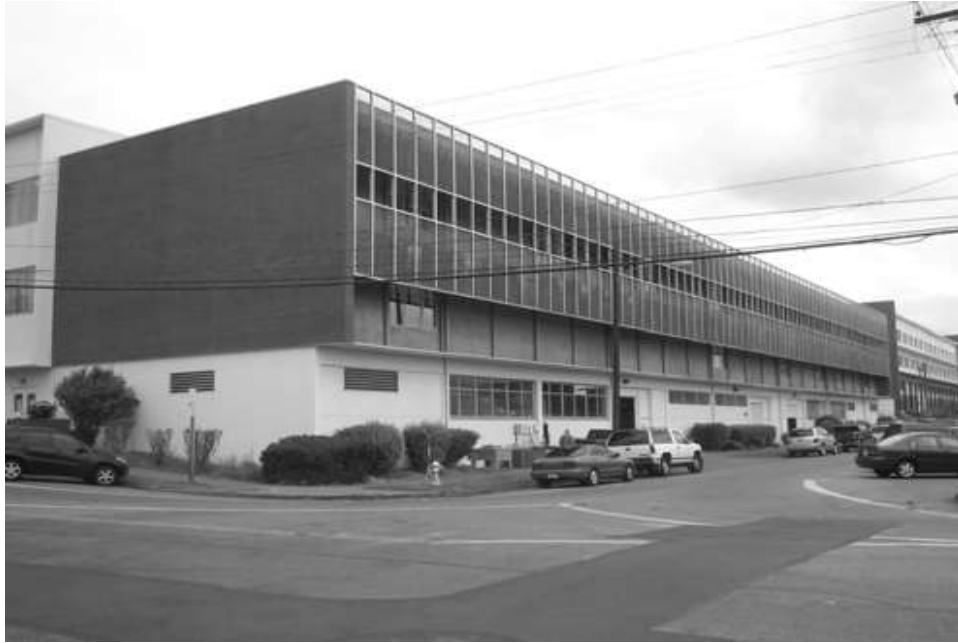
D.C. East Annex - Bldg. C (280-3) STATE UFI: A04062 Downtown Campus (280A)
AREA: 101,620 SF BUILT: 1964 REMODELED: No PREDOMINANT USE: Mixed Use
CONSTRUCTION TYPE: Heavy CRV/SF: \$395 REPLACEMENT VALUE: \$40,139,900

Primary Systems			
COMPONENT:	Structure	RATING: 2 x WEIGHT: 8 =	SCORE: 16
Minor cracks evident in a small portion of the structure			
COMMENTS: Concrete beam and post; some panel joint issues at stairs (should have structural review)			
COMPONENT:	Exterior Closure	RATING: 2 x WEIGHT: 8 =	SCORE: 16
Weatherproof exterior, but finish appears poorly maintained			
COMMENTS: Concrete; brick veneer-random cracking and spalling			
COMPONENT:	Roofing	RATING: 2 x WEIGHT: 10 =	SCORE: 20
Majority of roofing and flashing appear sound, but a small portion of roofing shows deterioration where maintenance or minor repair needed			
COMMENTS: Concrete roof used for parking; surface cracking/deteriorating

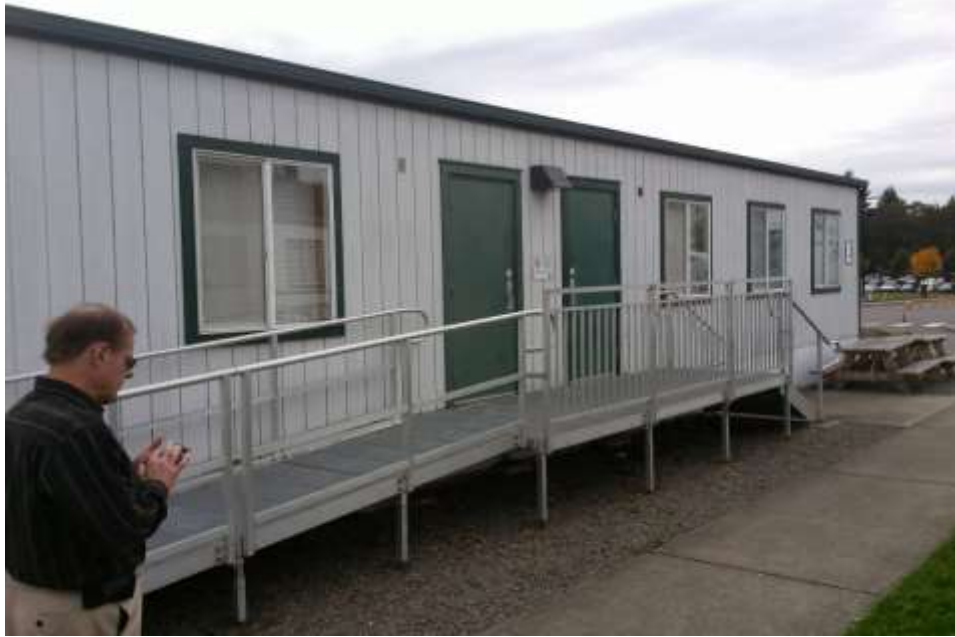
S.C. Portable E (280-9EP) STATE UFI: A02594 South Campus (280B)
AREA: 1,688 SF BUILT: 0 REMODELED: No PREDOMINANT USE: Vocational Arts
CONSTRUCTION TYPE: Temporary CRV/SF: \$198 REPLACEMENT VALUE: \$334,224

Primary Systems			
COMPONENT:	Structure	RATING: 3 x WEIGHT: 8.8 =	SCORE: 26.3
Some cracking evident but does not likely affect structural integrity; Visible defects apparent but are non-structural			
COMMENTS:	Wood framing		
COMPONENT:	Exterior Closure	RATING: 3 x WEIGHT: 8.8 =	SCORE: 26.3
Sound and weatherproof but with some physical deterioration evident			
COMMENTS:	T1-11 plywood; good condition		
COMPONENT:	Roofing	RATING: 3 x WEIGHT: 11 =	SCORE: 32.9
Some deterioration is evident in membrane and flashings; maintenance or minor repair is needed			
COMMENTS:	3 tab asphalt shingles-good condition

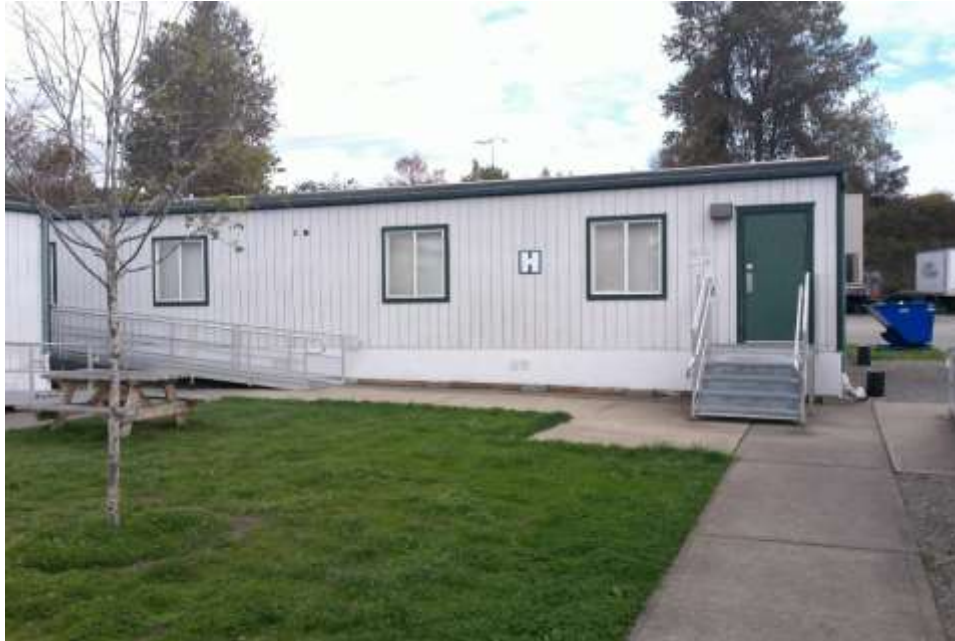
S.C. Portable H (280-9HP) STATE UFI: A02642 South Campus (280B)
AREA: 1,688 SF BUILT: 0 REMODELED: No PREDOMINANT USE: Vocational Arts
CONSTRUCTION TYPE: Temporary CRV/SF: \$198 REPLACEMENT VALUE: \$334,224

Primary Systems			
COMPONENT:	Structure	RATING: 3 x WEIGHT: 8.8 =	SCORE: 26.3
Some cracking evident but does not likely affect structural integrity; Visible defects apparent but are non-structural			
COMMENTS:	Wood framing		
COMPONENT:	Exterior Closure	RATING: 3 x WEIGHT: 8.8 =	SCORE: 26.3
Sound and weatherproof but with some physical deterioration evident			
COMMENTS:	T1-11 plywood; good condition		
COMPONENT:	Roofing	RATING: 2 x WEIGHT: 11 =	SCORE: 22
Majority of roofing and flashing appear sound, but a small portion of roofing shows deterioration where maintenance or minor repair needed			
COMMENTS:	3 tab asphalt shingles-good condition

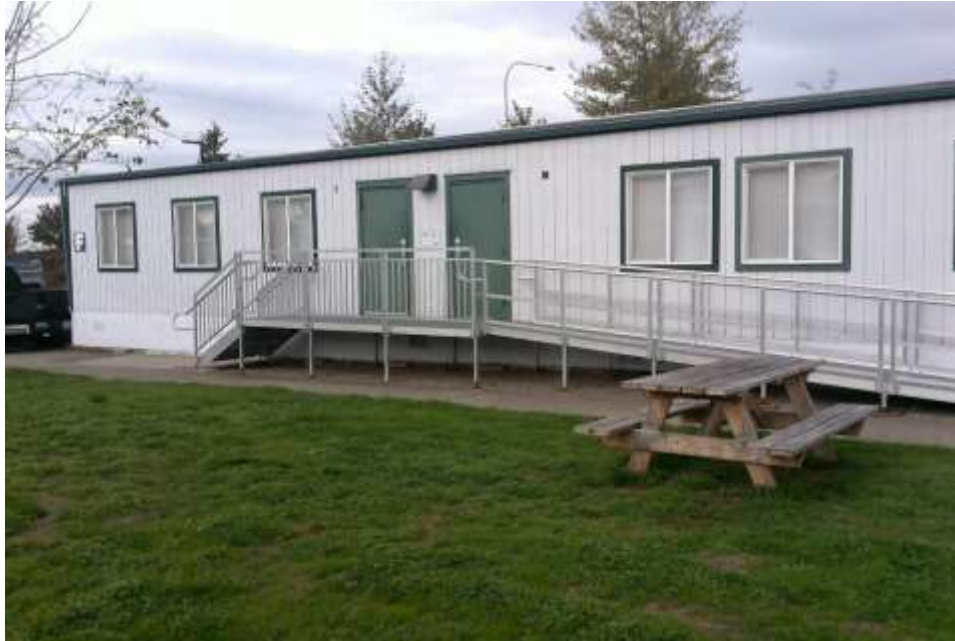
S.C. Portable F (280-9FP) STATE UFI: A04104 South Campus (280B)
AREA: 1,688 SF BUILT: 0 REMODELED: No PREDOMINANT USE: Vocational Arts
CONSTRUCTION TYPE: Temporary CRV/SF: \$198 REPLACEMENT VALUE: \$334,224

Primary Systems			
COMPONENT:	Structure	RATING: 3 x WEIGHT: 8.8 =	SCORE: 26.3
Some cracking evident but does not likely affect structural integrity; Visible defects apparent but are non-structural			
COMMENTS:	Wood framing		
COMPONENT:	Exterior Closure	RATING: 3 x WEIGHT: 8.8 =	SCORE: 26.3
Sound and weatherproof but with some physical deterioration evident			
COMMENTS:	T1-11 plywood; good condition		
COMPONENT:	Roofing	RATING: 2 x WEIGHT: 11 =	SCORE: 22
Majority of roofing and flashing appear sound, but a small portion of roofing shows deterioration where maintenance or minor repair needed			
COMMENTS:	3 tab asphalt shingles-good condition

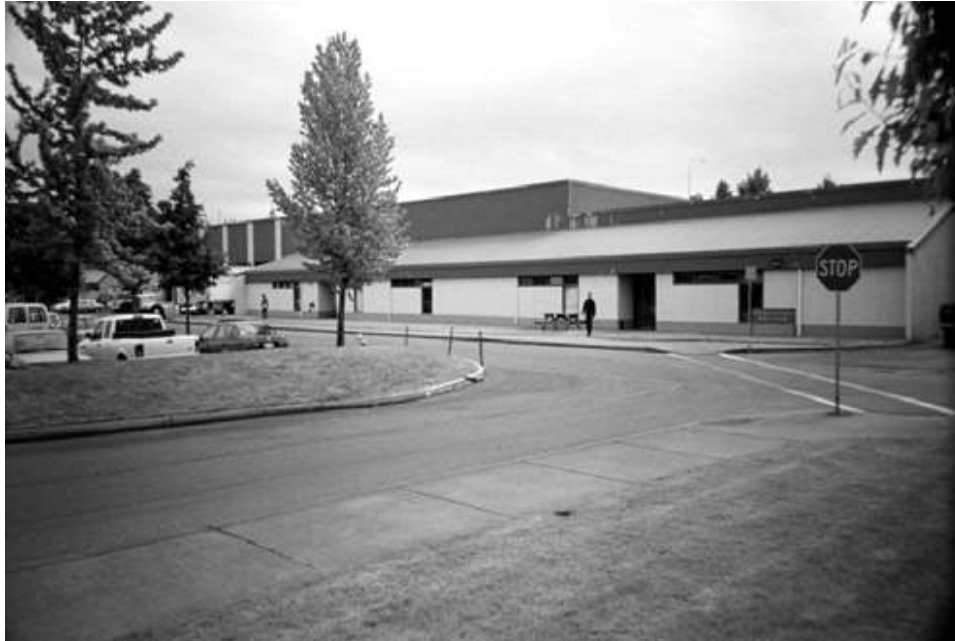
S.C. Bldg. D (280-7) STATE UFI: A05138 South Campus (280B)
 AREA: 47,040 SF BUILT: 1987 REMODELED: No PREDOMINANT USE: Vocational Arts
 CONSTRUCTION TYPE: Heavy CRV/SF: \$395 REPLACEMENT VALUE: \$18,580,800

Primary Systems			
COMPONENT:	Structure	RATING: 3 x WEIGHT: 8.3 =	SCORE: 25
Some cracking evident but does not likely affect structural integrity; Visible defects apparent but are non-structural			
COMMENTS:	Cast concrete; steel framing; steel joists		
COMPONENT:	Exterior Closure	RATING: 2 x WEIGHT: 8.3 =	SCORE: 16.7
Weatherproof exterior, but finish appears poorly maintained			
COMMENTS:	Concrete; stucco; metal fascia		
COMPONENT:	Roofing	RATING: 2 x WEIGHT: 10.4 =	SCORE: 20.9
Majority of roofing and flashing appear sound, but a small portion of roofing shows deterioration where maintenance or minor repair needed			
COMMENTS:	Hypalon membrane over metal roof-2006; standing seam metal

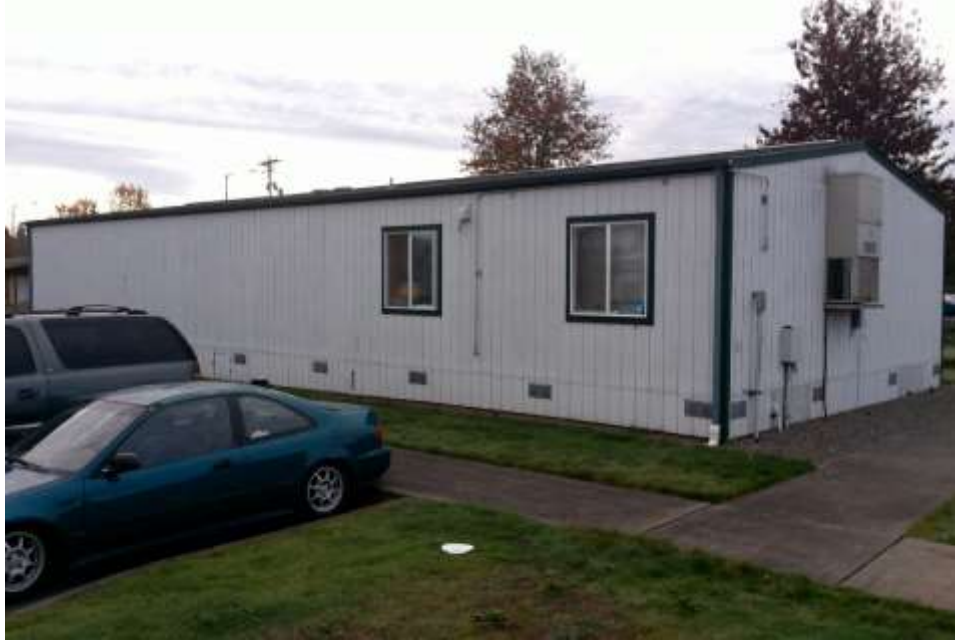
S.C. Portable G (280-9GP) STATE UFI: A07704 South Campus (280B)
AREA: 1,688 SF BUILT: 0 REMODELED: No PREDOMINANT USE: Vocational Arts
CONSTRUCTION TYPE: Temporary CRV/SF: \$198 REPLACEMENT VALUE: \$334,224

Primary Systems			
COMPONENT:	Structure	RATING: 3 x WEIGHT: 8.8 =	SCORE: 26.3
Some cracking evident but does not likely affect structural integrity; Visible defects apparent but are non-structural			
COMMENTS:	Wood framing		
COMPONENT:	Exterior Closure	RATING: 3 x WEIGHT: 8.8 =	SCORE: 26.3
Sound and weatherproof but with some physical deterioration evident			
COMMENTS:	T1-11 plywood; good condition		
COMPONENT:	Roofing	RATING: 3 x WEIGHT: 11 =	SCORE: 32.9
Some deterioration is evident in membrane and flashings; maintenance or minor repair is needed			
COMMENTS:	3 tab asphalt shingles-good condition

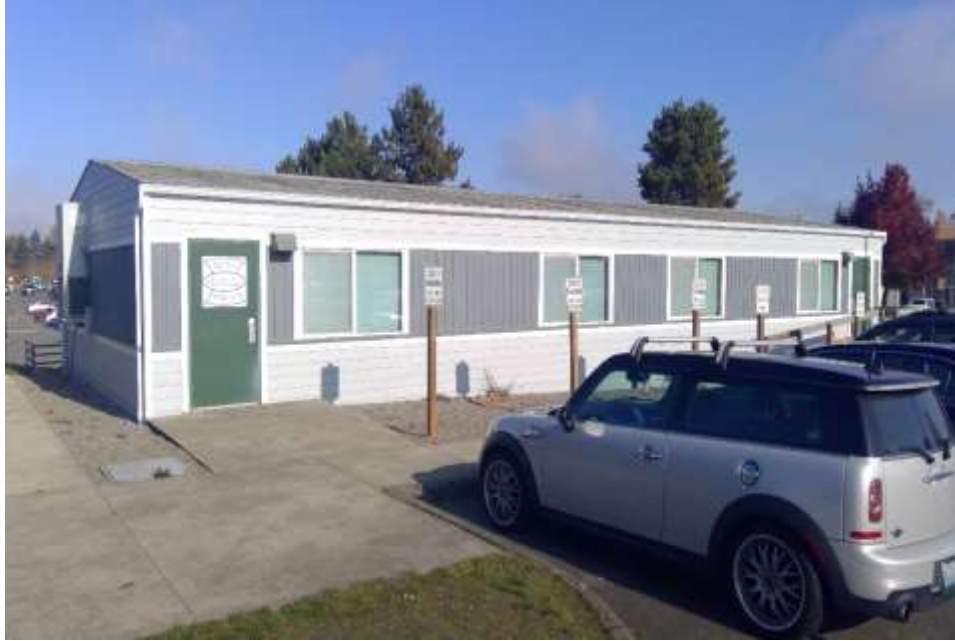
S.C. Portable J (280-9JP) STATE UFI: A09690 South Campus (280B)
AREA: 1,688 SF BUILT: 0 REMODELED: No PREDOMINANT USE: Vocational Arts
CONSTRUCTION TYPE: Temporary CRV/SF: \$198 REPLACEMENT VALUE: \$334,224

Primary Systems			
COMPONENT:	Structure	RATING: 4 x WEIGHT: 8.8 =	SCORE: 35.1
Some structural flaws potentially exist and should be evaluated by a structural engineer			
COMMENTS:	Wood framing		
COMPONENT:	Exterior Closure	RATING: 2 x WEIGHT: 8.8 =	SCORE: 17.6
Weatherproof exterior, but finish appears poorly maintained			
COMMENTS:	T1-11 plywood; good condition		
COMPONENT:	Roofing	RATING: 3 x WEIGHT: 11 =	SCORE: 32.9
Some deterioration is evident in membrane and flashings; maintenance or minor repair is needed			
COMMENTS:	3 tab asphalt shingles-good condition

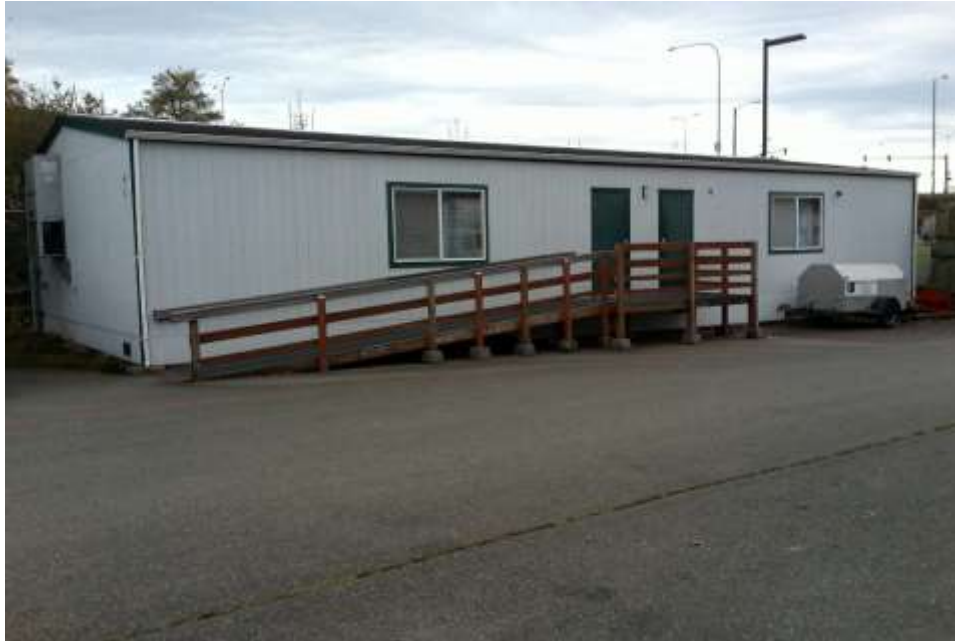
S.C. Portable K (280-9KP) STATE UFI: A14674 South Campus (280B)
AREA: 1,688 SF BUILT: 1997 REMODELED: No PREDOMINANT USE: Classroom
CONSTRUCTION TYPE: No data CRV/SF: \$356 REPLACEMENT VALUE: \$600,928

Primary Systems	
COMPONENT: Structure	RATING: 3 x WEIGHT: 9.3 = SCORE: 28
Some cracking evident but does not likely affect structural integrity; Visible defects apparent but are non-structural	
COMMENTS: No data	
COMPONENT: Exterior Closure	RATING: 3 x WEIGHT: 9.3 = SCORE: 28
Sound and weatherproof but with some physical deterioration evident	
COMMENTS: No data	
COMPONENT: Roofing	RATING: 2 x WEIGHT: 11.7 = SCORE: 23.4
Majority of roofing and flashing appear sound, but a small portion of roofing shows deterioration where maintenance or minor repair needed	
COMMENTS: No data

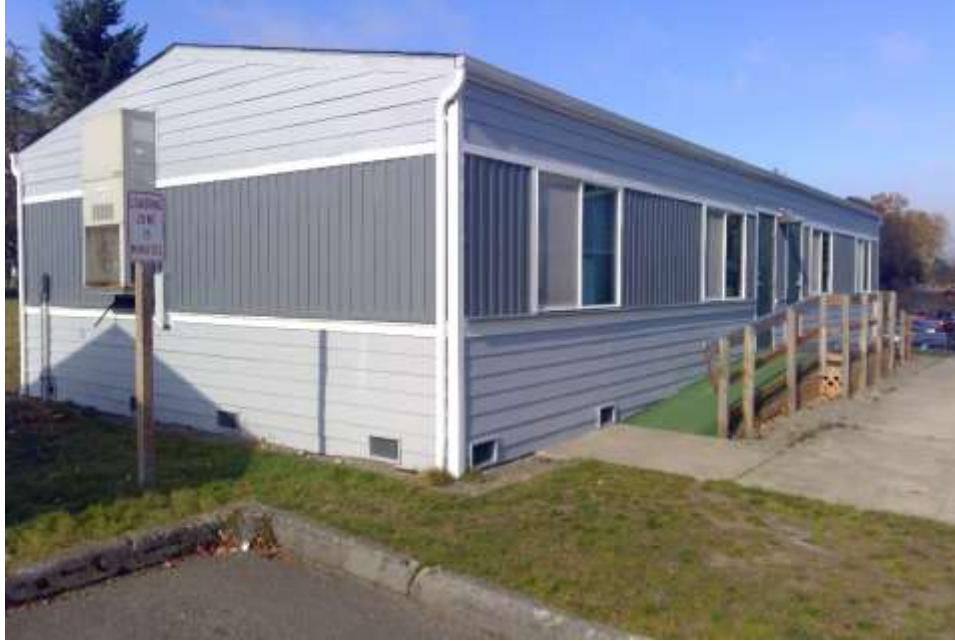
S.C. Portable I (280-9IP) STATE UFI: A09660 South Campus (280B)
AREA: 1,688 SF BUILT: 0 REMODELED: No PREDOMINANT USE: Vocational Arts
CONSTRUCTION TYPE: Temporary CRV/SF: \$198 REPLACEMENT VALUE: \$334,224

Primary Systems			
COMPONENT:	Structure	RATING: 4 x WEIGHT: 8.8 =	SCORE: 35.1
Some structural flaws potentially exist and should be evaluated by a structural engineer			
COMMENTS:	Wood framing		
COMPONENT:	Exterior Closure	RATING: 1 x WEIGHT: 8.8 =	SCORE: 8.8
Weatherproof, tight, well-maintained exterior walls, doors, windows/finishes			
COMMENTS:	T1-11 plywood; good condition		
COMPONENT:	Roofing	RATING: 3 x WEIGHT: 11 =	SCORE: 32.9
Some deterioration is evident in membrane and flashings; maintenance or minor repair is needed			
COMMENTS:	3 tab asphalt shingles-good condition

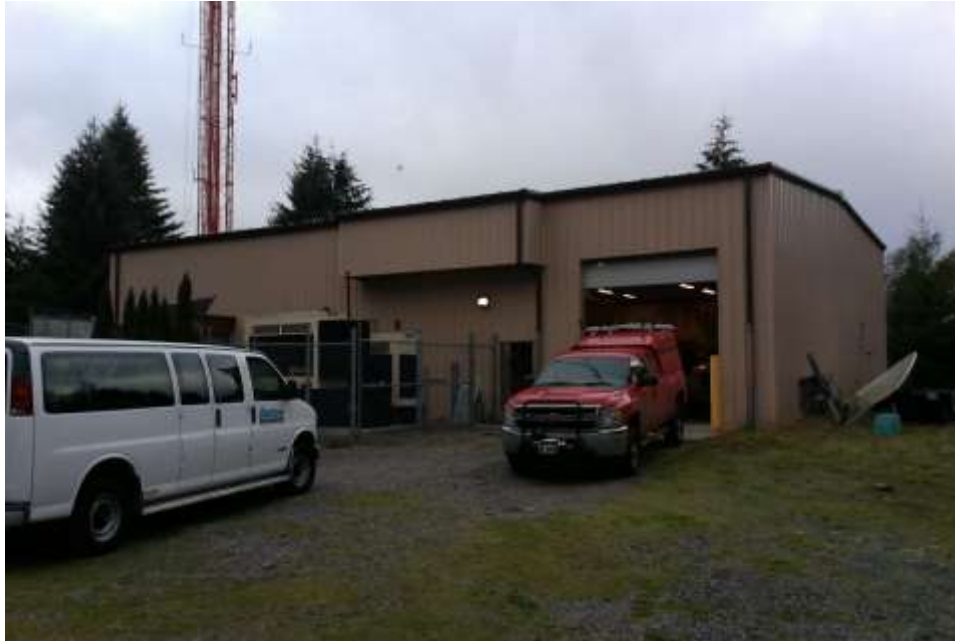
Transmitter - Bldg. A (280-8) STATE UFI: A05094 Transmitter Site (280E)
AREA: 4,000 SF BUILT: 1997 REMODELED: No PREDOMINANT USE: Transmitter storage
CONSTRUCTION TYPE: No data CRV/SF: \$438 REPLACEMENT VALUE: \$1,752,000

Primary Systems			
COMPONENT:	Structure	RATING: 1 x WEIGHT: 9.3 =	SCORE: 9.3
No signs of settlement or cracking, no abrupt vertical changes Columns, bearing walls and roof structure appears sound/free of defects			
COMMENTS:	No data		
COMPONENT:	Exterior Closure	RATING: 1 x WEIGHT: 9.3 =	SCORE: 9.3
Weatherproof, tight, well-maintained exterior walls, doors, windows/finishes			
COMMENTS:	No data		
COMPONENT:	Roofing	RATING: 2 x WEIGHT: 11.6 =	SCORE: 23.2
Majority of roofing and flashing appear sound, but a small portion of roofing shows deterioration where maintenance or minor repair needed			
COMMENTS:	Small area damaged by ice falling from tower
