# **2023** FACILITY CONDITION SURVEY

Bellevue College

SURVEY CONDUCTED BY:  
Steve Lewandowski  
State Board for Community  
and Technical Colleges

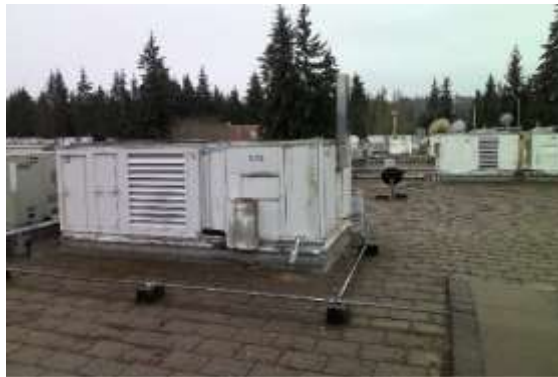
The HVAC units over the administrative portion of the building are near the end of their useful life. The units have required a higher level of maintenance and have become less reliable. There are more than twenty units in this south section of roof that are in a similar condition. Some units are in better condition than others. Ten of the units in the worst condition should be replaced.

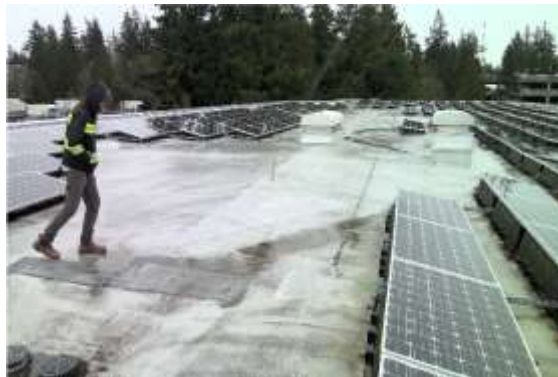
**Deficiency R01**

The roof has begun leaking near the stair well. There are also a few areas where blisters have formed. The majority of the roof is in good condition. The roof should be repaired to extend its useful life.

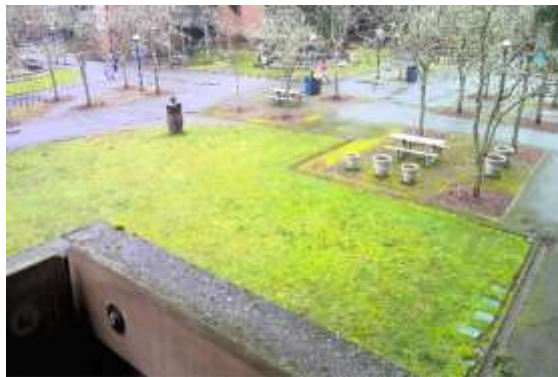
**Deficiency S01**

The main irrigation loop, valves and some secondary lines have corroded and leak. Some valves and controls no longer function. The core irrigation loop, main controls and the failing secondary lines and valves should be replaced.

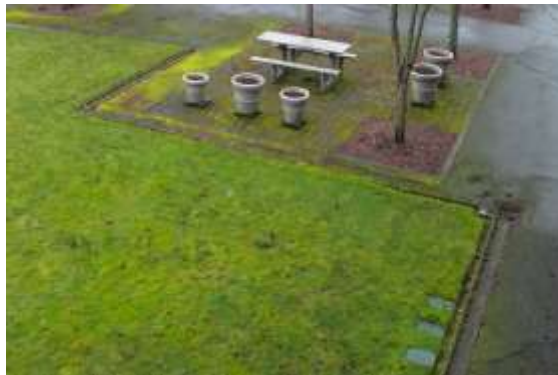
**Deficiency S02**

There are several areas where tree roots and frost heave have damaged asphalt pedestrian path surfaces. The damaged surfaces should be replaced.
