# **2023** FACILITY CONDITION SURVEY

Bellingham Technical College

SURVEY CONDUCTED BY:  
Steve Lewandowski  
State Board for Community  
and Technical Colleges

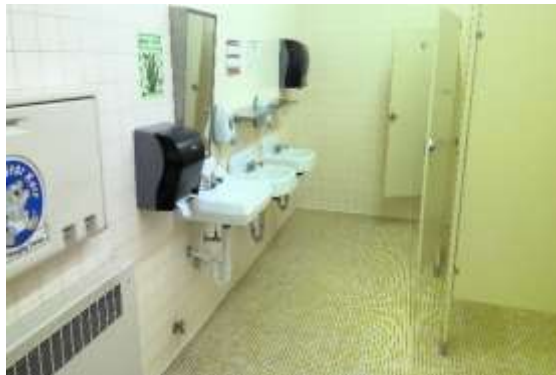
The bathroom fixtures and toilet partitions are dated, but still function. These components should continue to be monitored and be replaced in the future

| Deficiency score : $1 \times ((15 \times 80\%) + (12 \times 20\%)) + 2 = 16.4$ |

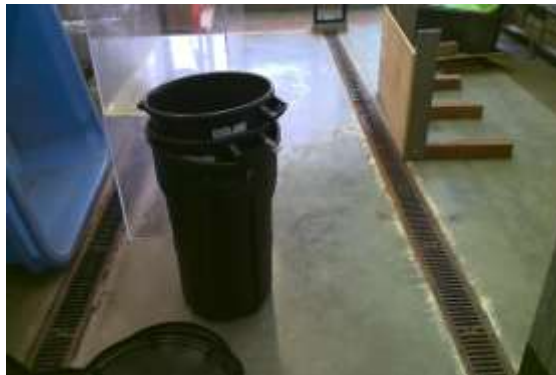
**Deficiency F02**

The salt water used for the program has deteriorated the floor drains. The corroded drains are no longer functioning as designed. The drain assembly should be replaced.

| Deficiency score : $4 \times ((15 \times 80\%) + (12 \times 20\%)) + 0 = 57.6$ |

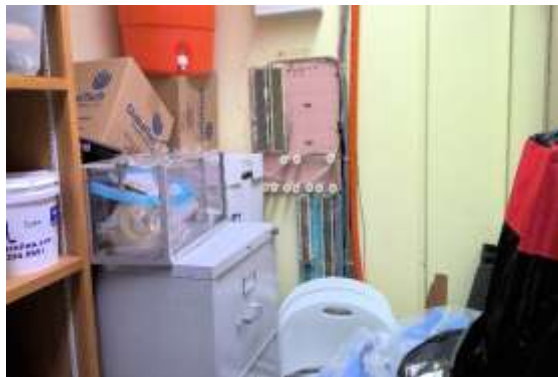
**Deficiency F04**

Nearly all of the buildings on campus have fire alarm systems that are linked by copper wire between buildings. The copper wire has degraded and is no longer reliable. The copper communication lines should be replaced to ensure that the system is reliable.

| Deficiency score : $4 \times (15 \times 100\%) + 0 = 60$ |

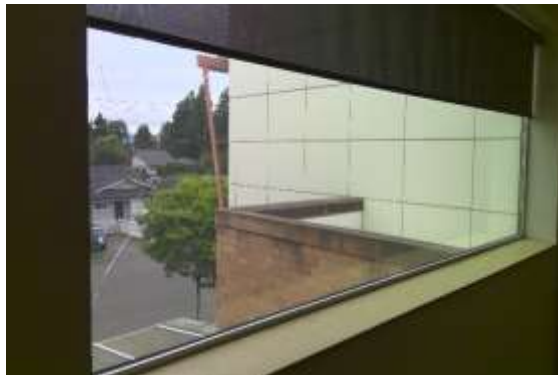
**Deficiency F05**

There are several windows in multiple buildings that have failed. The glazing should be replaced.

| Deficiency score : $4 \times (15 \times 100\%) + 0 = 60$ |

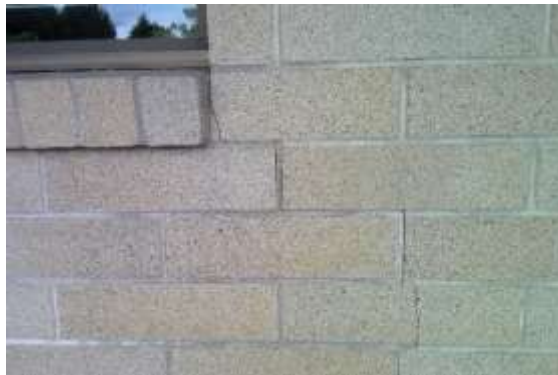
**Deficiency F06**

The masonry has cracks extending from openings. It is not know if these were the result of a previous seismic event. Additional information is required to determine the appropriate scope of repairs.

| Deficiency score : Needs study |

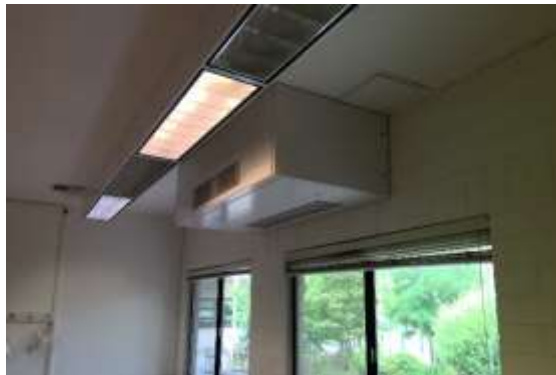
**Deficiency F07**

The unit ventilators have degraded. The controls have failed or are failing in roughly half of the units. These units should be replaced.

| Deficiency score : $4 \times ((15 \times 70\%) + (12 \times 30\%)) + 2 = 58.4$ |

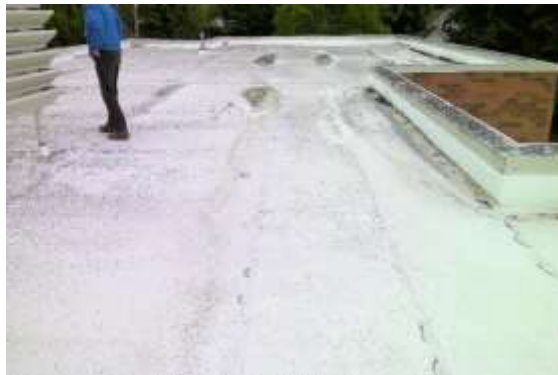
**Deficiency R01**

The roof has leaked in a few areas and the college is concerned about the age. The roof should continue to be monitored and be reconditioned in the future to extend the useful life.

| Deficiency score : $2.5 \times ((15 \times 70\%) + (12 \times 30\%)) + 1 = 36.3$ |

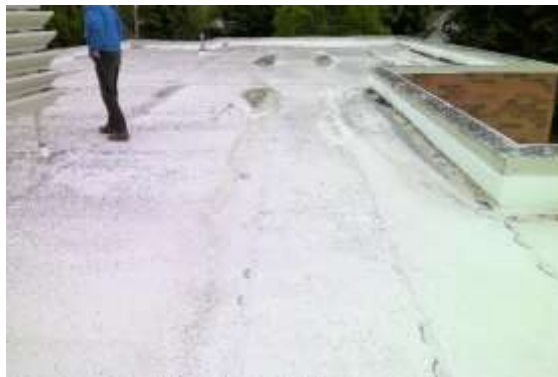
**Deficiency R02**

The college is concerned about the age of the roofing. The roofing currently does not leak, but the scrim layer has become visible in some areas. The roofing should be reconditioned in the future to extend its useful life.

| Deficiency score : $2.5 \times ((15 \times 70\%) + (12 \times 30\%)) + 0 = 35.3$ |

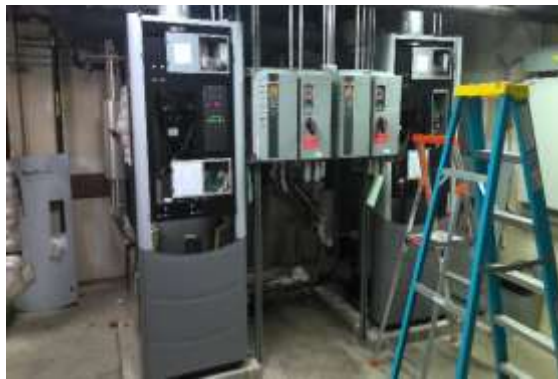
**Deficiency F08**

The three boilers have had frequent failures. The college has repaired the units in an attempt to regain function, but the units continue to be problematic. These unreliable units should be replaced. The circulation pumps should be maintained and re-used for the replacement boilers.

| Deficiency score : $4 \times ((15 \times 80\%) + (12 \times 20\%)) + 0 = 57.6$ |

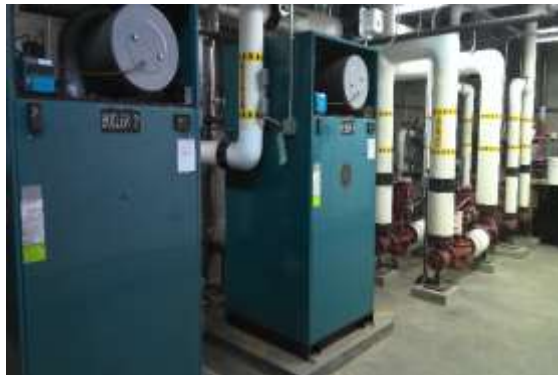
**Deficiency F09**

One of the boiler heat exchangers has begun to fail. The other heat exchanger in an adjacent boiler had failed in the past and has been replaced. The failing heat exchanger should be replaced.

| Deficiency score : $4 \times ((15 \times 80\%) + (12 \times 20\%)) + 0 = 57.6$ |

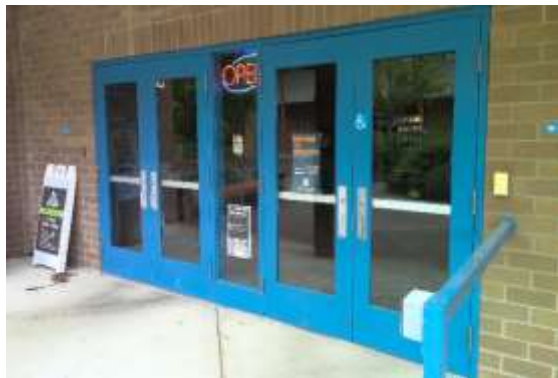
**Deficiency F10**

The exterior hollow metal doors on several buildings have degraded and should be replaced.

| Deficiency score : $4 \times (15 \times 100\%) + 0 = 60$ |

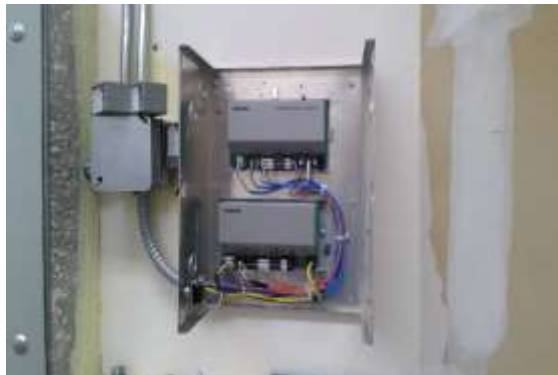
**Deficiency F11**

The HVAC controls are no longer reliable or maintainable. The system set points can no longer be modified. The controls should be replaced.

| Deficiency score : $4 \times ((15 \times 60\%) + (12 \times 40\%)) + 1 = 56.2$ |

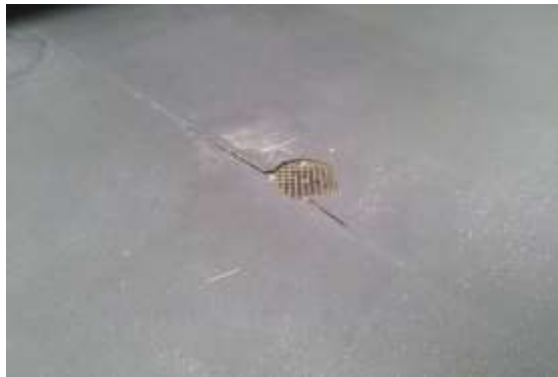
**Deficiency F12**

Several sections of the rubber floor surface have delaminated. Many seams have also failed. These areas should be repaired to maintain a surface that will meet health safety requirements

| Deficiency score : $4 \times ((15 \times 90\%) + (5 \times 10\%)) + 0 = 56$ |

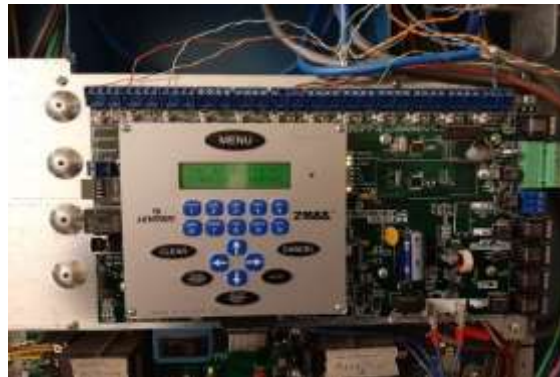
**Deficiency F13**

The lighting controls have become obsolete. Parts are no longer available from the vendor. The controls still function, but the components have been failing and the college has been forced to use all spare components. Since additional components are not available to make repairs, the controls should be replaced to maintain function.

| Deficiency score : $4 \times ((12 \times 80\%) + (15 \times 20\%)) + 0 = 50.4$ |

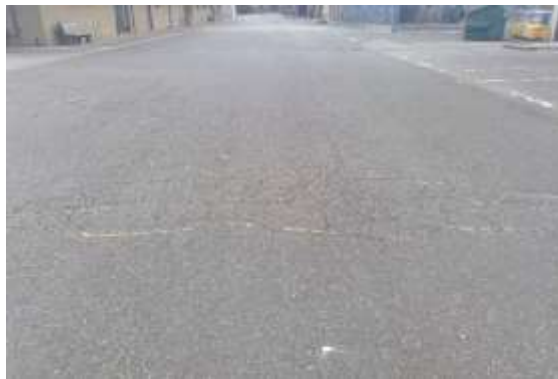
**Deficiency S01**

There are several areas along the fire lane (over utilities) that have settled and cracked. The area is on the north side of campus. These failed areas should be replaced as they become too damaged for emergency use.

| Deficiency score : $4 \times ((25 \times 60\%) + (5 \times 40\%)) + 0 = 68$ |

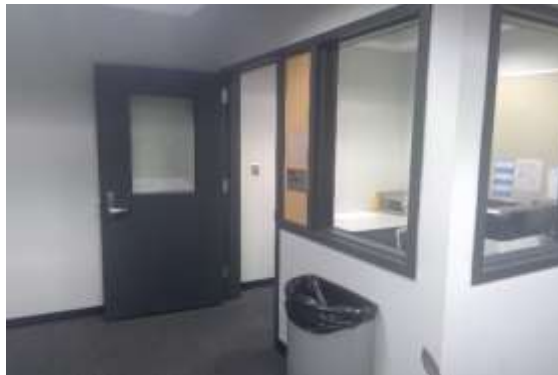
**Deficiency F14**

The settling building has warped many of the door frames. The doors are still in good condition. The frames should be replace.

| Deficiency score : $4 \times ((12 \times 80\%) + (15 \times 20\%)) + 0 = 50.4$ |

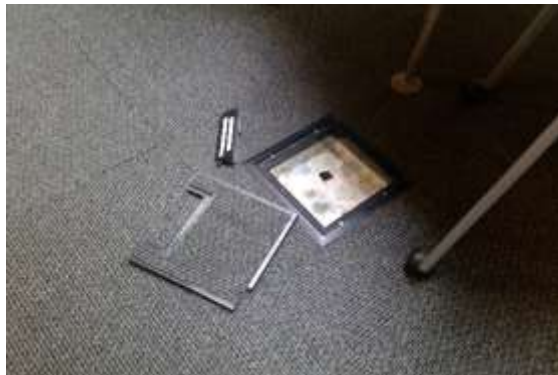
**Deficiency F15**

Plastic covers on electrical floor boxes are failing due to design. Need to replace with metal topped covers.

| Deficiency score : $4 \times ((12 \times 80\%) + (5 \times 20\%)) + 0 = 42.4$ |
