# **2023** FACILITY CONDITION SURVEY

Big Bend Community College

SURVEY CONDUCTED BY:  
Steve Lewandowski  
State Board for Community  
and Technical Colleges

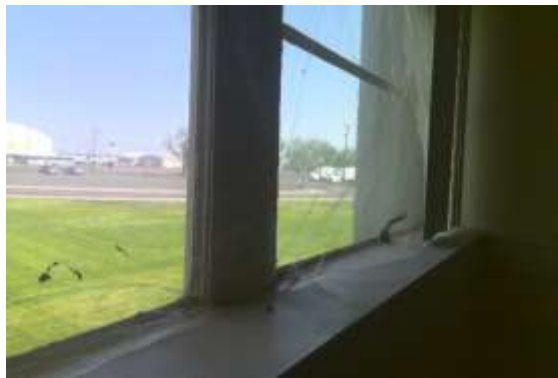
**Deficiency F01**

The hollow metal windows have failed and should be replaced.

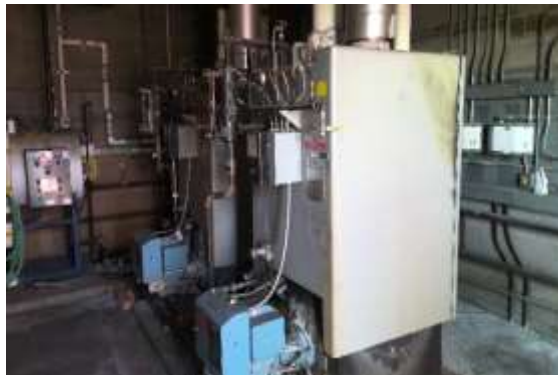
**Deficiency F02**

The boilers have required a higher level of maintenance, but are still functioning as designed. These should continue to be monitored for repair or replacement.

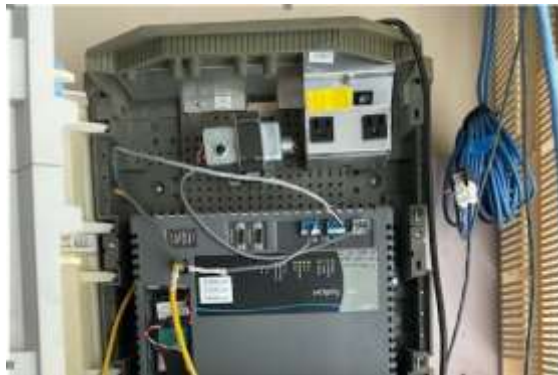
**Deficiency F03**

The Metasys HVAC controls in multiple buildings have degraded and are no longer reliable. Several of the components have also failed. The failing controls should be replaced.

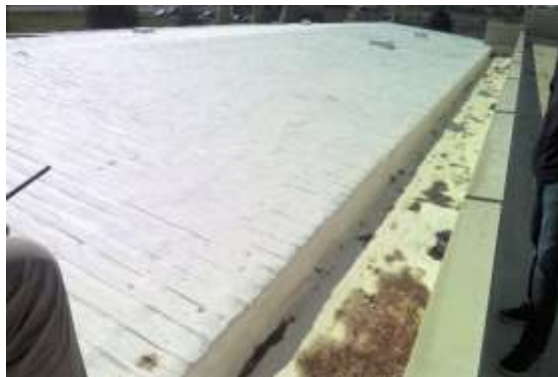
**Deficiency R01**

The college staff have recently repaired the leaking lower portion of the roof. The materials have degraded. The east portion over the STEM center was re-conditioned 15 years ago. The roofing is beyond its expected life and should be replaced.

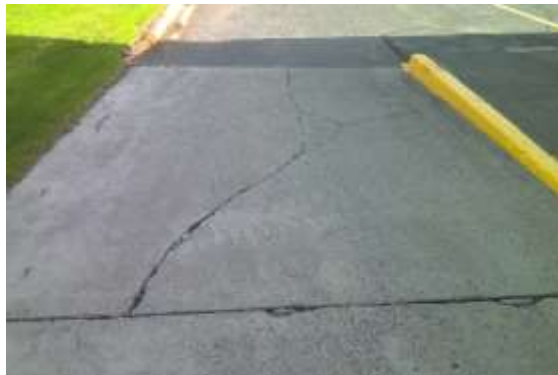
**Deficiency S01**

There are several sections of concrete walkways that have failed. These areas should be replaced.
