# **2023** FACILITY CONDITION SURVEY

Cascadia College

SURVEY CONDUCTED BY:  
Steve Lewandowski  
State Board for Community  
and Technical Colleges

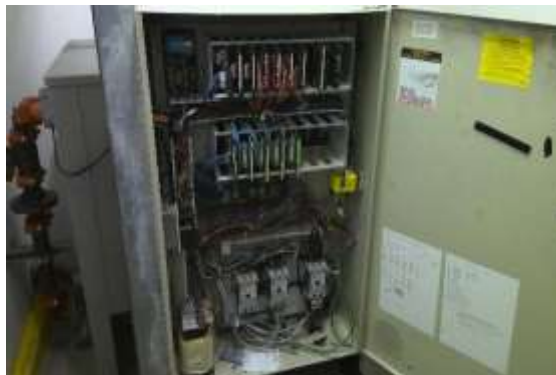
**Deficiency F01**

The college is concerned about the age and reliability of the elevator controls. Typically, elevators can be maintained and remain in service for up to 45 years, however, the college indicated that the elevator has frequent repair needs. The college believes that the vendor is no longer able to repair the controls. This elevator is a critical component of the accessible path to several campus buildings and should continue to be monitored and maintained to ensure reliability. The elevator vendor provided a memo that described obsolete parts, but did not state that the controls were no longer maintainable. The elevator control should be replaced within the next few years to ensure reliability. The cost should be shared 50/50 with UW.

| Deficiency score : $2.5 \times ((15 \times 80\%) + (20 \times 20\%)) + 1 = 41$ |

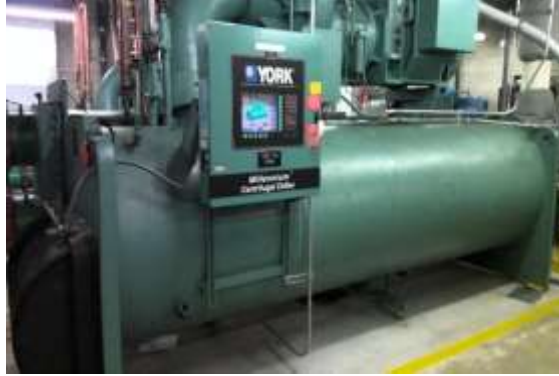
**Deficiency F02**

The college is concerned about the reliability of the 1,000 ton chiller. This is the biggest of three chillers that serve all buildings on campus. The automatic start function is no longer reliable due to the age and demand of the chiller. The chiller is now manually started, when required. The transformer that solely serves the chiller has recently been replaced. All of the equipment is original. The chiller currently is only used with high demand during summer months, but will be required to support two new buildings that will come online in the next few years. The chiller still functions as designed. Reconditioning the chill would likely cost more than half of the cost of a new chiller, so the chiller should be replaced rather than be reconditioned. Additional information from the equipment vendor is required to properly evaluate the remaining expected life of the chiller. The cost of the chiller should be split 50/50 with UW.

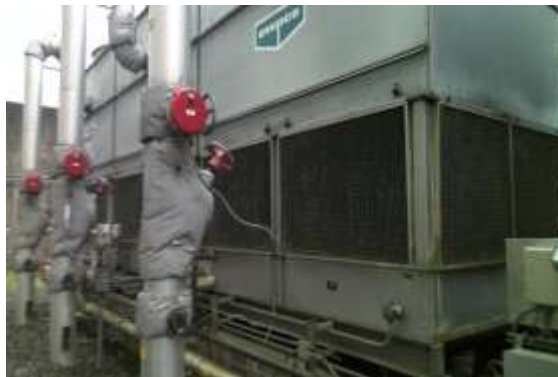
**Deficiency F03**

The three in-line cooling towers have degraded. The grills and pans have corroded. The cooling towers should be reconditioned to extend their useful life. The cost of the towers should be split 50/50 with the UW.

| Deficiency score : $4 \times (12 \times 100\%) + 1 = 49$ |

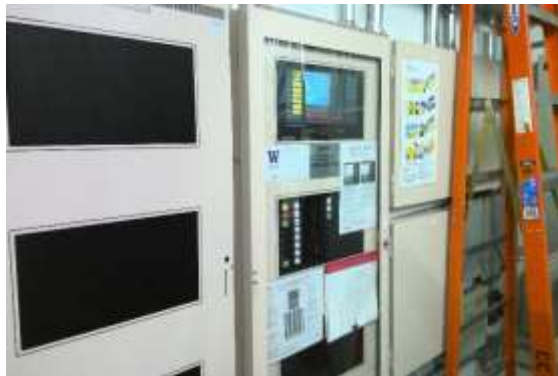
**Deficiency F04**

The college is concerned about the reliability of the fire alarm panels in CC1, CC2, CC3, Library, Library annex and the Physical plant. The college believes that the panels are no longer supported by the vendor and are no longer repairable. If that is true, then the panels should be replaced. A memo was provided from the vendor regarding panel upgrades, but did not address the question of maintaining the current panels. Additional information from the vendor is required to justify replacing the panels.

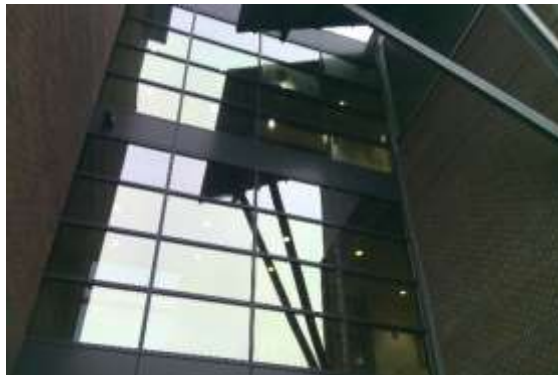
**Deficiency F05**

There are several windows in CC1, LB1, LB2 and the Physical plant that have failed. These failed windows should be replaced. The cost for windows in shared buildings should be split 50/50 with UW.

| Deficiency score : $4 \times (15 \times 100\%) + 0 = 60$ |

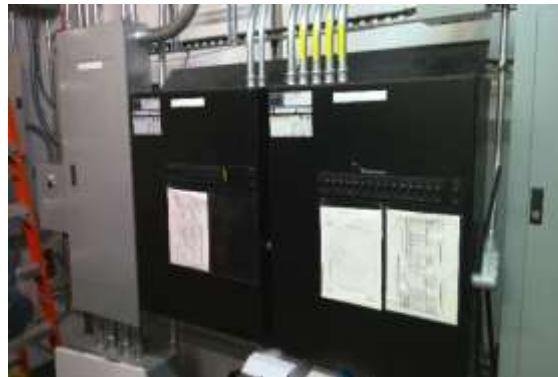
**Deficiency F06**

The college indicated that the Lutron lighting controls found in LB1 and LB2 have degraded and become unreliable. The panel components are no longer available and the vendor is no longer able to replace broken panel components. Portions of one of the panels did not function at the time of the survey. The failing lightning control panels should be replaced.

| Deficiency score : $4 \times (15 \times 100\%) + 0 = 60$ |
