2023 FACILITY CONDITION SURVEY

Centralia College

SURVEY CONDUCTED BY:
Steve Lewandowski
State Board for Community
and Technical Colleges

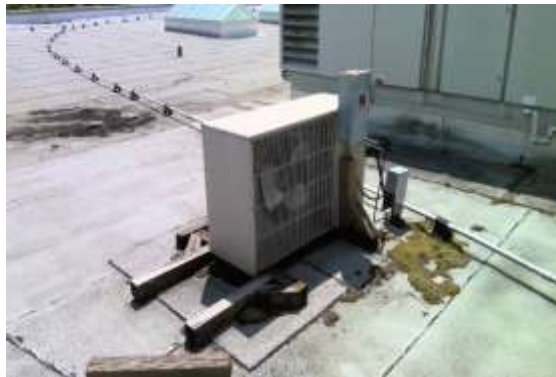
One of the Mammoth HVAC units has several compressors that have failed. Another unit has one failed compressor. Other units have had failed compressors replaced. These five units require a higher level of maintenance and repair due to deteriorating components. The two units in the worst condition should be reconditioned to extend their useful life. The remaining three units should be reconditioned in the next biennium.

Recommended funding schedule : Immediate (score = 4)
Estimated remaining life (years) : 3
Estimated average life expectancy (years) : 25
Scoring priority category 1 : System Use (score = 15)
Category 1 percentage : 70 %
Scoring priority category 2 : High Repair/Repl. Cost (score = 12)
Category 2 percentage : 30 %
Project construction estimate (MACC): \$100,000
Total project estimate (including soft costs): \$139,000
Additional points based on building condition: 1
Deficiency score : $4 \times ((15 \times 70\%) + (12 \times 30\%)) + 1 = 57.4$

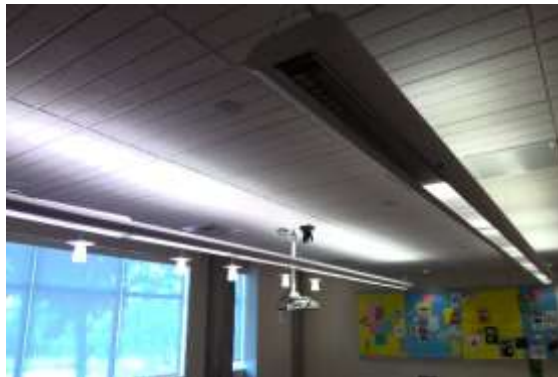
Deficiency F02

The light fixtures are frequently failing. Roughly one third of the fixtures have already prematurely failed. These fixtures are no longer supported and can no longer be repaired. These failed fixtures should be replaced in rooms with the most failures. The working fixtures that are removed should be retained and used for spare parts.

Carryover from prior survey : No
Location : Main Campus (121A)
Building name : Walton Science Center (121-Wsc)
Unique Facility Identifier (UFI) : A07887
Funding category in capital budget : Minor Works Facility appropriation
Unifomat category : D50-Electrical
Assessment : Asset is near or at the end of its useful life and should be replaced
Quantity : 100
Unit of measurement : EA
Component : Light fixtures
Location within building or site : Multiple
Issue clarity : Adequate information was provided to assess deficiency
Main cause of asset degradation or failure : Age/Wear
Detailed description : The light fixtures are frequently failing. Roughly one third of the fixtures have already prematurely failed. These fixtures are no longer supported and can no longer be repaired. These failed fixtures should be replaced in rooms with the most failures. The working fixtures that are removed should be retained and used for spare parts.

Recommended funding schedule : Immediate (scoring weight=4)
Estimated remaining life (years) : 3
Estimated average life expectancy (years) : 20
Scoring priority category 1 : System Use (scoring weight=15)
Category 1 percentage : 60 %
Scoring priority category 2 : High Repair/Repl. Cost (scoring weight=12)
Category 2 percentage : 40 %
Project construction estimate (MACC): \$100,000
Total project estimate (including soft costs): \$139,000
Additional points based on building condition: 0
Deficiency score : $4 \times ((15 \times 60\%) + (12 \times 40\%)) + 0 = 55.2$

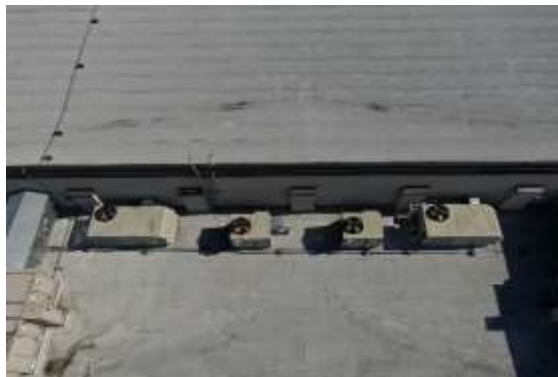
Deficiency F03

There are four HVAC units that have exceeded their useful life (AHU-1 through AHU-4). These units serve classroom space and have become unreliable. The units have required more frequent repairs and should be replaced.

Carryover from prior survey : No
Location : Main Campus (121A)
Building name : Michael Smith Gymnasium (121-Msg)
Unique Facility Identifier (UFI) : A02986
Funding category in capital budget : Minor Works Facility appropriation
Unifomat category : D30-HVAC
Assessment : Asset is near or at the end of its useful life and should be replaced
Quantity : 4
Unit of measurement : EA
Component : HVAC unit
Location within building or site : Roof
Issue clarity : Adequate information was provided to assess deficiency
Main cause of asset degradation or failure : Age/Wear
Detailed description : There are four HVAC units that have exceeded their useful life (AHU-1 though AHU-4). These units serve classroom space and have become unreliable. The units have required more frequent repairs and should be replaced.
Recommended funding schedule : Immediate (scoring weight=4)
Estimated remaining life (years) : 3
Estimated average life expectancy (years) : 20

Scoring priority category 1 : System Use (scoring weight=15)
Category 1 percentage : 50 %
Scoring priority category 2 : High Repair/Repl. Cost (scoring weight=12)
Category 2 percentage : 50 %
Project construction estimate (MACC): \$240,000
Total project estimate (including soft costs): \$334,000
Additional points based on building condition: 1
Deficiency score : $4 \times ((15 \times 50\%) + (12 \times 50\%)) + 1 = 55$

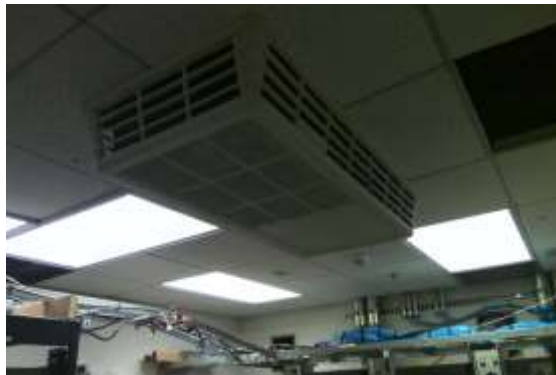
Deficiency F05

The split system unit has become unreliable when stressed due to degraded components. The unit has exceeded its expected life and should be replaced.

Carryover from prior survey : No
Location : Main Campus (121A)
Building name : Washington Hall (121-Wah)
Unique Facility Identifier (UFI) : A08675
Funding category in capital budget : Minor Works Facility appropriation
Unifomat category : D30-HVAC
Assessment : Asset is near or at the end of its useful life and should be replaced
Quantity : 1
Unit of measurement : EA
Component : HVAC unit
Location within building or site : 2nd floor
Issue clarity : Adequate information was provided to assess deficiency
Main cause of asset degradation or failure : Age/Wear
Detailed description : The split system unit has become unreliable when stressed due to degraded components. The unit has exceeded its expected life and should be replaced.
Recommended funding schedule : Immediate (scoring weight=4)
Estimated remaining life (years) : 3
Estimated average life expectancy (years) : 20
Scoring priority category 1 : System Use (scoring weight=15)

Category 1 percentage : 100 %
Scoring priority category 2 : None
Category 2 percentage : 0 %
Project construction estimate (MACC): \$22,000
Total project estimate (including soft costs): \$30,000
Additional points based on building condition: 1
Deficiency score : $4 \times (15 \times 100\%) + 1 = 61$

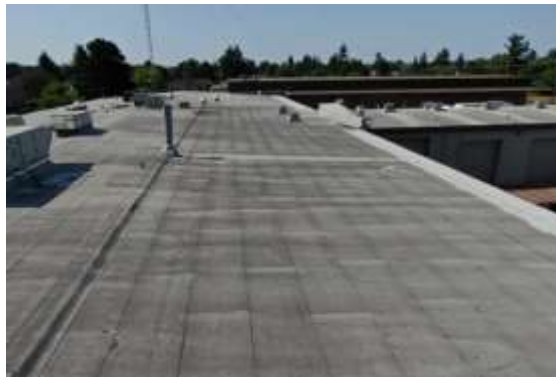
Deficiency R01

The roofing on the west side of the building has deteriorated. There are several areas with bubbles and leaks. The leaks have caused the plywood substrate to become saturated. Several attempts have been made to stop the leaks, but the roof continues to leak. The failing built-up portion of the roofing should be replaced.

Carryover from prior survey : No
Location : Main Campus (121A)
Building name : Technology Center (121-Tec)
Unique Facility Identifier (UFI) : A06178
Funding category in capital budget : Minor Works Roof appropriation
Unifomat category : B30-Roofing
Assessment : Asset should be repaired to extend its useful life
Quantity : 26200
Unit of measurement : SF
Component : Built-Up roofing
Location within building or site : Roof
Issue clarity : Adequate information was provided to assess deficiency
Main cause of asset degradation or failure : Age/Wear
Detailed description : The roofing on the west side of the building has deteriorated. There are several areas with bubbles and leaks. The leaks have caused the plywood substrate to become saturated. Several attempts have been made to stop the leaks, but the roof continues to leak. The failing built-up portion of the roofing should be replaced.
Recommended funding schedule : Immediate (scoring weight=4)

Estimated remaining life (years) : 3
Estimated average life expectancy (years) : 20
Scoring priority category 1 : System Use (scoring weight=15)
Category 1 percentage : 80 %
Scoring priority category 2 : High Repair/Repl. Cost (scoring weight=12)
Category 2 percentage : 20 %
Project construction estimate (MACC): \$734,000
Total project estimate (including soft costs): \$1,022,000
Additional points based on building condition: 2
Deficiency score : $4 \times ((15 \times 80\%) + (12 \times 20\%)) + 2 = 59.6$

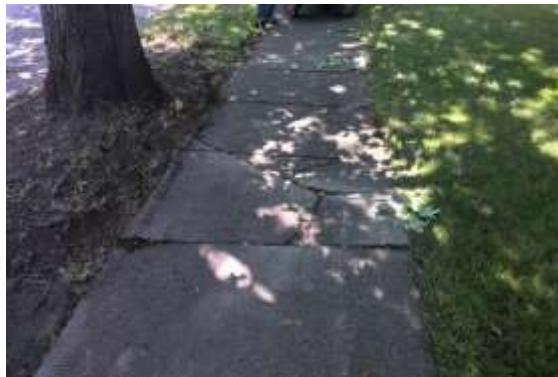
Deficiency S01

There are many sections of concrete curbing that has heaved and failed due to tree root growth. There are also areas of pedestrian access paths that have failed due to tree root growth. These curbs and sections of sidewalks should be replaced. The trees that are damaging these areas should be removed or replaced.

Carryover from prior survey : No
Location : Main Campus (121A)
Building name : Site (121A)
Unique Facility Identifier (UFI) : 121A
Funding category in capital budget : Minor Works Site appropriation
Unifomat category : G20-Site Improvements
Assessment : Asset is near or at the end of its useful life and should be replaced
Quantity : 5000
Unit of measurement : SF
Component : Concrete sidewalk
Location within building or site : Site
Issue clarity : Adequate information was provided to assess deficiency
Main cause of asset degradation or failure : Age/Wear
Detailed description : There are many sections of concrete curbing that has heaved and failed due to tree root growth. There are also areas of pedestrian access paths that have failed due to tree root growth. These curbs and sections of sidewalks should be replaced. The trees that are damaging these areas should be removed or replaced.
Recommended funding schedule : Immediate (scoring weight=4)

Estimated remaining life (years) : 3
Estimated average life expectancy (years) : 25
Scoring priority category 1 : Facility Use/ Civil Rights Violation (scoring weight=20)
Category 1 percentage : 60 %
Scoring priority category 2 : Quality of Use (scoring weight=5)
Category 2 percentage : 40 %
Project construction estimate (MACC): \$50,000
Total project estimate (including soft costs): \$69,000
Additional points based on building condition: 0
Deficiency score : $4 \times ((20 \times 60\%) + (5 \times 40\%)) + 0 = 56$

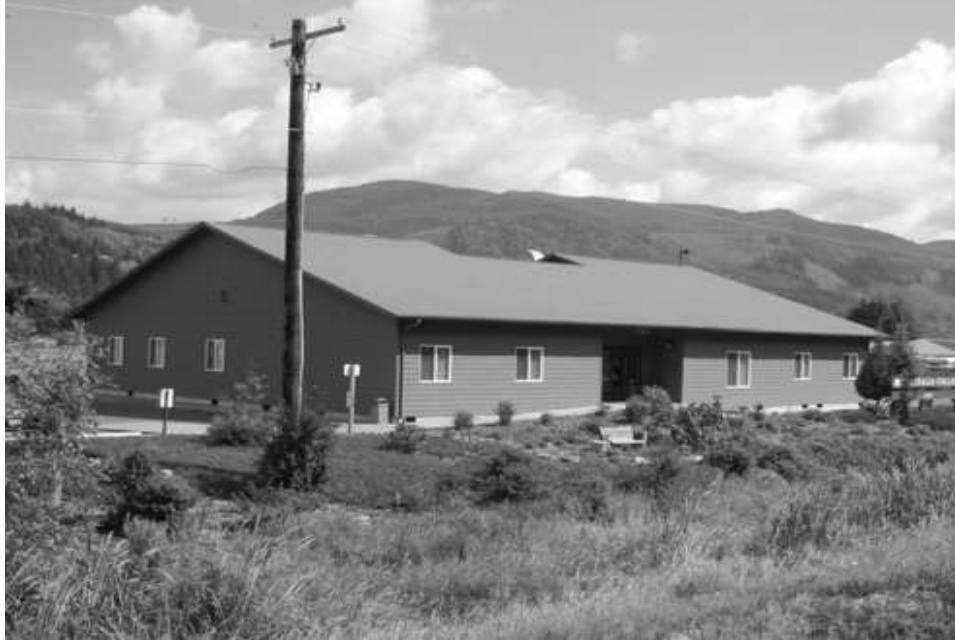
Centralia College East (121-CCE) STATE UFI: A00829 East Campus (121B)
AREA: 5,500 SF BUILT: 1997 REMODELED: No PREDOMINANT USE: Multi Use
CONSTRUCTION TYPE: Light CRV/SF: \$395 REPLACEMENT VALUE: \$2,172,500

Primary Systems			
COMPONENT:	Structure	RATING: 1 x WEIGHT: 8.8 =	SCORE: 8.8
No signs of settlement or cracking, no abrupt vertical changes Columns, bearing walls and roof structure appears sound/free of defects			
COMMENTS:	Wood framing with concrete foundation.		
COMPONENT:	Exterior Closure	RATING: 2 x WEIGHT: 8.8 =	SCORE: 17.6
Weatherproof exterior, but finish appears poorly maintained			
COMMENTS:	Wood framing with concrete foundation.		
COMPONENT:	Roofing	RATING: 1 x WEIGHT: 11 =	SCORE: 11
Flashing and penetrations appear sound and membrane appears water- tight; drainage is positive and there are overflow scuppers			
COMMENTS:	Metal roofing

Secondary Systems			
COMPONENT:	Floor Finishes	RATING: 4 x WEIGHT: 6.6 = SCORE: 26.3	
	General deterioration evident; one-third to one-half of flooring exhibits extensive deterioration		
COMMENTS:	Carpet-surface wear; vinyl tile-surface wear and cracking		
COMPONENT:	Wall Finishes	RATING: 1 x WEIGHT: 6.6 = SCORE: 6.6	
	Maintainable surfaces in good condition		
COMMENTS:	Gypsum board and textured wall panels		
COMPONENT:	Ceiling Finishes	RATING: 2 x WEIGHT: 6.6 = SCORE: 13.2	
	Aging surfaces in fair condition and good alignment		
COMMENTS:	Lay-in tile		
COMPONENT:	Doors & Hardware	RATING: 2 x WEIGHT: 6.6 = SCORE: 13.2	
	Fairly modern door surfaces and hardware with minor deterioration; good working order		
COMMENTS:	Interior/exterior wood doors/frames-surface wear

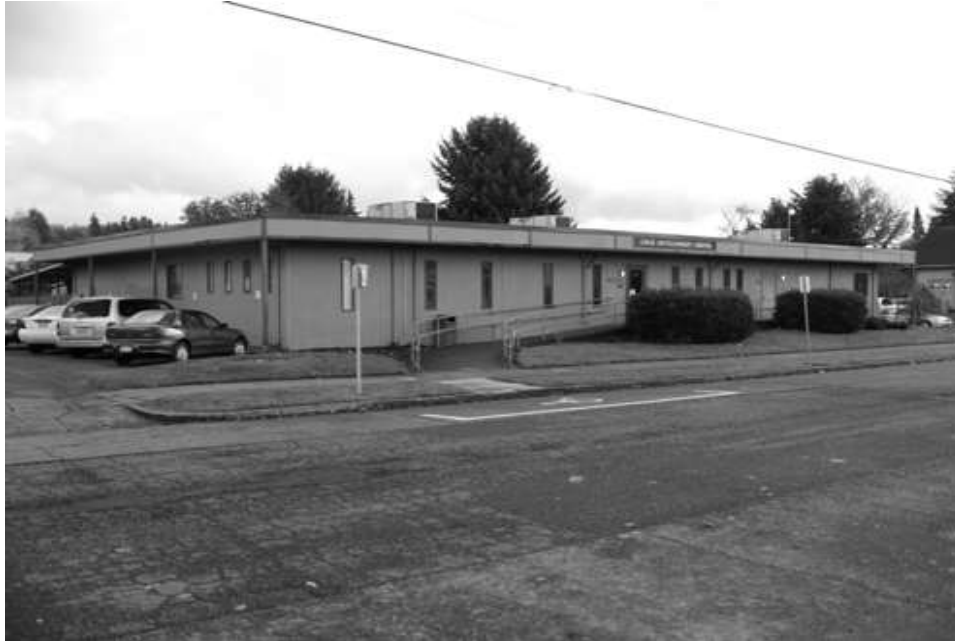
Child Development Center (121-CDC) STATE UFI: A04011 Main Campus (121A)
AREA: 7,920 SF BUILT: 1985 REMODELED: 2003 PREDOMINANT USE: Child Care
CONSTRUCTION TYPE: Temporary CRV/SF: \$264 REPLACEMENT VALUE: \$2,090,880

Primary Systems			
COMPONENT:	Structure	RATING: 1 x WEIGHT: 8.8 =	SCORE: 8.8
No signs of settlement or cracking, no abrupt vertical changes Columns, bearing walls and roof structure appears sound/free of defects			
COMMENTS:	Wood frame		
COMPONENT:	Exterior Closure	RATING: 4 x WEIGHT: 8.8 =	SCORE: 35.1
General deterioration detected, one or more minor leaks apparent			
COMMENTS:	Composition wood siding		
COMPONENT:	Roofing	RATING: 3 x WEIGHT: 11 =	SCORE: 32.9
Some deterioration is evident in membrane and flashings; maintenance or minor repair is needed			
COMMENTS:	Single-ply roof-no overflow scuppers; composition 3-tab shingles

Secondary Systems			
COMPONENT:	Floor Finishes	RATING: 2 x WEIGHT: 6.6 = SCORE: 13.2	
	Some wear is evident on finish; maintenance needed		
COMMENTS:	Laminate, sheet vinyl floor - 2018		
COMPONENT:	Wall Finishes	RATING: 2 x WEIGHT: 6.6 = SCORE: 13.2	
	Maintainable surfaces, minor maintenance is required in some areas		
COMMENTS:	Gypsum board and vinyl wall panels		
COMPONENT:	Ceiling Finishes	RATING: 4 x WEIGHT: 6.6 = SCORE: 26.3	
	General deterioration and moderate amount of staining or damage apparent		
COMMENTS:	Lay-in tile		
COMPONENT:	Doors & Hardware	RATING: 3 x WEIGHT: 6.6 = SCORE: 19.8	
	Functional, but dated; some maintenance required		
COMMENTS:	Interior composite wood doors/frames; exterior HM doors/frames; surface wear

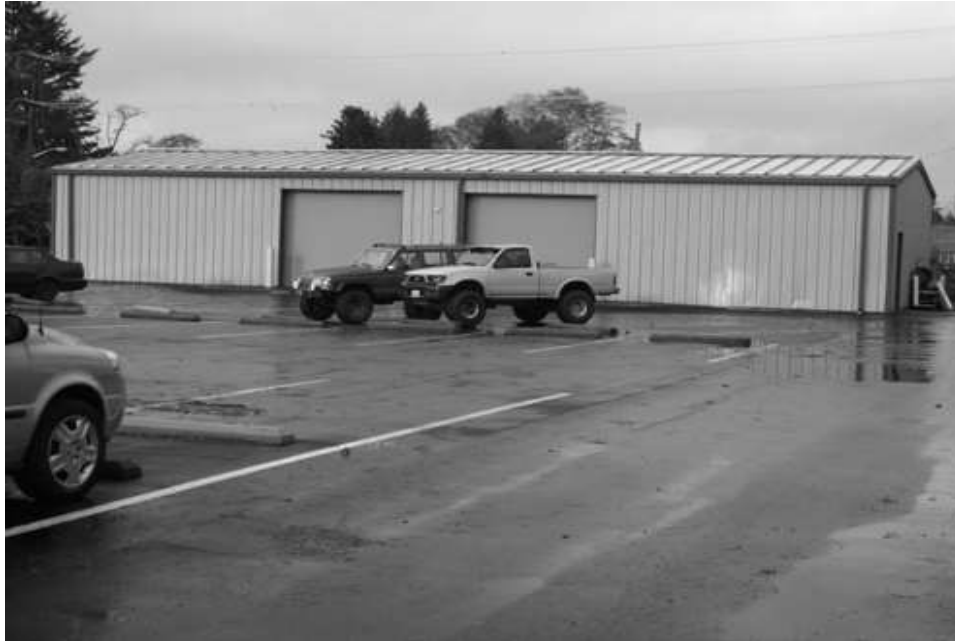
Detec Storage Building (121-STO) STATE UFI: A02983 Main Campus (121A)
AREA: 2,560 SF BUILT: 1999 REMODELED: No PREDOMINANT USE: Storage
CONSTRUCTION TYPE: Light CRV/SF: \$231 REPLACEMENT VALUE: \$591,360

Primary Systems			
COMPONENT:	Structure	RATING: 1 x WEIGHT: 11.8 =	SCORE: 11.8
No signs of settlement or cracking, no abrupt vertical changes Columns, bearing walls and roof structure appears sound/free of defects			
COMMENTS:	Steel frame		
COMPONENT:	Exterior Closure	RATING: 3 x WEIGHT: 11.8 =	SCORE: 35.4
Sound and weatherproof but with some physical deterioration evident			
COMMENTS:	Metal panels-random damage		
COMPONENT:	Roofing	RATING: 3 x WEIGHT: 14.7 =	SCORE: 44.2
Some deterioration is evident in membrane and flashings; maintenance or minor repair is needed			
COMMENTS:	Metal panels-surface wear

Secondary Systems			
COMPONENT:	Floor Finishes	RATING: 3 x WEIGHT: 8.8 =	SCORE: 26.5
Some physical wear and minor imperfections are evident; beginning deterioration			
COMMENTS:	Concrete		
COMPONENT:	Wall Finishes	RATING: 0 x WEIGHT: 0 =	SCORE: 0
No data			
COMMENTS:	Vinyl clad insulation		
COMPONENT:	Ceiling Finishes	RATING: 0 x WEIGHT: 0 =	SCORE: 0
No data			
COMMENTS:	None		
COMPONENT:	Doors & Hardware	RATING: 3 x WEIGHT: 8.8 =	SCORE: 26.5
Functional, but dated; some maintenance required			
COMMENTS:	Exterior HM doors/frames and aluminum roll-up doors

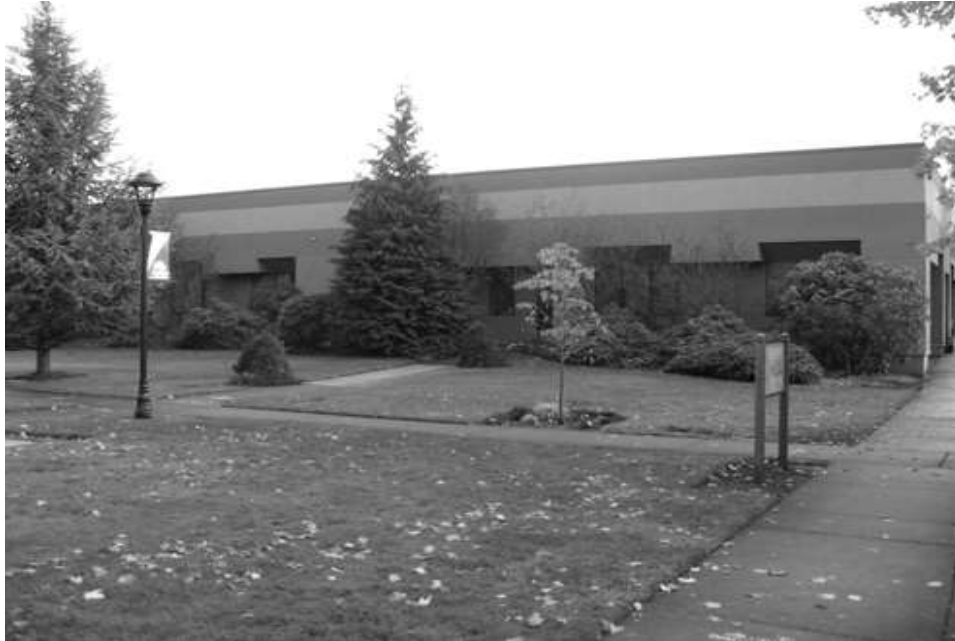
Hanson Administration Bld (121-HAN) STATE UFI: A04618 Main Campus (121A)
AREA: 9,100 SF BUILT: 1935 REMODELED: 1970 PREDOMINANT USE: Administration
CONSTRUCTION TYPE: Light CRV/SF: \$336 REPLACEMENT VALUE: \$3,057,600

Primary Systems			
COMPONENT:	Structure	RATING: 1 x WEIGHT: 8.3 =	SCORE: 8.3
No signs of settlement or cracking, no abrupt vertical changes Columns, bearing walls and roof structure appears sound/free of defects			
COMMENTS:	Wood frame; barrel roof		
COMPONENT:	Exterior Closure	RATING: 2 x WEIGHT: 8.3 =	SCORE: 16.7
Weatherproof exterior, but finish appears poorly maintained			
COMMENTS:	Building exterior replaced with stucco cladding in 2002; minor cracking		
COMPONENT:	Roofing	RATING: 2 x WEIGHT: 10.4 =	SCORE: 20.9
Majority of roofing and flashing appear sound, but a small portion of roofing shows deterioration where maintenance or minor repair needed			
COMMENTS:	Single-ply PVC membrane roof

Secondary Systems			
COMPONENT:	Floor Finishes	RATING: 3 x WEIGHT: 6.3 = SCORE: 18.8	
	Some physical wear and minor imperfections are evident; beginning deterioration		
COMMENTS:	Carpet and sheet vinyl		
COMPONENT:	Wall Finishes	RATING: 1 x WEIGHT: 6.3 = SCORE: 6.3	
	Maintainable surfaces in good condition		
COMMENTS:	Gypsum board; wood paneling; folding partition wall		
COMPONENT:	Ceiling Finishes	RATING: 1 x WEIGHT: 6.3 = SCORE: 6.3	
	Maintainable surfaces in good condition; good alignment and appearance		
COMMENTS:	Lay-in tile and gypsum board		
COMPONENT:	Doors & Hardware	RATING: 3 x WEIGHT: 6.3 = SCORE: 18.8	
	Functional, but dated; some maintenance required		
COMMENTS:	Interior wood doors w HM frames-surface wear; exterior aluminum doors/frames

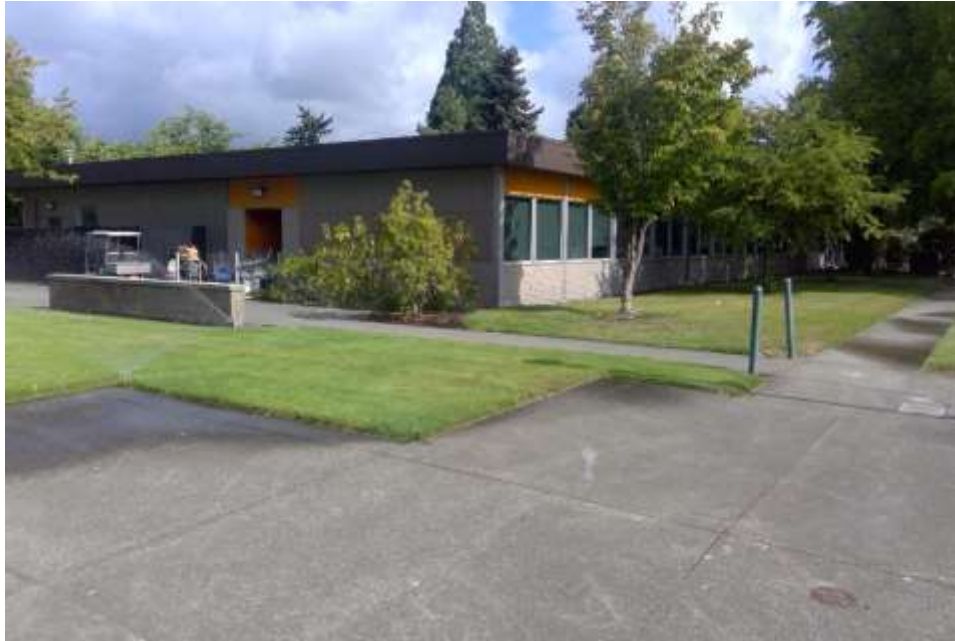
Transitional Services Building (121-TSB) STATE UFI: A01114 Main Campus (121A)
 AREA: 28,420 SF BUILT: 1968 REMODELED: 1988 PREDOMINANT USE: Student Center
 CONSTRUCTION TYPE: Light CRV/SF: \$391 REPLACEMENT VALUE: \$11,112,220

Primary Systems			
COMPONENT:	Structure	RATING: 3 x WEIGHT: 8 =	SCORE: 24
Some cracking evident but does not likely affect structural integrity; Visible defects apparent but are non-structural			
COMMENTS:	Wood frame; CMU; metal framing;		
COMPONENT:	Exterior Closure	RATING: 1 x WEIGHT: 8 =	SCORE: 8
Weatherproof, tight, well-maintained exterior walls, doors, windows/finishes			
COMMENTS:	Metal panels, masonry, storefront		
COMPONENT:	Roofing	RATING: 1 x WEIGHT: 10 =	SCORE: 10
Flashing and penetrations appear sound and membrane appears water- tight; drainage is positive and there are overflow scuppers			
COMMENTS:	TPO single-ply membrane on lower roof-2011; upper roof single-ply membrane - 2018

Secondary Systems			
COMPONENT:	Floor Finishes	RATING: 1 x WEIGHT: 6 = SCORE: 6	
	Nice appearance, smooth transitions, level subfloors, no cracks/separating		
COMMENTS:	Vinyl tile; carpet; ceramic tile; general surface wear		
COMPONENT:	Wall Finishes	RATING: 1 x WEIGHT: 6 = SCORE: 6	
	Maintainable surfaces in good condition		
COMMENTS:	Gypsum board; ceramic tile; CMU; vinyl wall cover		
COMPONENT:	Ceiling Finishes	RATING: 2 x WEIGHT: 6 = SCORE: 12	
	Aging surfaces in fair condition and good alignment		
COMMENTS:	Lay-in tile; direct adhered tile; gypsum board; wood decking		
COMPONENT:	Doors & Hardware	RATING: 3 x WEIGHT: 6 = SCORE: 18	
	Functional, but dated; some maintenance required		
COMMENTS:	Interior wood doors w HM frames-surface wear; glazed wood sidelites; exterior wood doors w HM frames

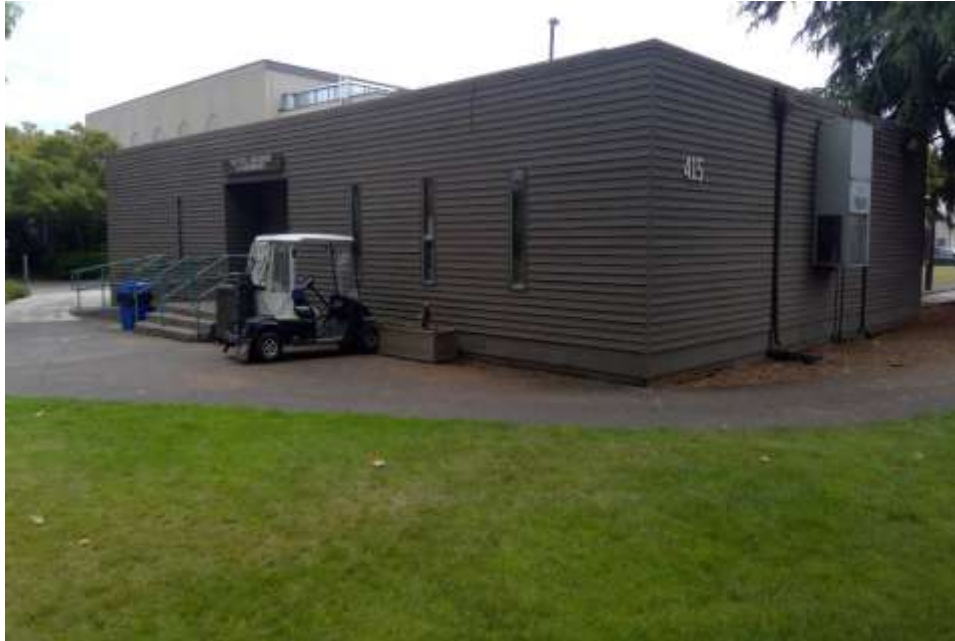
Facilities, Operations & Maintenance (121-FOM) STATE UFI: A02548 Main Campus (121A)
AREA: 2,400 SF BUILT: 1980 REMODELED: No PREDOMINANT USE: Maintenance
CONSTRUCTION TYPE: Temporary CRV/SF: \$231 REPLACEMENT VALUE: \$554,400

Primary Systems			
COMPONENT:	Structure	RATING: 3 x WEIGHT: 8.3 =	SCORE: 25
Some cracking evident but does not likely affect structural integrity; Visible defects apparent but are non-structural			
COMMENTS:	Wood frame		
COMPONENT:	Exterior Closure	RATING: 4 x WEIGHT: 8.3 =	SCORE: 33.4
General deterioration detected, one or more minor leaks apparent			
COMMENTS:	Beveled wood horizontal siding		
COMPONENT:	Roofing	RATING: 3 x WEIGHT: 10.4 =	SCORE: 31.3
Some deterioration is evident in membrane and flashings; maintenance or minor repair is needed			
COMMENTS:	Hypalon single-ply-1994; drains poorly

Secondary Systems			
COMPONENT:	Floor Finishes	RATING: 3 x WEIGHT: 6.3 = SCORE: 18.8	
	Some physical wear and minor imperfections are evident; beginning deterioration		
COMMENTS:	Carpet and vinyl tile		
COMPONENT:	Wall Finishes	RATING: 2 x WEIGHT: 6.3 = SCORE: 12.5	
	Maintainable surfaces, minor maintenance is required in some areas		
COMMENTS:	Gypsum board		
COMPONENT:	Ceiling Finishes	RATING: 2 x WEIGHT: 6.3 = SCORE: 12.5	
	Aging surfaces in fair condition and good alignment		
COMMENTS:	Lay-in tile		
COMPONENT:	Doors & Hardware	RATING: 3 x WEIGHT: 6.3 = SCORE: 18.8	
	Functional, but dated; some maintenance required		
COMMENTS:	Interior wood doors/frames; exterior HM doors/frames; surface wear

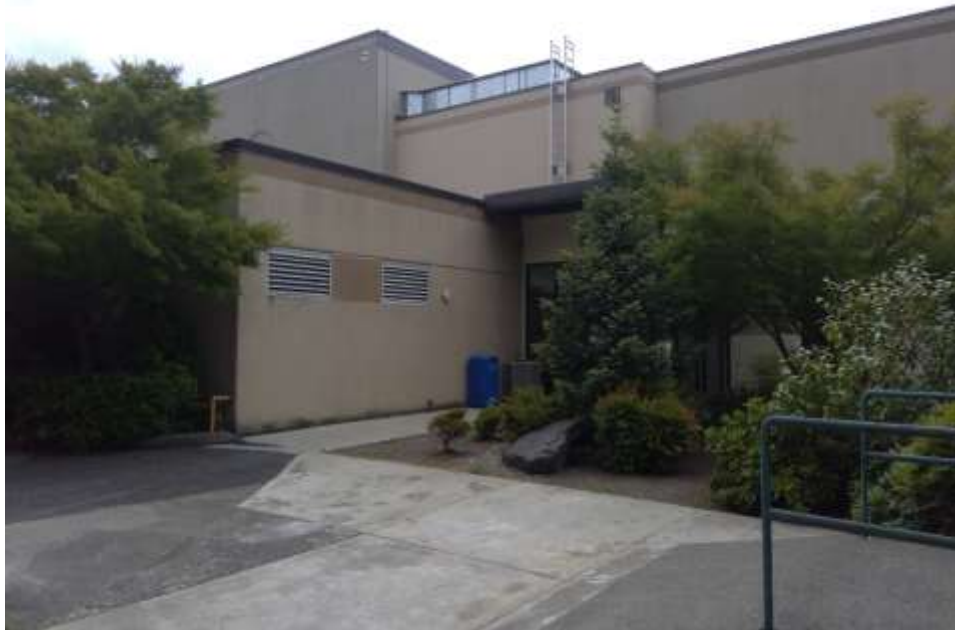
Michael Smith Gymnasium (121-MSG) STATE UFI: A02986 Main Campus (121A)
 AREA: 27,811 SF BUILT: 1936 REMODELED: 2008 PREDOMINANT USE: Gymnasium
 CONSTRUCTION TYPE: Medium CRV/SF: \$349 REPLACEMENT VALUE: \$9,706,039

Primary Systems			
COMPONENT:	Structure	RATING: 2 x WEIGHT: 8 =	SCORE: 16
Minor cracks evident in a small portion of the structure			
COMMENTS: Concrete; CMU; some wood and steel framing; seismic upgrades via renovation			
COMPONENT:	Exterior Closure	RATING: 2 x WEIGHT: 8 =	SCORE: 16
Weatherproof exterior, but finish appears poorly maintained			
COMMENTS: Stucco overlay on all sides of exterior except one; aluminum window walls			
COMPONENT:	Roofing	RATING: 2 x WEIGHT: 10 =	SCORE: 20
Majority of roofing and flashing appear sound, but a small portion of roofing shows deterioration where maintenance or minor repair needed			
COMMENTS: Single-ply PVC; BUR with mineral-surfaced cap sheet 2015

Secondary Systems			
COMPONENT:	Floor Finishes	RATING: 1 x WEIGHT: 6 =	SCORE: 6
	Nice appearance, smooth transitions, level subfloors, no cracks/separating		
COMMENTS:	Carpet; wood; vinyl tile; ceramic tile; hardwood; linoleum; wood composite panels		
COMPONENT:	Wall Finishes	RATING: 2 x WEIGHT: 6 =	SCORE: 12
	Maintainable surfaces, minor maintenance is required in some areas		
COMMENTS:	Gypsum board; ceramic tile; concrete		
COMPONENT:	Ceiling Finishes	RATING: 1 x WEIGHT: 6 =	SCORE: 6
	Maintainable surfaces in good condition; good alignment and appearance		
COMMENTS:	Lay-in tile; gypsum board; direct-adhered tile; wood deck; concrete		
COMPONENT:	Doors & Hardware	RATING: 1 x WEIGHT: 6 =	SCORE: 6
	Appropriate hardware, closers, panic devices; in good working order		
COMMENTS:	Interior wood doors w HM frames; exterior aluminum and HM doors/frames

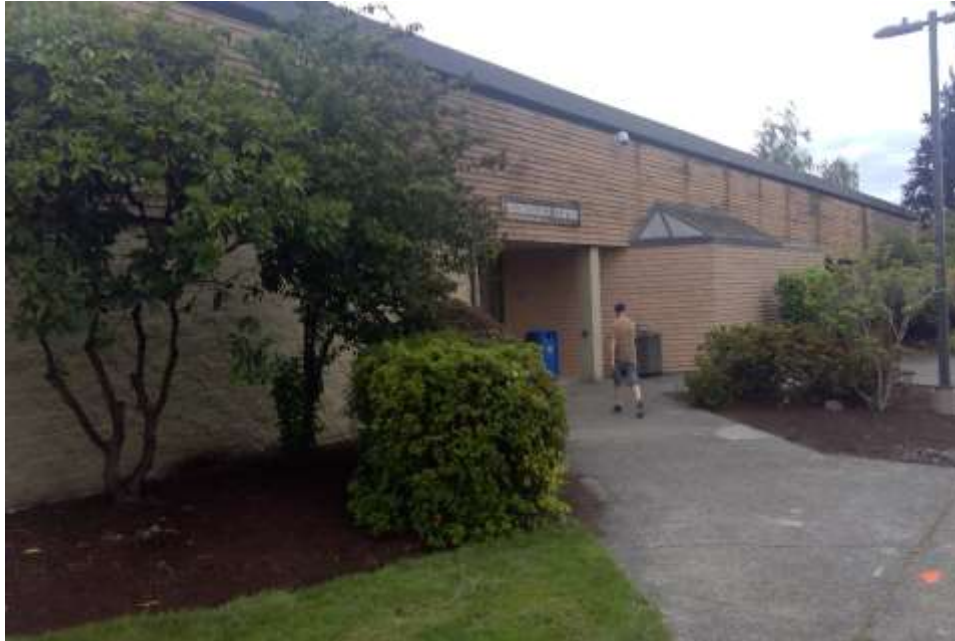
Technology Center (121-TEC) STATE UFI: A06178 Main Campus (121A)
 AREA: 46,272 SF BUILT: 1982 REMODELED: 1992 PREDOMINANT USE: Vocational Arts
 CONSTRUCTION TYPE: Heavy CRV/SF: \$395 REPLACEMENT VALUE: \$18,277,440

Primary Systems			
COMPONENT:	Structure	RATING: 1 x WEIGHT: 8 =	SCORE: 8
No signs of settlement or cracking, no abrupt vertical changes Columns, bearing walls and roof structure appears sound/free of defects			
COMMENTS:	Concrete; CMU; steel frame; wood frame		
COMPONENT:	Exterior Closure	RATING: 2 x WEIGHT: 8 =	SCORE: 16
Weatherproof exterior, but finish appears poorly maintained			
COMMENTS:	CMU; concrete; metal panels; beveled wood; some wood siding deterioration - funded 2021		
COMPONENT:	Roofing	RATING: 3 x WEIGHT: 10 =	SCORE: 30
Some deterioration is evident in membrane and flashings; maintenance or minor repair is needed			
COMMENTS:	BUR w mineral-surface cap sheet-2006; metal panels

Secondary Systems			
COMPONENT:	Floor Finishes	RATING: 3 x WEIGHT: 6 = SCORE: 18	
	Some physical wear and minor imperfections are evident; beginning deterioration		
COMMENTS:	Carpet; vinyl tile; sheet vinyl; ceramic tile; concrete		
COMPONENT:	Wall Finishes	RATING: 3 x WEIGHT: 6 = SCORE: 18	
	Aging surfaces, but sound; some maintenance is required		
COMMENTS:	Gypsum board; ceramic tile; interior walls in non-shop areas need paint		
COMPONENT:	Ceiling Finishes	RATING: 1 x WEIGHT: 6 = SCORE: 6	
	Maintainable surfaces in good condition; good alignment and appearance		
COMMENTS:	Lay-in tile; gypsum board; metal deck pan		
COMPONENT:	Doors & Hardware	RATING: 3 x WEIGHT: 6 = SCORE: 18	
	Functional, but dated; some maintenance required		
COMMENTS:	Interior wood/laminate/HM doors w HM frames-surface wear; exterior HM doors/frames; metal coiling doors

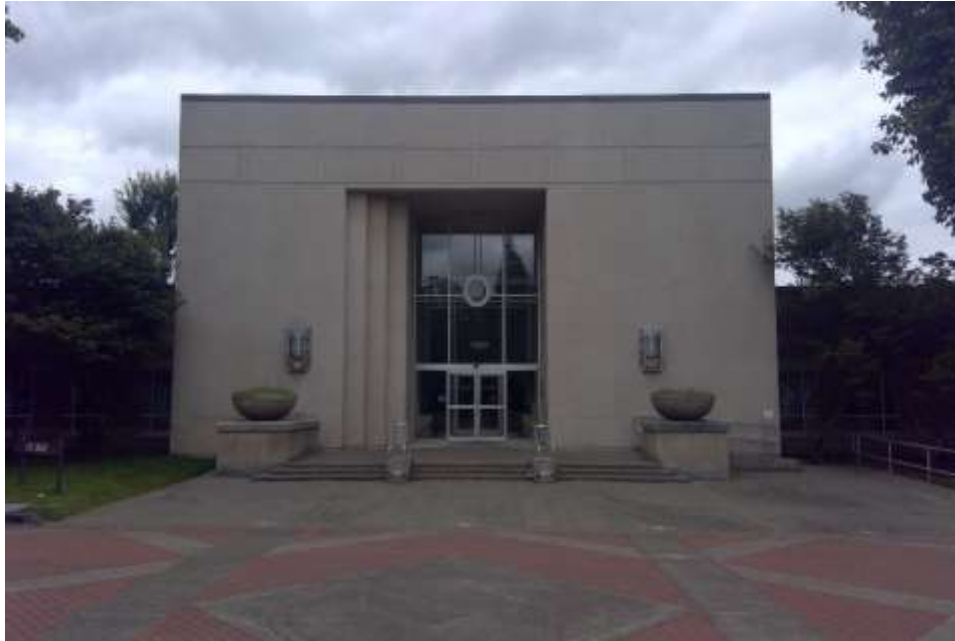
Kirk Library (121-LIB) STATE UFI: A07720 Main Campus (121A)
AREA: 25,000 SF BUILT: 1990 REMODELED: No PREDOMINANT USE: Library
CONSTRUCTION TYPE: Heavy CRV/SF: \$376 REPLACEMENT VALUE: \$9,400,000

Primary Systems			
COMPONENT:	Structure	RATING: 1 x WEIGHT: 8.8 = SCORE: 8.8	
No signs of settlement or cracking, no abrupt vertical changes Columns, bearing walls and roof structure appears sound/free of defects			
COMMENTS:	Concrete; brick; steel framing		
COMPONENT:	Exterior Closure	RATING: 1 x WEIGHT: 8.8 = SCORE: 8.8	
Weatherproof, tight, well-maintained exterior walls, doors, windows/finishes			
COMMENTS:	Concrete; brick		
COMPONENT:	Roofing	RATING: 1 x WEIGHT: 11 = SCORE: 11	
Flashing and penetrations appear sound and membrane appears water- tight; drainage is positive and there are overflow scuppers			
COMMENTS:	BUR with mineral-surface cap sheet-2009

Secondary Systems			
COMPONENT:	Floor Finishes	RATING: 3 x WEIGHT: 6.6 = SCORE: 19.8	
	Some physical wear and minor imperfections are evident; beginning deterioration		
COMMENTS:	Carpet-surface wear and staining; vinyl tile; ceramic tile; concrete		
COMPONENT:	Wall Finishes	RATING: 2 x WEIGHT: 6.6 = SCORE: 13.2	
	Maintainable surfaces, minor maintenance is required in some areas		
COMMENTS:	Gypsum board; wood; ceramic tile; vinyl wall cover; interior glazing		
COMPONENT:	Ceiling Finishes	RATING: 1 x WEIGHT: 6.6 = SCORE: 6.6	
	Maintainable surfaces in good condition; good alignment and appearance		
COMMENTS:	Lay-in tile; gypsum board;		
COMPONENT:	Doors & Hardware	RATING: 3 x WEIGHT: 6.6 = SCORE: 19.8	
	Functional, but dated; some maintenance required		
COMMENTS:	Interior wood doors/frames-surface wear; glazed wood sidelites; exterior aluminum doors/frames

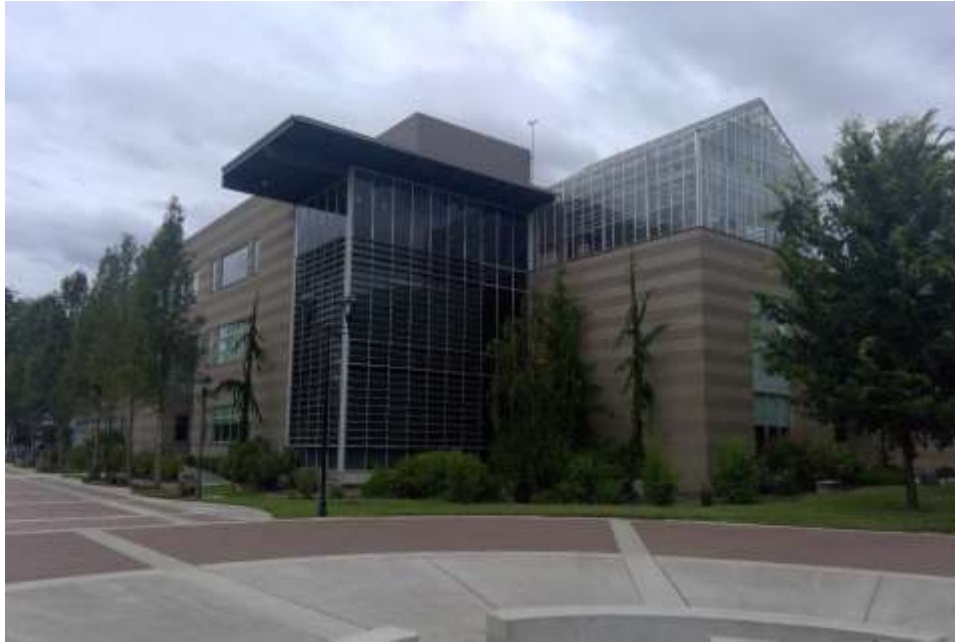
Walton Science Center (121-WSC) STATE UFI: A07887 Main Campus (121A)
AREA: 70,000 SF BUILT: 2008 REMODELED: No PREDOMINANT USE: Science Lab.
CONSTRUCTION TYPE: Heavy CRV/SF: \$489 REPLACEMENT VALUE: \$34,230,000

Primary Systems			
COMPONENT:	Structure	RATING: 1 x WEIGHT: 8.4 =	SCORE: 8.4
No signs of settlement or cracking, no abrupt vertical changes Columns, bearing walls and roof structure appears sound/free of defects			
COMMENTS:	Concrete; structural steel (heavy and light); metal frame		
COMPONENT:	Exterior Closure	RATING: 1 x WEIGHT: 8.4 =	SCORE: 8.4
Weatherproof, tight, well-maintained exterior walls, doors, windows/finishes			
COMMENTS:	Brick veneer; aluminum window walls; glass panels; metal panels		
COMPONENT:	Roofing	RATING: 1 x WEIGHT: 10.5 =	SCORE: 10.5
Flashing and penetrations appear sound and membrane appears water- tight; drainage is positive and there are overflow scuppers			
COMMENTS:	TPO single-ply membrane; glass panels

Secondary Systems			
COMPONENT:	Floor Finishes	RATING: 2 x WEIGHT: 6.3 =	SCORE: 12.6
Some wear is evident on finish; maintenance needed			
COMMENTS:	Linoleum; ceramic tile; concrete; terrazzo		
COMPONENT:	Wall Finishes	RATING: 1 x WEIGHT: 6.3 =	SCORE: 6.3
Maintainable surfaces in good condition			
COMMENTS:	Concrete; gypsum board; ceramic tile; aluminum window walls; structural steel		
COMPONENT:	Ceiling Finishes	RATING: 1 x WEIGHT: 6.3 =	SCORE: 6.3
Maintainable surfaces in good condition; good alignment and appearance			
COMMENTS:	Exposed structure; lay-in tile; wood strips		
COMPONENT:	Doors & Hardware	RATING: 1 x WEIGHT: 6.3 =	SCORE: 6.3
Appropriate hardware, closers, panic devices; in good working order			
COMMENTS:	Interior wood and HM doors/frames; exterior aluminum and HM doors/frames

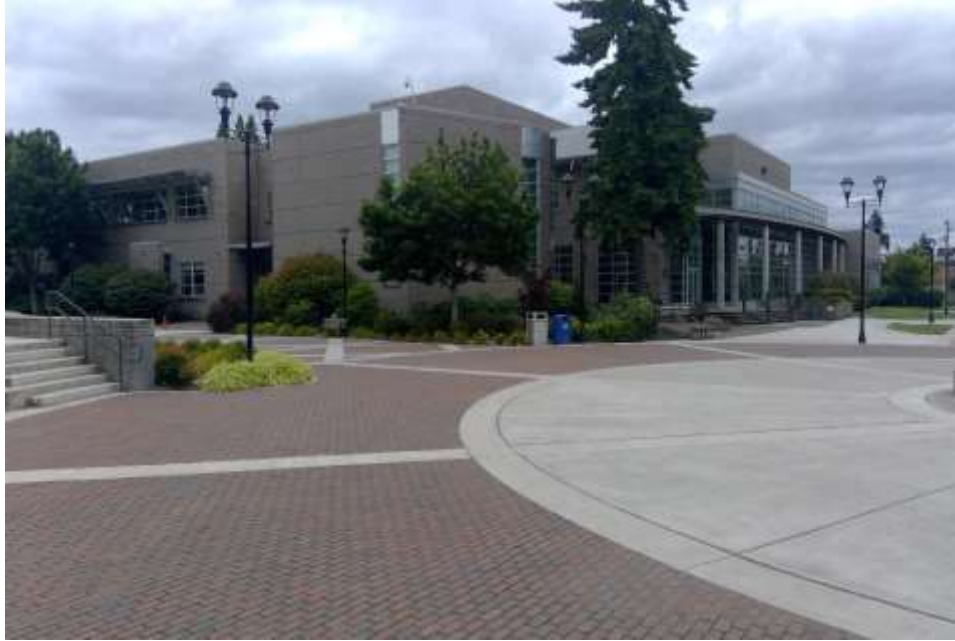
Washington Hall (121-WAH) STATE UFI: A08675 Main Campus (121A)
AREA: 67,000 SF BUILT: 2001 REMODELED: No PREDOMINANT USE: Performing Arts
CONSTRUCTION TYPE: Heavy CRV/SF: \$421 REPLACEMENT VALUE: \$28,207,000

Primary Systems			
COMPONENT:	Structure	RATING: 2 x WEIGHT: 8.4 =	SCORE: 16.8
Minor cracks evident in a small portion of the structure			
COMMENTS:	Steel frame; brick; CMU		
COMPONENT:	Exterior Closure	RATING: 1 x WEIGHT: 8.4 =	SCORE: 8.4
Weatherproof, tight, well-maintained exterior walls, doors, windows/finishes			
COMMENTS:	Steel frame; brick; CMU		
COMPONENT:	Roofing	RATING: 2 x WEIGHT: 10.5 =	SCORE: 21
Majority of roofing and flashing appear sound, but a small portion of roofing shows deterioration where maintenance or minor repair needed			
COMMENTS:	Built up roofing; deteriorated metal panels

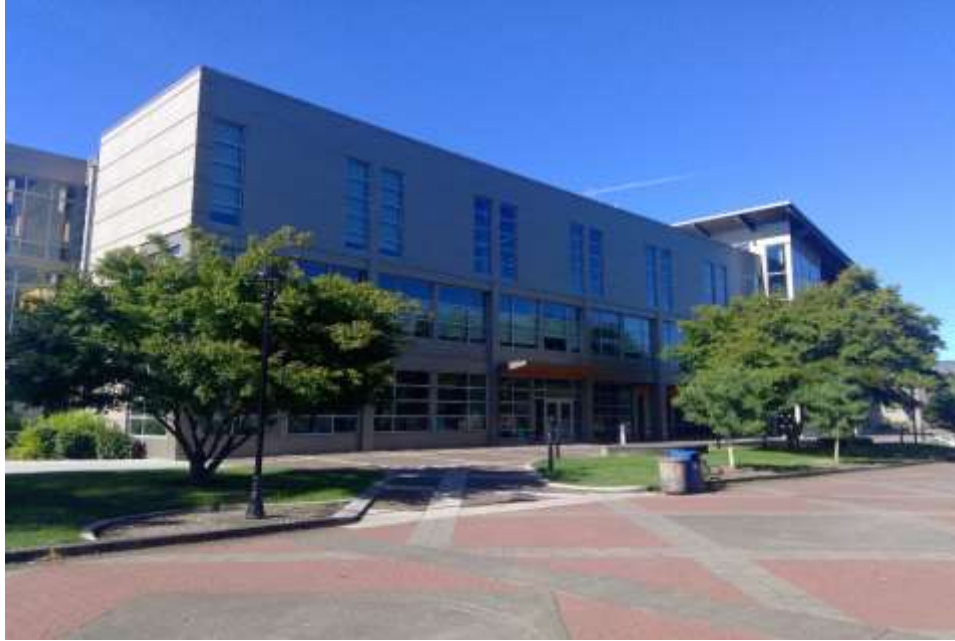
Transalta Commons (121-TAC) STATE UFI: A25604 Main Campus (121A)
AREA: 70,000 SF BUILT: 2017 REMODELED: No PREDOMINANT USE: Multi-Use
CONSTRUCTION TYPE: No data CRV/SF: \$396 REPLACEMENT VALUE: \$27,720,000

Primary Systems			
COMPONENT:	Structure	RATING: 1 x WEIGHT: 8.4 =	SCORE: 8.4
No signs of settlement or cracking, no abrupt vertical changes Columns, bearing walls and roof structure appears sound/free of defects			
COMMENTS:	No data		
COMPONENT:	Exterior Closure	RATING: 1 x WEIGHT: 8.4 =	SCORE: 8.4
Weatherproof, tight, well-maintained exterior walls, doors, windows/finishes			
COMMENTS:	No data		
COMPONENT:	Roofing	RATING: 1 x WEIGHT: 10.5 =	SCORE: 10.5
Flashing and penetrations appear sound and membrane appears water- tight; drainage is positive and there are overflow scuppers			
COMMENTS:	No data
