2023 FACILITY CONDITION SURVEY

Clark College

SURVEY CONDUCTED BY:
Steve Lewandowski
State Board for Community
and Technical Colleges

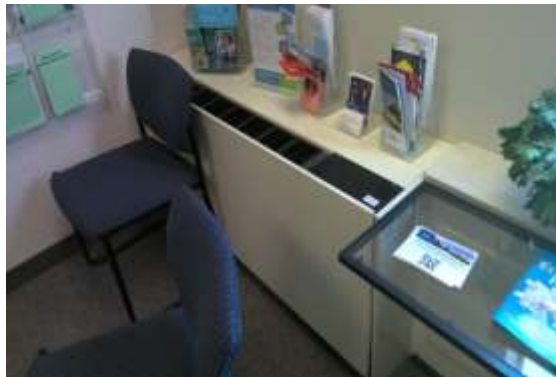
Recommended funding schedule : Immediate (score = 4)
Estimated remaining life (years) : 3
Estimated average life expectancy (years) : 25
Scoring priority category 1 : High Repair/Repl. Cost (score = 12)
Category 1 percentage : 70 %
Scoring priority category 2 : High Operating Cost (score = 10)
Category 2 percentage : 30 %
Project construction estimate (MACC): \$216,000
Total project estimate (including soft costs): \$302,000
Additional points based on building condition: 2
Deficiency score : $4 \times ((12 \times 70\%) + (10 \times 30\%)) + 2 = 47.6$

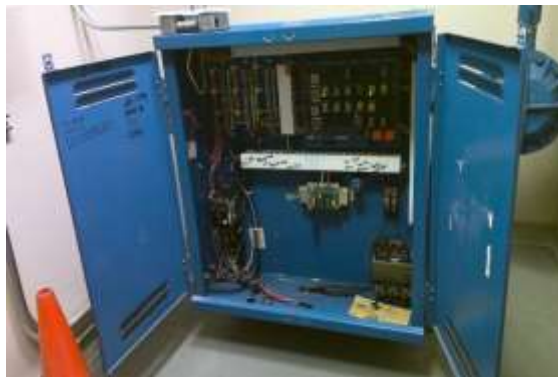
Deficiency F02

The college is concerned about the condition of the elevator controls. The controls still function as designed and the elevator has been reliable. The 38 year elevator should continue to be monitored for future replacement.

Scoring priority category 1 : System Use (scoring weight=15)
Category 1 percentage : 70 %
Scoring priority category 2 : Facility Use/ Civil Rights Violation (scoring weight=20)
Category 2 percentage : 30 %
Project construction estimate (MACC): \$198,000
Total project estimate (including soft costs): \$277,000
Additional points based on building condition: 1
Deficiency score : $2.5 \times ((15 \times 70\%) + (20 \times 30\%)) + 1 = 42.3$

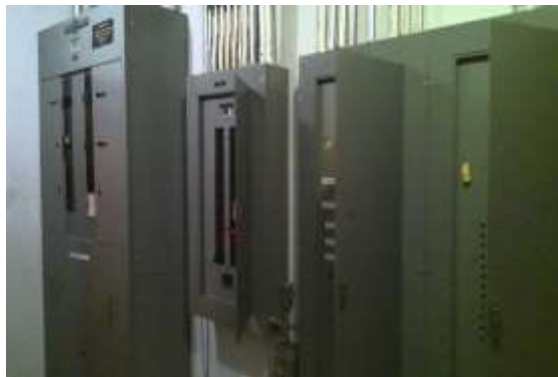
Deficiency F03

Estimated remaining life (years) : (No Data)
Estimated average life expectancy (years) : 40
Scoring priority category 1 : System Use (scoring weight=15)
Category 1 percentage : 100 %
Scoring priority category 2 : None
Category 2 percentage : 0 %
Project construction estimate (MACC): \$226,000
Total project estimate (including soft costs): \$316,000
Additional points based on building condition: 2
Deficiency score : Needs study

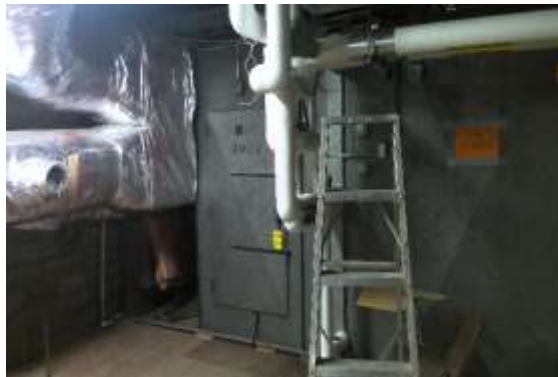
Deficiency F04

The college is concerned about the age and condition of the unit. There has been a higher level of maintenance required to maintain function. The unit is at the end of its expected life and should be replaced. This unit only serves the gym. It is not known if the gym is used for instruction. Add information is required to determine if this unit serves instructional space.

Recommended funding schedule : Fund in Next Biennium (scoring weight=2.5)
Estimated remaining life (years) : 5
Estimated average life expectancy (years) : 30
Scoring priority category 1 : System Use (scoring weight=15)
Category 1 percentage : 80 %
Scoring priority category 2 : High Repair/Repl. Cost (scoring weight=12)
Category 2 percentage : 20 %
Project construction estimate (MACC): \$85,000
Total project estimate (including soft costs): \$119,000
Additional points based on building condition: 2
Deficiency score : $2.5 \times ((15 \times 80\%) + (12 \times 20\%)) + 2 = 38$

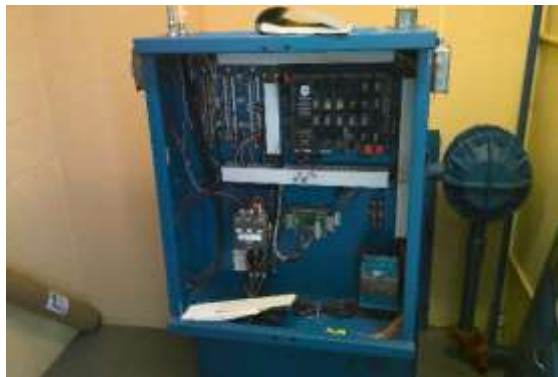
Deficiency F05

The Dover elevator controls have become obsolete and are no longer repairable. If these controls fail, the elevators would be disabled for extended periods. The controls should be replaced.
(Multiple buildings (140A), UFI:, \$774,000)

Estimated average life expectancy (years) : 40
Scoring priority category 1 : System Use (scoring weight=15)
Category 1 percentage : 80 %
Scoring priority category 2 : Facility Use/ Civil Rights Violation (scoring weight=20)
Category 2 percentage : 20 %
Project construction estimate (MACC): \$250,000
Total project estimate (including soft costs): \$350,000
Additional points based on building condition: 0
Deficiency score : $4 \times ((15 \times 80\%) + (20 \times 20\%)) + 0 = 64$

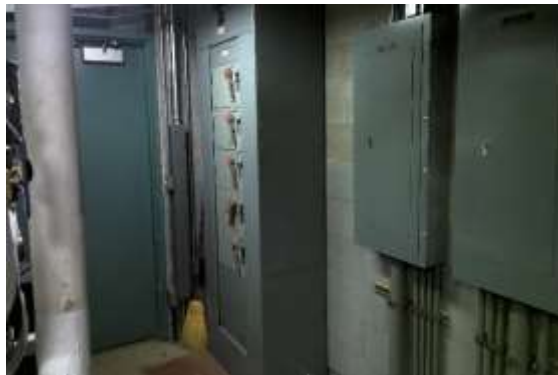
Deficiency F06

The switchgear has become obsolete and parts are no longer available. The gear is beyond its expected life and should be replaced.

Category 1 percentage : 50 %
Scoring priority category 2 : Facility Use/ Civil Rights Violation (scoring weight=20)
Category 2 percentage : 50 %
Project construction estimate (MACC): \$360,000
Total project estimate (including soft costs): \$504,000
Additional points based on building condition: 5
Deficiency score : $4 \times ((15 \times 50\%) + (20 \times 50\%)) + 5 = 75$

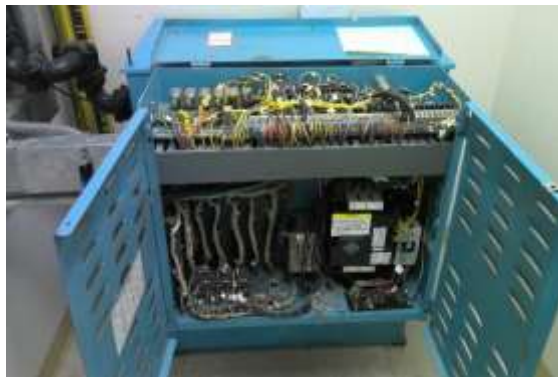
Deficiency F07

The college is concerned about the Otis elevator controls. It was not known if the controls have become obsolete and are no longer repairable. Additional information is required to determine if the controls are still supported and repairable by the vendor.

Estimated average life expectancy (years) : 40
Scoring priority category 1 : System Use (scoring weight=15)
Category 1 percentage : 80 %
Scoring priority category 2 : Facility Use/ Civil Rights Violation (scoring weight=20)
Category 2 percentage : 20 %
Project construction estimate (MACC): \$300,000
Total project estimate (including soft costs): \$420,000
Additional points based on building condition: 1
Deficiency score : Needs study

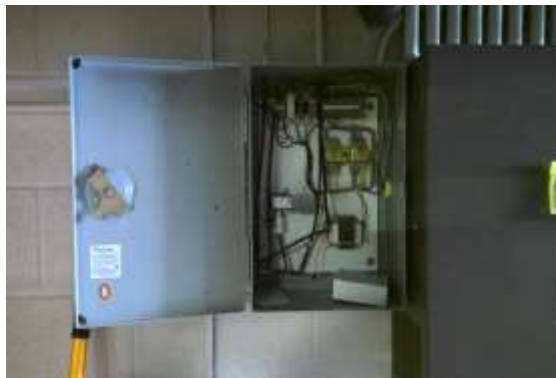
Deficiency F08

The pneumatic controls and fire dampers have become unreliable and should be replaced.

Scoring priority category 2 : System Use (scoring weight=15)
Category 2 percentage : 30 %
Project construction estimate (MACC): \$130,000
Total project estimate (including soft costs): \$182,000
Additional points based on building condition: 1
Deficiency score : $2.5 \times ((12 \times 70\%) + (15 \times 30\%)) + 1 = 33.3$

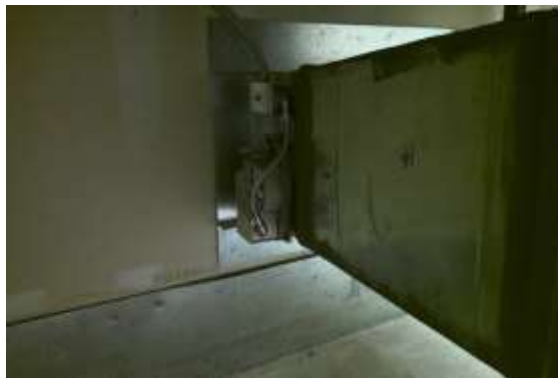
Deficiency F09

The fire dampers have failed and should be replaced.

Category 2 percentage : 20 %
Project construction estimate (MACC): \$33,000
Total project estimate (including soft costs): \$46,000
Additional points based on building condition: 1
Deficiency score : $4 \times ((15 \times 80\%) + (25 \times 20\%)) + 1 = 69$

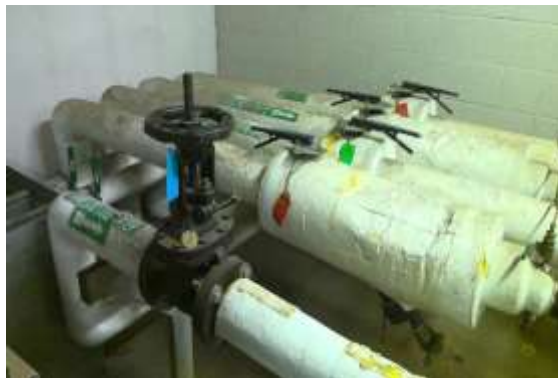
Deficiency F10

Several buildings have isolation valves that have failed. These valves should be replaced.

Category 2 percentage : 0 %
Project construction estimate (MACC): \$60,000
Total project estimate (including soft costs): \$84,000
Additional points based on building condition: 0
Deficiency score : $4 \times (15 \times 100\%) + 0 = 60$

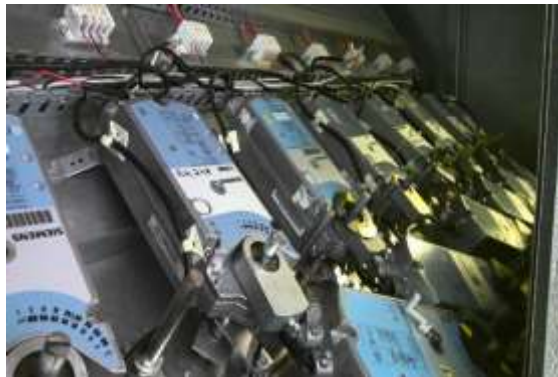
Deficiency F11

Some minor components of the supply air damper system have failed. The damper system should be reconditioned to extend its useful life.

Category 1 percentage : 70 %
Scoring priority category 2 : High Repair/Repl. Cost (scoring weight=12)
Category 2 percentage : 30 %
Project construction estimate (MACC): \$150,000
Total project estimate (including soft costs): \$210,000
Additional points based on building condition: 0
Deficiency score : $4 \times ((15 \times 70\%) + (12 \times 30\%)) + 0 = 56.4$

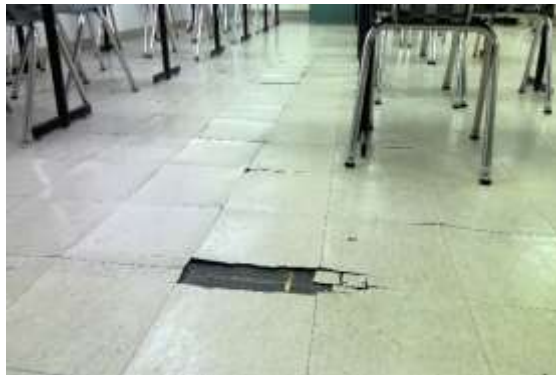
Deficiency F12

The VCT flooring has failed. The subfloor has been previously saturated and appears to be damaged. The flooring should be replaced and the water damage should be repaired.

Scoring priority category 1 : System Use (scoring weight=15)
Category 1 percentage : 60 %
Scoring priority category 2 : High Repair/Repl. Cost (scoring weight=12)
Category 2 percentage : 40 %
Project construction estimate (MACC): \$38,000
Total project estimate (including soft costs): \$53,000
Additional points based on building condition: 5
Deficiency score : $4 \times ((15 \times 60\%) + (12 \times 40\%)) + 5 = 60.2$

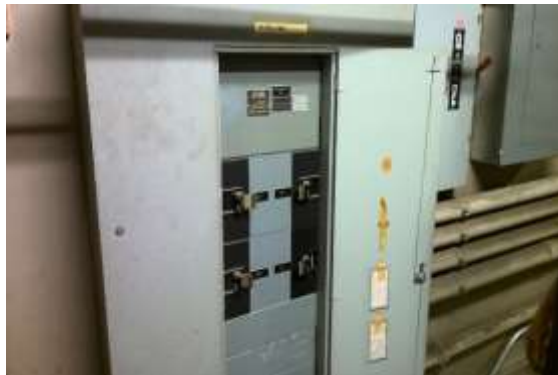
Deficiency F13

The switchgear is at the end of its useful life and has required repairs to maintain function. The gear is beyond its expected life should be replaced.

Category 1 percentage : 60 %
Scoring priority category 2 : Facility Use/ Civil Rights Violation (scoring weight=20)
Category 2 percentage : 40 %
Project construction estimate (MACC): \$125,000
Total project estimate (including soft costs): \$175,000
Additional points based on building condition: 2
Deficiency score : $4 \times ((15 \times 60\%) + (20 \times 40\%)) + 2 = 70$

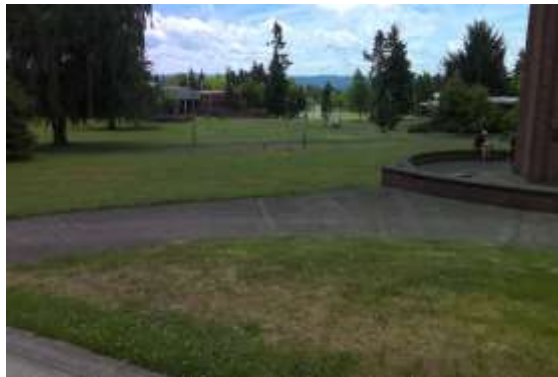
Deficiency S01

The college was concerned about the condition of the main heating and cooling loops. Some of the sections near the south end of campus had prior leaks repaired. It was not clear if other sections further to the north leaked. The pipes should continue to be monitored to determine if they leak to establish the appropriate scope of work for future replacement of the pipe.

Recommended funding schedule : Fund in Next Biennium (scoring weight=2.5)
Estimated remaining life (years) : 5
Estimated average life expectancy (years) : 30
Scoring priority category 1 : High Repair/Repl. Cost (scoring weight=12)
Category 1 percentage : 50 %
Scoring priority category 2 : System Use (scoring weight=15)
Category 2 percentage : 50 %
Project construction estimate (MACC): \$1,000,000
Total project estimate (including soft costs): \$1,400,000
Additional points based on building condition: 0
Deficiency score : $2.5 \times ((12 \times 50\%) + (15 \times 50\%)) + 0 = 33.8$

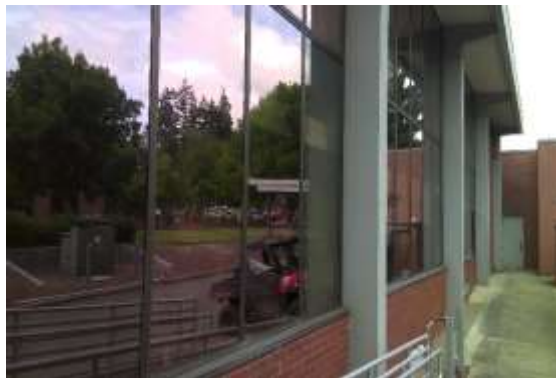
Deficiency F14

Several windows have failed and should be replaced.

Category 2 percentage : 20 %
Project construction estimate (MACC): \$20,000
Total project estimate (including soft costs): \$28,000
Additional points based on building condition: 1
Deficiency score : $4 \times ((12 \times 80\%) + (15 \times 20\%)) + 1 = 51.4$

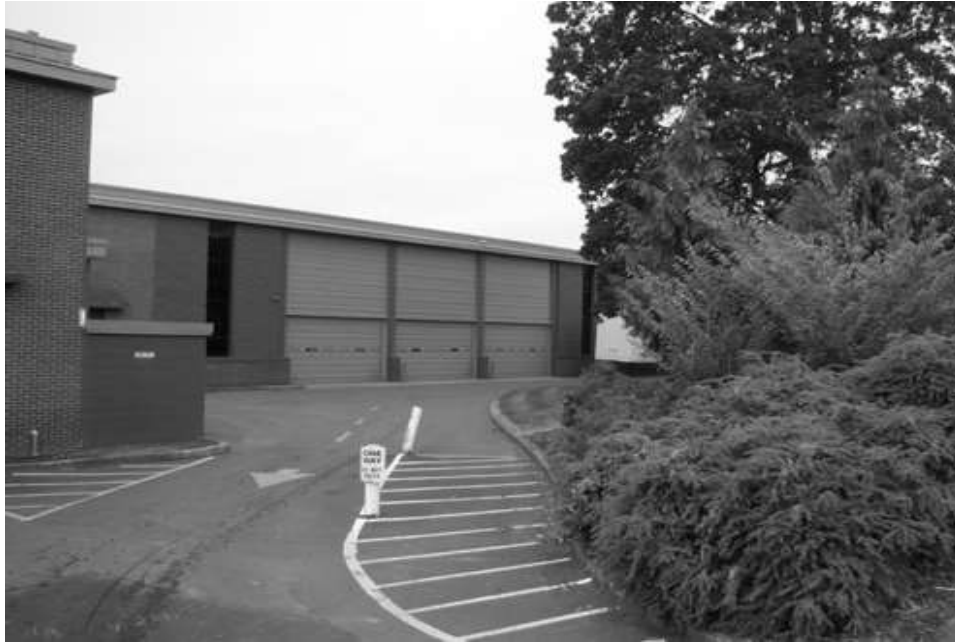
Applied Arts I (140-AA1) STATE UFI: A04453 Main Campus (140A)
AREA: 12,074 SF BUILT: 1950 REMODELED: No PREDOMINANT USE: Vocational Arts
CONSTRUCTION TYPE: Medium CRV/SF: \$395 REPLACEMENT VALUE: \$4,769,230

Primary Systems			
COMPONENT:	Structure	RATING: 3 x WEIGHT: 8 =	SCORE: 24
Some cracking evident but does not likely affect structural integrity; Visible defects apparent but are non-structural			
COMMENTS:	Brick; steel frame; wood frame		
COMPONENT:	Exterior Closure	RATING: 3 x WEIGHT: 8 =	SCORE: 24
Sound and weatherproof but with some physical deterioration evident			
COMMENTS:	Brick-random mortar deterioration; CMU		
COMPONENT:	Roofing	RATING: 3 x WEIGHT: 10 =	SCORE: 30
Some deterioration is evident in membrane and flashings; maintenance or minor repair is needed			
COMMENTS:	Single-ply TPO membrane- 2000.

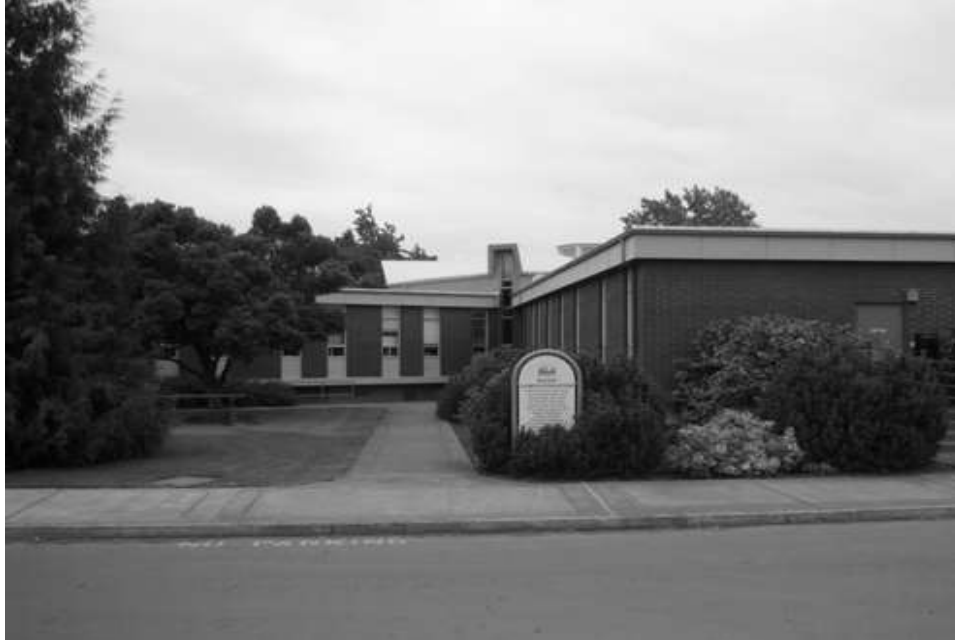
Baird Administration (140-BRD) STATE UFI: A04257 Main Campus (140A)
AREA: 23,949 SF BUILT: 1966 REMODELED: No PREDOMINANT USE: Administration
CONSTRUCTION TYPE: Medium CRV/SF: \$336 REPLACEMENT VALUE: \$8,046,864

Primary Systems			
COMPONENT:	Structure	RATING: 2 x WEIGHT: 8 =	SCORE: 16
Minor cracks evident in a small portion of the structure			
COMMENTS:	Concrete; wood frame		
COMPONENT:	Exterior Closure	RATING: 3 x WEIGHT: 8 =	SCORE: 24
Sound and weatherproof but with some physical deterioration evident			
COMMENTS:	Brick-random mortar wear; concrete; metal panel fascia		
COMPONENT:	Roofing	RATING: 1 x WEIGHT: 10 =	SCORE: 10
Flashing and penetrations appear sound and membrane appears water- tight; drainage is positive and there are overflow scuppers			
COMMENTS:	single-ply membrane 2013

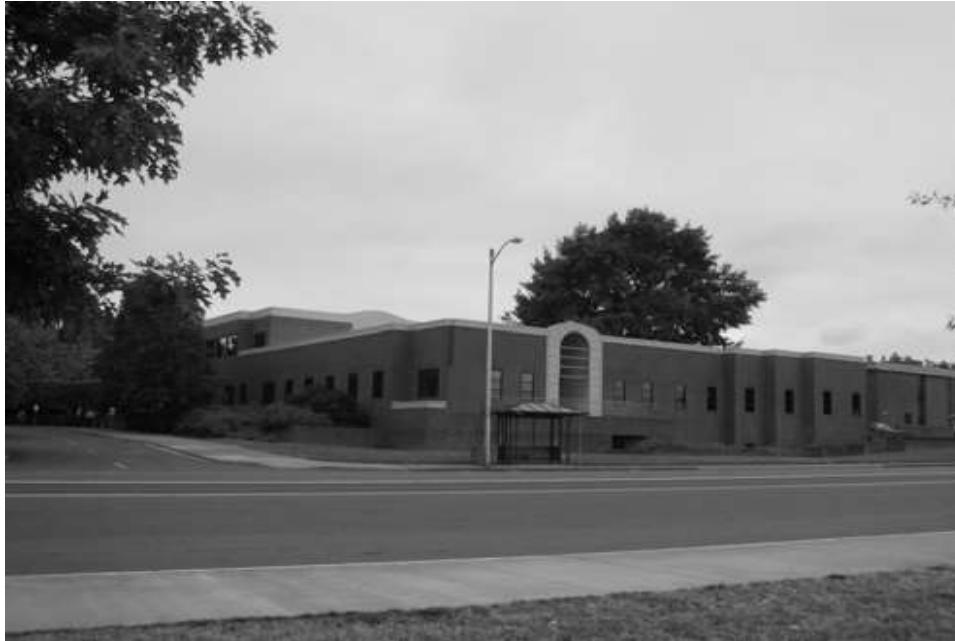
Bauer Hall (140-BHL) STATE UFI: A05212 Main Campus (140A)
 AREA: 31,091 SF BUILT: 1985 REMODELED: 1990 PREDOMINANT USE: General Classroom
 CONSTRUCTION TYPE: Medium CRV/SF: \$376 REPLACEMENT VALUE: \$11,690,216

Primary Systems			
COMPONENT:	Structure	RATING: 1 x WEIGHT: 8 =	SCORE: 8
No signs of settlement or cracking, no abrupt vertical changes Columns, bearing walls and roof structure appears sound/free of defects			
COMMENTS:	Brick; wood-frame; concrete		
COMPONENT:	Exterior Closure	RATING: 2 x WEIGHT: 8 =	SCORE: 16
Weatherproof exterior, but finish appears poorly maintained			
COMMENTS:	Brick; dryvit		
COMPONENT:	Roofing	RATING: 1 x WEIGHT: 10 =	SCORE: 10
Flashing and penetrations appear sound and membrane appears water- tight; drainage is positive and there are overflow scuppers			
COMMENTS:	single-ply membrane 2013

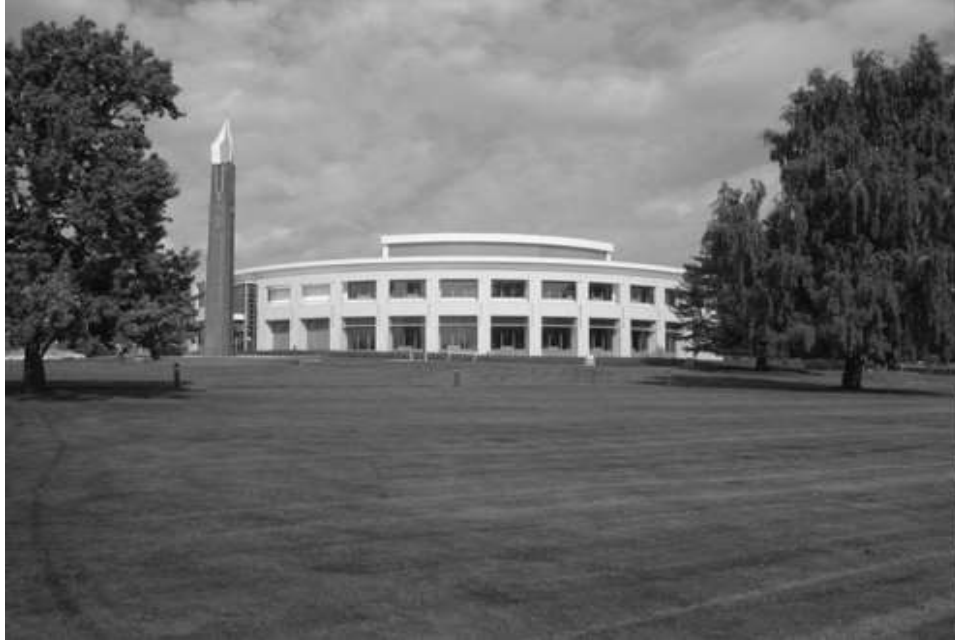
Cannell Library (140-LIB) STATE UFI: A08326 Main Campus (140A)
AREA: 48,250 SF BUILT: 1990 REMODELED: No PREDOMINANT USE: Library
CONSTRUCTION TYPE: Heavy CRV/SF: \$376 REPLACEMENT VALUE: \$18,142,000

Primary Systems			
COMPONENT:	Structure	RATING: 2 x WEIGHT: 8 =	SCORE: 16
Minor cracks evident in a small portion of the structure			
COMMENTS:	Brick; CMU; steel frame		
COMPONENT:	Exterior Closure	RATING: 1 x WEIGHT: 8 =	SCORE: 8
Weatherproof, tight, well-maintained exterior walls, doors, windows/finishes			
COMMENTS:	Brick; spectra glaze tile trim		
COMPONENT:	Roofing	RATING: 2 x WEIGHT: 10 =	SCORE: 20
Majority of roofing and flashing appear sound, but a small portion of roofing shows deterioration where maintenance or minor repair needed			
COMMENTS:	Single-ply Hypalon membrane

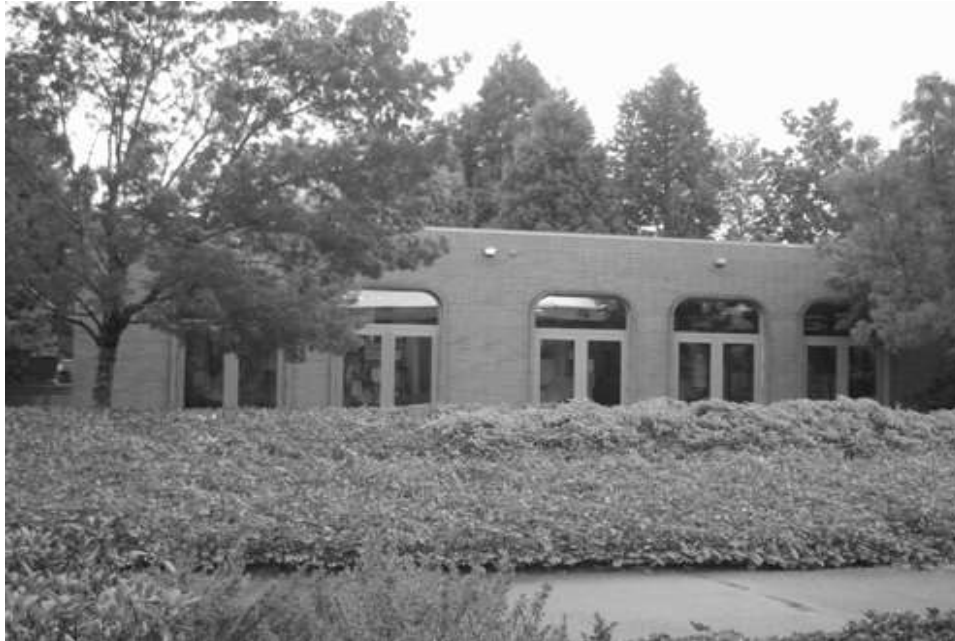
Central Mechanical (140-CMB) STATE UFI: A04181 Main Campus (140A)
AREA: 3,155 SF BUILT: 1984 REMODELED: No PREDOMINANT USE: Boiler/Chiller Plant
CONSTRUCTION TYPE: Medium CRV/SF: \$231 REPLACEMENT VALUE: \$728,805

Primary Systems			
COMPONENT:	Structure	RATING: 1 x WEIGHT: 9.7 = SCORE: 9.7	
No signs of settlement or cracking, no abrupt vertical changes Columns, bearing walls and roof structure appears sound/free of defects			
COMMENTS:	Steel frame; brick		
COMPONENT:	Exterior Closure	RATING: 2 x WEIGHT: 9.7 = SCORE: 19.3	
Weatherproof exterior, but finish appears poorly maintained			
COMMENTS:	Brick		
COMPONENT:	Roofing	RATING: 1 x WEIGHT: 12.1 = SCORE: 12.1	
Flashing and penetrations appear sound and membrane appears water- tight; drainage is positive and there are overflow scuppers			
COMMENTS:	BUR with mineral-surfaced capsheet-2009

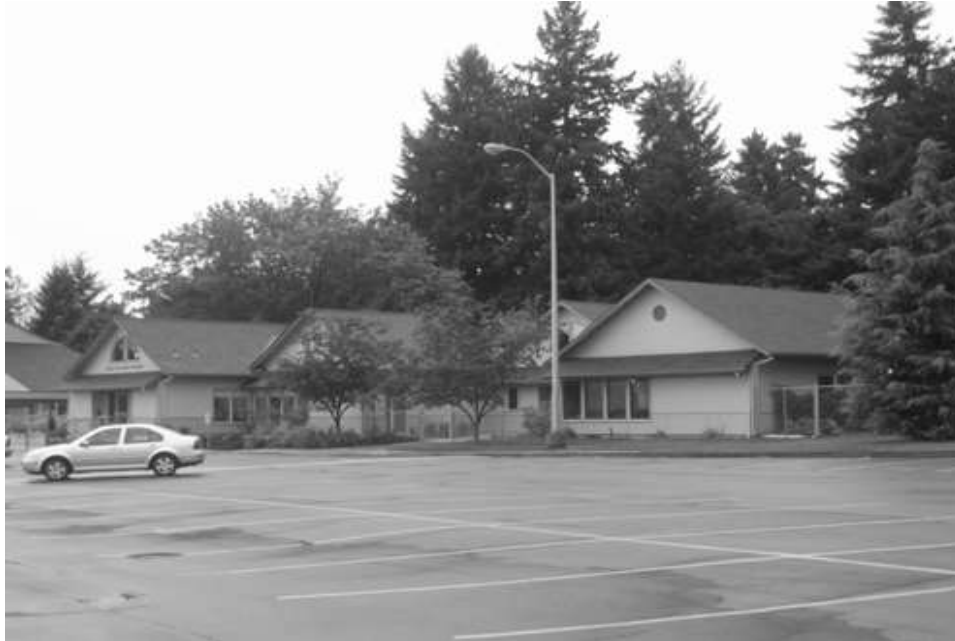
Child & Family Studies (140-CFS) STATE UFI: A03615 Main Campus (140A)
AREA: 6,321 SF BUILT: 1990 REMODELED: 2002 PREDOMINANT USE: Child Care
CONSTRUCTION TYPE: Light CRV/SF: \$231 REPLACEMENT VALUE: \$1,460,151

Primary Systems			
COMPONENT:	Structure	RATING: 1 x WEIGHT: 8.8 = SCORE: 8.8	
No signs of settlement or cracking, no abrupt vertical changes Columns, bearing walls and roof structure appears sound/free of defects			
COMMENTS:	Wood frame		
COMPONENT:	Exterior Closure	RATING: 2 x WEIGHT: 8.8 = SCORE: 17.6	
Weatherproof exterior, but finish appears poorly maintained			
COMMENTS:	Horizontal Hardie-board cement siding; plywood panels		
COMPONENT:	Roofing	RATING: 1 x WEIGHT: 11 = SCORE: 11	
Flashing and penetrations appear sound and membrane appears water- tight; drainage is positive and there are overflow scuppers			
COMMENTS:	30 year comp 2017

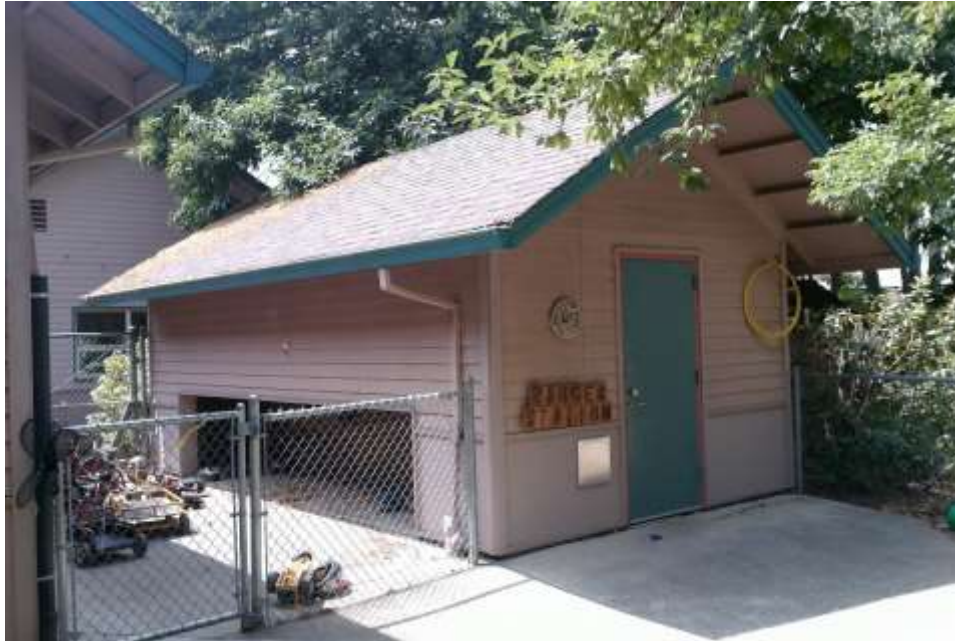
Child Care Storage Shed (140-CCS) STATE UFI: A03093 Main Campus (140A)
AREA: 264 SF BUILT: 1994 REMODELED: No PREDOMINANT USE: Storage
CONSTRUCTION TYPE: Light CRV/SF: \$54 REPLACEMENT VALUE: \$14,256

Primary Systems			
COMPONENT:	Structure	RATING: 1 x WEIGHT: 11.8 =	SCORE: 11.8
No signs of settlement or cracking, no abrupt vertical changes Columns, bearing walls and roof structure appears sound/free of defects			
COMMENTS:	No data		
COMPONENT:	Exterior Closure	RATING: 1 x WEIGHT: 11.8 =	SCORE: 11.8
Weatherproof, tight, well-maintained exterior walls, doors, windows/finishes			
COMMENTS:	No data		
COMPONENT:	Roofing	RATING: 1 x WEIGHT: 14.7 =	SCORE: 14.7
Flashing and penetrations appear sound and membrane appears water- tight; drainage is positive and there are overflow scuppers			
COMMENTS:	No data
