2023 FACILITY CONDITION SURVEY

Clover Park Technical College

SURVEY CONDUCTED BY:
Steve Lewandowski
State Board for Community
and Technical Colleges

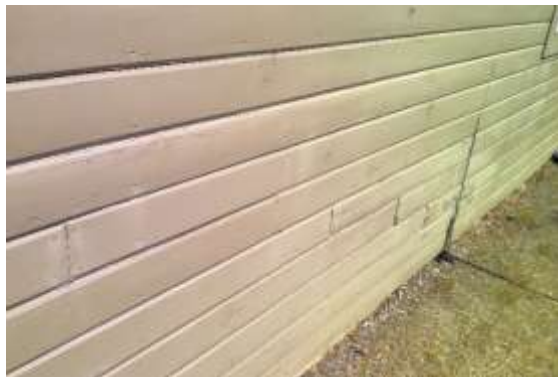
Deficiency F01

The wood siding on the south side of the building has begun to fail. The college staff can seal and paint the existing siding to extend its useful life, however, the failed section of siding should be replaced in the next biennium.

Estimated average life expectancy (years) : 30
Scoring priority category 1 : System Use (score = 15)
Category 1 percentage : 80 %
Scoring priority category 2 : High Repair/Repl. Cost (score = 12)
Category 2 percentage : 20 %
Project construction estimate (MACC): \$90,000
Total project estimate (including soft costs): \$127,000
Additional points based on building condition: 0
Deficiency score : $2.5 \times ((15 \times 80\%) + (12 \times 20\%)) + 0 = 36$

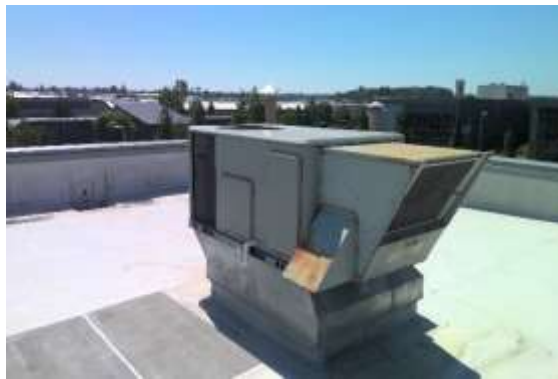
Deficiency F02

The heat pumps require a high level of maintenance and are near the end of their useful life. Four heat pumps in the worst condition should be repaired or replaced. The remaining heat pumps should continue to be monitored for future replacement.

Carryover from prior survey : No
Location : Main Campus (290A)
Building name : Technology (290-16)
Unique Facility Identifier (UFI) : A09483
Funding category in capital budget : Minor Works Facility appropriation
Unifomat category : D30-HVAC
Assessment : Asset is near or at the end of its useful life and should be replaced
Quantity : 4
Unit of measurement : EA
Component : Heat pumps
Location within building or site : Roof
Issue clarity : Adequate information was provided to assess deficiency
Main cause of asset degradation or failure : Age/Wear
Detailed description : The heat pumps require a high level of maintenance and are near the end of their useful life. Four heat pumps in the worst condition should be repaired or replaced. The remaining heat pumps should continue to be monitored for future replacement.
Recommended funding schedule : Immediate (scoring weight=4)
Estimated remaining life (years) : 7

Estimated average life expectancy (years) : 20
Scoring priority category 1 : System Use (scoring weight=15)
Category 1 percentage : 60 %
Scoring priority category 2 : High Repair/Repl. Cost (scoring weight=12)
Category 2 percentage : 40 %
Project construction estimate (MACC): \$234,000
Total project estimate (including soft costs): \$331,000
Additional points based on building condition: 5
Deficiency score : $4 \times ((15 \times 60\%) + (12 \times 40\%)) + 5 = 60.2$

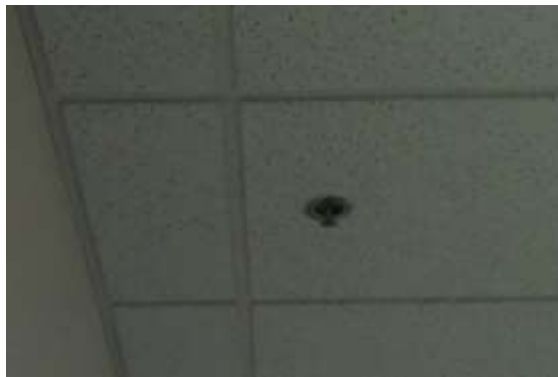
Deficiency F03

Sprinkler heads in building 10 and 11 are beyond their useful life and the fire department inspections have flagged them for replacement. A memo regarding the sprinkler head problem is required to justify replacement.

Carryover from prior survey : No
Location : Main Campus (290A)
Building name : Multiple (290A)
Unique Facility Identifier (UFI) : 290A
Funding category in capital budget : Minor Works Facility appropriation
Unifomat category : D40-Fire Protection
Assessment : Asset is near or at the end of its useful life and should be replaced
Quantity : 100
Unit of measurement : EA
Component : Fire sprinkler heads
Location within building or site : Interior
Issue clarity : Additional information is required to assess deficiency
Main cause of asset degradation or failure : Code Issue
Detailed description : Sprinkler heads in building 10 and 11 are beyond their useful life and the fire department inspections have flagged them for replacement. A memo regarding the sprinkler head problem is required to justify replacement.
Recommended funding schedule : Immediate (scoring weight=4)
Estimated remaining life (years) : 3
Estimated average life expectancy (years) : 40

Scoring priority category 1 : Health/Safety (scoring weight=25)
Category 1 percentage : 50 %
Scoring priority category 2 : High Repair/Repl. Cost (scoring weight=12)
Category 2 percentage : 50 %
Project construction estimate (MACC): \$50,000
Total project estimate (including soft costs): \$70,000
Additional points based on building condition: 0
Deficiency score : Needs study

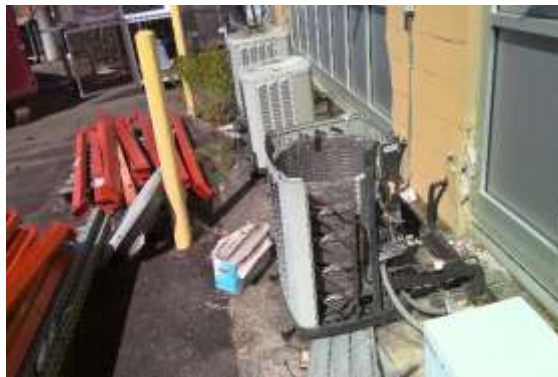
Deficiency F04

The eight condensing units are beyond their useful life and starting to fail. Some units are in worse condition than others. The worst four units should be replaced. The remaining units should continue to be monitored for replacement in the following biennium.

Carryover from prior survey : No
Location : Main Campus (290A)
Building name : Machine Trades (290-25)
Unique Facility Identifier (UFI) : A01268
Funding category in capital budget : Minor Works Facility appropriation
Unifomat category : D30-HVAC
Assessment : Asset is near or at the end of its useful life and should be replaced
Quantity : 4
Unit of measurement : EA
Component : Condensing units
Location within building or site : Mechanical
Issue clarity : Adequate information was provided to assess deficiency
Main cause of asset degradation or failure : Age/Wear
Detailed description : The eight condensing units are beyond their useful life and starting to fail. Some units are in worse condition than others. The worst four units should be replaced. The remaining units should continue to be monitored for replacement in the following biennium.
Recommended funding schedule : Immediate (scoring weight=4)
Estimated remaining life (years) : 3

Estimated average life expectancy (years) : 20
Scoring priority category 1 : High Repair/Repl. Cost (scoring weight=12)
Category 1 percentage : 70 %
Scoring priority category 2 : System Use (scoring weight=15)
Category 2 percentage : 30 %
Project construction estimate (MACC): \$160,000
Total project estimate (including soft costs): \$226,000
Additional points based on building condition: 1
Deficiency score : $4 \times ((12 \times 70\%) + (15 \times 30\%)) + 1 = 52.6$

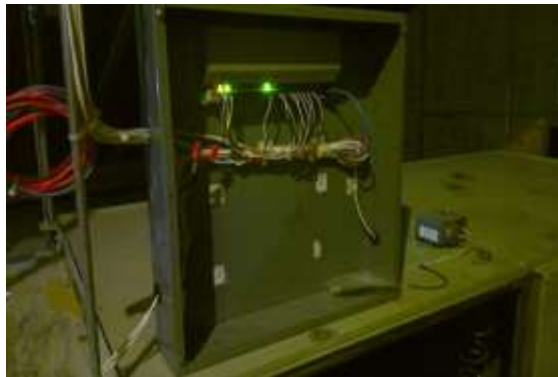
Deficiency F05

The HVAC controls in multiple buildings are at the end of their useful life and replacement parts (TEC's) may no longer be available from the vendor. If so, the worst controls systems in 3 of the buildings should be replaced. The removed components should be retained as spare parts to extend the life of the other building systems. A memo from the vendor must be provided to justify replacement.

Carryover from prior survey : No
Location : Main Campus (290A)
Building name : Multiple (290A)
Unique Facility Identifier (UFI) : 290A
Funding category in capital budget : Minor Works Facility appropriation
Uniformat category : D30-HVAC
Assessment : Asset should be repaired to extend its useful life
Quantity : 3
Unit of measurement : EA
Component : Controls - Digital
Location within building or site : Interior
Issue clarity : Additional information is required to assess deficiency
Main cause of asset degradation or failure : Age/Wear
Detailed description : The HVAC controls in multiple buildings are at the end of their useful life and replacement parts (TEC's) may no longer be available from the vendor. If so, the worst controls systems in 3 of the buildings should be replaced. The removed components should be retained as spare parts to extend the life of the other building systems. A memo from the vendor must be provided to justify replacement.

Recommended funding schedule : Immediate (scoring weight=4)
Estimated remaining life (years) : 3
Estimated average life expectancy (years) : 20
Scoring priority category 1 : System Use (scoring weight=15)
Category 1 percentage : 60 %
Scoring priority category 2 : High Repair/Repl. Cost (scoring weight=12)
Category 2 percentage : 40 %
Project construction estimate (MACC): \$1,370,000
Total project estimate (including soft costs): \$1,941,000
Additional points based on building condition: 0
Deficiency score : Needs study

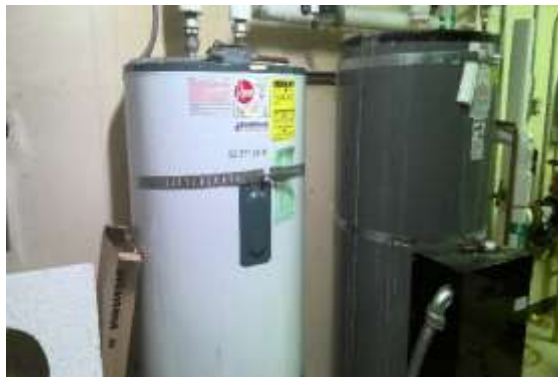
Deficiency F06

The four water heaters are near the end of their useful life. Two of the units appeared to be in better condition than the older units. The two oldest water heaters should be replaced. The other water heaters should continue to be monitored for replacement.

Estimated remaining life (years) : 3
Estimated average life expectancy (years) : 20
Scoring priority category 1 : System Use (scoring weight=15)
Category 1 percentage : 50 %
Scoring priority category 2 : High Repair/Repl. Cost (scoring weight=12)
Category 2 percentage : 50 %
Project construction estimate (MACC): \$108,000
Total project estimate (including soft costs): \$153,000
Additional points based on building condition: 1
Deficiency score : $4 \times ((15 \times 50\%) + (12 \times 50\%)) + 1 = 55$

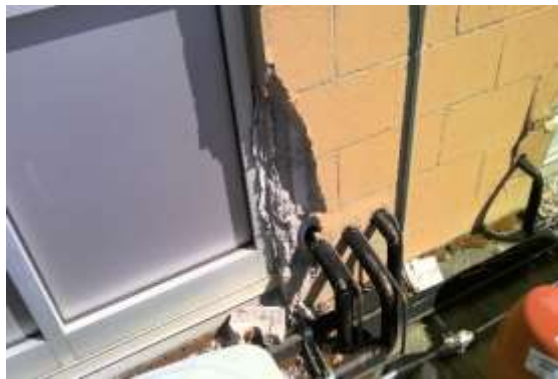
Deficiency F07

The CMU is broken at several overhead door locations. These sections should be repaired. Additional information is required to determine if the building structural system has been compromised and requires more significant repairs.

Scoring priority category 1 : System Use (scoring weight=15)
Category 1 percentage : 80 %
Scoring priority category 2 : Health/Safety (scoring weight=25)
Category 2 percentage : 20 %
Project construction estimate (MACC): \$30,000
Total project estimate (including soft costs): \$42,000
Additional points based on building condition: 1
Deficiency score : $4 \times ((15 \times 80\%) + (25 \times 20\%)) + 1 = 69$

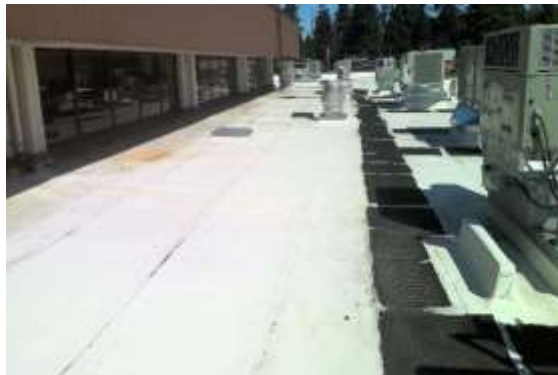
Deficiency R01

The roof is deteriorating. Some areas have degraded due to exposure and show the scrim layer. A few areas have begun to leak. The roof should be reconditioned to extend its useful life.

Category 1 percentage : 100 %
Scoring priority category 2 : None
Category 2 percentage : 0 %
Project construction estimate (MACC): \$248,000
Total project estimate (including soft costs): \$351,000
Additional points based on building condition: 1
Deficiency score : $4 \times (15 \times 100\%) + 1 = 61$

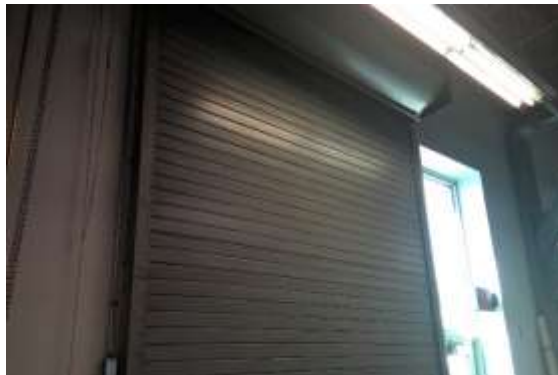
Deficiency F08

Several overhead doors no longer function as designed. Door guide wheels fall out of the track when the doors are raised. These doors should be replaced to regain full function.

Scoring priority category 1 : System Use (scoring weight=15)
Category 1 percentage : 70 %
Scoring priority category 2 : High Repair/Repl. Cost (scoring weight=12)
Category 2 percentage : 30 %
Project construction estimate (MACC): \$30,000
Total project estimate (including soft costs): \$42,000
Additional points based on building condition: 1
Deficiency score : $4 \times ((15 \times 70\%) + (12 \times 30\%)) + 1 = 57.4$

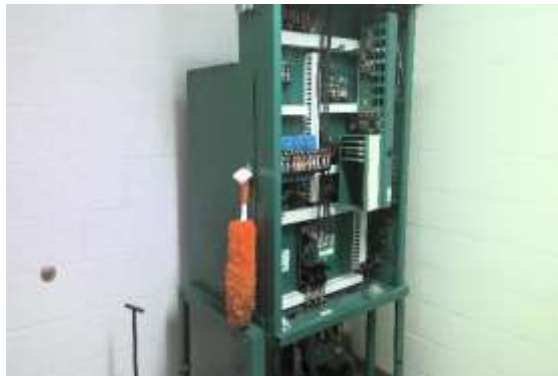
Deficiency F09

The college is concerned about the age of the elevator controls in three elevators. The elevator vendor can no longer get parts for the controls, but the controls still function as designed. Controls repairs are difficult or impossible. Since there are three elevators serving this building at least one must have guaranteed reliability in each main area. The controls for the two elevators with the highest use should be replaced to ensure reliability. The remaining elevator controls should continue to be monitored for replacement.

Recommended funding schedule : Immediate (scoring weight=4)
Estimated remaining life (years) : 3
Estimated average life expectancy (years) : 40
Scoring priority category 1 : System Use (scoring weight=15)
Category 1 percentage : 80 %
Scoring priority category 2 : Facility Use/ Civil Rights Violation (scoring weight=20)
Category 2 percentage : 20 %
Project construction estimate (MACC): \$300,000
Total project estimate (including soft costs): \$425,000
Additional points based on building condition: 1
Deficiency score : $4 \times ((15 \times 80\%) + (20 \times 20\%)) + 1 = 65$

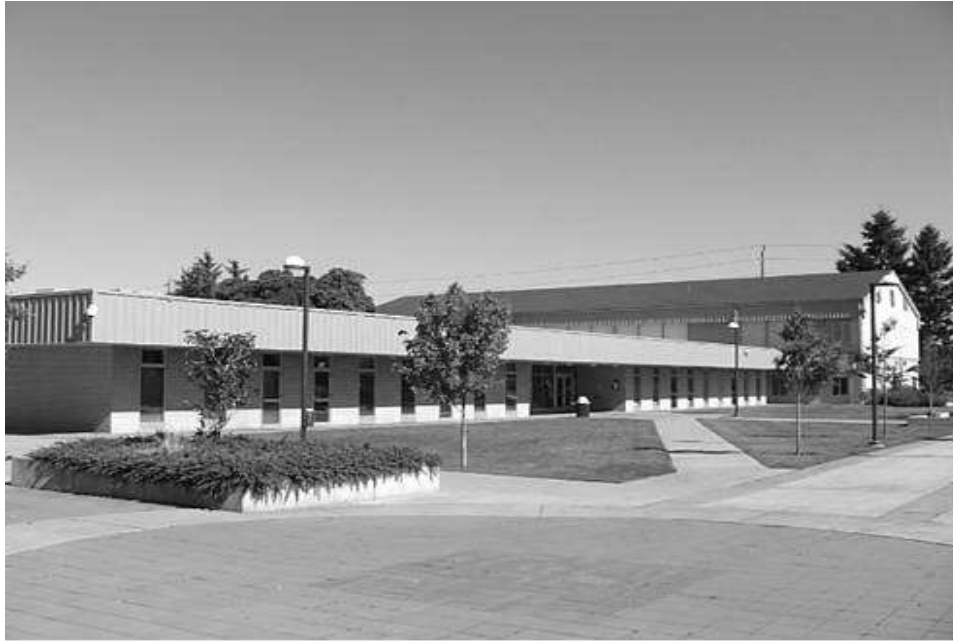
Administration (290-17) STATE UFI: A09048 Main Campus (290A)
AREA: 30,203 SF BUILT: 1962 REMODELED: 2015 PREDOMINANT USE: Administration
CONSTRUCTION TYPE: Heavy CRV/SF: \$336 REPLACEMENT VALUE: \$10,148,208

Primary Systems			
COMPONENT:	Structure	RATING: 1 x WEIGHT: 8 =	SCORE: 8
No signs of settlement or cracking, no abrupt vertical changes Columns, bearing walls and roof structure appears sound/free of defects			
COMMENTS:	Concrete frame; wood frame; steel columns and trusses		
COMPONENT:	Exterior Closure	RATING: 1 x WEIGHT: 8 =	SCORE: 8
Weatherproof, tight, well-maintained exterior walls, doors, windows/finishes			
COMMENTS:	CMU, stucco soffits, metal fascia; brick; aluminum window walls		
COMPONENT:	Roofing	RATING: 2 x WEIGHT: 10 =	SCORE: 20
Majority of roofing and flashing appear sound, but a small portion of roofing shows deterioration where maintenance or minor repair needed			
COMMENTS:	Composition shingles; single-ply hypalon-1999

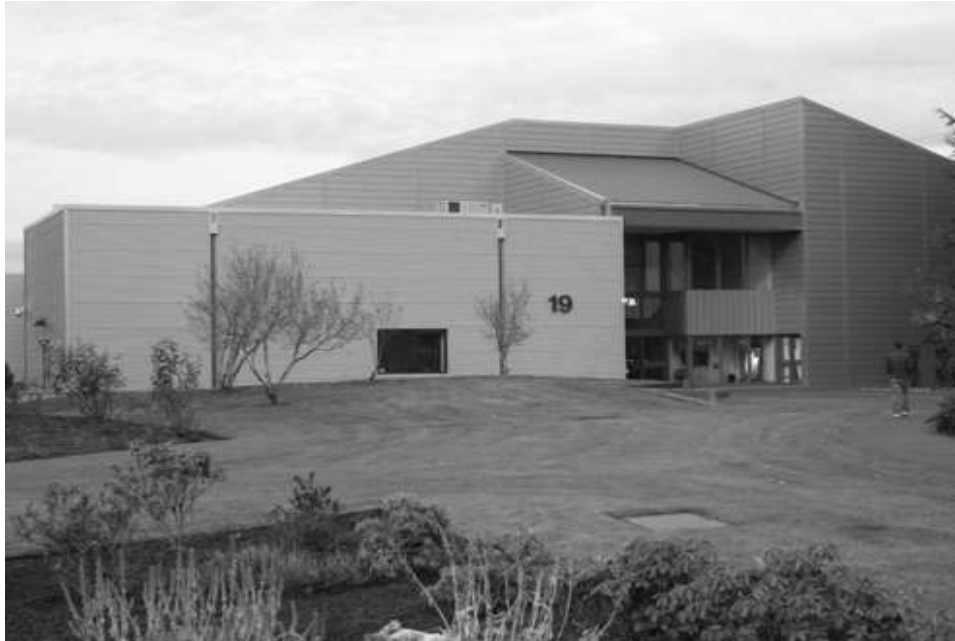
Administration/Classrooms (290-19) STATE UFI: A02436 Main Campus (290A)
AREA: 33,458 SF BUILT: 1983 REMODELED: 2006 PREDOMINANT USE: Visual Arts
CONSTRUCTION TYPE: Heavy CRV/SF: \$376 REPLACEMENT VALUE: \$12,580,208

Primary Systems			
COMPONENT:	Structure	RATING: 1 x WEIGHT: 8 =	SCORE: 8
No signs of settlement or cracking, no abrupt vertical changes Columns, bearing walls and roof structure appears sound/free of defects			
COMMENTS: CMU bearing walls; open web steel roof joists			
COMPONENT:	Exterior Closure	RATING: 1 x WEIGHT: 8 =	SCORE: 8
Weatherproof, tight, well-maintained exterior walls, doors, windows/finishes			
COMMENTS: Metal flat and corrugated panels-2006/2009			
COMPONENT:	Roofing	RATING: 3 x WEIGHT: 10 =	SCORE: 30
Some deterioration is evident in membrane and flashings; maintenance or minor repair is needed			
COMMENTS: Standing seam metal; TPO single-ply membrane in mechanical well-2010

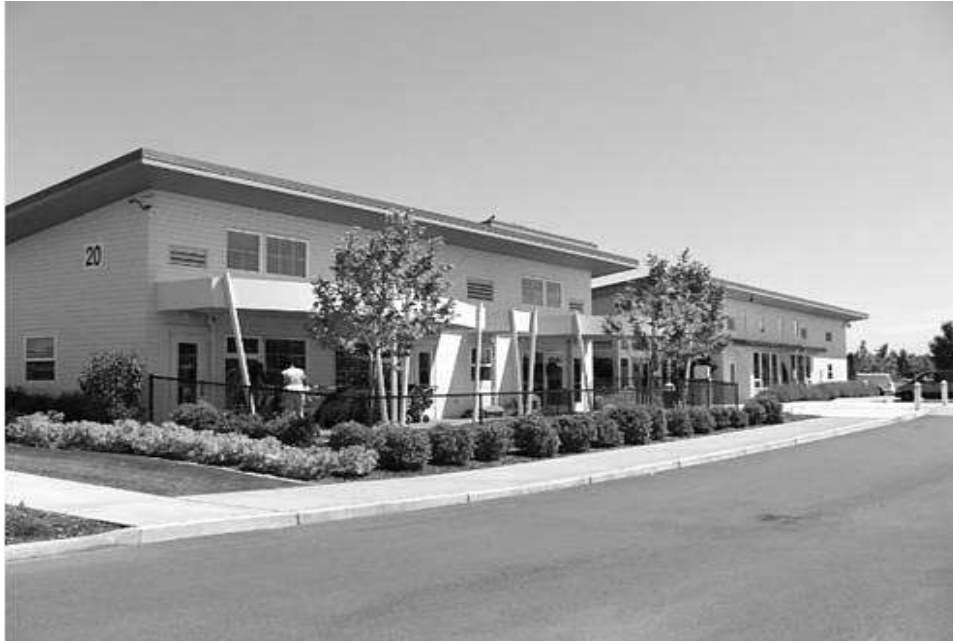
Childcare Facility (290-20) STATE UFI: A01569 Main Campus (290A)
 AREA: 12,128 SF BUILT: 2005 REMODELED: No PREDOMINANT USE: Child Care
 CONSTRUCTION TYPE: Light CRV/SF: \$231 REPLACEMENT VALUE: \$2,801,568

Primary Systems			
COMPONENT:	Structure	RATING: 1 x WEIGHT: 8.8 = SCORE: 8.8	
No signs of settlement or cracking, no abrupt vertical changes Columns, bearing walls and roof structure appears sound/free of defects			
COMMENTS:	Wood frame		
COMPONENT:	Exterior Closure	RATING: 3 x WEIGHT: 8.8 = SCORE: 26.3	
Sound and weatherproof but with some physical deterioration evident			
COMMENTS:	Horizontal and vertical tight knot T&G wood; knot bleed through on vertical siding		
COMPONENT:	Roofing	RATING: 2 x WEIGHT: 11 = SCORE: 22	
Majority of roofing and flashing appear sound, but a small portion of roofing shows deterioration where maintenance or minor repair needed			
COMMENTS:	Standing seam metal roof; PVC single ply membrane

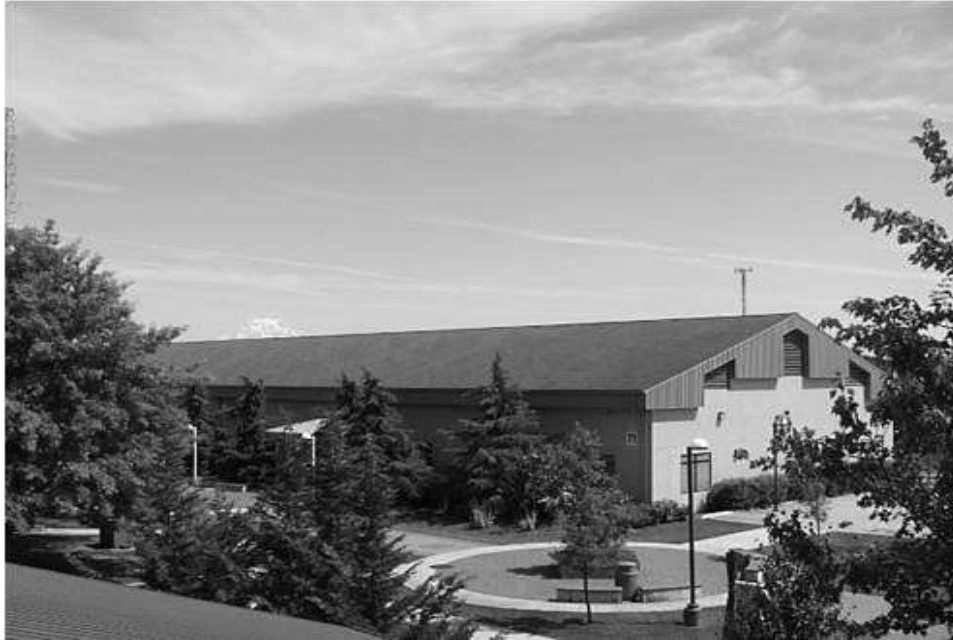
Communications (290-11) STATE UFI: A03622 Main Campus (290A)
AREA: 28,551 SF BUILT: 1940 REMODELED: 2001 PREDOMINANT USE: Vocational Arts
CONSTRUCTION TYPE: Heavy CRV/SF: \$395 REPLACEMENT VALUE: \$11,277,645

Primary Systems			
COMPONENT:	Structure	RATING: 1 x WEIGHT: 8.3 =	SCORE: 8.3
No signs of settlement or cracking, no abrupt vertical changes Columns, bearing walls and roof structure appears sound/free of defects			
COMMENTS:	CMU; structural steel studs; wood roof beams; glu-lam beams		
COMPONENT:	Exterior Closure	RATING: 1 x WEIGHT: 8.3 =	SCORE: 8.3
Weatherproof, tight, well-maintained exterior walls, doors, windows/finishes			
COMMENTS:	Stucco and metal fascia		
COMPONENT:	Roofing	RATING: 2 x WEIGHT: 10.4 =	SCORE: 20.9
Majority of roofing and flashing appear sound, but a small portion of roofing shows deterioration where maintenance or minor repair needed			
COMMENTS:	Composition shingles-1997

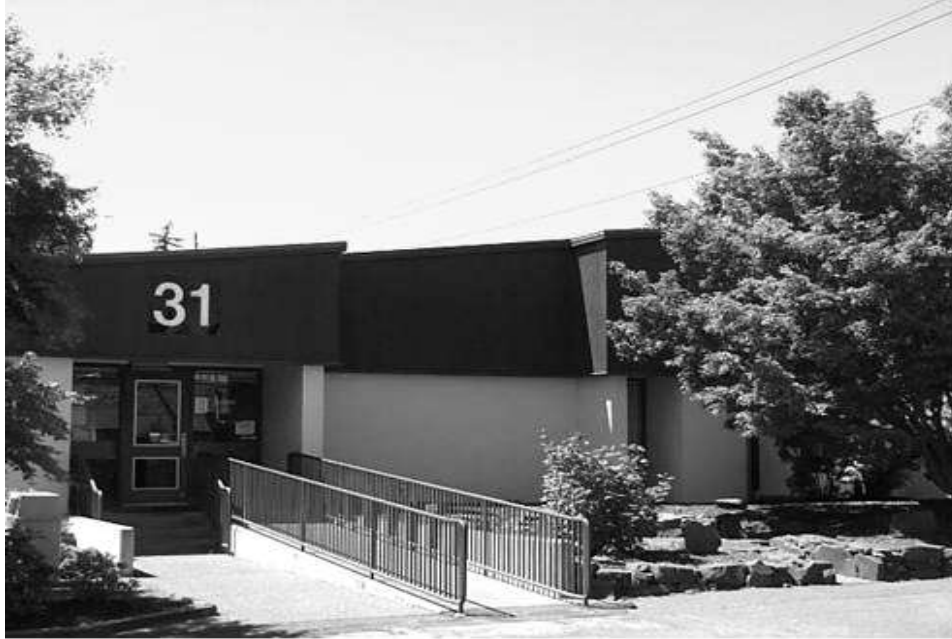
Culinary Arts (290-31) STATE UFI: A02697 Main Campus (290A)
 AREA: 5,966 SF BUILT: 1974 REMODELED: No PREDOMINANT USE: Vocational Arts
 CONSTRUCTION TYPE: Medium CRV/SF: \$395 REPLACEMENT VALUE: \$2,356,570

Primary Systems			
COMPONENT:	Structure	RATING: 1 x WEIGHT: 8.3 = SCORE: 8.3	
No signs of settlement or cracking, no abrupt vertical changes Columns, bearing walls and roof structure appears sound/free of defects			
COMMENTS:	CMU walls; wood columns & glu-lam beam roof structure		
COMPONENT:	Exterior Closure	RATING: 1 x WEIGHT: 8.3 = SCORE: 8.3	
Weatherproof, tight, well-maintained exterior walls, doors, windows/finishes			
COMMENTS:	CMU, metal fascia 2017		
COMPONENT:	Roofing	RATING: 1 x WEIGHT: 10.4 = SCORE: 10.4	
Flashing and penetrations appear sound and membrane appears water- tight; drainage is positive and there are overflow scuppers			
COMMENTS:	Built-up, metal roof 2017

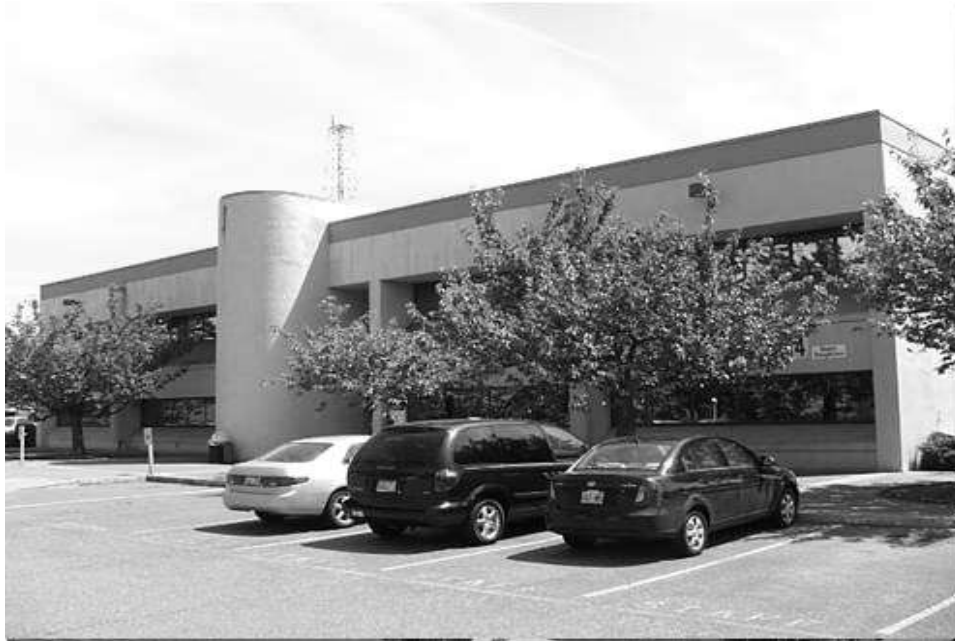
Dental/Nwcths/Labs/Classrooms (290-14) STATE UFI: A00602 Main Campus (290A)
AREA: 23,662 SF BUILT: 1981 REMODELED: 2001 PREDOMINANT USE: Vocational Arts
CONSTRUCTION TYPE: Heavy CRV/SF: \$395 REPLACEMENT VALUE: \$9,346,490

Primary Systems			
COMPONENT:	Structure	RATING: 2 x WEIGHT: 8 =	SCORE: 16
Minor cracks evident in a small portion of the structure			
COMMENTS:	Concrete frame & stair towers; metal stud exterior wall framing		
COMPONENT:	Exterior Closure	RATING: 2 x WEIGHT: 8 =	SCORE: 16
Weatherproof exterior, but finish appears poorly maintained			
COMMENTS:	EIFS-random cracks		
COMPONENT:	Roofing	RATING: 3 x WEIGHT: 10 =	SCORE: 30
Some deterioration is evident in membrane and flashings; maintenance or minor repair is needed			
COMMENTS:	Single-ply PVC membrane-1998; skylights

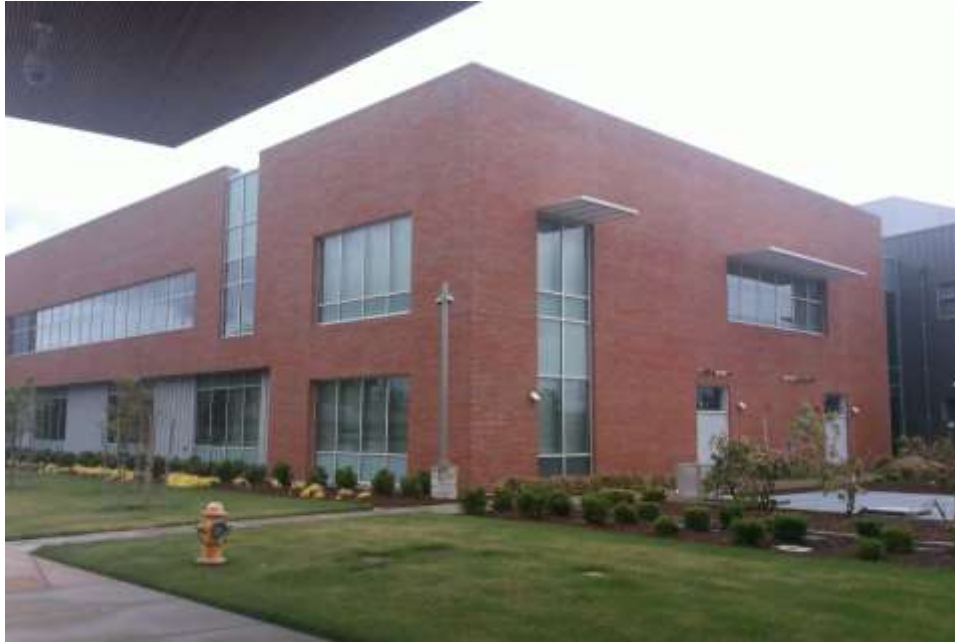
Health Sciences Facility (290-21) STATE UFI: A10198 Main Campus (290A)
AREA: 56,648 SF BUILT: 2013 REMODELED: 2015 PREDOMINANT USE: Classroom
CONSTRUCTION TYPE: No data CRV/SF: \$356 REPLACEMENT VALUE: \$20,166,688

Primary Systems			
COMPONENT:	Structure	RATING: 1 x WEIGHT: 8.4 =	SCORE: 8.4
No signs of settlement or cracking, no abrupt vertical changes Columns, bearing walls and roof structure appears sound/free of defects			
COMMENTS:	No data		
COMPONENT:	Exterior Closure	RATING: 1 x WEIGHT: 8.4 =	SCORE: 8.4
Weatherproof, tight, well-maintained exterior walls, doors, windows/finishes			
COMMENTS:	No data		
COMPONENT:	Roofing	RATING: 1 x WEIGHT: 10.5 =	SCORE: 10.5
Flashing and penetrations appear sound and membrane appears water- tight; drainage is positive and there are overflow scuppers			
COMMENTS:	No data

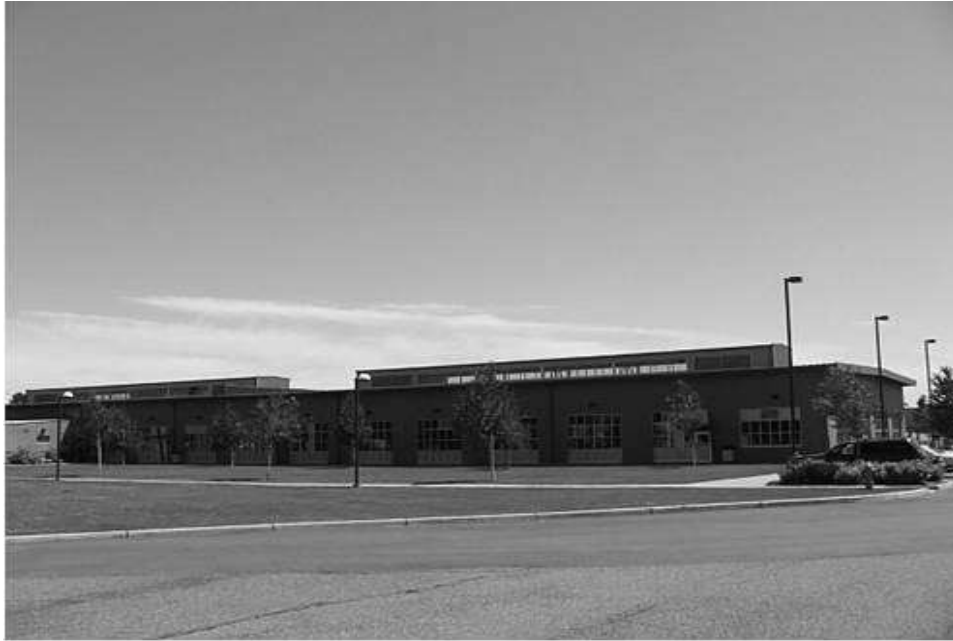
Machine Trades (290-25) STATE UFI: A01268 Main Campus (290A)
 AREA: 38,871 SF BUILT: 1940 REMODELED: 2005 PREDOMINANT USE: Vocational Arts
 CONSTRUCTION TYPE: Medium CRV/SF: \$395 REPLACEMENT VALUE: \$15,354,045

Primary Systems			
COMPONENT:	Structure	RATING: 4 x WEIGHT: 8.3 =	SCORE: 33.4
Some structural flaws potentially exist and should be evaluated by a structural engineer			
COMMENTS:	CMU with seismic improvements and furred walls; wood columns & roof trusses		
COMPONENT:	Exterior Closure	RATING: 3 x WEIGHT: 8.3 =	SCORE: 25
Sound and weatherproof but with some physical deterioration evident			
COMMENTS:	CMU; corrugated metal panels; aluminum window walls		
COMPONENT:	Roofing	RATING: 2 x WEIGHT: 10.4 =	SCORE: 20.9
Majority of roofing and flashing appear sound, but a small portion of roofing shows deterioration where maintenance or minor repair needed			
COMMENTS:	Standing seam metal with corrugated metal sided monitors

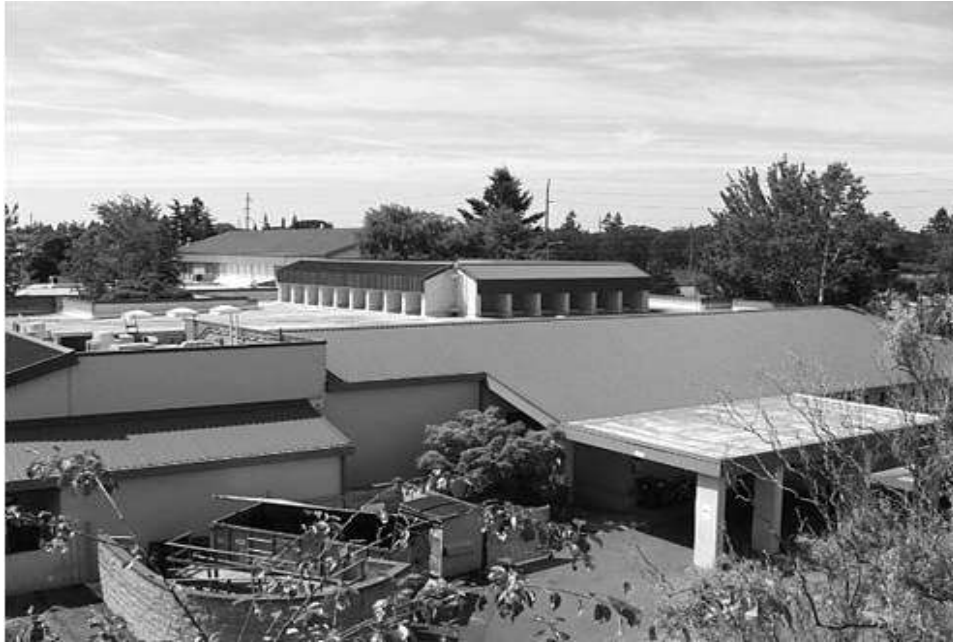
Resource Center (290-15) STATE UFI: A08250 Main Campus (290A)
 AREA: 20,675 SF BUILT: 1977 REMODELED: 2013 PREDOMINANT USE: Library
 CONSTRUCTION TYPE: Medium CRV/SF: \$376 REPLACEMENT VALUE: \$7,773,800

Primary Systems			
COMPONENT:	Structure	RATING: 1 x WEIGHT: 8.3 = SCORE: 8.3	
No signs of settlement or cracking, no abrupt vertical changes Columns, bearing walls and roof structure appears sound/free of defects			
COMMENTS:	Concrete tilt-up; glu-lam beam framed roof		
COMPONENT:	Exterior Closure	RATING: 1 x WEIGHT: 8.3 = SCORE: 8.3	
Weatherproof, tight, well-maintained exterior walls, doors, windows/finishes			
COMMENTS:	Concrete; corrugated metal fascia; aluminum window walls; CMU; plywood panels		
COMPONENT:	Roofing	RATING: 1 x WEIGHT: 10.4 = SCORE: 10.4	
Flashing and penetrations appear sound and membrane appears water- tight; drainage is positive and there are overflow scuppers			
COMMENTS:	Single-ply Hypalon; standing seam metal; TPO single-ply 2016

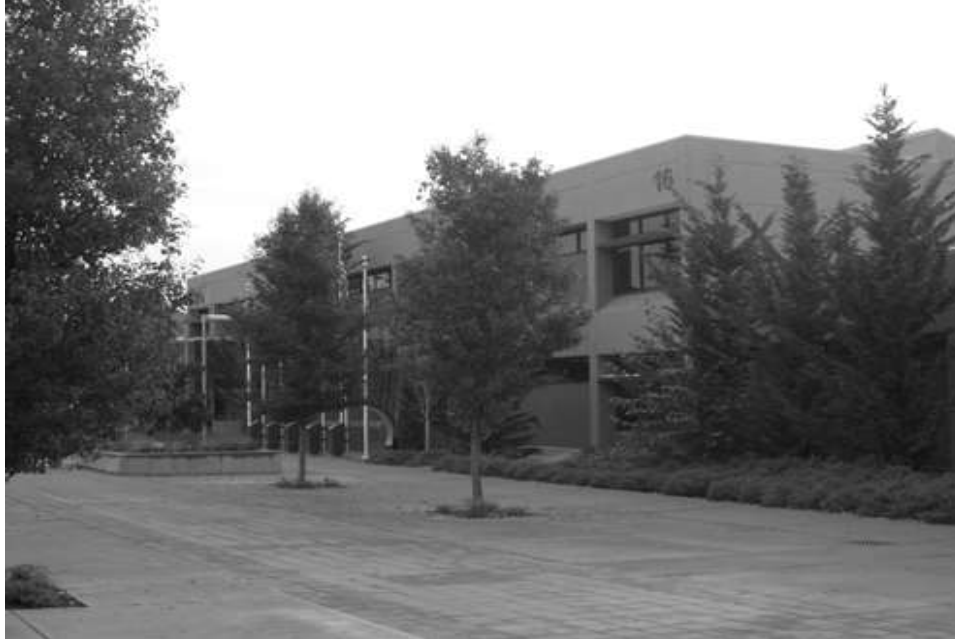
Technology (290-16) STATE UFI: A09483 Main Campus (290A)
AREA: 35,546 SF BUILT: 1983 REMODELED: No PREDOMINANT USE: Vocational Arts
CONSTRUCTION TYPE: Heavy CRV/SF: \$395 REPLACEMENT VALUE: \$14,040,670

Primary Systems			
COMPONENT:	Structure	RATING: 1 x WEIGHT: 8 =	SCORE: 8
No signs of settlement or cracking, no abrupt vertical changes Columns, bearing walls and roof structure appears sound/free of defects			
COMMENTS:	Concrete structure w finish coat		
COMPONENT:	Exterior Closure	RATING: 3 x WEIGHT: 8 =	SCORE: 24
Sound and weatherproof but with some physical deterioration evident			
COMMENTS:	Metal stud wall framing w EIFS-random cracks		
COMPONENT:	Roofing	RATING: 2 x WEIGHT: 10 =	SCORE: 20
Majority of roofing and flashing appear sound, but a small portion of roofing shows deterioration where maintenance or minor repair needed			
COMMENTS:	Single ply hypalon-2002; standing seam metal roof

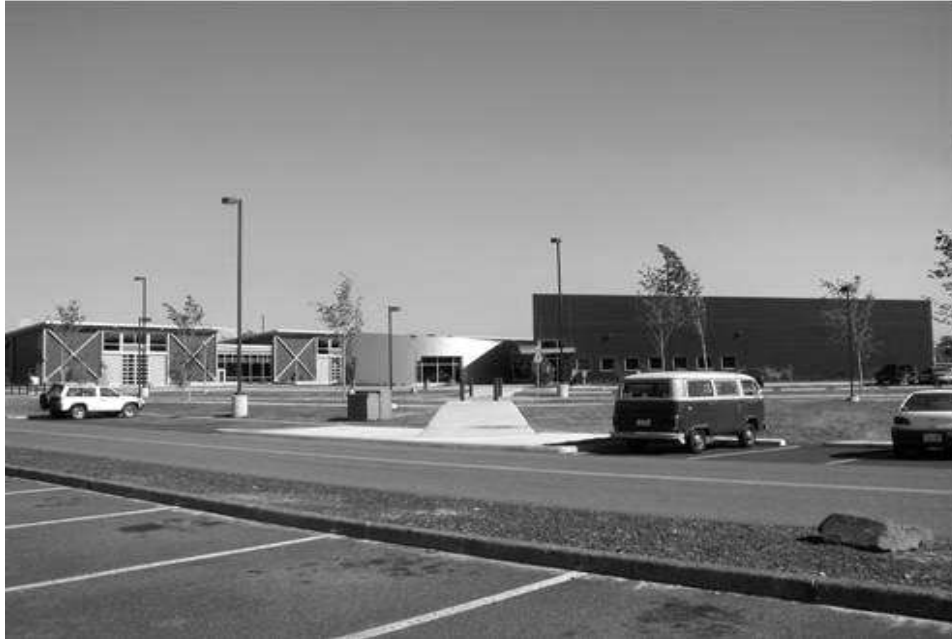
Transportation Trades (290-3) STATE UFI: A02550 Main Campus (290A)
 AREA: 80,509 SF BUILT: 2001 REMODELED: No PREDOMINANT USE: Vocational Arts
 CONSTRUCTION TYPE: Heavy CRV/SF: \$395 REPLACEMENT VALUE: \$31,801,055

Primary Systems			
COMPONENT:	Structure	RATING: 1 x WEIGHT: 8.3 =	SCORE: 8.3
No signs of settlement or cracking, no abrupt vertical changes Columns, bearing walls and roof structure appears sound/free of defects			
COMMENTS:	Steel frame; open web steel roof joists, metal deck		
COMPONENT:	Exterior Closure	RATING: 2 x WEIGHT: 8.3 =	SCORE: 16.7
Weatherproof exterior, but finish appears poorly maintained			
COMMENTS:	Exposed structure; metal building panels' corrugated metal siding; steel X bracing; aluminum window walls		
COMPONENT:	Roofing	RATING: 1 x WEIGHT: 10.4 =	SCORE: 10.4
Flashing and penetrations appear sound and membrane appears water- tight; drainage is positive and there are overflow scuppers			
COMMENTS:	Standing seam metal; single ply PVC membrane

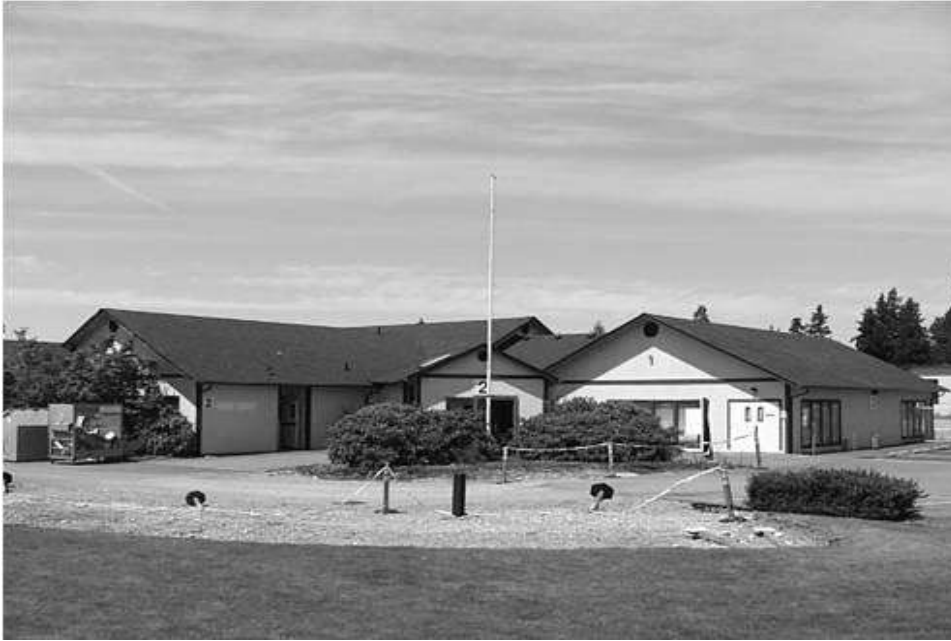
Class Rooms (290-2) STATE UFI: A05796 Main Campus (290A)
AREA: 9,190 SF BUILT: 1980 REMODELED: 2006 PREDOMINANT USE: General Classroom
CONSTRUCTION TYPE: Temporary CRV/SF: \$376 REPLACEMENT VALUE: \$3,455,440

Primary Systems			
COMPONENT:	Structure	RATING: 3 x WEIGHT: 8.3 =	SCORE: 25
Some cracking evident but does not likely affect structural integrity; Visible defects apparent but are non-structural			
COMMENTS:	Wood frame manufactured structure		
COMPONENT:	Exterior Closure	RATING: 2 x WEIGHT: 8.3 =	SCORE: 16.7
Weatherproof exterior, but finish appears poorly maintained			
COMMENTS:	Plywood siding		
COMPONENT:	Roofing	RATING: 1 x WEIGHT: 10.4 =	SCORE: 10.4
Flashing and penetrations appear sound and membrane appears water- tight; drainage is positive and there are overflow scuppers			
COMMENTS:	Composition roof 2015; skylights

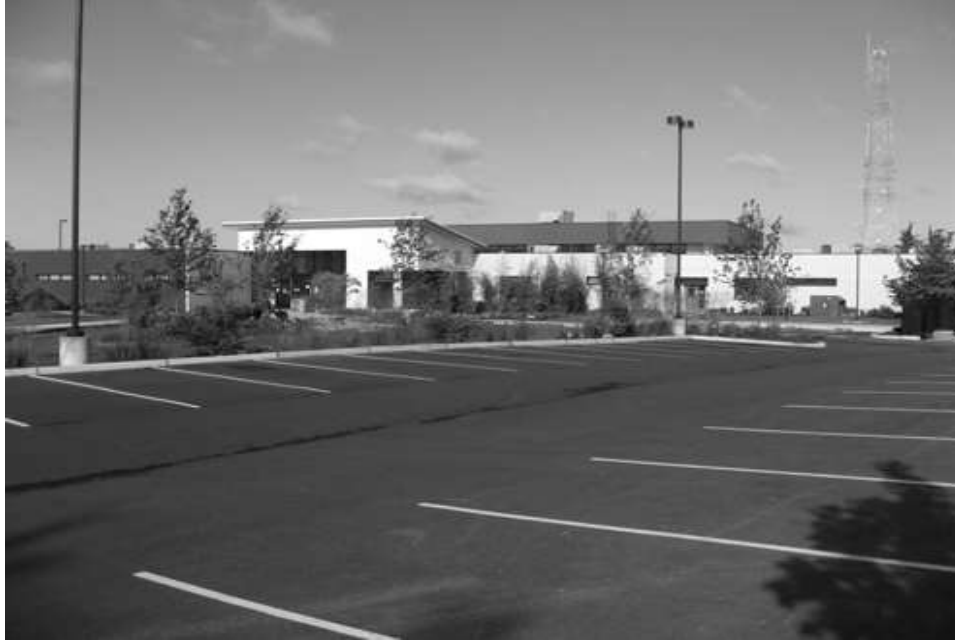
Personal Care Services (290-8) STATE UFI: A08189 Main Campus (290A)
AREA: 30,083 SF BUILT: 1982 REMODELED: 2008 PREDOMINANT USE: Vocational Arts
CONSTRUCTION TYPE: Heavy CRV/SF: \$395 REPLACEMENT VALUE: \$11,882,785

Primary Systems			
COMPONENT:	Structure	RATING: 1 x WEIGHT: 8.3 =	SCORE: 8.3
No signs of settlement or cracking, no abrupt vertical changes Columns, bearing walls and roof structure appears sound/free of defects			
COMMENTS: Concrete columns, open-web steel bar roof joists; CMU			
COMPONENT:	Exterior Closure	RATING: 1 x WEIGHT: 8.3 =	SCORE: 8.3
Weatherproof, tight, well-maintained exterior walls, doors, windows/finishes			
COMMENTS: Split-face CMU; corrugated and flat metal panels			
COMPONENT:	Roofing	RATING: 3 x WEIGHT: 10.4 =	SCORE: 31.3
Some deterioration is evident in membrane and flashings; maintenance or minor repair is needed			
COMMENTS: PVC single-ply membrane

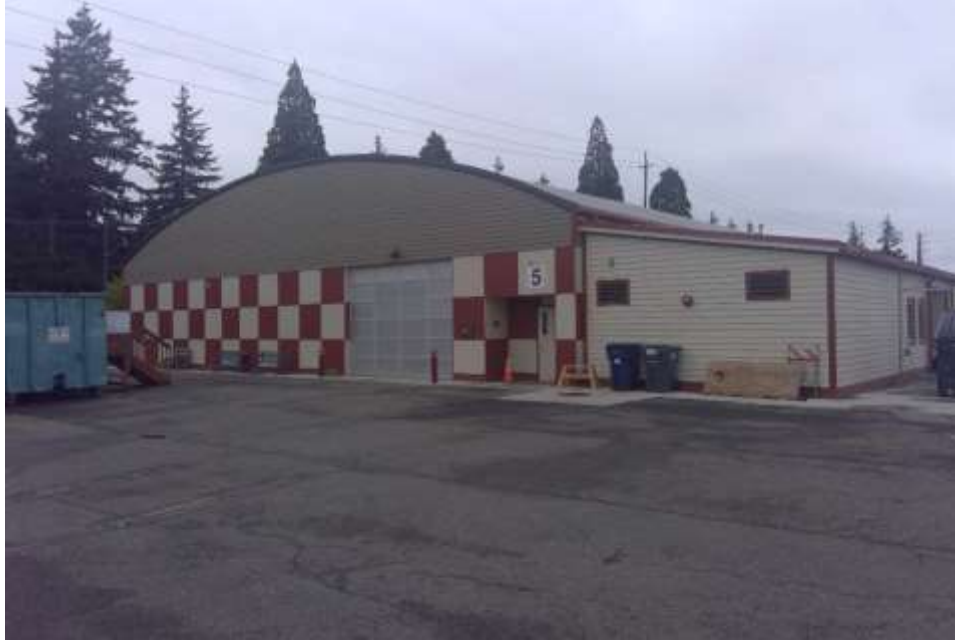
Residential Construction (290-5) STATE UFI: A01814 Main Campus (290A)
AREA: 15,087 SF BUILT: 1940 REMODELED: 2017 PREDOMINANT USE: Vocational Arts
CONSTRUCTION TYPE: Heavy CRV/SF: \$395 REPLACEMENT VALUE: \$5,959,365

Primary Systems			
COMPONENT:	Structure	RATING: 2 x WEIGHT: 8.3 =	SCORE: 16.7
Minor cracks evident in a small portion of the structure			
COMMENTS: Heavy timber columns.& beams w/ clear span wood trusses; wood stud wall framing			
COMPONENT:	Exterior Closure	RATING: 1 x WEIGHT: 8.3 =	SCORE: 8.3
Weatherproof, tight, well-maintained exterior walls, doors, windows/finishes			
COMMENTS: Wood siding covered w/deteriorating stucco			
COMPONENT:	Roofing	RATING: 1 x WEIGHT: 10.4 =	SCORE: 10.4
Flashing and penetrations appear sound and membrane appears water- tight; drainage is positive and there are overflow scuppers			
COMMENTS: BUR w mineral-surfaced capsheet-2009

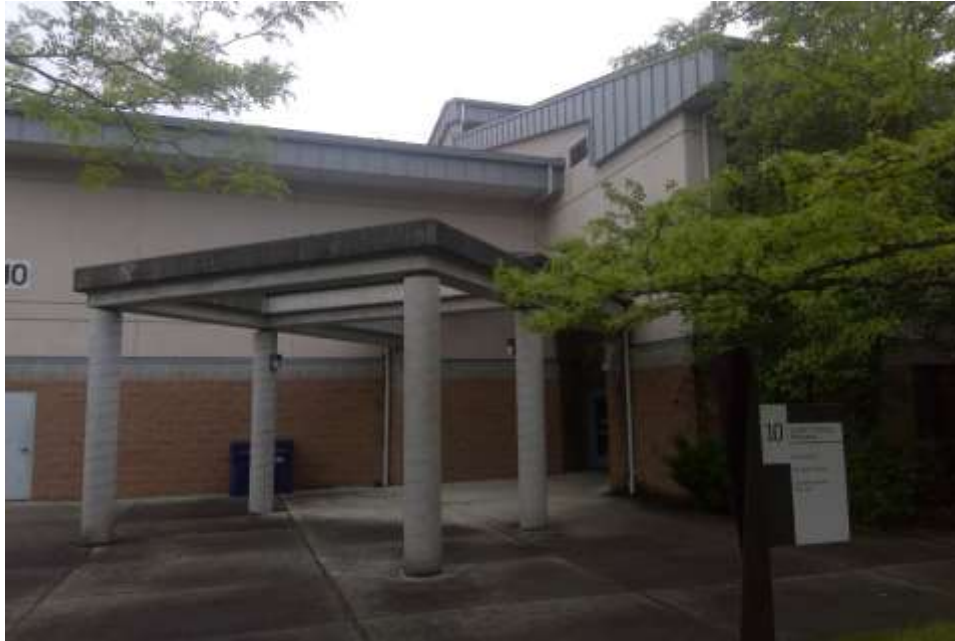
Business Occupations (290-10) STATE UFI: A07310 Main Campus (290A)
AREA: 19,175 SF BUILT: 1993 REMODELED: No PREDOMINANT USE: General Classroom
CONSTRUCTION TYPE: Heavy CRV/SF: \$376 REPLACEMENT VALUE: \$7,209,800

Primary Systems			
COMPONENT:	Structure	RATING: 1 x WEIGHT: 8 =	SCORE: 8
No signs of settlement or cracking, no abrupt vertical changes Columns, bearing walls and roof structure appears sound/free of defects			
COMMENTS:	Concrete & steel structure		
COMPONENT:	Exterior Closure	RATING: 2 x WEIGHT: 8 =	SCORE: 16
Weatherproof exterior, but finish appears poorly maintained			
COMMENTS:	CMU; stucco-random cracking; metal fascia		
COMPONENT:	Roofing	RATING: 1 x WEIGHT: 10 =	SCORE: 10
Flashing and penetrations appear sound and membrane appears water- tight; drainage is positive and there are overflow scuppers			
COMMENTS:	Composition shingles-2009; framed glass canopies at entries

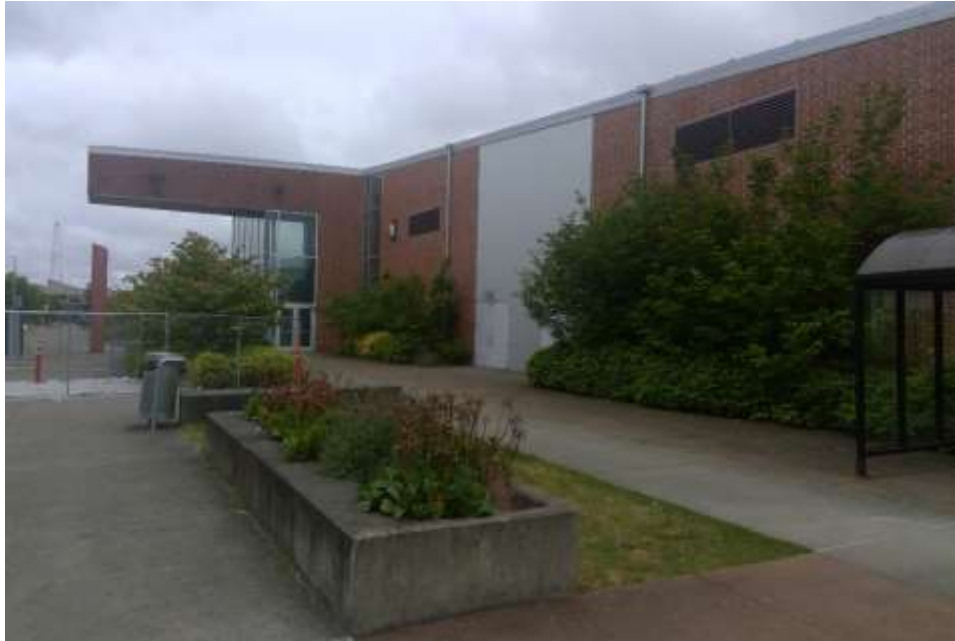
Student Center (290-23) STATE UFI: A07516 Main Campus (290A)
 AREA: 47,988 SF BUILT: 2004 REMODELED: 2017 PREDOMINANT USE: Student Center
 CONSTRUCTION TYPE: Heavy CRV/SF: \$429 REPLACEMENT VALUE: \$20,586,852

Primary Systems			
COMPONENT:	Structure	RATING: 1 x WEIGHT: 8.8 = SCORE: 8.8	
No signs of settlement or cracking, no abrupt vertical changes Columns, bearing walls and roof structure appears sound/free of defects			
COMMENTS:	Steel-frame; brick		
COMPONENT:	Exterior Closure	RATING: 2 x WEIGHT: 8.8 = SCORE: 17.6	
Weatherproof exterior, but finish appears poorly maintained			
COMMENTS:	Brick; T&G wood siding; aluminum window walls; metal panels; vent-wood soffits		
COMPONENT:	Roofing	RATING: 2 x WEIGHT: 11 = SCORE: 22	
Majority of roofing and flashing appear sound, but a small portion of roofing shows deterioration where maintenance or minor repair needed			
COMMENTS:	Hypalon single-ply; standing seam metal

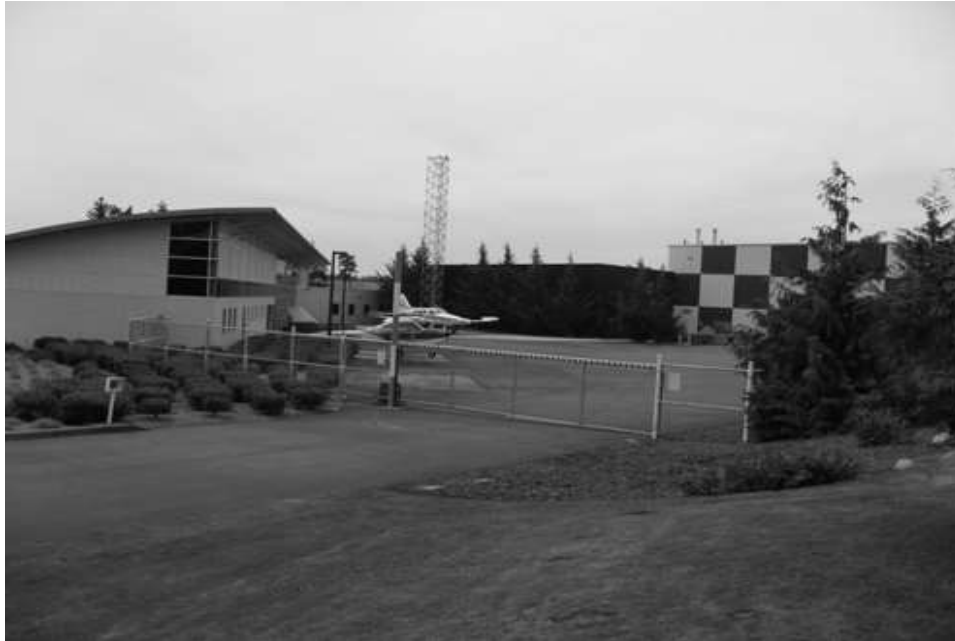
South Hill Campus (290-SHC) STATE UFI: A09957 Pierce Co. Airport Site (290G)
 AREA: 59,833 SF BUILT: 1999 REMODELED: No PREDOMINANT USE: Vocational Arts
 CONSTRUCTION TYPE: Heavy CRV/SF: \$395 REPLACEMENT VALUE: \$23,634,035

Primary Systems			
COMPONENT:	Structure	RATING: 1 x WEIGHT: 8.3 =	SCORE: 8.3
No signs of settlement or cracking, no abrupt vertical changes Columns, bearing walls and roof structure appears sound/free of defects			
COMMENTS:	Steel columns & open web steel roof trusses; steel hangar roof girders		
COMPONENT:	Exterior Closure	RATING: 2 x WEIGHT: 8.3 =	SCORE: 16.7
Weatherproof exterior, but finish appears poorly maintained			
COMMENTS:	Metal siding; aluminum window walls; stucco panels		
COMPONENT:	Roofing	RATING: 1 x WEIGHT: 10.4 =	SCORE: 10.4
Flashing and penetrations appear sound and membrane appears water- tight; drainage is positive and there are overflow scuppers			
COMMENTS:	Metal roof; shed portion slope too low - allows water infiltration during wind conditions
