2023 FACILITY CONDITION SURVEY

Columbia Basin College

SURVEY CONDUCTED BY:
Steve Lewandowski
State Board for Community
and Technical Colleges

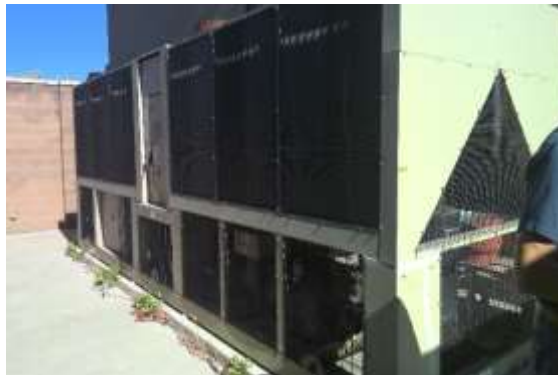
Deficiency F03

The college is concerned about the age of the chiller. The chiller is near the end of its expected life, but still functions as designed. The chiller should continue to be monitored for future replacement.

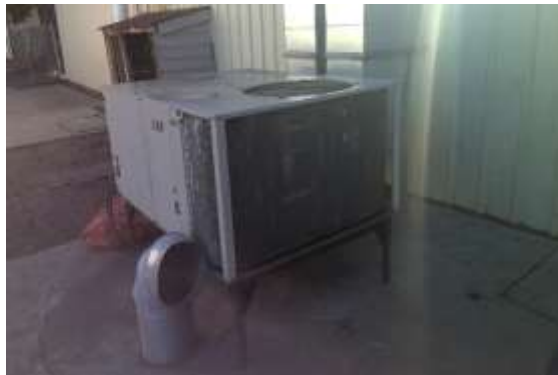
Deficiency F04

Heat pump in building was recycled from another building years ago and is well outside the expected lifespan. The heat pump should be replaced.

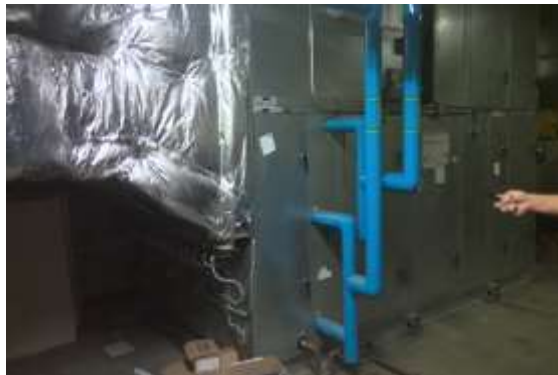
Deficiency F05

The five air handler units are near the end of their expected life, but still function as designed. The units should continue to be monitored for replacement.

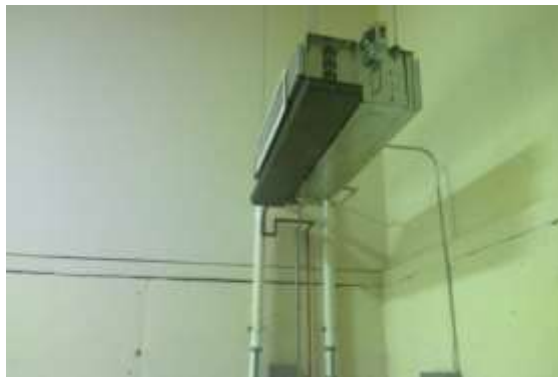
Deficiency F06

The fan coil units are near the end of their expected life, but still function as designed. The function of the unit serving the upper stair area did not appear to be critical. The units should continue to be monitored for replacement.

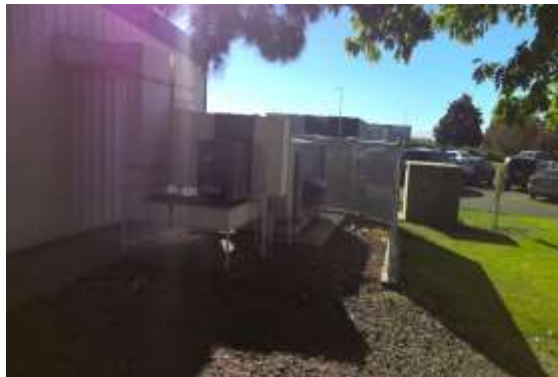
Deficiency F07

The HVAC units have exceeded their expected life, but still function as designed. The units are maintainable and should continue to be monitored for replacement.

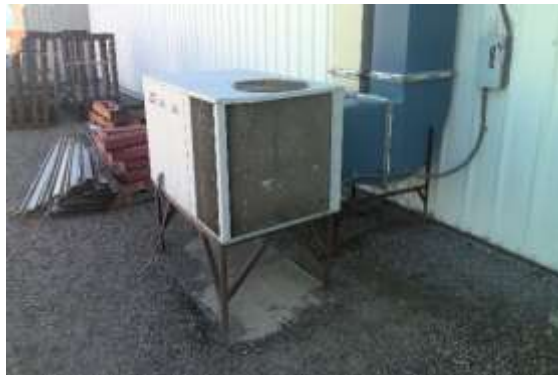
Deficiency R01

The HVAC unit has exceeded its useful life and requires a high level of maintenance to maintain function. The unit should be replaced.

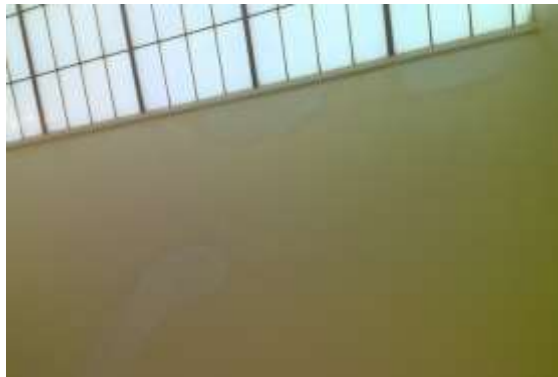
Deficiency R02

The college believes that rain leaks through the Kalwall skylight in multiple areas within the CTE and T buildings. During the survey, the source of the rain intrusion was not clear. It appeared that the issue may be related to improper flashing or failed sealant. Additional information is required to correctly identify the source of the problem and the proper scope of repairs required.

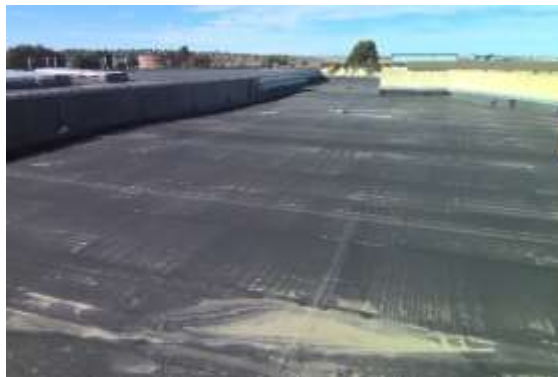
Deficiency R03

The college is concerned about the age of the roofing. The roofing appeared to be in fairly good condition and leaks were not identified. The roofing should continue to be monitored for future reconditioning.

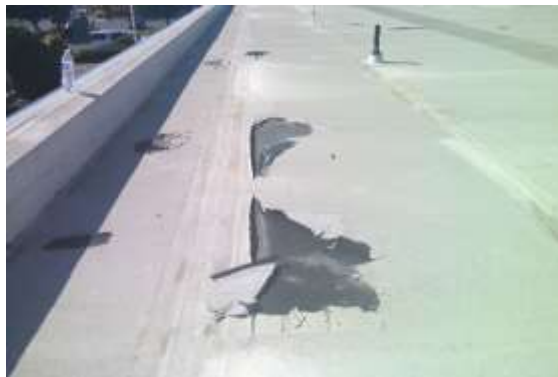
Deficiency F08

All three old small buildings, RA, RB, RC, have roofs that have been improperly reconditioned. The surface treatment did not adhere properly and has begun to delaminate. The roof leaks because of this. The roofing should be replaced.

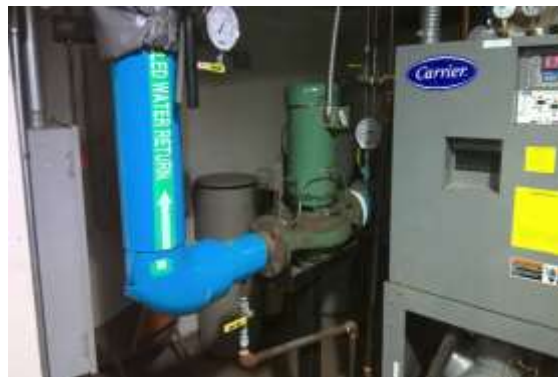
Deficiency F09

The chilled water pump has exceeded its useful life and has required frequent repairs. The pump should be replaced.

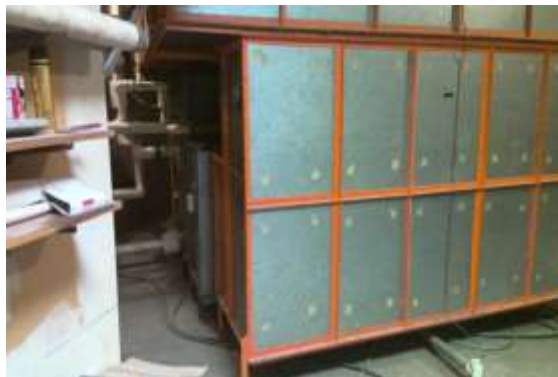
Deficiency F10

The air handlers have exceeded their expected life, but are still maintainable. The units should continue to be monitored and maintained. The units should be reconditioned as maintenance and repairs become more frequent.

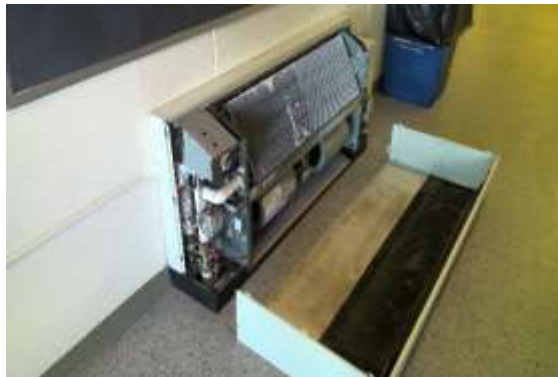
Deficiency F11

The fan coil units are near the end of their expected life, but still function as designed. The units should continue to be monitored for replacement.
