2023 FACILITY CONDITION SURVEY

Edmonds Community College

SURVEY CONDUCTED BY:
Steve Lewandowski
State Board for Community
and Technical Colleges

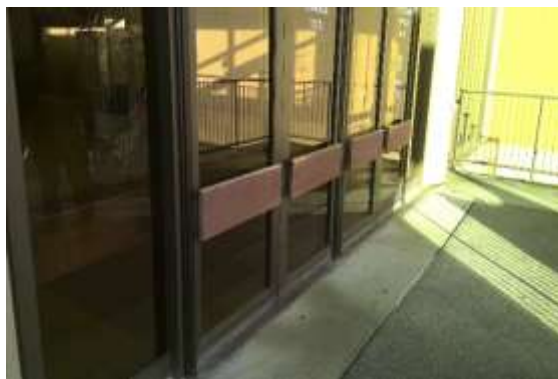
Estimated remaining life (years) : 5
Estimated average life expectancy (years) : 30
Scoring priority category 1 : High Repair/Repl. Cost (score = 12)
Category 1 percentage : 50 %
Scoring priority category 2 : System Use (score = 15)
Category 2 percentage : 50 %
Project construction estimate (MACC): \$542,000
Total project estimate (including soft costs): \$771,000
Additional points based on building condition: 1
Deficiency score : $2.5 \times ((12 \times 50\%) + (15 \times 50\%)) + 1 = 34.8$

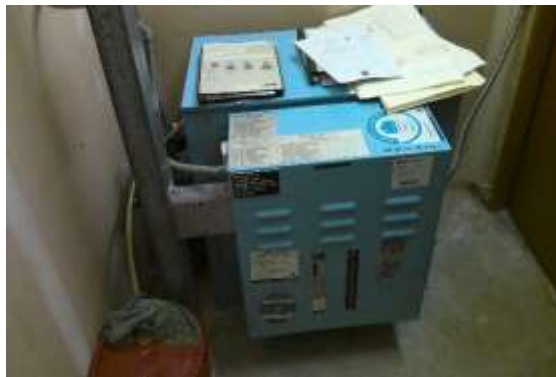
Deficiency F02

Scoring priority category 1 : System Use (scoring weight=15)
Category 1 percentage : 70 %
Scoring priority category 2 : Facility Use/ Civil Rights Violation (scoring weight=20)
Category 2 percentage : 30 %
Project construction estimate (MACC): \$465,000
Total project estimate (including soft costs): \$661,000
Additional points based on building condition: 1
Deficiency score : $1 \times ((15 \times 70\%) + (20 \times 30\%)) + 1 = 17.5$

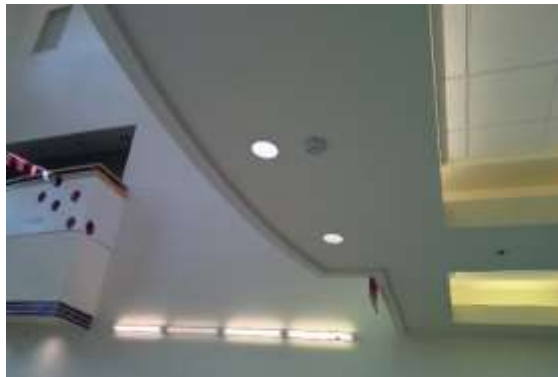
Deficiency F03

Recommended funding schedule : Deferred Backlog (scoring weight=1)
Estimated remaining life (years) : 7
Estimated average life expectancy (years) : 40
Scoring priority category 1 : High Repair/Repl. Cost (scoring weight=12)
Category 1 percentage : 80 %
Scoring priority category 2 : System Use (scoring weight=15)
Category 2 percentage : 20 %
Project construction estimate (MACC): \$264,000
Total project estimate (including soft costs): \$375,000
Additional points based on building condition: 0
Deficiency score : Needs study

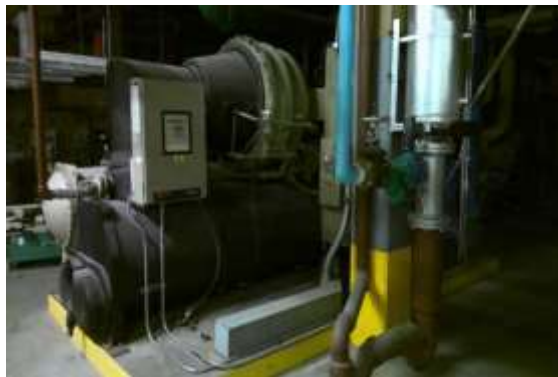
Deficiency F04

Scoring priority category 1 : High Repair/Repl. Cost (scoring weight=12)
Category 1 percentage : 50 %
Scoring priority category 2 : System Use (scoring weight=15)
Category 2 percentage : 50 %
Project construction estimate (MACC): \$254,000
Total project estimate (including soft costs): \$361,000
Additional points based on building condition: 2
Deficiency score : $4 \times ((12 \times 50\%) + (15 \times 50\%)) + 2 = 56$

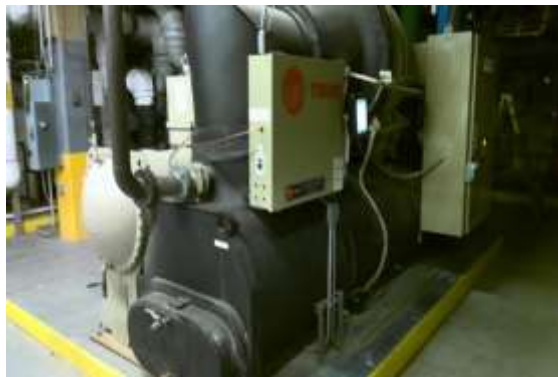
Deficiency F05

Scoring priority category 1 : High Repair/Repl. Cost (scoring weight=12)
Category 1 percentage : 50 %
Scoring priority category 2 : System Use (scoring weight=15)
Category 2 percentage : 50 %
Project construction estimate (MACC): \$170,000
Total project estimate (including soft costs): \$241,000
Additional points based on building condition: 2
Deficiency score : $2.5 \times ((12 \times 50\%) + (15 \times 50\%)) + 2 = 35.8$

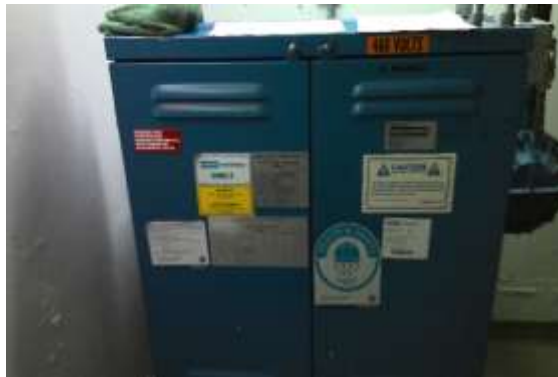
Deficiency F06

Recommended funding schedule : Immediate (scoring weight=4)
Estimated remaining life (years) : 7
Estimated average life expectancy (years) : 40
Scoring priority category 1 : High Repair/Repl. Cost (scoring weight=12)
Category 1 percentage : 80 %
Scoring priority category 2 : Facility Use/ Civil Rights Violation (scoring weight=20)
Category 2 percentage : 20 %
Project construction estimate (MACC): \$170,000
Total project estimate (including soft costs): \$241,000
Additional points based on building condition: 2
Deficiency score : $4 \times ((12 \times 80\%) + (20 \times 20\%)) + 2 = 56.4$

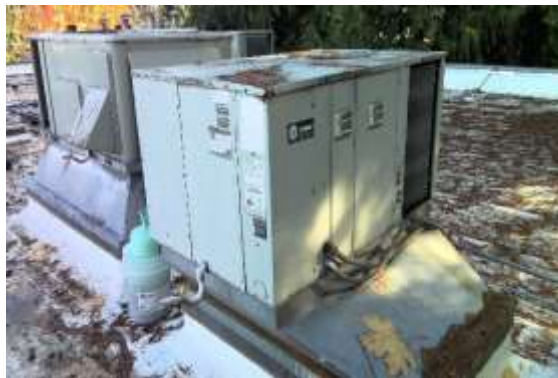
Deficiency F07

Category 2 percentage : 20 %
Project construction estimate (MACC): \$30,000
Total project estimate (including soft costs): \$42,000
Additional points based on building condition: 1
Deficiency score : $4 \times ((15 \times 80\%) + (12 \times 20\%)) + 1 = 58.6$

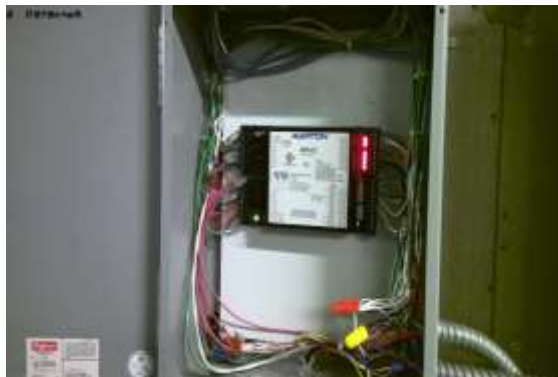
Deficiency F08

Scoring priority category 1 : High Repair/Repl. Cost (scoring weight=12)
Category 1 percentage : 70 %
Scoring priority category 2 : System Use (scoring weight=15)
Category 2 percentage : 30 %
Project construction estimate (MACC): \$240,000
Total project estimate (including soft costs): \$341,000
Additional points based on building condition: 1
Deficiency score : $4 \times ((12 \times 70\%) + (15 \times 30\%)) + 1 = 52.6$

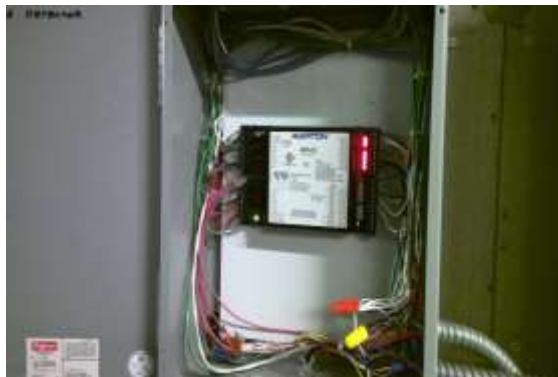
Deficiency F09

Estimated average life expectancy (years) : 25
Scoring priority category 1 : High Repair/Repl. Cost (scoring weight=12)
Category 1 percentage : 80 %
Scoring priority category 2 : System Use (scoring weight=15)
Category 2 percentage : 20 %
Project construction estimate (MACC): \$45,000
Total project estimate (including soft costs): \$64,000
Additional points based on building condition: 1
Deficiency score : $4 \times ((12 \times 80\%) + (15 \times 20\%)) + 1 = 51.4$

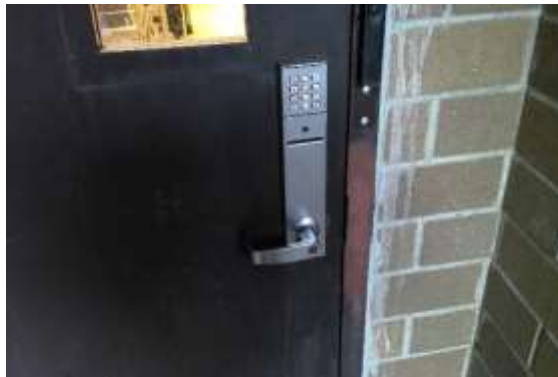
Deficiency F10

Recommended funding schedule : Immediate (scoring weight=4)
Estimated remaining life (years) : 7
Estimated average life expectancy (years) : 25
Scoring priority category 1 : High Repair/Repl. Cost (scoring weight=12)
Category 1 percentage : 60 %
Scoring priority category 2 : System Use (scoring weight=15)
Category 2 percentage : 40 %
Project construction estimate (MACC): \$80,000
Total project estimate (including soft costs): \$113,000
Additional points based on building condition: 0
Deficiency score : $4 \times ((12 \times 60\%) + (15 \times 40\%)) + 0 = 52.8$

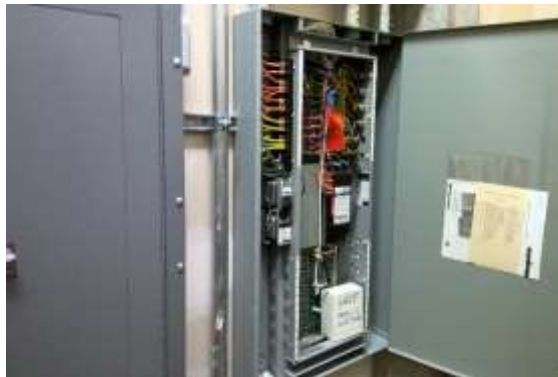
Deficiency F11

Recommended funding schedule : Fund in Next Biennium (scoring weight=2.5)
Estimated remaining life (years) : 3
Estimated average life expectancy (years) : 25
Scoring priority category 1 : High Repair/Repl. Cost (scoring weight=12)
Category 1 percentage : 80 %
Scoring priority category 2 : System Use (scoring weight=15)
Category 2 percentage : 20 %
Project construction estimate (MACC): \$25,000
Total project estimate (including soft costs): \$35,000
Additional points based on building condition: 1
Deficiency score : Needs study

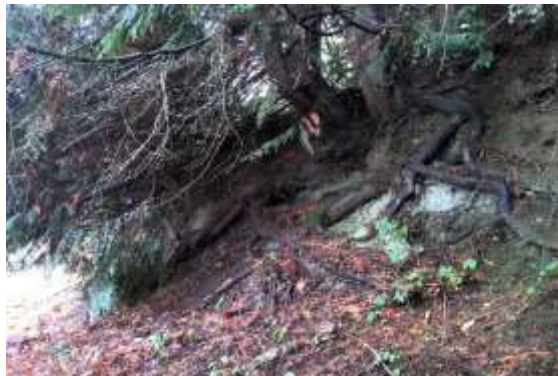
Deficiency S01

The steep soil embankment on the south side of the Cedar Warehouse has eroded. The failing embankment is adjacent to a golf cart path leased by the golf course and also next to a fire lane on the lower sloped side. The soil cannot be stabilized due to the steep slope. Access to the fire lane must be maintained clear. The soil should be stabilized by placing ecology blocks and soil stabilizing geoforms to ensure that access to the fire lane is maintained.

Recommended funding schedule : Immediate (scoring weight=4)
Estimated remaining life (years) : 3
Estimated average life expectancy (years) : 50
Scoring priority category 1 : High Repair/Repl. Cost (scoring weight=12)
Category 1 percentage : 80 %
Scoring priority category 2 : System Use (scoring weight=15)
Category 2 percentage : 20 %
Project construction estimate (MACC): \$177,000
Total project estimate (including soft costs): \$251,000
Additional points based on building condition: 0
Deficiency score : $4 \times ((12 \times 80\%) + (15 \times 20\%)) + 0 = 50.4$

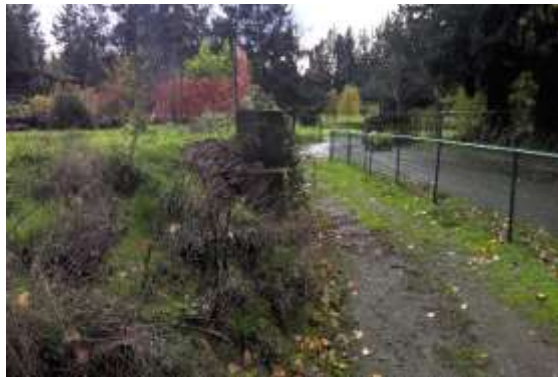
Deficiency S02

The college is concerned about the water runoff and small collection pond near the campus garden area. The source of the water was not clear at the time of the survey. It may be possible to originate from the irrigation lines serving the garden area. Additional information is required to determine the appropriate scope of repairs.

Total project estimate (including soft costs): \$35,000
Additional points based on building condition: 0
Deficiency score : Needs study

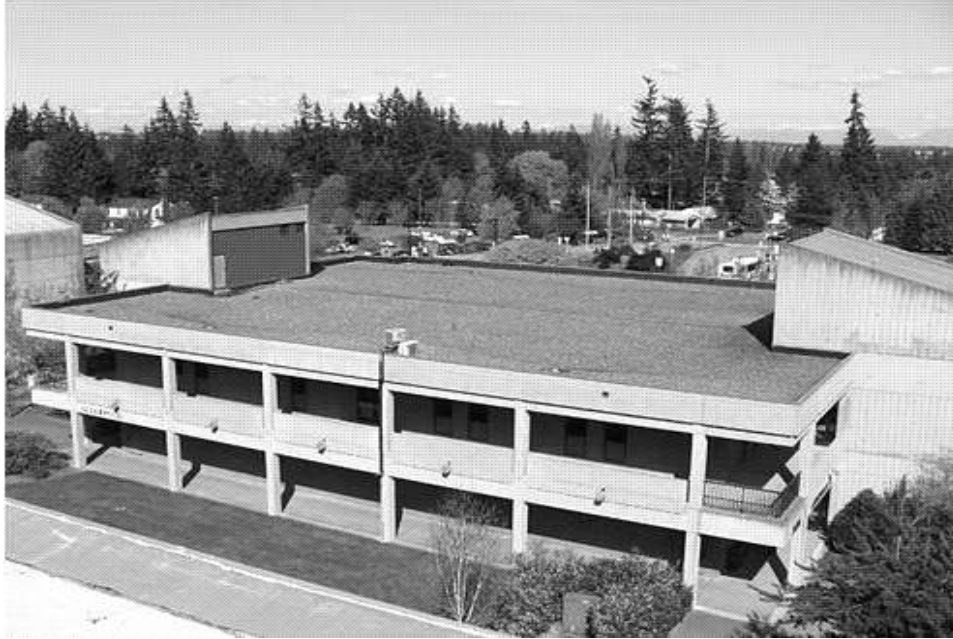
Alderwood Hall (230-ALD) STATE UFI: A05756 Main Campus (230A)
AREA: 22,050 SF BUILT: 1989 REMODELED: No PREDOMINANT USE: General Classroom
CONSTRUCTION TYPE: Heavy CRV/SF: \$376 REPLACEMENT VALUE: \$8,290,800

Primary Systems			
COMPONENT:	Structure	RATING: 2 x WEIGHT: 8 =	SCORE: 16
Minor cracks evident in a small portion of the structure			
COMMENTS:	Concrete; steel frame		
COMPONENT:	Exterior Closure	RATING: 1 x WEIGHT: 8 =	SCORE: 8
Weatherproof, tight, well-maintained exterior walls, doors, windows/finishes			
COMMENTS:	Brick; concrete frame; plaster soffits		
COMPONENT:	Roofing	RATING: 3 x WEIGHT: 10 =	SCORE: 30
Some deterioration is evident in membrane and flashings; maintenance or minor repair is needed			
COMMENTS:	Gravel ballasted Carlisle roof

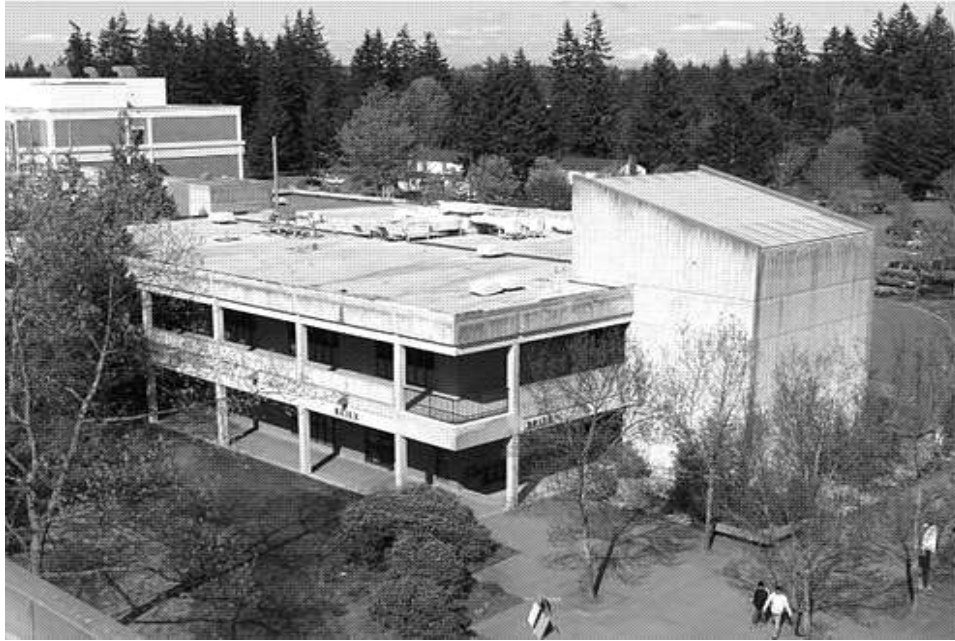
Brier Hall (230-BRI) STATE UFI: A03970 Main Campus (230A)
 AREA: 73,924 SF BUILT: 1976 REMODELED: 2008 PREDOMINANT USE: Multi-Use
 CONSTRUCTION TYPE: Heavy CRV/SF: \$395 REPLACEMENT VALUE: \$29,199,980

Primary Systems			
COMPONENT:	Structure	RATING: 1 x WEIGHT: 8 =	SCORE: 8
No signs of settlement or cracking, no abrupt vertical changes Columns, bearing walls and roof structure appears sound/free of defects			
COMMENTS:	Concrete; steel frame		
COMPONENT:	Exterior Closure	RATING: 1 x WEIGHT: 8 =	SCORE: 8
Weatherproof, tight, well-maintained exterior walls, doors, windows/finishes			
COMMENTS:	Brick; concrete frame; plaster soffits		
COMPONENT:	Roofing	RATING: 2 x WEIGHT: 10 =	SCORE: 20
Majority of roofing and flashing appear sound, but a small portion of roofing shows deterioration where maintenance or minor repair needed			
COMMENTS:	PVC single-ply-2009; standing seam metal; ballasted EPDM; BUR w mineral-surfaced capsheet-2004; skylight

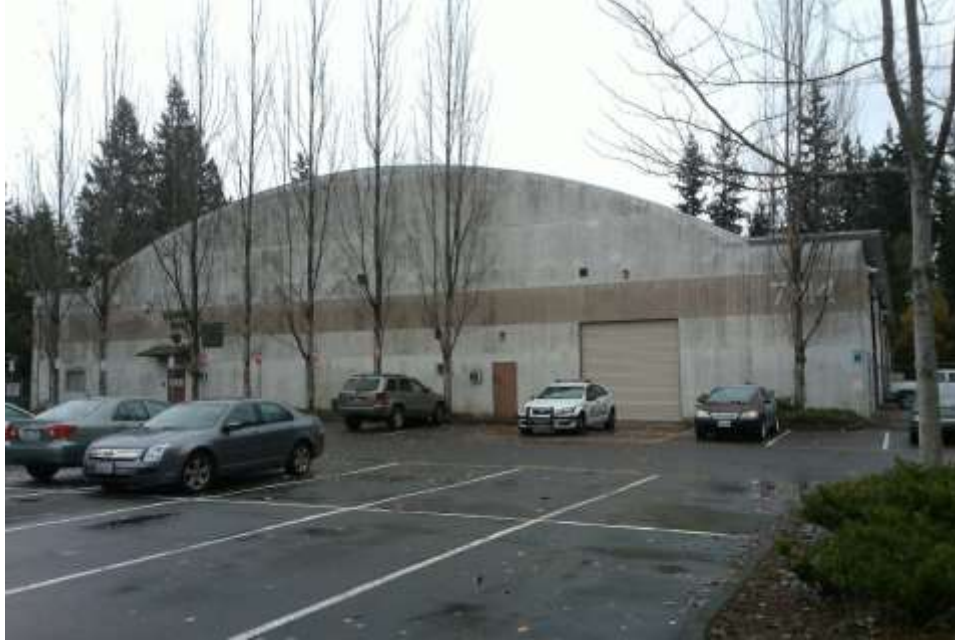
Cedar Building (230-CDR) STATE UFI: A10031 Main Campus (230A)
AREA: 32,736 SF BUILT: 1962 REMODELED: No PREDOMINANT USE: Storage
CONSTRUCTION TYPE: Medium CRV/SF: \$330 REPLACEMENT VALUE: \$10,802,880

Primary Systems			
COMPONENT:	Structure	RATING: 1 x WEIGHT: 8.8 = SCORE: 8.8	
No signs of settlement or cracking, no abrupt vertical changes Columns, bearing walls and roof structure appears sound/free of defects			
COMMENTS:	Timber-framed; wood frame roof deck		
COMPONENT:	Exterior Closure	RATING: 1 x WEIGHT: 8.8 = SCORE: 8.8	
Weatherproof, tight, well-maintained exterior walls, doors, windows/finishes			
COMMENTS:	T1-11 plywood-needs paint		
COMPONENT:	Roofing	RATING: 1 x WEIGHT: 11 = SCORE: 11	
Flashing and penetrations appear sound and membrane appears water- tight; drainage is positive and there are overflow scuppers			
COMMENTS:	3-tab composition shingles; BUR; repairs funded 21-23

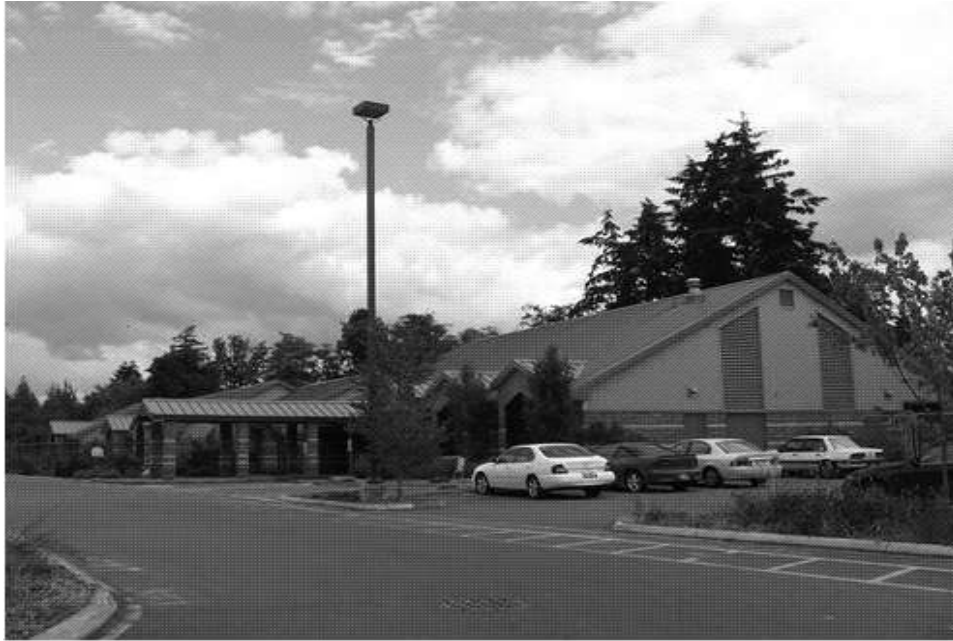
Center For Families (230-CFF) STATE UF: A05918 Main Campus (230A)
AREA: 15,542 SF BUILT: 2002 REMODELED: No PREDOMINANT USE: Early Learning
CONSTRUCTION TYPE: Medium CRV/SF: \$296 REPLACEMENT VALUE: \$4,600,432

Primary Systems			
COMPONENT:	Structure	RATING: 1 x WEIGHT: 8.8 = SCORE: 8.8	
No signs of settlement or cracking, no abrupt vertical changes Columns, bearing walls and roof structure appears sound/free of defects			
COMMENTS:	Steel columns; glu-lam beams; exposed glu-lam trusses; micro-lam rafters		
COMPONENT:	Exterior Closure	RATING: 1 x WEIGHT: 8.8 = SCORE: 8.8	
Weatherproof, tight, well-maintained exterior walls, doors, windows/finishes			
COMMENTS:	Split face and smooth CMU; brick; metal panels; gypsum board soffits		
COMPONENT:	Roofing	RATING: 1 x WEIGHT: 11 = SCORE: 11	
Flashing and penetrations appear sound and membrane appears water- tight; drainage is positive and there are overflow scuppers			
COMMENTS:	Standing seam metal at slopes & EPDM at flat areas; glass skylights

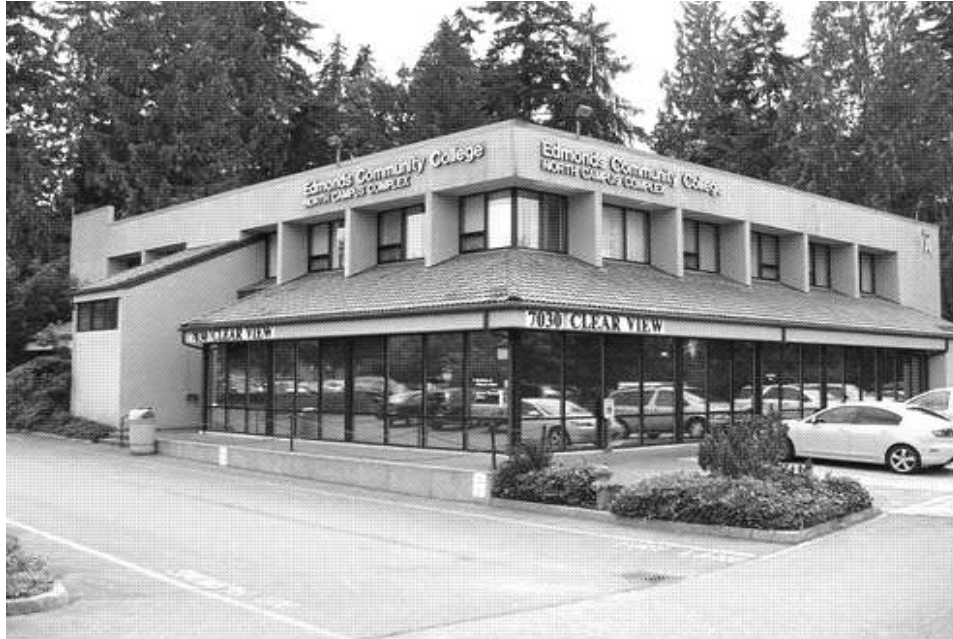
Clearview (230-CLA) STATE UFI: A07180 Main Campus (230A)
 AREA: 14,000 SF BUILT: 1990 REMODELED: No PREDOMINANT USE: Administration
 CONSTRUCTION TYPE: Light CRV/SF: \$336 REPLACEMENT VALUE: \$4,704,000

Primary Systems			
COMPONENT:	Structure	RATING: 1 x WEIGHT: 8 =	SCORE: 8
No signs of settlement or cracking, no abrupt vertical changes Columns, bearing walls and roof structure appears sound/free of defects			
COMMENTS:	Wood frame		
COMPONENT:	Exterior Closure	RATING: 1 x WEIGHT: 8 =	SCORE: 8
Weatherproof, tight, well-maintained exterior walls, doors, windows/finishes			
COMMENTS:	Stucco; aluminum window walls; repairs at upper wall and soffits need painting		
COMPONENT:	Roofing	RATING: 3 x WEIGHT: 10 =	SCORE: 30
Some deterioration is evident in membrane and flashings; maintenance or minor repair is needed			
COMMENTS:	Concrete tile on sloped roof; BUR w mineral-surfaced cap sheet

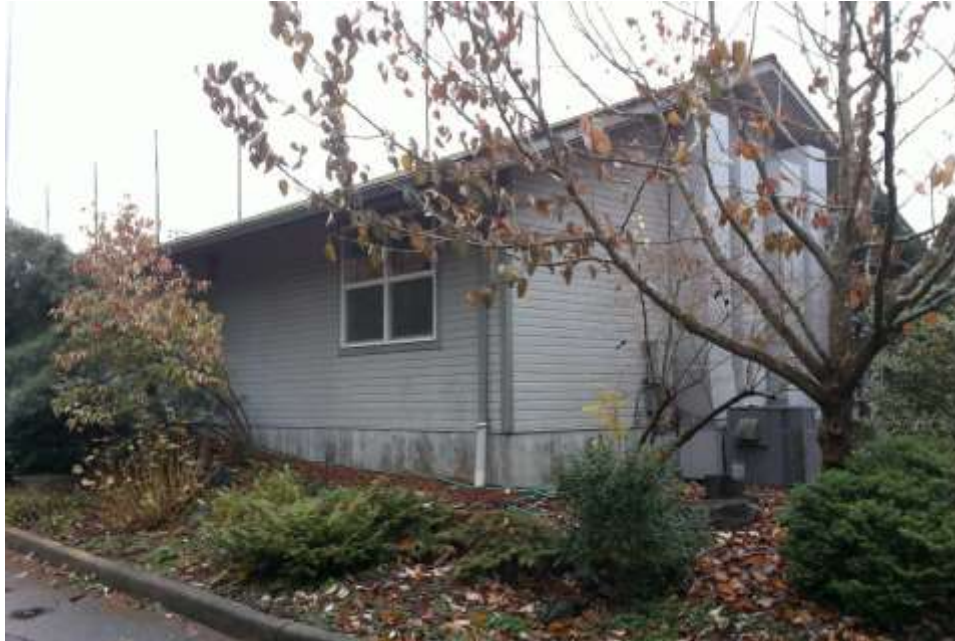
Firdale Hall (230-FIR) STATE UFI: A09490 Main Campus (230A)
 AREA: 4,000 SF BUILT: 1995 REMODELED: No PREDOMINANT USE: General Classroom
 CONSTRUCTION TYPE: Light CRV/SF: \$244 REPLACEMENT VALUE: \$976,000

Primary Systems			
COMPONENT:	Structure	RATING: 1 x WEIGHT: 8.8 = SCORE: 8.8	
No signs of settlement or cracking, no abrupt vertical changes Columns, bearing walls and roof structure appears sound/free of defects			
COMMENTS:	Wood frame		
COMPONENT:	Exterior Closure	RATING: 1 x WEIGHT: 8.8 = SCORE: 8.8	
Weatherproof, tight, well-maintained exterior walls, doors, windows/finishes			
COMMENTS:	Manufactured board beveled siding		
COMPONENT:	Roofing	RATING: 1 x WEIGHT: 11 = SCORE: 11	
Flashing and penetrations appear sound and membrane appears water- tight; drainage is positive and there are overflow scuppers			
COMMENTS:	3-tab composition shingles

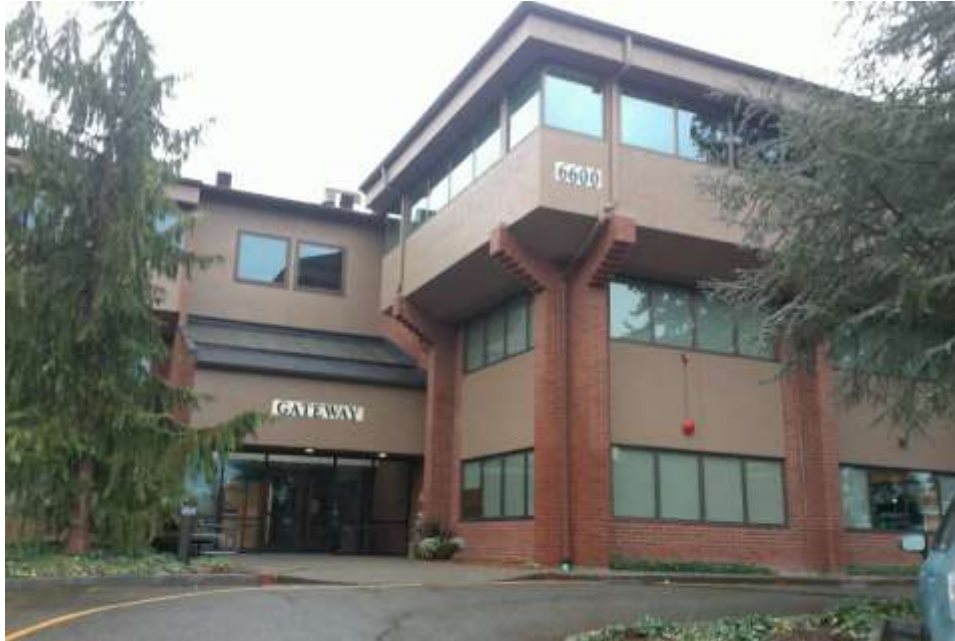
Gateway Hall (230-GWY) STATE UFI: A10107 Main Campus (230A)
AREA: 32,239 SF BUILT: 1986 REMODELED: No PREDOMINANT USE: General Classroom
CONSTRUCTION TYPE: No data CRV/SF: \$376 REPLACEMENT VALUE: \$12,121,864

Primary Systems			
COMPONENT:	Structure	RATING: 1 x WEIGHT: 8 =	SCORE: 8
No signs of settlement or cracking, no abrupt vertical changes Columns, bearing walls and roof structure appears sound/free of defects			
COMMENTS:	No data		
COMPONENT:	Exterior Closure	RATING: 1 x WEIGHT: 8 =	SCORE: 8
Weatherproof, tight, well-maintained exterior walls, doors, windows/finishes			
COMMENTS:	No data		
COMPONENT:	Roofing	RATING: 1 x WEIGHT: 10 =	SCORE: 10
Flashing and penetrations appear sound and membrane appears water- tight; drainage is positive and there are overflow scuppers			
COMMENTS:	Single-ply 2014

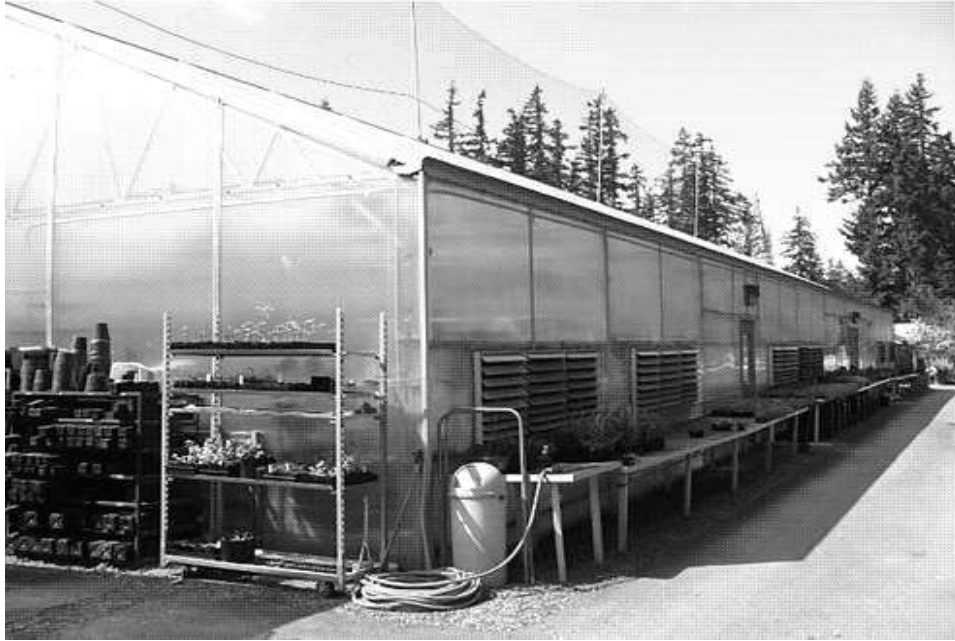
Hort Green House (230-HGH) STATE UFI: A05986 Main Campus (230A)
 AREA: 4,356 SF BUILT: 1990 REMODELED: No PREDOMINANT USE: Greenhouse
 CONSTRUCTION TYPE: Light CRV/SF: \$231 REPLACEMENT VALUE: \$1,006,236

Primary Systems			
COMPONENT:	Structure	RATING: 1 x WEIGHT: 10.1 =	SCORE: 10.1
No signs of settlement or cracking, no abrupt vertical changes Columns, bearing walls and roof structure appears sound/free of defects			
COMMENTS:	Galvanized steel framing		
COMPONENT:	Exterior Closure	RATING: 2 x WEIGHT: 10.1 =	SCORE: 20.1
Weatherproof exterior, but finish appears poorly maintained			
COMMENTS:	Polycarbonate panels-2008		
COMPONENT:	Roofing	RATING: 2 x WEIGHT: 12.6 =	SCORE: 25.2
Majority of roofing and flashing appear sound, but a small portion of roofing shows deterioration where maintenance or minor repair needed			
COMMENTS:	Polycarbonate panels-2008

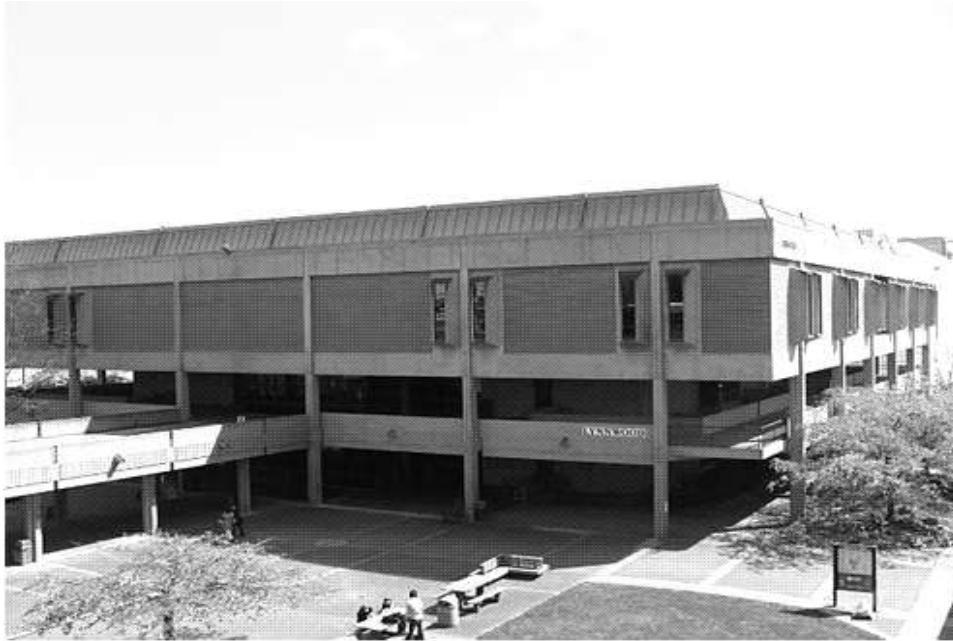
Lynnwood Hall (230-LYN) STATE UFI: A04627 Main Campus (230A)
AREA: 90,960 SF BUILT: 1972 REMODELED: 1998 PREDOMINANT USE: Multi-Use
CONSTRUCTION TYPE: Heavy CRV/SF: \$395 REPLACEMENT VALUE: \$35,929,200

Primary Systems			
COMPONENT:	Structure	RATING: 1 x WEIGHT: 8 =	SCORE: 8
No signs of settlement or cracking, no abrupt vertical changes Columns, bearing walls and roof structure appears sound/free of defects			
COMMENTS:	Cast concrete; steel frame		
COMPONENT:	Exterior Closure	RATING: 2 x WEIGHT: 8 =	SCORE: 16
Weatherproof exterior, but finish appears poorly maintained			
COMMENTS:	Brick; concrete frame; stucco soffits		
COMPONENT:	Roofing	RATING: 2 x WEIGHT: 10 =	SCORE: 20
Majority of roofing and flashing appear sound, but a small portion of roofing shows deterioration where maintenance or minor repair needed			
COMMENTS:	BUR w mineral-surfaced cap sheet

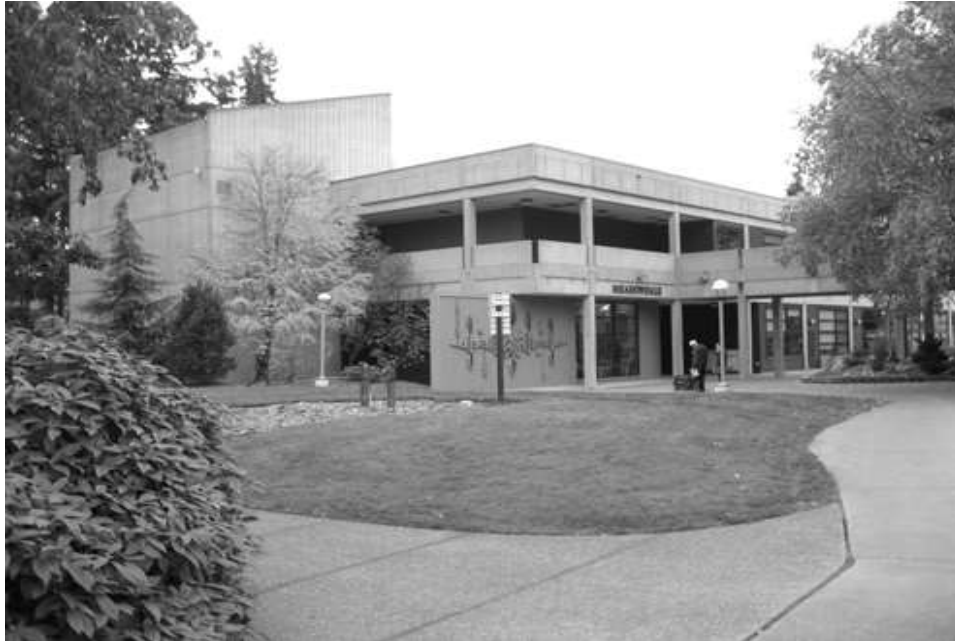
Meadowdale Hall (230-MDL) STATE UFI: A06716 Main Campus (230A)
 AREA: 36,393 SF BUILT: 1976 REMODELED: 2010 PREDOMINANT USE: Visual Arts
 CONSTRUCTION TYPE: Heavy CRV/SF: \$376 REPLACEMENT VALUE: \$13,683,768

Primary Systems			
COMPONENT:	Structure	RATING: 1 x WEIGHT: 8 =	SCORE: 8
No signs of settlement or cracking, no abrupt vertical changes Columns, bearing walls and roof structure appears sound/free of defects			
COMMENTS:	Concrete; steel frame		
COMPONENT:	Exterior Closure	RATING: 1 x WEIGHT: 8 =	SCORE: 8
Weatherproof, tight, well-maintained exterior walls, doors, windows/finishes			
COMMENTS:	Brick, concrete frame; metal panels		
COMPONENT:	Roofing	RATING: 1 x WEIGHT: 10 =	SCORE: 10
Flashing and penetrations appear sound and membrane appears water- tight; drainage is positive and there are overflow scuppers			
COMMENTS:	BUR w neoprene UV coat; Repairs/ reconditioning funded 21-23

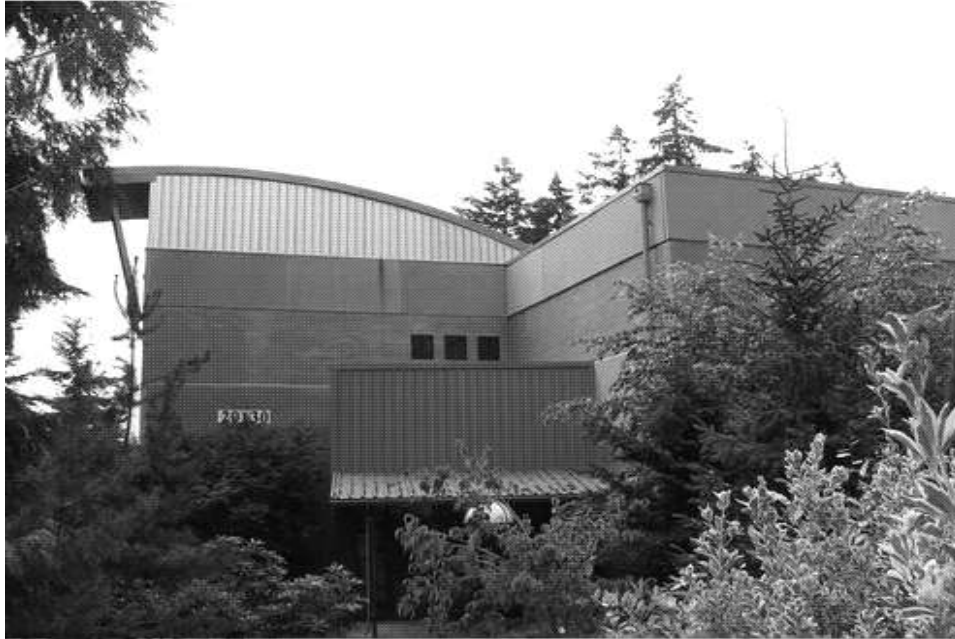
Mill Creek Hall (230-MIL) STATE UFI: A00343 Main Campus (230A)
 AREA: 19,380 SF BUILT: 2000 REMODELED: No PREDOMINANT USE: Performing Arts
 CONSTRUCTION TYPE: Heavy CRV/SF: \$421 REPLACEMENT VALUE: \$8,158,980

Primary Systems			
COMPONENT:	Structure	RATING: 1 x WEIGHT: 8.4 =	SCORE: 8.4
No signs of settlement or cracking, no abrupt vertical changes Columns, bearing walls and roof structure appears sound/free of defects			
COMMENTS:	Structural steel; pre cast concrete		
COMPONENT:	Exterior Closure	RATING: 1 x WEIGHT: 8.4 =	SCORE: 8.4
Weatherproof, tight, well-maintained exterior walls, doors, windows/finishes			
COMMENTS:	Brick; pre-cast concrete; metal siding; concrete base		
COMPONENT:	Roofing	RATING: 2 x WEIGHT: 10.5 =	SCORE: 21
Majority of roofing and flashing appear sound, but a small portion of roofing shows deterioration where maintenance or minor repair needed			
COMMENTS:	BUR and standing seam metal; minor blistering on BUR

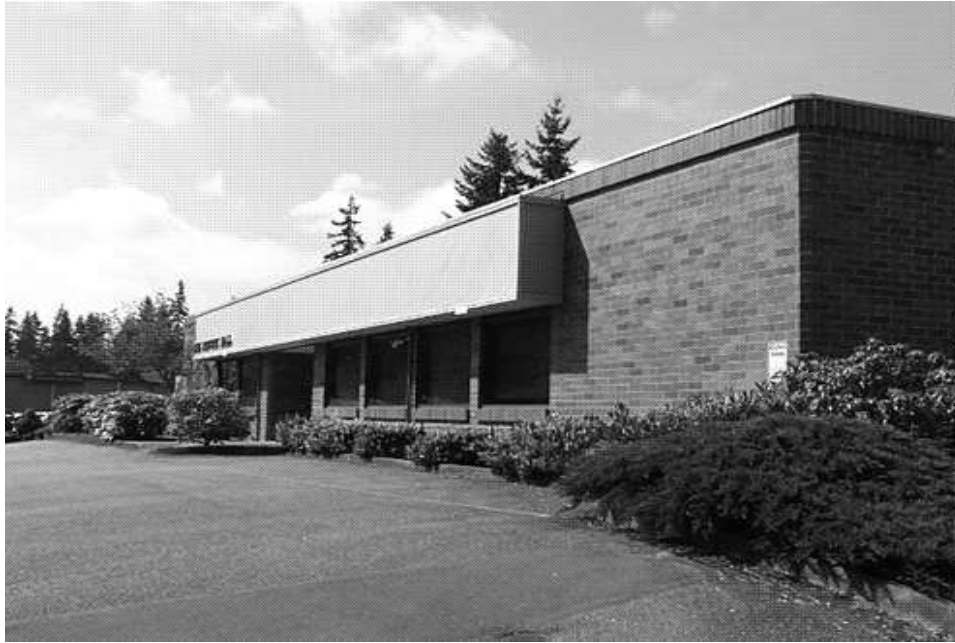
Monroe Hall (230-MON) STATE UFI: A04561 Main Campus (230A)
AREA: 10,608 SF BUILT: 0 REMODELED: No PREDOMINANT USE: Vocational Arts
CONSTRUCTION TYPE: Medium CRV/SF: \$363 REPLACEMENT VALUE: \$3,850,704

Primary Systems			
COMPONENT:	Structure	RATING: 1 x WEIGHT: 8.3 = SCORE: 8.3	
No signs of settlement or cracking, no abrupt vertical changes Columns, bearing walls and roof structure appears sound/free of defects			
COMMENTS:	Wood frame		
COMPONENT:	Exterior Closure	RATING: 1 x WEIGHT: 8.3 = SCORE: 8.3	
Weatherproof, tight, well-maintained exterior walls, doors, windows/finishes			
COMMENTS:	Brick		
COMPONENT:	Roofing	RATING: 1 x WEIGHT: 10.4 = SCORE: 10.4	
Flashing and penetrations appear sound and membrane appears water- tight; drainage is positive and there are overflow scuppers			
COMMENTS:	BUR w mineral-surfaced capsheet-2009
