2023 FACILITY CONDITION SURVEY

Everett Community College

SURVEY CONDUCTED BY:
Steve Lewandowski
State Board for Community
and Technical Colleges

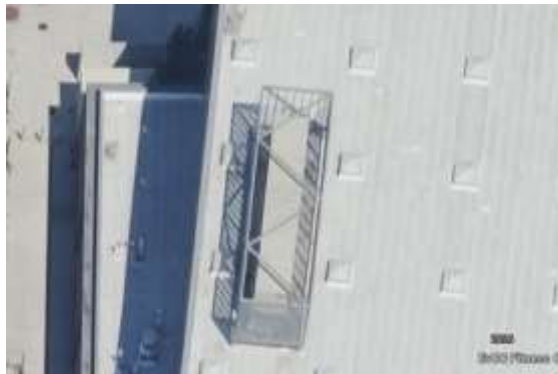
Deficiency F02

The air handler electric motor is out of alignment and makes a rubbing noise. The heating loop pipe flanges leak. The air flow sensors are failing and trigger false alarms daily. The HVAC unit should be reconditioned to correct these issues. This is a building funded entirely with COP funds, but the college claims that it has instructional uses. It is not clear if the building is used for required program courses that lead to college certifications or degrees. Additional information is required to justify repairs in the capital budget.

Recommended funding schedule : Immediate (scoring weight=4)
Estimated remaining life (years) : 3
Estimated average life expectancy (years) : 20
Scoring priority category 1 : High Repair/Repl. Cost (scoring weight=12)
Category 1 percentage : 80 %
Scoring priority category 2 : System Use (scoring weight=15)
Category 2 percentage : 20 %
Project construction estimate (MACC): \$40,000
Total project estimate (including soft costs): \$56,000
Additional points based on building condition: 0
Deficiency score : $4 \times ((12 \times 80\%) + (15 \times 20\%)) + 0 = 50.4$

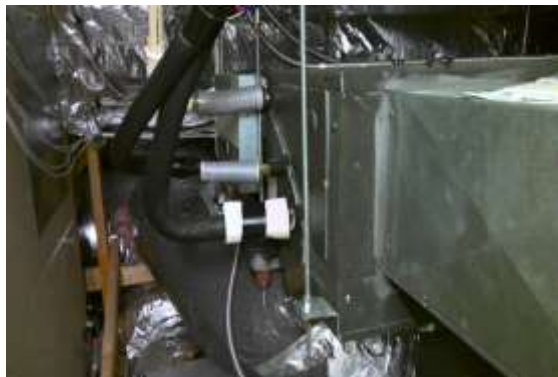
Deficiency F03

The college indicated that the attic fan boxes have become unreliable. Several of the boxes have had coil leaks and have required repairs. The boxes were not leaking at the time of the survey. The failing fan boxes should be replaced to ensure the reliability of the HVAC system.

Estimated remaining life (years) : 7
Estimated average life expectancy (years) : 15
Scoring priority category 1 : High Repair/Repl. Cost (scoring weight=12)
Category 1 percentage : 50 %
Scoring priority category 2 : System Use (scoring weight=15)
Category 2 percentage : 50 %
Project construction estimate (MACC): \$100,000
Total project estimate (including soft costs): \$141,000
Additional points based on building condition: 1
Deficiency score : $4 \times ((12 \times 50\%) + (15 \times 50\%)) + 1 = 55$

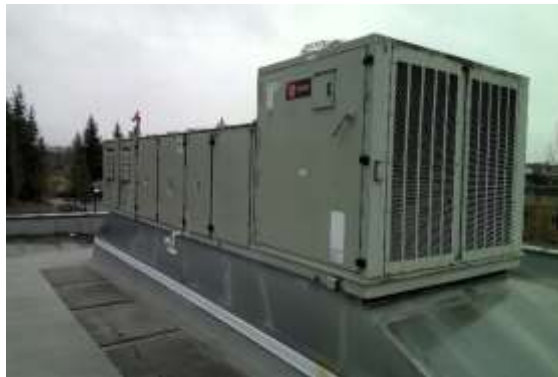
Deficiency F04

The college is concerned about the condition of the five air handler units on the roof. The units exhibited minor rust, but the college indicated that the units leak around the access doors and condensate pans. The failing unit enclosures and condensate pans should be repaired to maintain water-tight enclosures and leak-free pans.

Estimated remaining life (years) : 3
Estimated average life expectancy (years) : 20
Scoring priority category 1 : High Repair/Repl. Cost (scoring weight=12)
Category 1 percentage : 100 %
Scoring priority category 2 : None
Category 2 percentage : 0 %
Project construction estimate (MACC): \$60,000
Total project estimate (including soft costs): \$84,000
Additional points based on building condition: 1
Deficiency score : $4 \times (12 \times 100\%) + 1 = 49$

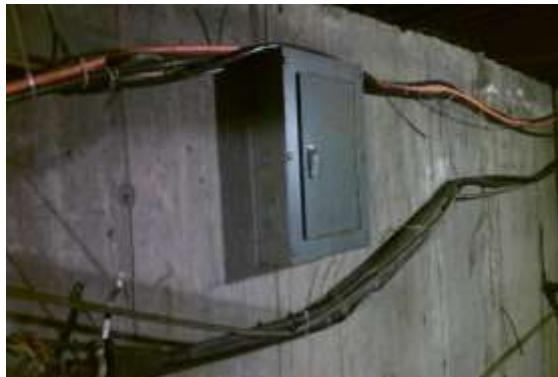
Deficiency F05

There are several interior-grade electrical boxes located within the utilidor. These boxes are not water-tight and exhibit damage due to water exposure. This is an unsafe condition. The boxes should be replaced with exterior-grade boxes. The utilidor lid should also be repaired near all critical equipment to avoid continued water damage to utilities within the tunnel.

Recommended funding schedule : Immediate (scoring weight=4)
Estimated remaining life (years) : 3
Estimated average life expectancy (years) : 30
Scoring priority category 1 : System Use (scoring weight=15)
Category 1 percentage : 70 %
Scoring priority category 2 : Health/Safety (scoring weight=25)
Category 2 percentage : 30 %
Project construction estimate (MACC): \$600,000
Total project estimate (including soft costs): \$848,000
Additional points based on building condition: 1
Deficiency score : $4 \times ((15 \times 70\%) + (25 \times 30\%)) + 1 = 73$

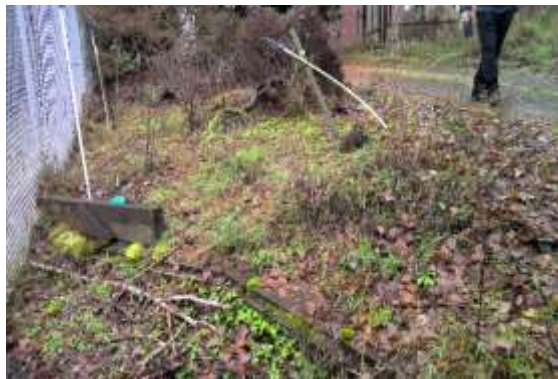
Deficiency S01

A portion of the wastewater/sewage line that collects roof water and sewage from the maintenance building regularly becomes restricted due to root intrusion. The failing section of pipe should be replaced to maintain full function of the system.

Estimated average life expectancy (years) : 50
Scoring priority category 1 : System Use (scoring weight=15)
Category 1 percentage : 90 %
Scoring priority category 2 : Health/Safety (scoring weight=25)
Category 2 percentage : 10 %
Project construction estimate (MACC): \$50,000
Total project estimate (including soft costs): \$70,000
Additional points based on building condition: 0
Deficiency score : $4 \times ((15 \times 90\%) + (25 \times 10\%)) + 0 = 64$
