2023 FACILITY CONDITION SURVEY

Grays Harbor College

SURVEY CONDUCTED BY:
Steve Lewandowski
State Board for Community
and Technical Colleges

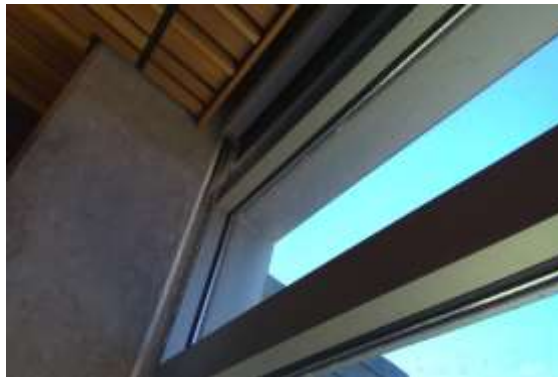
The windows have leaked for about 6 months, but are fairly new. It was not known if the flashing or sealant has failed. It appears that the envelope window header flashing has not provided protection from water intrusion. The interior damage should be repaired and the window headers should be replaced to ensure a water-tight condition.

Recommended funding schedule : Fund in Next Biennium (score = 2.5)
Estimated remaining life (years) : 5
Estimated average life expectancy (years) : 40
Scoring priority category 1 : System Use (score = 15)
Category 1 percentage : 100 %
Scoring priority category 2 : None
Category 2 percentage : 0 %
Project construction estimate (MACC): \$26,000
Total project estimate (including soft costs): \$36,000
Additional points based on building condition: 0
Deficiency score : Needs study

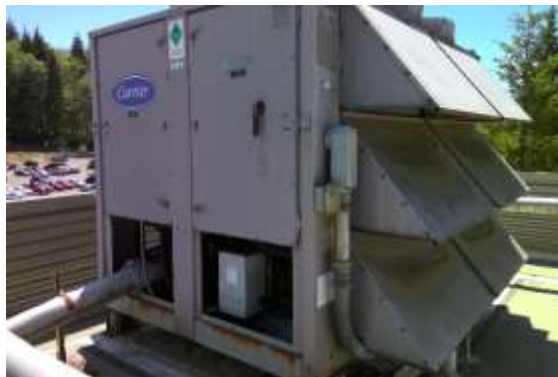
Deficiency F02

The college is concerned about the HVAC unit on the upper roof due to component age and reliability. The unit appeared to be functioning during the survey. Additional information is required to better evaluate the repair need.

Carryover from prior survey : No
Location : Main Campus (020A)
Building name : Lib (020-1500)
Unique Facility Identifier (UFI) : A09264
Funding category in capital budget : Minor Works Facility appropriation
Unifomat category : D30-HVAC
Assessment : Asset is near or at the end of its useful life and should be replaced
Quantity : 1
Unit of measurement : EA
Component : HVAC unit
Location within building or site : rooftop
Issue clarity : Additional information is required to assess deficiency
Main cause of asset degradation or failure : Age/Wear
Detailed description : The college is concerned about the HVAC unit on the upper roof due to component age and reliability. The unit appeared to be functioning during the survey. Additional information is required to better evaluate the repair need.
Recommended funding schedule : Immediate (scoring weight=4)
Estimated remaining life (years) : (No Data)
Estimated average life expectancy (years) : 20

Scoring priority category 1 : System Use (scoring weight=15)
Category 1 percentage : 90 %
Scoring priority category 2 : High Repair/Repl. Cost (scoring weight=12)
Category 2 percentage : 10 %
Project construction estimate (MACC): \$80,000
Total project estimate (including soft costs): \$112,000
Additional points based on building condition: 0
Deficiency score : Needs study

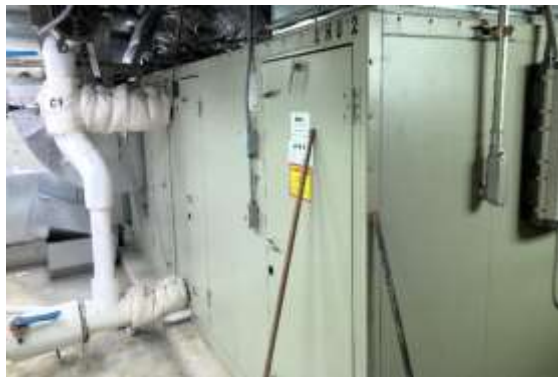
Deficiency F03

The two units have started to have component failure. The dampers have become unreliable and other main components have degraded. The dampers should be replaced and the units should be reconditioned to extend their useful life.

Carryover from prior survey : No
Location : Main Campus (020A)
Building name : Lib (020-1500)
Unique Facility Identifier (UFI) : A09264
Funding category in capital budget : Minor Works Facility appropriation
Unifomat category : D30-HVAC
Assessment : Asset should be repaired to extend its useful life
Quantity : 2
Unit of measurement : EA
Component : Air handler
Location within building or site : Mechanical penthouse
Issue clarity : Adequate information was provided to assess deficiency
Main cause of asset degradation or failure : Age/Wear
Detailed description : The two units have started to have component failure. The dampers have become unreliable and other main components have degraded. The dampers should be replaced and the units should be reconditioned to extend their useful life.
Recommended funding schedule : Immediate (scoring weight=4)
Estimated remaining life (years) : 3
Estimated average life expectancy (years) : 20

Scoring priority category 1 : System Use (scoring weight=15)
Category 1 percentage : 60 %
Scoring priority category 2 : High Repair/Repl. Cost (scoring weight=12)
Category 2 percentage : 40 %
Project construction estimate (MACC): \$80,000
Total project estimate (including soft costs): \$112,000
Additional points based on building condition: 0
Deficiency score : $4 \times ((15 \times 60\%) + (12 \times 40\%)) + 0 = 55.2$

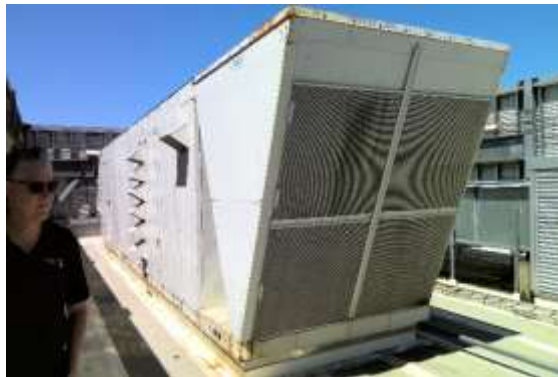
Deficiency F04

The air handler has degraded and has been recently repaired through regular maintenance efforts. The unit should continue to be monitored for reconditioning or replacement.

Carryover from prior survey : No
Location : Main Campus (020A)
Building name : Manspeaker Instructional (020-2000)
Unique Facility Identifier (UFI) : A04686
Funding category in capital budget : Minor Works Facility appropriation
Unifomat category : D30-HVAC
Assessment : Asset should be repaired to extend its useful life
Quantity : 1
Unit of measurement : EA
Component : Air handler
Location within building or site : rooftop
Issue clarity : Adequate information was provided to assess deficiency
Main cause of asset degradation or failure : Age/Wear
Detailed description : The air handler has degraded and has been recently repaired through regular maintenance efforts. The unit should continue to be monitored for reconditioning or replacement.
Recommended funding schedule : Fund in Next Biennium (scoring weight=2.5)
Estimated remaining life (years) : 5
Estimated average life expectancy (years) : 20
Scoring priority category 1 : System Use (scoring weight=15)

Category 1 percentage : 80 %
Scoring priority category 2 : High Repair/Repl. Cost (scoring weight=12)
Category 2 percentage : 20 %
Project construction estimate (MACC): \$125,000
Total project estimate (including soft costs): \$175,000
Additional points based on building condition: 0
Deficiency score : $2.5 \times ((15 \times 80\%) + (12 \times 20\%)) + 0 = 36$

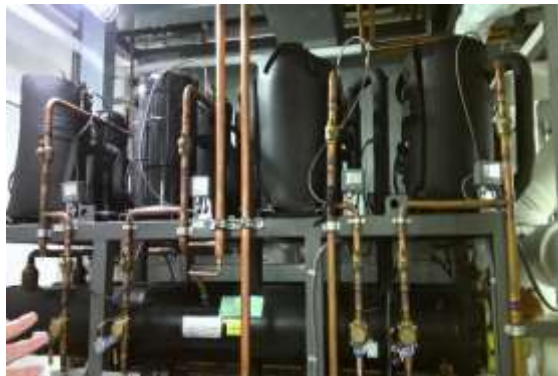
Deficiency F05

The eight compressors that serve the chiller are structured in an array that no longer functions. The pairs of larger and smaller compressors distribute oil incorrectly and has resulted in failed compressors. Currently five out of the eight compressors have failed. Many compressors have been replaced and have failed a second time due to an improper design. The compressor array system should be re-designed and replaced to restore function to the chiller.

Carryover from prior survey : No
Location : Main Campus (020A)
Building name : Schermer Instructional (020-4000)
Unique Facility Identifier (UFI) : A21240
Funding category in capital budget : Minor Works Facility appropriation
Unifomat category : D20-Plumbing
Assessment : Asset is near or at the end of its useful life and should be replaced
Quantity : 1
Unit of measurement : LS
Component : Chiller compressor array
Location within building or site : 1st floor
Issue clarity : Adequate information was provided to assess deficiency
Main cause of asset degradation or failure : Design
Detailed description : The eight compressors that serve the chiller are structured in an array that no longer functions. The pairs of larger and smaller compressors distribute oil incorrectly and has resulted in failed compressors. Currently five out of the eight compressors have failed. Many compressors have been replaced and have failed a second time due to an improper design. The compressor array system should be re-designed and replaced to restore function to the chiller.

Recommended funding schedule : Immediate (scoring weight=4)
Estimated remaining life (years) : 3
Estimated average life expectancy (years) : 20
Scoring priority category 1 : System Use (scoring weight=15)
Category 1 percentage : 80 %
Scoring priority category 2 : High Repair/Repl. Cost (scoring weight=12)
Category 2 percentage : 20 %
Project construction estimate (MACC): \$180,000
Total project estimate (including soft costs): \$253,000
Additional points based on building condition: 0
Deficiency score : $4 \times ((15 \times 80\%) + (12 \times 20\%)) + 0 = 57.6$

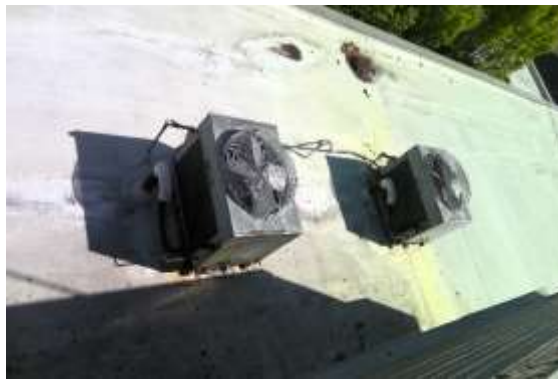
Deficiency F06

The two units that serve the network server room and electrical rooms have reached the end of their useful life. The units are no longer repairable, but still partially function. The supporting steel has also degraded. The units and supports should be replaced.

Carryover from prior survey : No
Location : Main Campus (020A)
Building name : Lib (020-1500)
Unique Facility Identifier (UFI) : A09264
Funding category in capital budget : Minor Works Facility appropriation
Unifomat category : D30-HVAC
Assessment : Asset is near or at the end of its useful life and should be replaced
Quantity : 2
Unit of measurement : EA
Component : HVAC unit
Location within building or site : Roof
Issue clarity : Adequate information was provided to assess deficiency
Main cause of asset degradation or failure : Age/Wear
Detailed description : The two units that serve the network server room and electrical rooms have reached the end of their useful life. The units are no longer repairable, but still partially function. The supporting steel has also degraded. The units and supports should be replaced.
Recommended funding schedule : Immediate (scoring weight=4)
Estimated remaining life (years) : 3

Estimated average life expectancy (years) : 20
Scoring priority category 1 : System Use (scoring weight=15)
Category 1 percentage : 50 %
Scoring priority category 2 : High Repair/Repl. Cost (scoring weight=12)
Category 2 percentage : 50 %
Project construction estimate (MACC): \$40,000
Total project estimate (including soft costs): \$56,000
Additional points based on building condition: 0
Deficiency score : $4 \times ((15 \times 50\%) + (12 \times 50\%)) + 0 = 54$

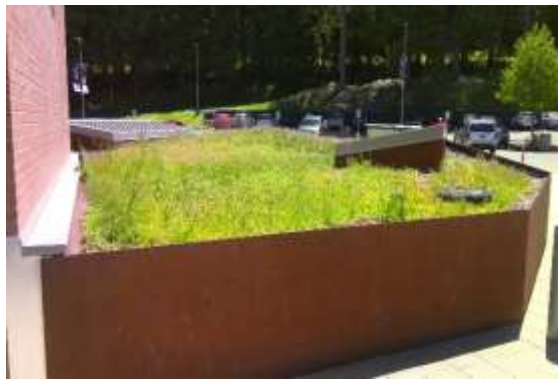
Deficiency R01

The green roof is leaking. The college does not know the extent of the failed section of roofing, but know the general location. A portion of the green roof material should be removed and the leak should be fixed.

Carryover from prior survey (not yet funded) : Yes
Location : Main Campus (020A)
Building name : Schermer Instructional (020-4000)
Unique Facility Identifier (UFI) : A21240
Funding category in capital budget : Minor Works Roof appropriation
Unifomat category : B30-Roofing
Assessment : Asset should be repaired to extend its useful life
Quantity : 1
Unit of measurement : EA
Component : Single-Ply (EPDM)
Location within building or site : Roof
Issue clarity : Adequate information was provided to assess deficiency
Main cause of asset degradation or failure : Unknown
Detailed description : The green roof is leaking. The college does not know the extent of the failed section of roofing, but know the general location. A portion of the green roof material should be removed and the leak should be fixed.
Recommended funding schedule : Immediate (scoring weight=4)
Estimated remaining life (years) : 3
Estimated average life expectancy (years) : 20

Scoring priority category 1 : High Repair/Repl. Cost (scoring weight=12)
Category 1 percentage : 60 %
Scoring priority category 2 : System Use (scoring weight=15)
Category 2 percentage : 40 %
Project construction estimate (MACC): \$22,000
Total project estimate (including soft costs): \$30,000
Additional points based on building condition: 0
Deficiency score : $4 \times ((12 \times 60\%) + (15 \times 40\%)) + 0 = 52.8$

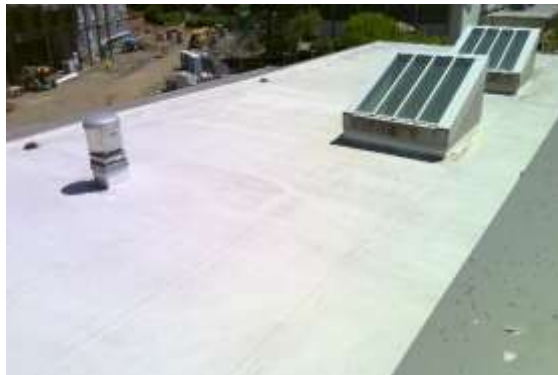
Deficiency R02

Membrane roof has been identified as defective, with a lifespan of 13-15 years. The lower roofs should be reconditioned to extend their useful life. The upper roof requires repairs and should be replaced.

Carryover from prior survey : No
Location : Main Campus (020A)
Building name : Lib (020-1500)
Unique Facility Identifier (UFI) : A09264
Funding category in capital budget : Minor Works Roof appropriation
Unifomat category : B30-Roofing
Assessment : Asset is near or at the end of its useful life and should be replaced
Quantity : 21000
Unit of measurement : sq feet
Component : Single-Ply (EPDM)
Location within building or site : lower roof
Issue clarity : Adequate information was provided to assess deficiency
Main cause of asset degradation or failure : Age/Wear
Detailed description : Membrane roof has been identified as defective, with a lifespan of 13-15 years. The lower roofs should be reconditioned to extend their useful life. The upper roof requires repairs and should be replaced.
Recommended funding schedule : Immediate (scoring weight=4)
Estimated remaining life (years) : 3
Estimated average life expectancy (years) : 20

Scoring priority category 1 : System Use (scoring weight=15)
Category 1 percentage : 70 %
Scoring priority category 2 : High Repair/Repl. Cost (scoring weight=12)
Category 2 percentage : 30 %
Project construction estimate (MACC): \$230,000
Total project estimate (including soft costs): \$323,000
Additional points based on building condition: 0
Deficiency score : $4 \times ((15 \times 70\%) + (12 \times 30\%)) + 0 = 56.4$

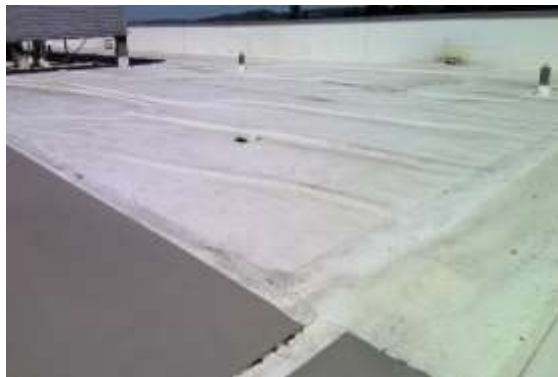
Deficiency R03

The roofing material has deformed and degraded. Pinhole leaks have started to form in some locations. The roof cannot be easily reconditioned because of the deformed surface. The roofing should be replaced.

Category 1 percentage : 70 %
Scoring priority category 2 : High Repair/Repl. Cost (scoring weight=12)
Category 2 percentage : 30 %
Project construction estimate (MACC): \$550,000
Total project estimate (including soft costs): \$773,000
Additional points based on building condition: 0
Deficiency score : $4 \times ((15 \times 70\%) + (12 \times 30\%)) + 0 = 56.4$
