2023 FACILITY CONDITION SURVEY

Highline College

SURVEY CONDUCTED BY:
Steve Lewandowski
State Board for Community
and Technical Colleges

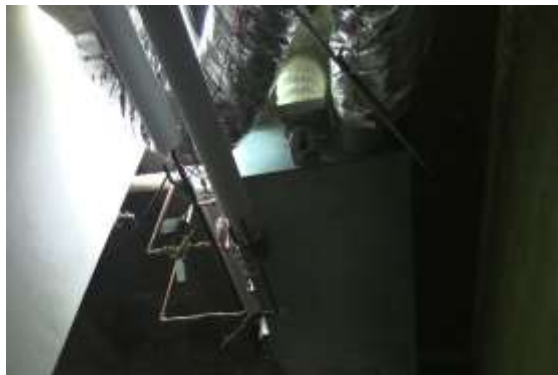
Recommended funding schedule : Immediate (score = 4)
Estimated remaining life (years) : 3
Estimated average life expectancy (years) : 40
Scoring priority category 1 : System Use (score = 15)
Category 1 percentage : 50 %
Scoring priority category 2 : High Repair/Repl. Cost (score = 12)
Category 2 percentage : 50 %
Project construction estimate (MACC): \$300,000
Total project estimate (including soft costs): \$425,000
Additional points based on building condition: 2
Deficiency score : $4 \times ((15 \times 50\%) + (12 \times 50\%)) + 2 = 56$

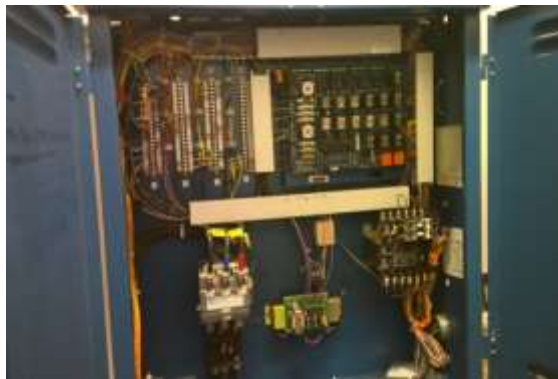
Deficiency F02

The Dover elevator has controls that are no longer supported by the vendor. If any control component fails, the elevator will not be able to function for an extended period of time. The controls should be replaced to ensure that the elevator is reliable.

Estimated remaining life (years) : 3
Estimated average life expectancy (years) : 40
Scoring priority category 1 : System Use (scoring weight=15)
Category 1 percentage : 70 %
Scoring priority category 2 : Facility Use/ Civil Rights Violation (scoring weight=20)
Category 2 percentage : 30 %
Project construction estimate (MACC): \$120,000
Total project estimate (including soft costs): \$170,000
Additional points based on building condition: 1
Deficiency score : $4 \times ((15 \times 70\%) + (20 \times 30\%)) + 1 = 67$

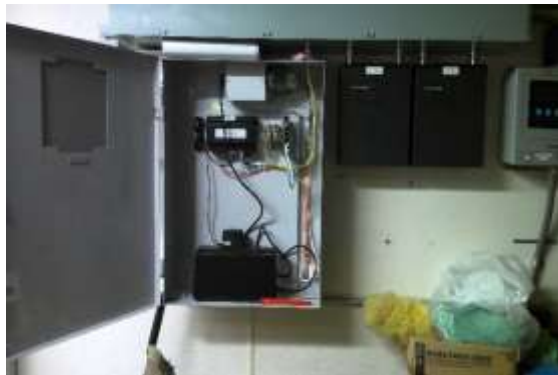
Deficiency F03

The HVAC controls have become unreliable and no longer communicate with the main control system. The controls can no longer be repaired. The controls should be replaced.

Category 1 percentage : 100 %
Scoring priority category 2 : None
Category 2 percentage : 0 %
Project construction estimate (MACC): \$70,000
Total project estimate (including soft costs): \$99,000
Additional points based on building condition: 1
Deficiency score : $4 \times (15 \times 100\%) + 1 = 61$

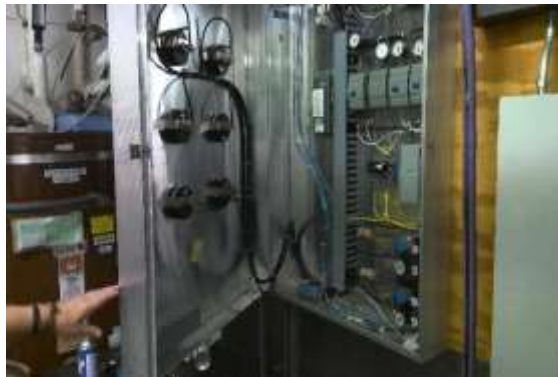
Deficiency F04

The pneumatic controls have become unreliable and require frequent repairs. The controls should be replaced.

Scoring priority category 2 : High Operating Cost (scoring weight=10)
Category 2 percentage : 30 %
Project construction estimate (MACC): \$35,000
Total project estimate (including soft costs): \$49,000
Additional points based on building condition: 1
Deficiency score : $4 \times ((15 \times 70\%) + (10 \times 30\%)) + 1 = 55$

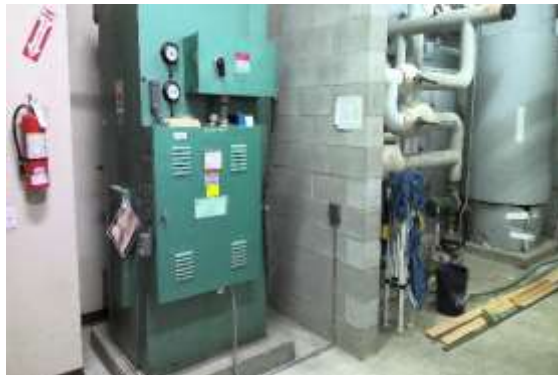
Deficiency F05

The hot water tank and circulation pump are well beyond their expected life. However, they still function as designed. The tank and pumps should be replaced in the next biennium.

Scoring priority category 1 : System Use (scoring weight=15)
Category 1 percentage : 100 %
Scoring priority category 2 : None
Category 2 percentage : 0 %
Project construction estimate (MACC): \$115,000
Total project estimate (including soft costs): \$163,000
Additional points based on building condition: 5
Deficiency score : $2.5 \times (15 \times 100\%) + 5 = 42.5$

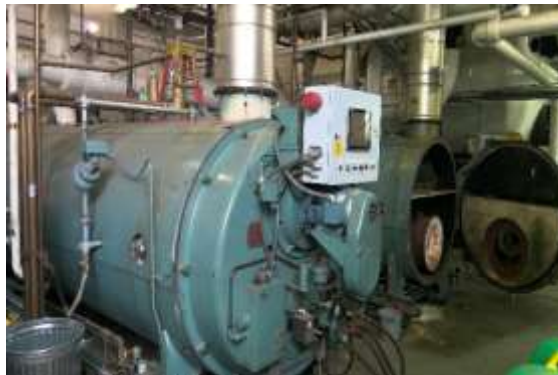
Deficiency F06

The boilers and circulation pumps are near the end of their useful life and have become unreliable. They have required more frequent repairs. The two smaller boilers should be replaced.

Scoring priority category 1 : Facility Use/ Civil Rights Violation (scoring weight=20)
Category 1 percentage : 80 %
Scoring priority category 2 : System Use (scoring weight=15)
Category 2 percentage : 20 %
Project construction estimate (MACC): \$850,000
Total project estimate (including soft costs): \$1,205,000
Additional points based on building condition: 2
Deficiency score : $4 \times ((20 \times 80\%) + (15 \times 20\%)) + 2 = 78$

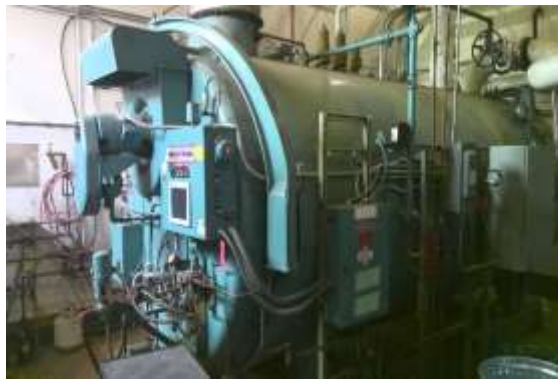
Deficiency F07

The larger boiler (#3) has failed and should be replaced to restore the hot water capacity to several building heating systems. The other boilers currently provide the hot water to the campus loops, so this is a redundant boiler. The circulation pumps are also at the end of their useful life and should be replaced.

Estimated remaining life (years) : 5
Estimated average life expectancy (years) : 30
Scoring priority category 1 : Facility Use/ Civil Rights Violation (scoring weight=20)
Category 1 percentage : 70 %
Scoring priority category 2 : System Use (scoring weight=15)
Category 2 percentage : 30 %
Project construction estimate (MACC): \$485,000
Total project estimate (including soft costs): \$687,000
Additional points based on building condition: 2
Deficiency score : $2.5 \times ((20 \times 70\%) + (15 \times 30\%)) + 2 = 48.3$

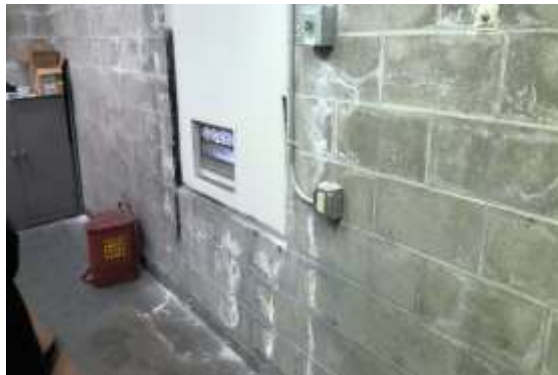
Deficiency R01

The roof around the north penthouse is leaking into the mechanical penthouse. It was not clear where the leak originated. Additional information is required to properly scope the repair

Category 1 percentage : 100 %
Scoring priority category 2 : None
Category 2 percentage : 0 %
Project construction estimate (MACC): \$42,000
Total project estimate (including soft costs): \$59,000
Additional points based on building condition: 2
Deficiency score : Needs study

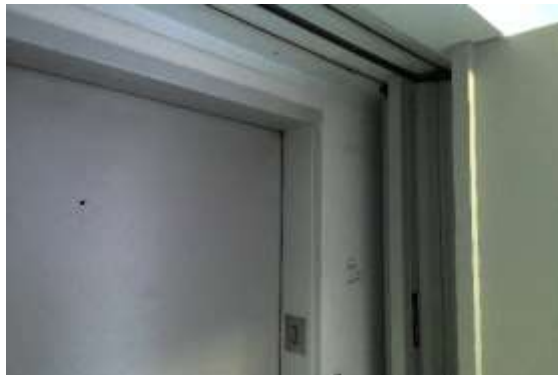
Deficiency F08

Emergency Fire doors are not working properly. When the doors are tested, they require manual operation to fully close and then reset. The door should be replaced.

Scoring priority category 1 : Health/Safety (scoring weight=25)
Category 1 percentage : 70 %
Scoring priority category 2 : System Use (scoring weight=15)
Category 2 percentage : 30 %
Project construction estimate (MACC): \$34,000
Total project estimate (including soft costs): \$48,000
Additional points based on building condition: 1
Deficiency score : $4 \times ((25 \times 70\%) + (15 \times 30\%)) + 1 = 89$

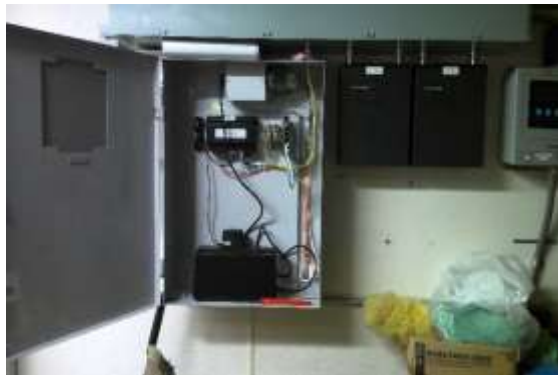
Deficiency F09

The HVAC controls have become unreliable. The controls have lost function and no longer communicate with the main control system. The controls still function locally. The controls should be replaced.

Scoring priority category 1 : High Repair/Repl. Cost (scoring weight=12)
Category 1 percentage : 50 %
Scoring priority category 2 : High Operating Cost (scoring weight=10)
Category 2 percentage : 50 %
Project construction estimate (MACC): \$220,000
Total project estimate (including soft costs): \$312,000
Additional points based on building condition: 0
Deficiency score : $4 \times ((12 \times 50\%) + (10 \times 50\%)) + 0 = 44$

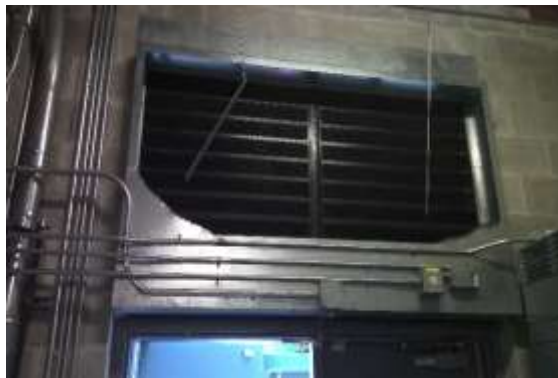
Deficiency F10

The exhaust fan failed and has been removed. The fan should be replaced.

Category 2 percentage : 0 %
Project construction estimate (MACC): \$20,000
Total project estimate (including soft costs): \$28,000
Additional points based on building condition: 1
Deficiency score : $4 \times (15 \times 100\%) + 1 = 61$

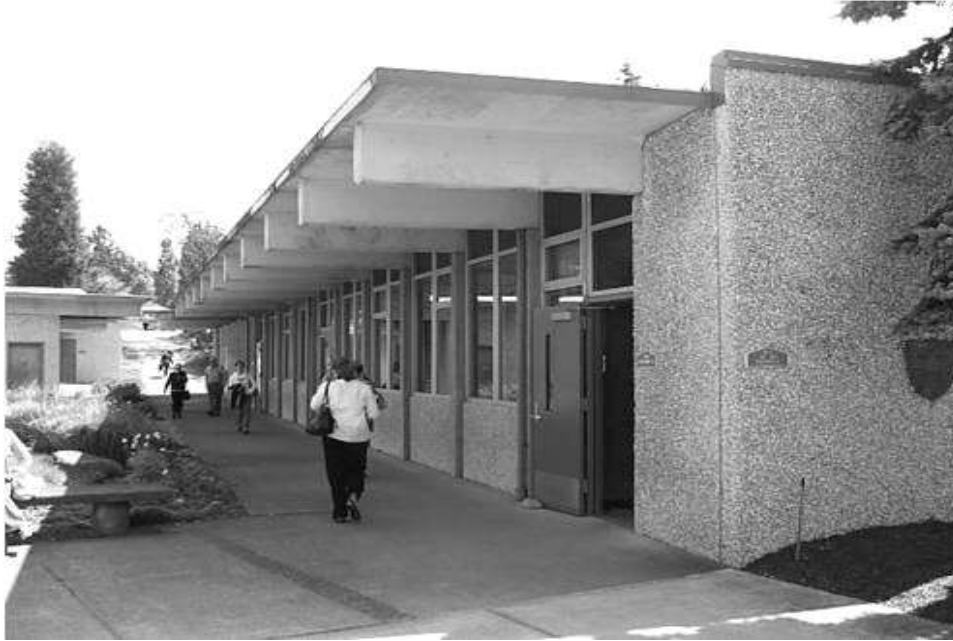
Biology/Science Bldg (090-12) STATE UFI: A01395 Main Campus (090A)
AREA: 6,158 SF BUILT: 1964 REMODELED: No PREDOMINANT USE: Science Lab.
CONSTRUCTION TYPE: Heavy CRV/SF: \$489 REPLACEMENT VALUE: \$3,011,262

Primary Systems			
COMPONENT:	Structure	RATING: 1 x WEIGHT: 8.3 = SCORE: 8.3	
No signs of settlement or cracking, no abrupt vertical changes Columns, bearing walls and roof structure appears sound/free of defects			
COMMENTS:	Concrete frame and tilt-up panels		
COMPONENT:	Exterior Closure	RATING: 1 x WEIGHT: 8.3 = SCORE: 8.3	
Weatherproof, tight, well-maintained exterior walls, doors, windows/finishes			
COMMENTS:	Exposed marble aggregate panels		
COMPONENT:	Roofing	RATING: 1 x WEIGHT: 10.4 = SCORE: 10.4	
Flashing and penetrations appear sound and membrane appears water- tight; drainage is positive and there are overflow scuppers			
COMMENTS:	Hypalon single-ply-2020

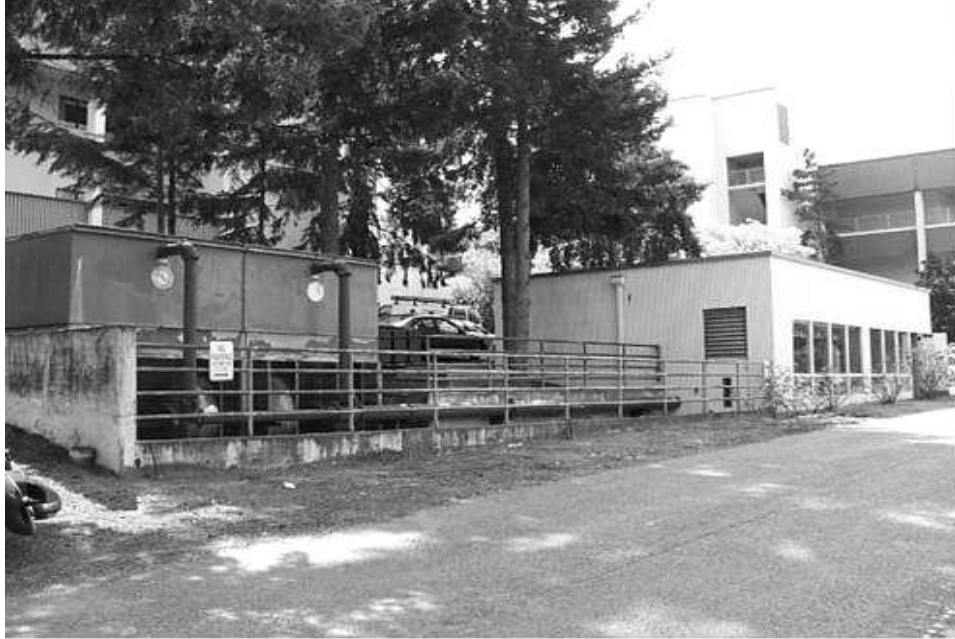
Chiller Bldg (090-25A) STATE UFI: A08359 Main Campus (090A)
AREA: 885 SF BUILT: 1978 REMODELED: No PREDOMINANT USE: Maintenance
CONSTRUCTION TYPE: Medium CRV/SF: \$198 REPLACEMENT VALUE: \$175,230

Primary Systems			
COMPONENT:	Structure	RATING: 1 x WEIGHT: 8.7 =	SCORE: 8.7
No signs of settlement or cracking, no abrupt vertical changes Columns, bearing walls and roof structure appears sound/free of defects			
COMMENTS:	Fluted CMU, open web steel roof joists; concrete base		
COMPONENT:	Exterior Closure	RATING: 3 x WEIGHT: 8.7 =	SCORE: 26.1
Sound and weatherproof but with some physical deterioration evident			
COMMENTS:	CMU		
COMPONENT:	Roofing	RATING: 3 x WEIGHT: 10.9 =	SCORE: 32.7
Some deterioration is evident in membrane and flashings; maintenance or minor repair is needed			
COMMENTS:	Hypalon single-ply

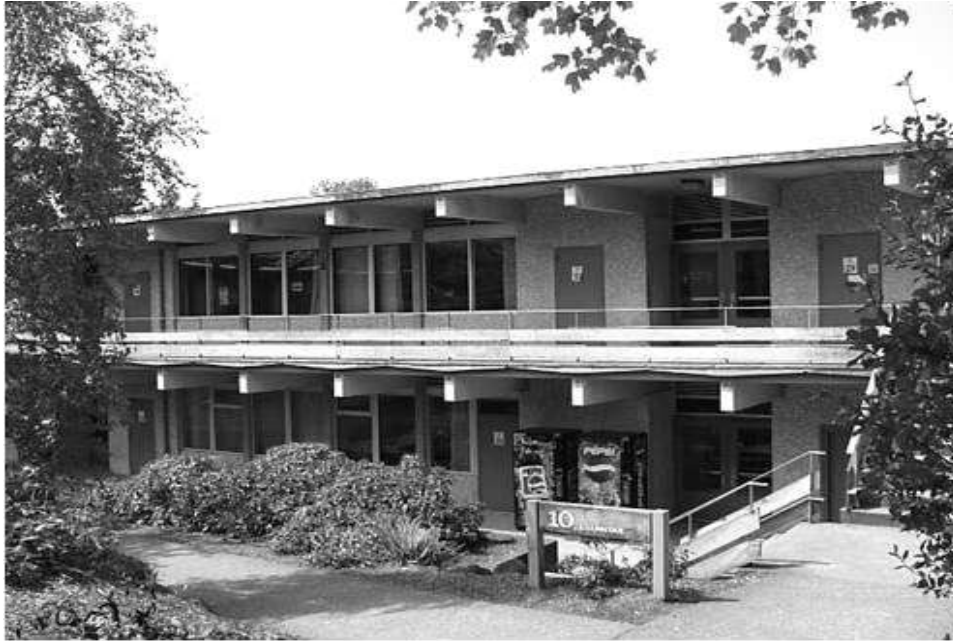
Classroom A Bldg (090-10) STATE UFI: A08756 Main Campus (090A)
AREA: 11,526 SF BUILT: 1964 REMODELED: 1996 PREDOMINANT USE: General Classroom
CONSTRUCTION TYPE: Heavy CRV/SF: \$376 REPLACEMENT VALUE: \$4,333,776

Primary Systems			
COMPONENT:	Structure	RATING: 1 x WEIGHT: 8 =	SCORE: 8
No signs of settlement or cracking, no abrupt vertical changes Columns, bearing walls and roof structure appears sound/free of defects			
COMMENTS:	Concrete frame and tilt-up panels		
COMPONENT:	Exterior Closure	RATING: 2 x WEIGHT: 8 =	SCORE: 16
Weatherproof exterior, but finish appears poorly maintained			
COMMENTS:	Exposed marble aggregate panels, joints need to be re-caulked		
COMPONENT:	Roofing	RATING: 1 x WEIGHT: 10 =	SCORE: 10
Flashing and penetrations appear sound and membrane appears water- tight; drainage is positive and there are overflow scuppers			
COMMENTS:	PVC single-ply membrane-2010

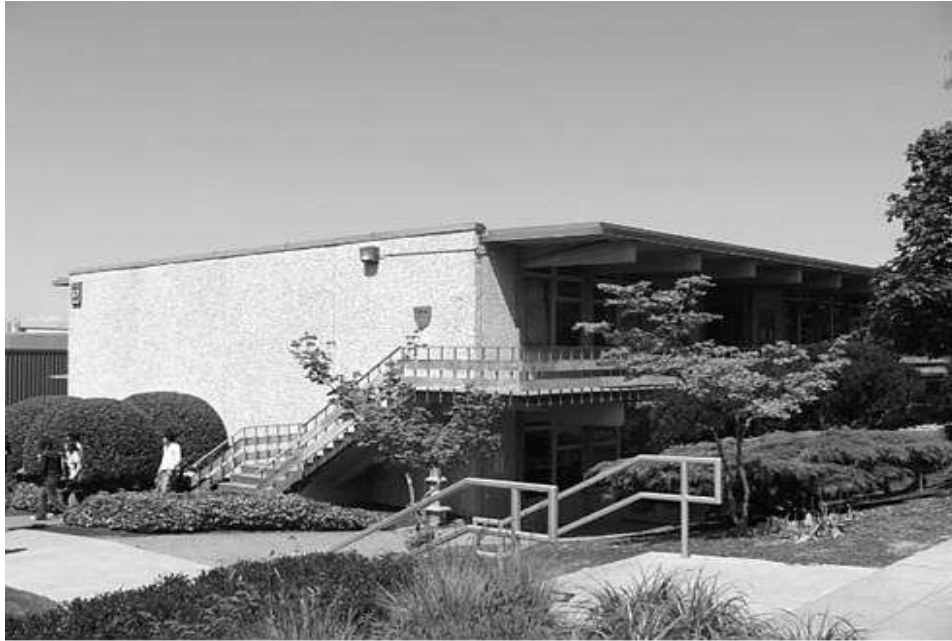
Classroom B Bldg (090-17) STATE UFI: A01532 Main Campus (090A)
AREA: 11,426 SF BUILT: 1967 REMODELED: No PREDOMINANT USE: General Classroom
CONSTRUCTION TYPE: Heavy CRV/SF: \$376 REPLACEMENT VALUE: \$4,296,176

Primary Systems			
COMPONENT:	Structure	RATING: 2 x WEIGHT: 8 =	SCORE: 16
Minor cracks evident in a small portion of the structure			
COMMENTS: Concrete frame and tilt-up panels			
COMPONENT:	Exterior Closure	RATING: 1 x WEIGHT: 8 =	SCORE: 8
Weatherproof, tight, well-maintained exterior walls, doors, windows/finishes			
COMMENTS: Exposed marble aggregate panels; concrete; repairs and panel seals 2019			
COMPONENT:	Roofing	RATING: 1 x WEIGHT: 10 =	SCORE: 10
Flashing and penetrations appear sound and membrane appears water- tight; drainage is positive and there are overflow scuppers			
COMMENTS: single-ply-2013

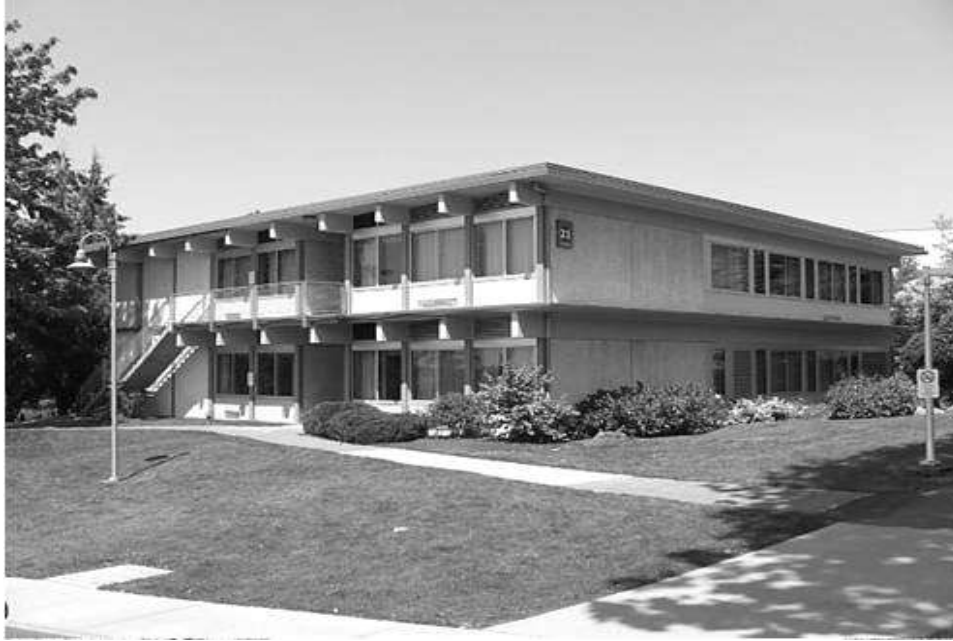
Classroom C Bldg (090-21) STATE UFI: A02397 Main Campus (090A)
AREA: 9,418 SF BUILT: 1967 REMODELED: 2003 PREDOMINANT USE: General Classroom
CONSTRUCTION TYPE: Heavy CRV/SF: \$376 REPLACEMENT VALUE: \$3,541,168

Primary Systems			
COMPONENT:	Structure	RATING: 1 x WEIGHT: 8 =	SCORE: 8
No signs of settlement or cracking, no abrupt vertical changes Columns, bearing walls and roof structure appears sound/free of defects			
COMMENTS:	Concrete frame and tilt-up panels		
COMPONENT:	Exterior Closure	RATING: 3 x WEIGHT: 8 =	SCORE: 24
Sound and weatherproof but with some physical deterioration evident			
COMMENTS:	Exposed marble aggregate panels; metal panels		
COMPONENT:	Roofing	RATING: 2 x WEIGHT: 10 =	SCORE: 20
Majority of roofing and flashing appear sound, but a small portion of roofing shows deterioration where maintenance or minor repair needed			
COMMENTS:	PVC roof-2004; skylights

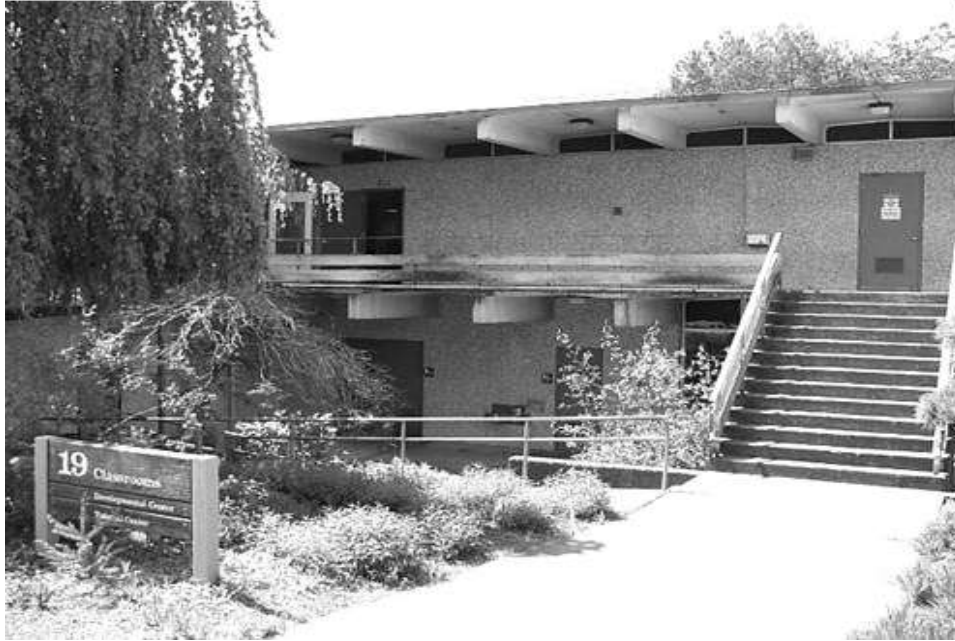
Classroom E Bldg (090-19) STATE UFI: A05596 Main Campus (090A)
AREA: 15,624 SF BUILT: 1964 REMODELED: 2008 PREDOMINANT USE: General Classroom
CONSTRUCTION TYPE: Heavy CRV/SF: \$376 REPLACEMENT VALUE: \$5,874,624

Primary Systems			
COMPONENT:	Structure	RATING: 2 x WEIGHT: 8 =	SCORE: 16
Minor cracks evident in a small portion of the structure			
COMMENTS: Concrete frame and tilt-up panels; spalling concrete at second floor balcony edge			
COMPONENT:	Exterior Closure	RATING: 1 x WEIGHT: 8 =	SCORE: 8
Weatherproof, tight, well-maintained exterior walls, doors, windows/finishes			
COMMENTS: Exposed marble aggregate panels			
COMPONENT:	Roofing	RATING: 1 x WEIGHT: 10 =	SCORE: 10
Flashing and penetrations appear sound and membrane appears water- tight; drainage is positive and there are overflow scuppers			
COMMENTS: TPO single-ply membrane-2008

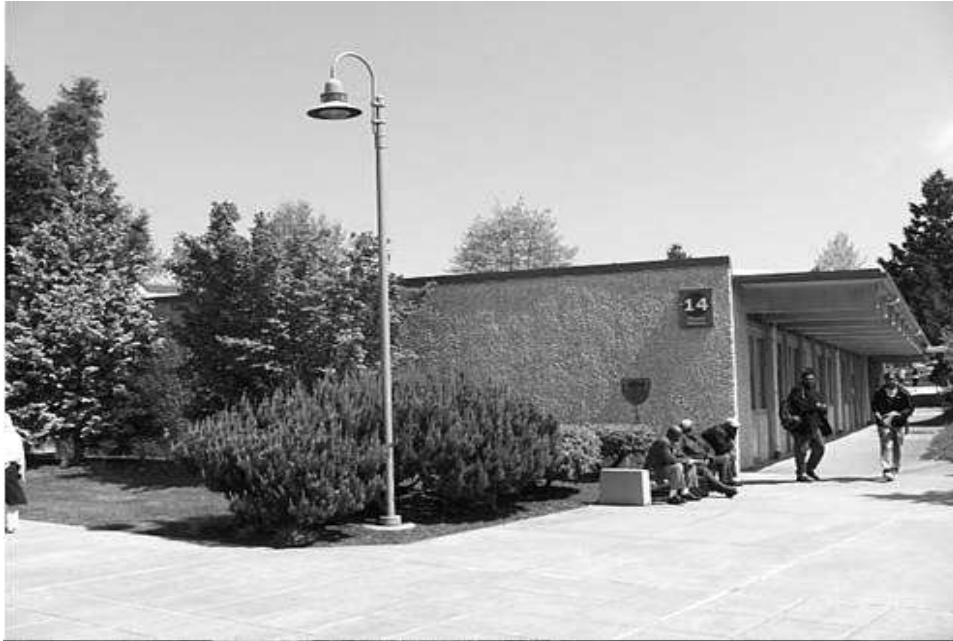
Classroom F (090-14) STATE UFI: A05209 Main Campus (090A)
 AREA: 6,060 SF BUILT: 1964 REMODELED: 2006 PREDOMINANT USE: General Classroom
 CONSTRUCTION TYPE: Heavy CRV/SF: \$376 REPLACEMENT VALUE: \$2,278,560

Primary Systems			
COMPONENT:	Structure	RATING: 1 x WEIGHT: 8.3 = SCORE: 8.3	
No signs of settlement or cracking, no abrupt vertical changes Columns, bearing walls and roof structure appears sound/free of defects			
COMMENTS:	Concrete frame and tilt-up panels		
COMPONENT:	Exterior Closure	RATING: 1 x WEIGHT: 8.3 = SCORE: 8.3	
Weatherproof, tight, well-maintained exterior walls, doors, windows/finishes			
COMMENTS:	Exposed marble aggregate panels		
COMPONENT:	Roofing	RATING: 1 x WEIGHT: 10.4 = SCORE: 10.4	
Flashing and penetrations appear sound and membrane appears water- tight; drainage is positive and there are overflow scuppers			
COMMENTS:	PVC single-ply membrane-2005

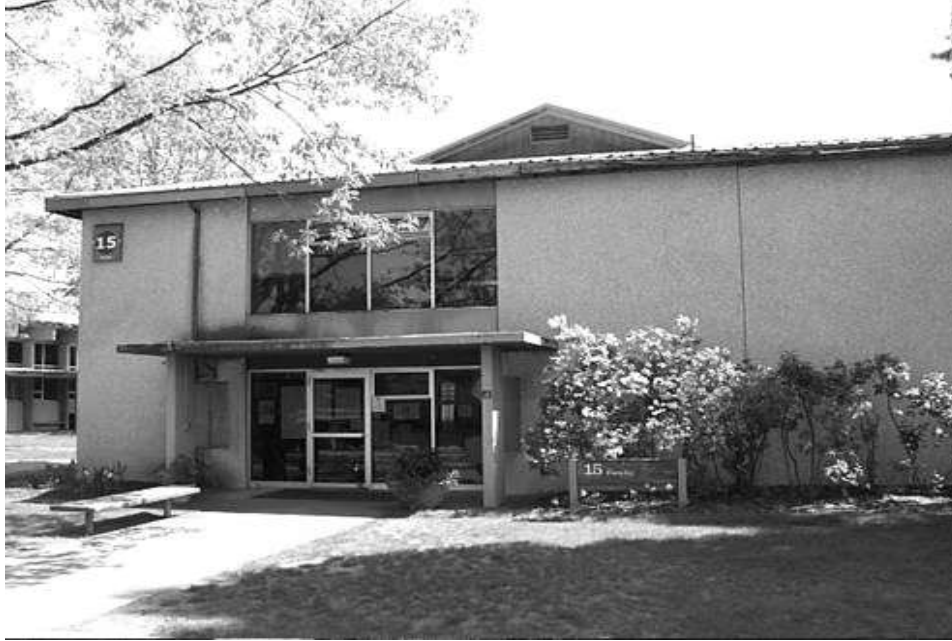
Faculty C Bldg (090-15) STATE UFI: A03870 Main Campus (090A)
 AREA: 4,297 SF BUILT: 1967 REMODELED: No PREDOMINANT USE: Faculty Office
 CONSTRUCTION TYPE: Medium CRV/SF: \$336 REPLACEMENT VALUE: \$1,443,792

Primary Systems			
COMPONENT:	Structure	RATING: 3 x WEIGHT: 8 =	SCORE: 24
Some cracking evident but does not likely affect structural integrity; Visible defects apparent but are non-structural			
COMMENTS:	Concrete; glu-lam beams; entry canopy concerns; seismic concerns		
COMPONENT:	Exterior Closure	RATING: 3 x WEIGHT: 8 =	SCORE: 24
Sound and weatherproof but with some physical deterioration evident			
COMMENTS:	Exposed marble aggregate panels, need to be re-caulked		
COMPONENT:	Roofing	RATING: 3 x WEIGHT: 10 =	SCORE: 30
Some deterioration is evident in membrane and flashings; maintenance or minor repair is needed			
COMMENTS:	Standing seam metal-1985; skylights

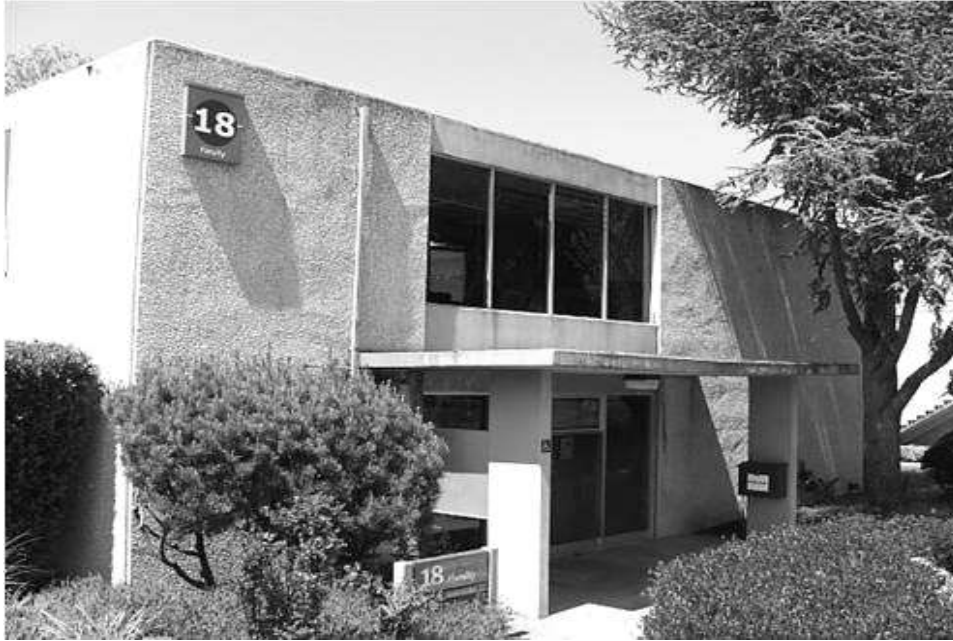
Faculty D Bldg (090-18) STATE UFI: A06104 Main Campus (090A)
AREA: 4,291 SF BUILT: 1967 REMODELED: No PREDOMINANT USE: Faculty Office
CONSTRUCTION TYPE: Medium CRV/SF: \$336 REPLACEMENT VALUE: \$1,441,776

Primary Systems			
COMPONENT:	Structure	RATING: 3 x WEIGHT: 8 =	SCORE: 24
Some cracking evident but does not likely affect structural integrity; Visible defects apparent but are non-structural			
COMMENTS:	Concrete; glu-lam beams; entry canopy concerns; seismic concerns		
COMPONENT:	Exterior Closure	RATING: 3 x WEIGHT: 8 =	SCORE: 24
Sound and weatherproof but with some physical deterioration evident			
COMMENTS:	Exposed marble aggregate panels, need to be re-caulked		
COMPONENT:	Roofing	RATING: 3 x WEIGHT: 10 =	SCORE: 30
Some deterioration is evident in membrane and flashings; maintenance or minor repair is needed			
COMMENTS:	Hypalon single-ply membrane-1992;deteriorated
