2023 FACILITY CONDITION SURVEY

Lake Washington Institute of
Technology

SURVEY CONDUCTED BY:
Steve Lewandowski
State Board for Community
and Technical Colleges

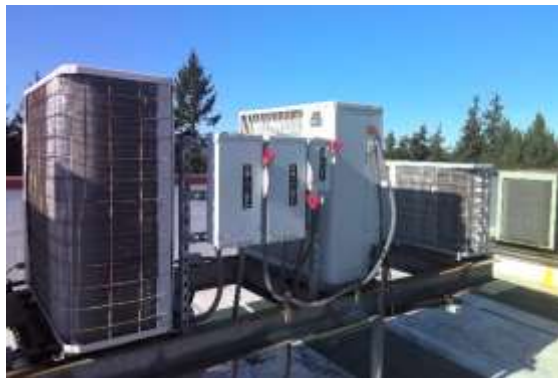
Deficiency F02

The HVAC unit (number four) has failed and should be replaced.

Carryover from prior survey : No
Location : Main Campus (260A)
Building name : Technology Center (260-Tec)
Unique Facility Identifier (UFI) : A05661
Funding category in capital budget : Minor Works Facility appropriation
Uniformat category : D30-HVAC
Assessment : Asset is near or at the end of its useful life and should be replaced
Quantity : 1
Unit of measurement : EA
Component : HVAC unit
Location within building or site : 3 rd floor and roof
Issue clarity : Adequate information was provided to assess deficiency
Main cause of asset degradation or failure : Age/Wear
Detailed description : The HVAC unit (number four) has failed and should be replaced.
Recommended funding schedule : Immediate (scoring weight=4)
Estimated remaining life (years) : 7
Estimated average life expectancy (years) : 25
Scoring priority category 1 : High Repair/Repl. Cost (scoring weight=12)
Category 1 percentage : 60 %
Scoring priority category 2 : System Use (scoring weight=15)

Category 2 percentage : 40 %
Project construction estimate (MACC): \$50,000
Total project estimate (including soft costs): \$70,000
Additional points based on building condition: 1
Deficiency score : $4 \times ((12 \times 60\%) + (15 \times 40\%)) + 1 = 53.8$

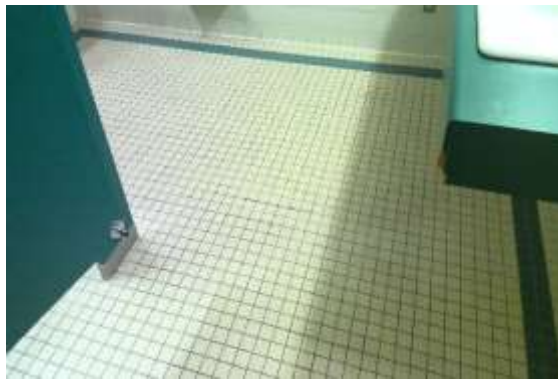
Deficiency F03

There is a small area of floor tile that has become loose. The tile is still intact, but requires maintenance to re-attached it to the sub-flooring. The college is concerned that this delamination may continue to become worse. The tile should continue to be monitored for repairs.

Carryover from prior survey : No
Location : Main Campus (260A)
Building name : West Building (260-Wes)
Unique Facility Identifier (UFI) : A09481
Funding category in capital budget : Minor Works Facility appropriation
Unifomat category : C10-Interior Construction
Assessment : Asset is near or at the end of its useful life and should be replaced
Quantity : 4
Unit of measurement : EA
Component : Flooring (non carpet)
Location within building or site : 4th floor
Issue clarity : Adequate information was provided to assess deficiency
Main cause of asset degradation or failure : Age/Wear
Detailed description : There is a small area of floor tile that has become loose. The tile is still intact, but requires maintenance to re-attached it to the sub-flooring. The college is concerned that this delamination may continue to become worse. The tile should continue to be monitored for repairs.
Recommended funding schedule : Deferred Backlog (scoring weight=1)

Estimated remaining life (years) : 7
Estimated average life expectancy (years) : 30
Scoring priority category 1 : Quality of Use (scoring weight=5)
Category 1 percentage : 70 %
Scoring priority category 2 : High Repair/Repl. Cost (scoring weight=12)
Category 2 percentage : 30 %
Project construction estimate (MACC): \$60,000
Total project estimate (including soft costs): \$85,000
Additional points based on building condition: 1
Deficiency score : $1 \times ((5 \times 70\%) + (12 \times 30\%)) + 1 = 8.1$

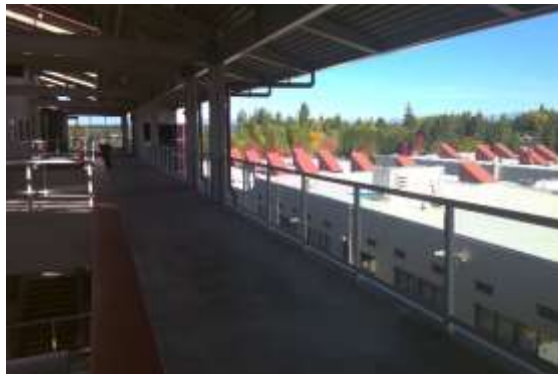
Deficiency F04

The exterior circulation is not protected from the elements, which cause damage to the walkway building components. Also, during winter months, the snow and rain can create hazardous conditions for occupants using the exterior circulation. The roof overhang has failed to protect the building as designed. The lower two levels of the exterior circulation areas on the east side of the building should be protected from the elements to ensure that further damage does not occur.

Carryover from prior survey : No
Location : Main Campus (260A)
Building name : Technology Center (260-Tec)
Unique Facility Identifier (UFI) : A05661
Funding category in capital budget : Minor Works Facility appropriation
Uniformat category : B20-Exterior Enclosure
Assessment : Asset is near or at the end of its useful life and should be replaced
Quantity : 1
Unit of measurement : EA
Component : Storefront system
Location within building or site : Multiple
Issue clarity : Adequate information was provided to assess deficiency
Main cause of asset degradation or failure : Design
Detailed description : The exterior circulation is not protected from the elements, which cause damage to the walkway building components. Also, during winter months, the snow and rain can create hazardous conditions for occupants using the exterior circulation. The roof overhang has failed to protect the building as designed. The lower two levels of the exterior circulation areas on the east side of the building should be protected from the elements to ensure that further damage does not occur.

Recommended funding schedule : Immediate (scoring weight=4)
Estimated remaining life (years) : 3
Estimated average life expectancy (years) : 40
Scoring priority category 1 : System Use (scoring weight=15)
Category 1 percentage : 90 %
Scoring priority category 2 : Quality of Use (scoring weight=5)
Category 2 percentage : 10 %
Project construction estimate (MACC): \$778,000
Total project estimate (including soft costs): \$1,104,000
Additional points based on building condition: 1
Deficiency score : $4 \times ((15 \times 90\%) + (5 \times 10\%)) + 1 = 57$

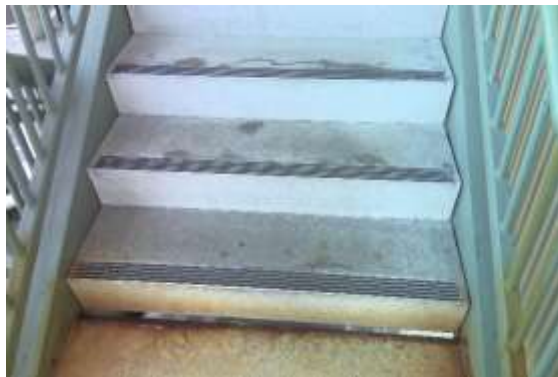
Deficiency F05

The north exterior stairwell stair treads have exhibited some cracking. The cracking has been repaired through regular maintenance efforts, but the college is concerned about the condition getting worse. The stairs should continue to be maintained and be monitored for repairs or replacement.

Carryover from prior survey : No
Location : Main Campus (260A)
Building name : Technology Center (260-Tec)
Unique Facility Identifier (UFI) : A05661
Funding category in capital budget : Minor Works Facility appropriation
Unifomat category : C20-Stairs
Assessment : Asset is near or at the end of its useful life and should be replaced
Quantity : 1
Unit of measurement : EA
Component : Stair surface
Location within building or site : Multiple
Issue clarity : Adequate information was provided to assess deficiency
Main cause of asset degradation or failure : Weather
Detailed description : The north exterior stairwell stair treads have exhibited some cracking. The cracking has been repaired through regular maintenance efforts, but the college is concerned about the condition getting worse. The stairs should continue to be maintained and be monitored for repairs or replacement.
Recommended funding schedule : Deferred Backlog (scoring weight=1)

Estimated remaining life (years) : 3
Estimated average life expectancy (years) : 25
Scoring priority category 1 : High Repair/Repl. Cost (scoring weight=12)
Category 1 percentage : 60 %
Scoring priority category 2 : System Use (scoring weight=15)
Category 2 percentage : 40 %
Project construction estimate (MACC): \$120,000
Total project estimate (including soft costs): \$170,000
Additional points based on building condition: 1
Deficiency score : $1 \times ((12 \times 60\%) + (15 \times 40\%)) + 1 = 14.2$

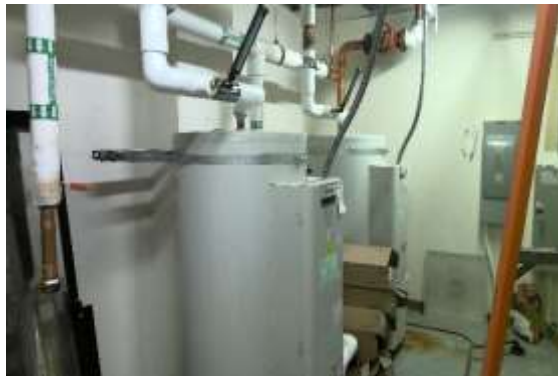
Deficiency F06

The hot water storage tanks have begun to rust and leak. Also, many sections of the copper piping leaks due to thinning pipe walls and pinhole leaks. The copper pipe has degraded more severely in the lower level of the building due to gravity and delivery of circulated water. The storage tanks and the lower level domestic water lines should be replaced. The domestic water lines in the upper levels should continue to be monitored for repairs or replacement.

Carryover from prior survey : No
Location : Main Campus (260A)
Building name : West Building (260-Wes)
Unique Facility Identifier (UFI) : A09481
Funding category in capital budget : Minor Works Facility appropriation
Unifomat category : D20-Plumbing
Assessment : Asset is near or at the end of its useful life and should be replaced
Quantity : 2
Unit of measurement : EA
Component : Hot water tank
Location within building or site : Multiple
Issue clarity : Adequate information was provided to assess deficiency
Main cause of asset degradation or failure : Installation
Detailed description : The hot water storage tanks have begun to rust and leak. Also, many sections of the copper piping leaks due to thinning pipe walls and pinhole leaks. The copper pipe has degraded more severely in the lower level of the building due to gravity and delivery of circulated water. The storage tanks and the lower level domestic water lines should be replaced. The domestic water lines in the upper levels should continue to be monitored for repairs or replacement.

Recommended funding schedule : Immediate (scoring weight=4)
Estimated remaining life (years) : 3
Estimated average life expectancy (years) : 30
Scoring priority category 1 : High Repair/Repl. Cost (scoring weight=12)
Category 1 percentage : 90 %
Scoring priority category 2 : High Repair/Repl. Cost (scoring weight=12)
Category 2 percentage : 10 %
Project construction estimate (MACC): \$65,000
Total project estimate (including soft costs): \$92,000
Additional points based on building condition: 1
Deficiency score : $4 \times ((12 \times 90\%) + (12 \times 10\%)) + 1 = 49$

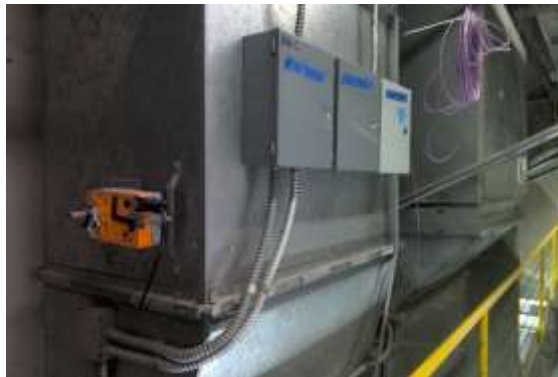
Deficiency F07

The college is concerned about the age of the unit heaters located on the north ends of the shop portions of the building. These units are near the end of their expectant life, but still function well. All of the other unit heaters serving the shop portions of the buildings have already been replaced since they were in worse condition. These units should continue to be monitored for replacement.

Carryover from prior survey : No
Location : Main Campus (260A)
Building name : East Building (260-Eas)
Unique Facility Identifier (UFI) : A02059
Funding category in capital budget : Minor Works Facility appropriation
Unifomat category : D30-HVAC
Assessment : Asset is near or at the end of its useful life and should be replaced
Quantity : 2
Unit of measurement : EA
Component : Unit heaters
Location within building or site : 1st floor
Issue clarity : Adequate information was provided to assess deficiency
Main cause of asset degradation or failure : Age/Wear
Detailed description : The college is concerned about the age of the unit heaters located on the north ends of the shop portions of the building. These units are near the end of their expectant life, but still function well. All of the other unit heaters serving the shop portions of the buildings have already been replaced since they were in worse condition. These units should continue to be monitored for replacement.

Recommended funding schedule : Fund in Next Biennium (scoring weight=2.5)
Estimated remaining life (years) : (No Data)
Estimated average life expectancy (years) : 30
Scoring priority category 1 : High Repair/Repl. Cost (scoring weight=12)
Category 1 percentage : 80 %
Scoring priority category 2 : High Operating Cost (scoring weight=10)
Category 2 percentage : 20 %
Project construction estimate (MACC): \$184,000
Total project estimate (including soft costs): \$261,000
Additional points based on building condition: 2
Deficiency score : $2.5 \times ((12 \times 80\%) + (10 \times 20\%)) + 2 = 31$

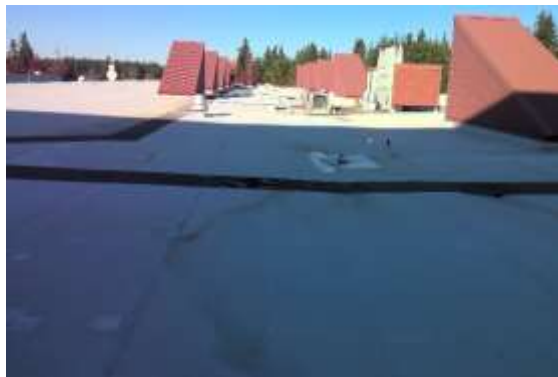
Deficiency R01

The east portion of the single-ply roofing has degraded and leaks in several areas near the roof transitions and drains. The roofing should be repaired to regain a water-tight condition and also be reconditioned to extend its useful life.

Carryover from prior survey : No
Location : Main Campus (260A)
Building name : East Building (260-Eas)
Unique Facility Identifier (UFI) : A02059
Funding category in capital budget : Minor Works Roof appropriation
Unifomat category : B30-Roofing
Assessment : Asset should be repaired to extend its useful life
Quantity : 33700
Unit of measurement : SF
Component : Single-Ply (PVC)
Location within building or site : Roof
Issue clarity : Adequate information was provided to assess deficiency
Main cause of asset degradation or failure : Age/Wear
Detailed description : The east portion of the single-ply roofing has degraded and leaks in several areas near the roof transitions and drains. The roofing should be repaired to regain a water-tight condition and also be reconditioned to extend its useful life.
Recommended funding schedule : Immediate (scoring weight=4)
Estimated remaining life (years) : 3
Estimated average life expectancy (years) : 25

Scoring priority category 1 : System Use (scoring weight=15)
Category 1 percentage : 70 %
Scoring priority category 2 : High Repair/Repl. Cost (scoring weight=12)
Category 2 percentage : 30 %
Project construction estimate (MACC): \$404,000
Total project estimate (including soft costs): \$573,000
Additional points based on building condition: 2
Deficiency score : $4 \times ((15 \times 70\%) + (12 \times 30\%)) + 2 = 58.4$

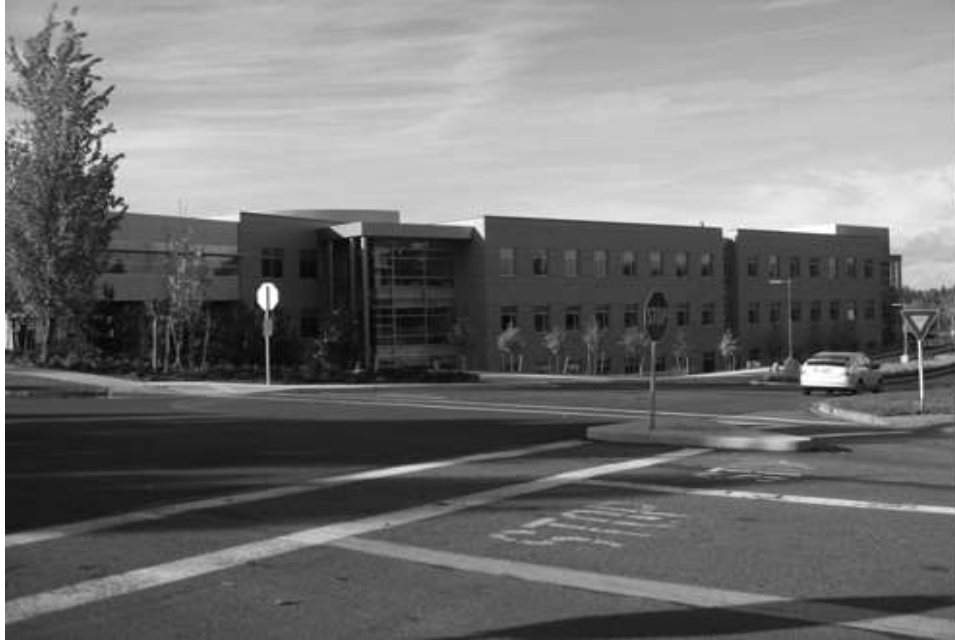
Allied Health Building (260-AHB) STATE UFI: A10928 Main Campus (260A)
AREA: 83,700 SF BUILT: 2011 REMODELED: No PREDOMINANT USE: Vocational
CONSTRUCTION TYPE: Heavy CRV/SF: \$494 REPLACEMENT VALUE: \$41,347,800

Primary Systems			
COMPONENT:	Structure	RATING: 1 x WEIGHT: 8.4 =	SCORE: 8.4
No signs of settlement or cracking, no abrupt vertical changes Columns, bearing walls and roof structure appears sound/free of defects			
COMMENTS:	Steel frame		
COMPONENT:	Exterior Closure	RATING: 1 x WEIGHT: 8.4 =	SCORE: 8.4
Weatherproof, tight, well-maintained exterior walls, doors, windows/finishes			
COMMENTS:	Brick; aluminum window walls		
COMPONENT:	Roofing	RATING: 1 x WEIGHT: 10.5 =	SCORE: 10.5
Flashing and penetrations appear sound and membrane appears water- tight; drainage is positive and there are overflow scuppers			
COMMENTS:	TPO single-ply

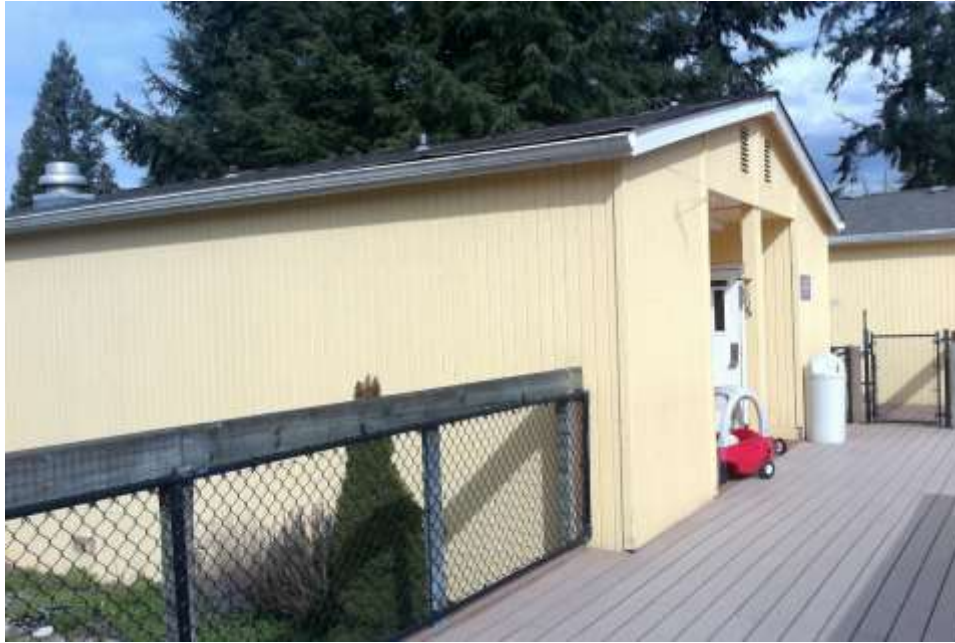
Child Care 1 (260-S01) STATE UFI: A10926 Main Campus (260A)
 AREA: 1,130 SF BUILT: 0 REMODELED: No PREDOMINANT USE: Rest Room
 CONSTRUCTION TYPE: Temporary CRV/SF: \$198 REPLACEMENT VALUE: \$223,740

Primary Systems			
COMPONENT:	Structure	RATING: 5 x WEIGHT: 8.3 = SCORE: 41.7	
Visible settlement and potential structural failure; potential safety hazard Structural defects apparent in superstructure			
COMMENTS:	Wood frame; pier block foundations		
COMPONENT:	Exterior Closure	RATING: 3 x WEIGHT: 8.3 = SCORE: 25	
Sound and weatherproof but with some physical deterioration evident			
COMMENTS:	T1-11 plywood		
COMPONENT:	Roofing	RATING: 1 x WEIGHT: 10.4 = SCORE: 10.4	
Flashing and penetrations appear sound and membrane appears water- tight; drainage is positive and there are overflow scuppers			
COMMENTS:	3-tab composition shingles-1999

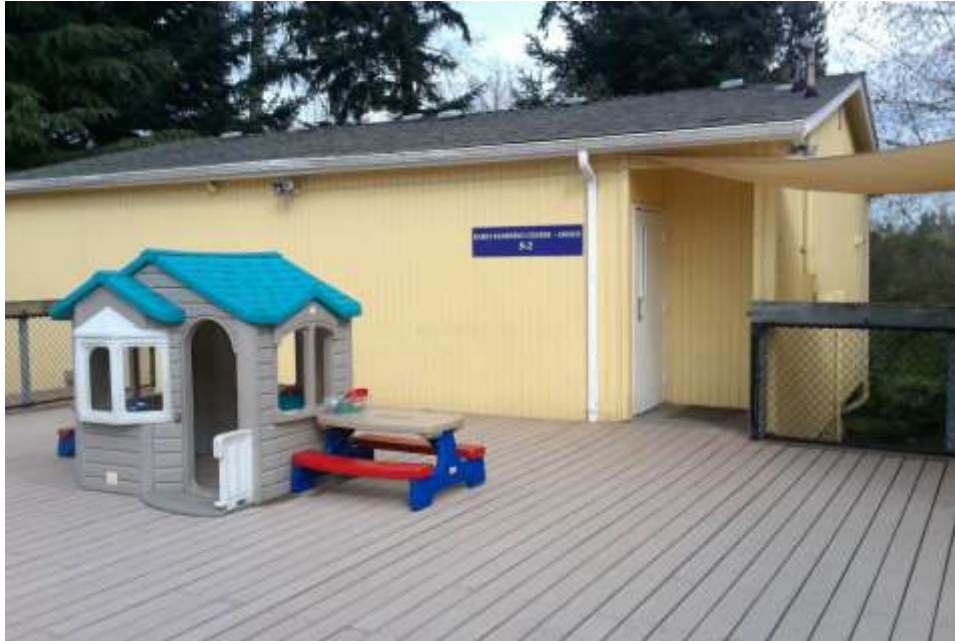
Child Care 2 (260-S02) STATE UFI: A10851 Main Campus (260A)
AREA: 1,130 SF BUILT: 0 REMODELED: No PREDOMINANT USE: Child Care
CONSTRUCTION TYPE: Temporary CRV/SF: \$198 REPLACEMENT VALUE: \$223,740

Primary Systems			
COMPONENT:	Structure	RATING: 5 x WEIGHT: 8.3 = SCORE: 41.7	
Visible settlement and potential structural failure; potential safety hazard Structural defects apparent in superstructure			
COMMENTS:	Wood frame; pier block foundations		
COMPONENT:	Exterior Closure	RATING: 3 x WEIGHT: 8.3 = SCORE: 25	
Sound and weatherproof but with some physical deterioration evident			
COMMENTS:	T1-11 plywood		
COMPONENT:	Roofing	RATING: 2 x WEIGHT: 10.4 = SCORE: 20.9	
Majority of roofing and flashing appear sound, but a small portion of roofing shows deterioration where maintenance or minor repair needed			
COMMENTS:	3-tab composition shingles-1999

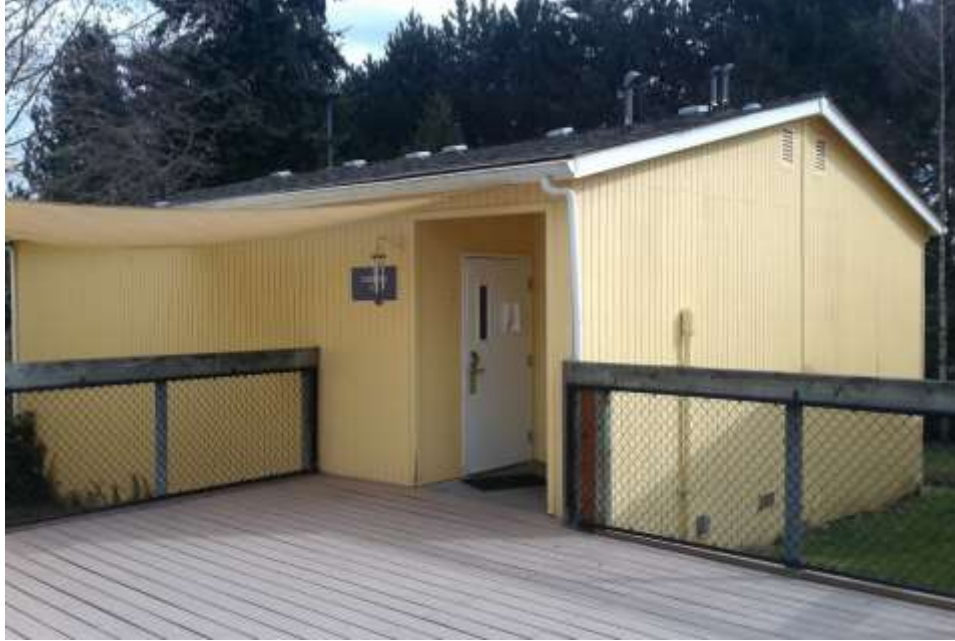
Child Care 3 (260-S03) STATE UFI: A10016 Main Campus (260A)
AREA: 1,130 SF BUILT: 0 REMODELED: No PREDOMINANT USE: Child Care
CONSTRUCTION TYPE: No data CRV/SF: \$188 REPLACEMENT VALUE: \$212,440

Primary Systems			
COMPONENT:	Structure	RATING: 5 x WEIGHT: 8.3 = SCORE: 41.7	
Visible settlement and potential structural failure; potential safety hazard Structural defects apparent in superstructure			
COMMENTS:	Wood frame; pier block foundations		
COMPONENT:	Exterior Closure	RATING: 4 x WEIGHT: 8.3 = SCORE: 33.4	
General deterioration detected, one or more minor leaks apparent			
COMMENTS:	T1-11 plywood		
COMPONENT:	Roofing	RATING: 1 x WEIGHT: 10.4 = SCORE: 10.4	
Flashing and penetrations appear sound and membrane appears water- tight; drainage is positive and there are overflow scuppers			
COMMENTS:	3-tab composition shingles-1999

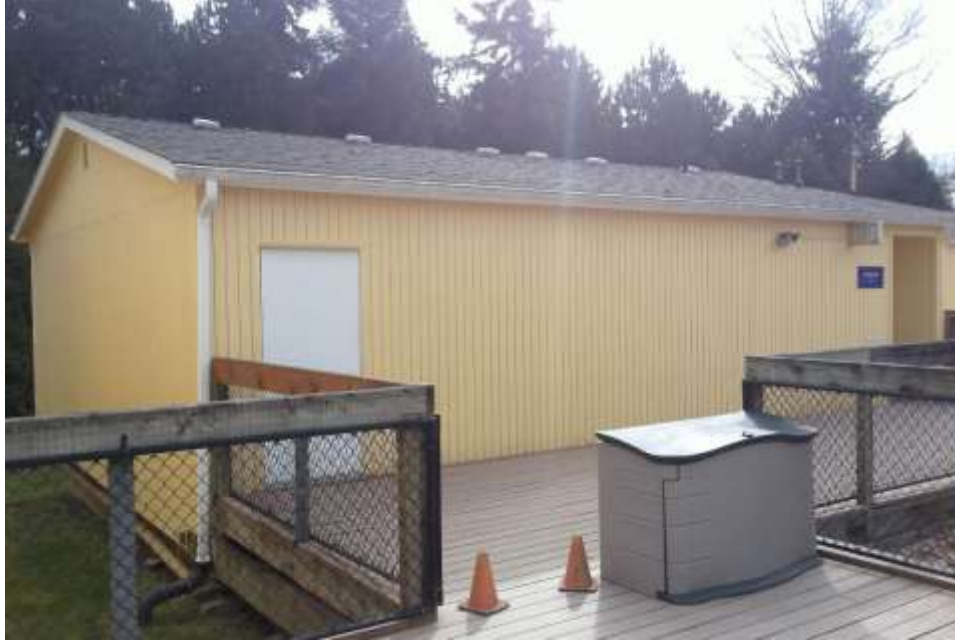
Child Care 4 (260-S04) STATE UFI: A10660 Main Campus (260A)
AREA: 1,130 SF BUILT: 0 REMODELED: No PREDOMINANT USE: Child Care
CONSTRUCTION TYPE: No data CRV/SF: \$188 REPLACEMENT VALUE: \$212,440

Primary Systems			
COMPONENT:	Structure	RATING: 5 x WEIGHT: 8.3 = SCORE: 41.7	
Visible settlement and potential structural failure; potential safety hazard Structural defects apparent in superstructure			
COMMENTS:	Wood frame; pier block foundations		
COMPONENT:	Exterior Closure	RATING: 3 x WEIGHT: 8.3 = SCORE: 25	
Sound and weatherproof but with some physical deterioration evident			
COMMENTS:	T1-11 plywood		
COMPONENT:	Roofing	RATING: 2 x WEIGHT: 10.4 = SCORE: 20.9	
Majority of roofing and flashing appear sound, but a small portion of roofing shows deterioration where maintenance or minor repair needed			
COMMENTS:	3-tab composition shingles-1999

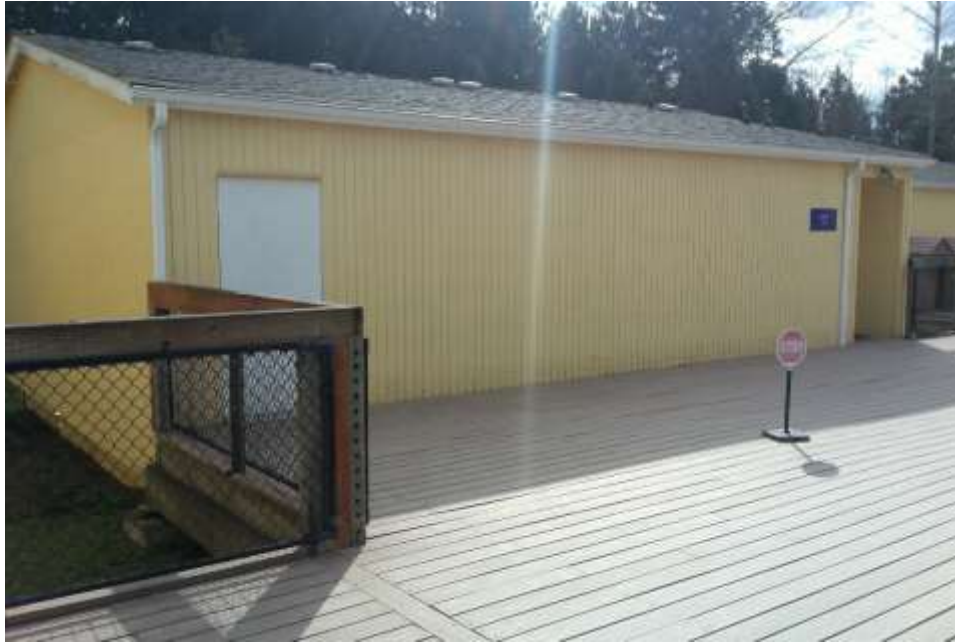
Child Care 5 (260-S05) STATE UFI: A10739 Main Campus (260A)
 AREA: 1,130 SF BUILT: 0 REMODELED: No PREDOMINANT USE: Child Care
 CONSTRUCTION TYPE: No data CRV/SF: \$188 REPLACEMENT VALUE: \$212,440

Primary Systems			
COMPONENT:	Structure	RATING: 5 x WEIGHT: 8.3 =	SCORE: 41.7
Visible settlement and potential structural failure; potential safety hazard Structural defects apparent in superstructure			
COMMENTS:	Wood frame; pier block foundations		
COMPONENT:	Exterior Closure	RATING: 3 x WEIGHT: 8.3 =	SCORE: 25
Sound and weatherproof but with some physical deterioration evident			
COMMENTS:	T1-11 plywood		
COMPONENT:	Roofing	RATING: 2 x WEIGHT: 10.4 =	SCORE: 20.9
Majority of roofing and flashing appear sound, but a small portion of roofing shows deterioration where maintenance or minor repair needed			
COMMENTS:	3-tab composition shingles-1999

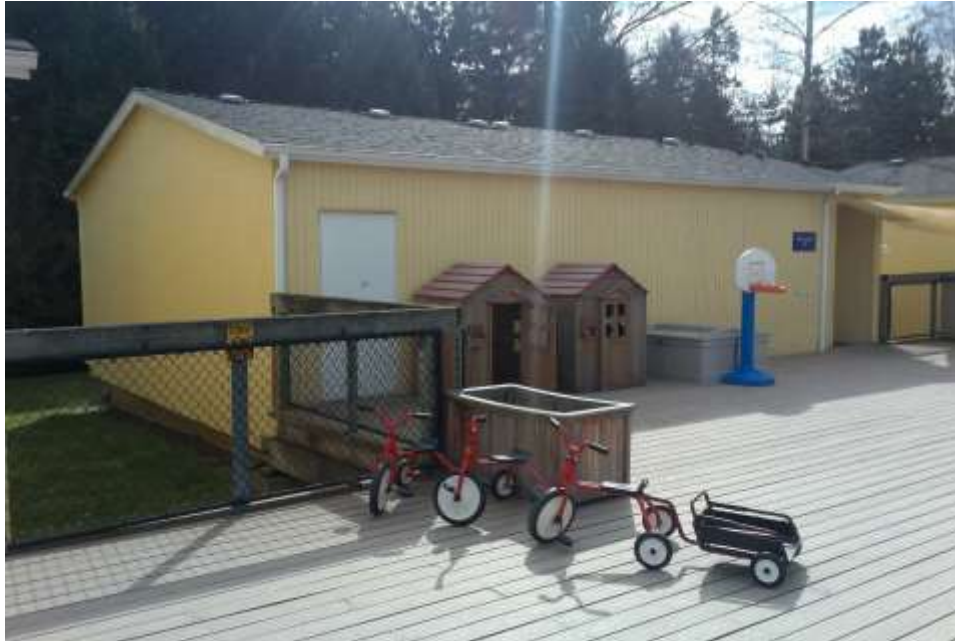
Child Care 6 (260-S06) STATE UFI: A10290 Main Campus (260A)
 AREA: 1,130 SF BUILT: 0 REMODELED: No PREDOMINANT USE: Child Care
 CONSTRUCTION TYPE: No data CRV/SF: \$188 REPLACEMENT VALUE: \$212,440

Primary Systems			
COMPONENT:	Structure	RATING: 5 x WEIGHT: 8.3 = SCORE: 41.7	
Visible settlement and potential structural failure; potential safety hazard Structural defects apparent in superstructure			
COMMENTS:	Wood frame; pier block foundations		
COMPONENT:	Exterior Closure	RATING: 3 x WEIGHT: 8.3 = SCORE: 25	
Sound and weatherproof but with some physical deterioration evident			
COMMENTS:	T1-11 plywood		
COMPONENT:	Roofing	RATING: 2 x WEIGHT: 10.4 = SCORE: 20.9	
Majority of roofing and flashing appear sound, but a small portion of roofing shows deterioration where maintenance or minor repair needed			
COMMENTS:	3-tab composition shingles-1999

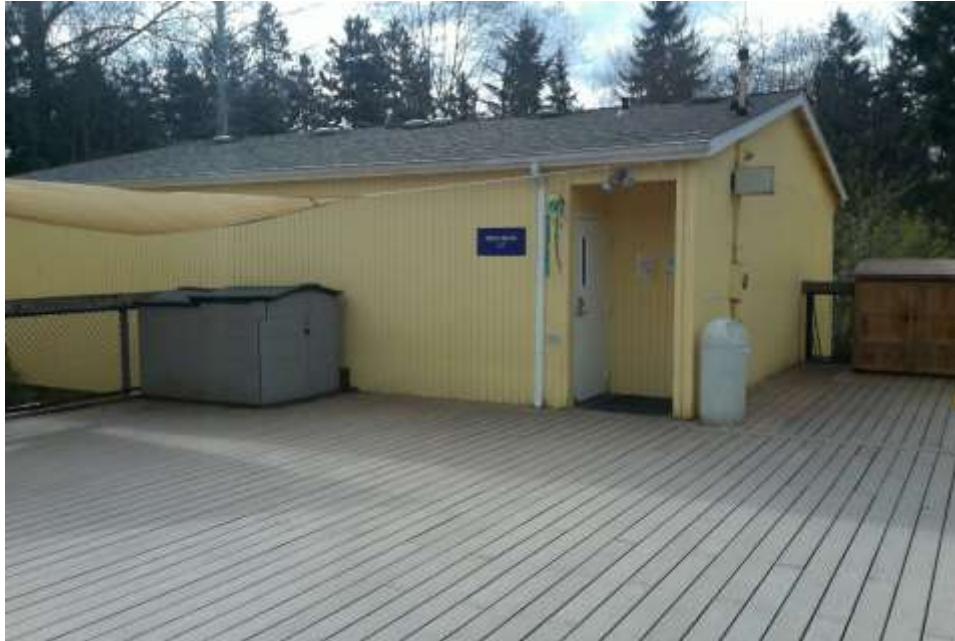
Child Care 7 (260-S07) STATE UFI: A10047 Main Campus (260A)
AREA: 1,130 SF BUILT: 0 REMODELED: No PREDOMINANT USE: Child Care
CONSTRUCTION TYPE: No data CRV/SF: \$188 REPLACEMENT VALUE: \$212,440

Primary Systems			
COMPONENT:	Structure	RATING: 5 x WEIGHT: 8.3 =	SCORE: 41.7
Visible settlement and potential structural failure; potential safety hazard Structural defects apparent in superstructure			
COMMENTS:	Wood frame; pier block foundations		
COMPONENT:	Exterior Closure	RATING: 3 x WEIGHT: 8.3 =	SCORE: 25
Sound and weatherproof but with some physical deterioration evident			
COMMENTS:	T1-11 plywood		
COMPONENT:	Roofing	RATING: 3 x WEIGHT: 10.4 =	SCORE: 31.3
Some deterioration is evident in membrane and flashings; maintenance or minor repair is needed			
COMMENTS:	3-tab composition shingles-1999

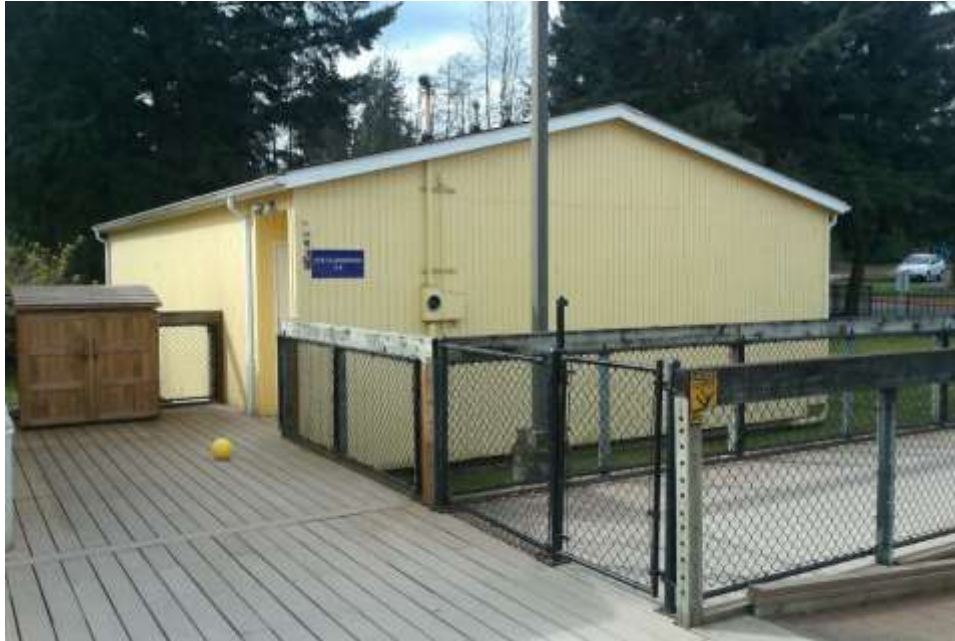
Child Care 8 (260-S08) STATE UFI: A10315 Main Campus (260A)
 AREA: 1,130 SF BUILT: 0 REMODELED: No PREDOMINANT USE: Child Care
 CONSTRUCTION TYPE: No data CRV/SF: \$188 REPLACEMENT VALUE: \$212,440

Primary Systems			
COMPONENT:	Structure	RATING: 5 x WEIGHT: 8.8 = SCORE: 44.2	
Visible settlement and potential structural failure; potential safety hazard Structural defects apparent in superstructure			
COMMENTS:	Wood frame; pier block foundations		
COMPONENT:	Exterior Closure	RATING: 3 x WEIGHT: 8.8 = SCORE: 26.5	
Sound and weatherproof but with some physical deterioration evident			
COMMENTS:	T1-11 plywood		
COMPONENT:	Roofing	RATING: 2 x WEIGHT: 11.1 = SCORE: 22.1	
Majority of roofing and flashing appear sound, but a small portion of roofing shows deterioration where maintenance or minor repair needed			
COMMENTS:	3-tab composition shingles-1999

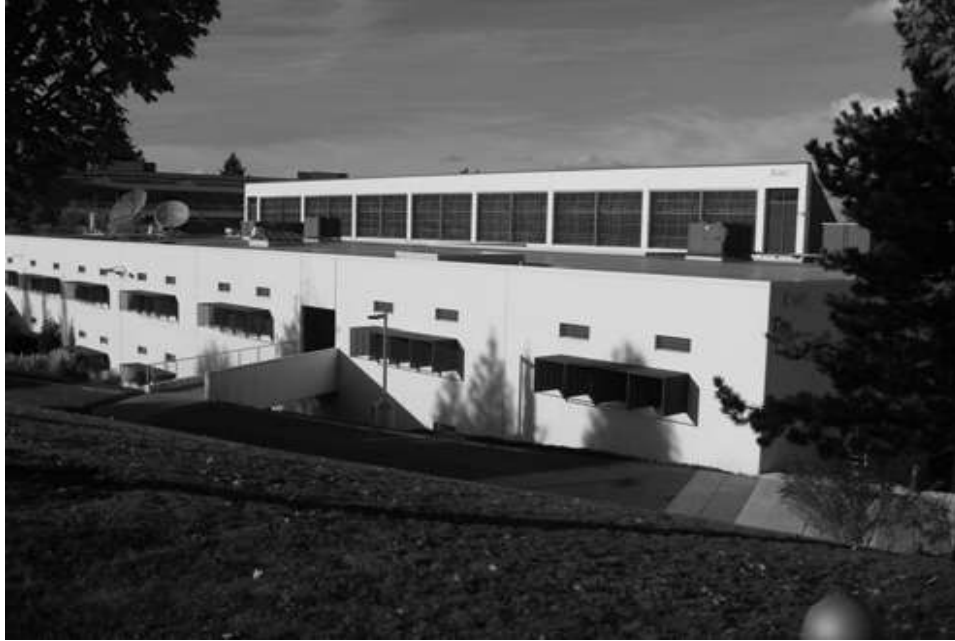
East Building (260-EAS) STATE UFI: A02059 Main Campus (260A)
AREA: 214,827 SF BUILT: 1983 REMODELED: No PREDOMINANT USE: Vocational Arts
CONSTRUCTION TYPE: Heavy CRV/SF: \$395 REPLACEMENT VALUE: \$84,856,665

Primary Systems			
COMPONENT:	Structure	RATING: 2 x WEIGHT: 8 =	SCORE: 16
Minor cracks evident in a small portion of the structure			
COMMENTS:	Concrete		
COMPONENT:	Exterior Closure	RATING: 1 x WEIGHT: 8 =	SCORE: 8
Weatherproof, tight, well-maintained exterior walls, doors, windows/finishes			
COMMENTS:	Concrete; minor cracking throughout exterior		
COMPONENT:	Roofing	RATING: 3 x WEIGHT: 10 =	SCORE: 30
Some deterioration is evident in membrane and flashings; maintenance or minor repair is needed			
COMMENTS:	PVC single-ply; walking pads are shredded and need replacement

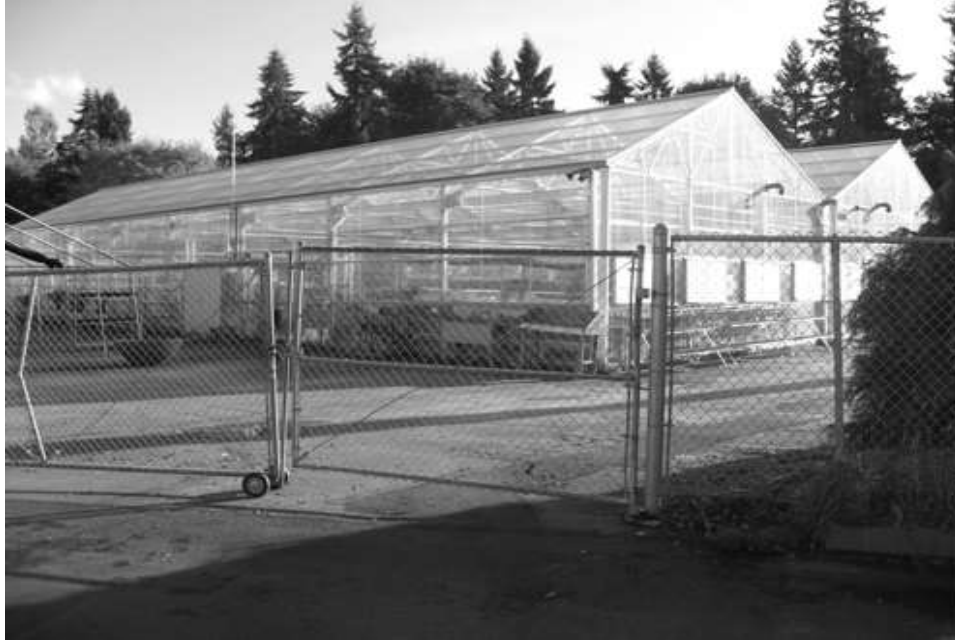
Greenhouse 1 (260-GH1) STATE UFI: A02681 Main Campus (260A)
AREA: 6,000 SF BUILT: 2001 REMODELED: No PREDOMINANT USE: Greenhouse
CONSTRUCTION TYPE: Light CRV/SF: \$224 REPLACEMENT VALUE: \$1,344,000

Primary Systems			
COMPONENT:	Structure	RATING: 1 x WEIGHT: 10.7 =	SCORE: 10.7
No signs of settlement or cracking, no abrupt vertical changes Columns, bearing walls and roof structure appears sound/free of defects			
COMMENTS:	Metal framing		
COMPONENT:	Exterior Closure	RATING: 2 x WEIGHT: 10.7 =	SCORE: 21.4
Weatherproof exterior, but finish appears poorly maintained			
COMMENTS:	Lexan panels		
COMPONENT:	Roofing	RATING: 2 x WEIGHT: 13.4 =	SCORE: 26.8
Majority of roofing and flashing appear sound, but a small portion of roofing shows deterioration where maintenance or minor repair needed			
COMMENTS:	Lexan panels

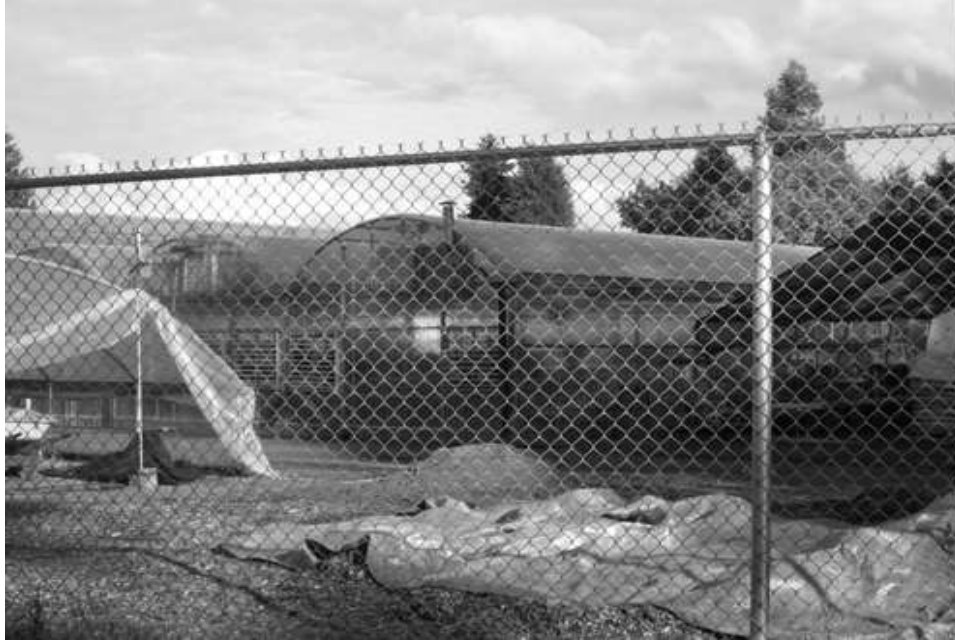
Greenhouse 2 (260-GH2) STATE UFI: A01044 Main Campus (260A)
AREA: 6,000 SF BUILT: 1986 REMODELED: No PREDOMINANT USE: Greenhouse
CONSTRUCTION TYPE: Light CRV/SF: \$224 REPLACEMENT VALUE: \$1,344,000

Primary Systems			
COMPONENT:	Structure	RATING: 2 x WEIGHT: 10.7 =	SCORE: 21.4
Minor cracks evident in a small portion of the structure			
COMMENTS:	Metal framing		
COMPONENT:	Exterior Closure	RATING: 2 x WEIGHT: 10.7 =	SCORE: 21.4
Weatherproof exterior, but finish appears poorly maintained			
COMMENTS:	Lexan panels		
COMPONENT:	Roofing	RATING: 3 x WEIGHT: 13.4 =	SCORE: 40.2
Some deterioration is evident in membrane and flashings; maintenance or minor repair is needed			
COMMENTS:	Plastic sheeting

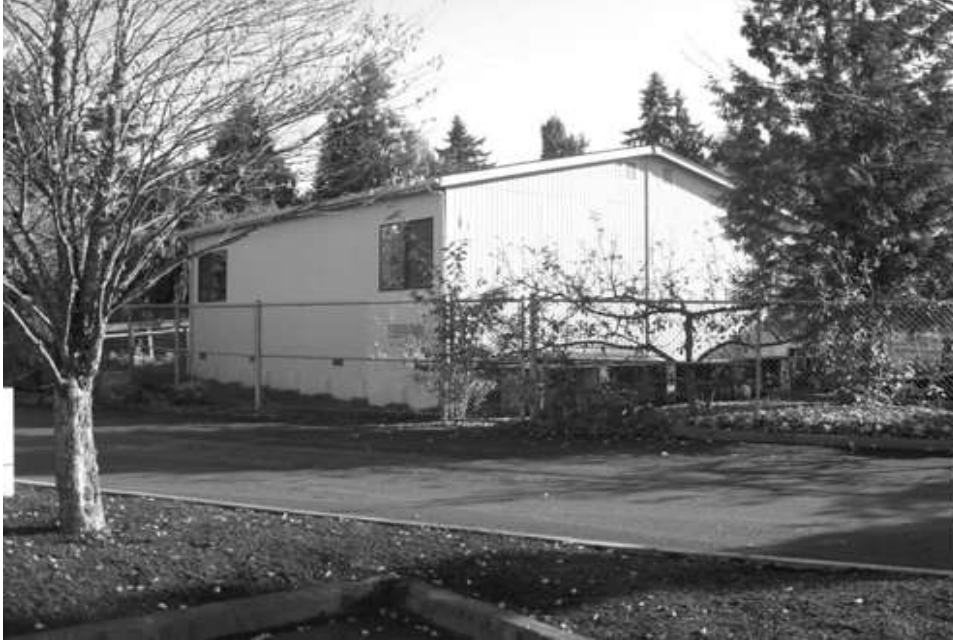
Horticulture (260-H01) STATE UFI: A05822 Main Campus (260A)
AREA: 1,130 SF BUILT: 0 REMODELED: No PREDOMINANT USE: Faculty Office
CONSTRUCTION TYPE: Temporary CRV/SF: \$198 REPLACEMENT VALUE: \$223,740

Primary Systems			
COMPONENT:	Structure	RATING: 3 x WEIGHT: 9.3 =	SCORE: 28
Some cracking evident but does not likely affect structural integrity; Visible defects apparent but are non-structural			
COMMENTS:	Wood frame		
COMPONENT:	Exterior Closure	RATING: 3 x WEIGHT: 9.3 =	SCORE: 28
Sound and weatherproof but with some physical deterioration evident			
COMMENTS:	T1-11 plywood		
COMPONENT:	Roofing	RATING: 3 x WEIGHT: 11.7 =	SCORE: 35
Some deterioration is evident in membrane and flashings; maintenance or minor repair is needed			
COMMENTS:	3-tab composition shingle-1999

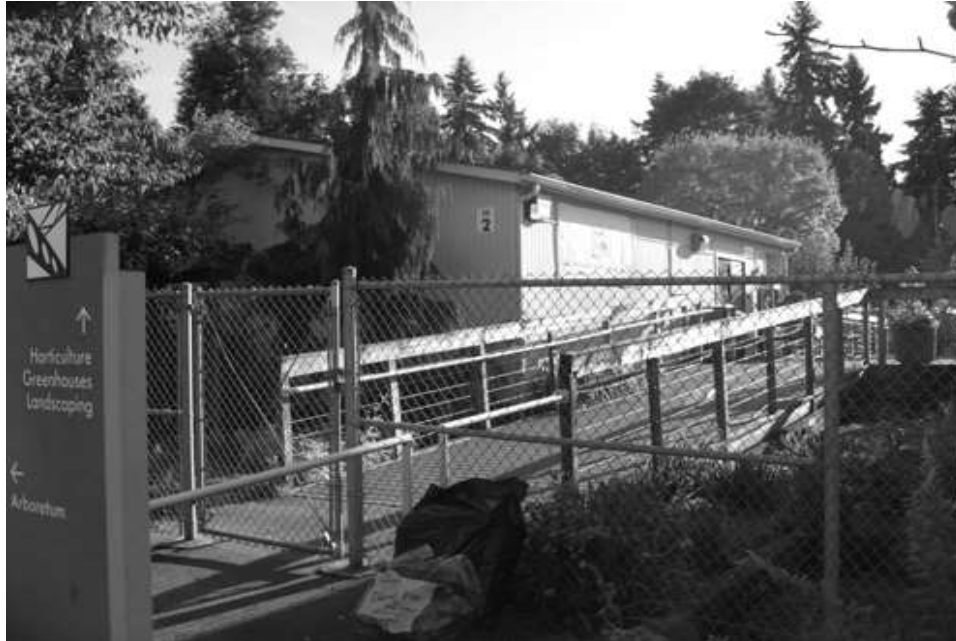
Horticulture (260-H02) STATE UFI: A03723 Main Campus (260A)
 AREA: 1,130 SF BUILT: 0 REMODELED: No PREDOMINANT USE: General Classroom
 CONSTRUCTION TYPE: Temporary CRV/SF: \$198 REPLACEMENT VALUE: \$223,740

Primary Systems			
COMPONENT:	Structure	RATING: 3 x WEIGHT: 8.8 =	SCORE: 26.3
Some cracking evident but does not likely affect structural integrity; Visible defects apparent but are non-structural			
COMMENTS:	Wood frame		
COMPONENT:	Exterior Closure	RATING: 3 x WEIGHT: 8.8 =	SCORE: 26.3
Sound and weatherproof but with some physical deterioration evident			
COMMENTS:	T1-11 plywood		
COMPONENT:	Roofing	RATING: 2 x WEIGHT: 11 =	SCORE: 22
Majority of roofing and flashing appear sound, but a small portion of roofing shows deterioration where maintenance or minor repair needed			
COMMENTS:	3-tab composition shingle-1999

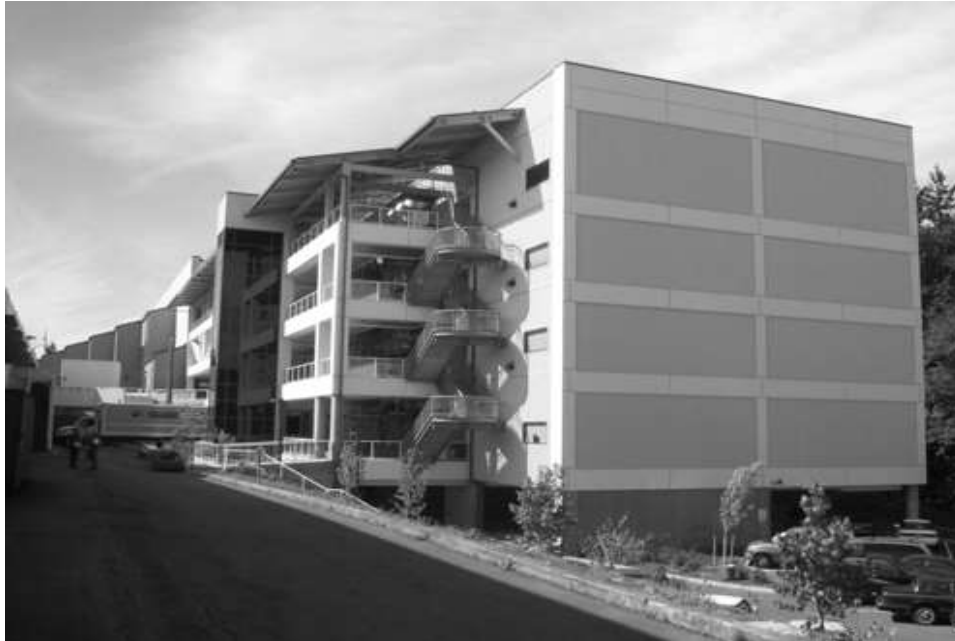
Technology Center (260-TEC) STATE UFI: A05661 Main Campus (260A)
AREA: 60,000 SF BUILT: 2004 REMODELED: No PREDOMINANT USE: Mixed Use
CONSTRUCTION TYPE: Heavy CRV/SF: \$395 REPLACEMENT VALUE: \$23,700,000

Primary Systems			
COMPONENT:	Structure	RATING: 1 x WEIGHT: 8 =	SCORE: 8
No signs of settlement or cracking, no abrupt vertical changes Columns, bearing walls and roof structure appears sound/free of defects			
COMMENTS:	Concrete; steel frame; concrete slab		
COMPONENT:	Exterior Closure	RATING: 2 x WEIGHT: 8 =	SCORE: 16
Weatherproof exterior, but finish appears poorly maintained			
COMMENTS:	Metal panels; stucco; glass block; soffit tile; very problematic; enclosure improvements & repairs funded 2019 & 2021		
COMPONENT:	Roofing	RATING: 3 x WEIGHT: 10 =	SCORE: 30
Some deterioration is evident in membrane and flashings; maintenance or minor repair is needed			
COMMENTS:	Single-ply PVC; standing seam metal panels; glass skylights

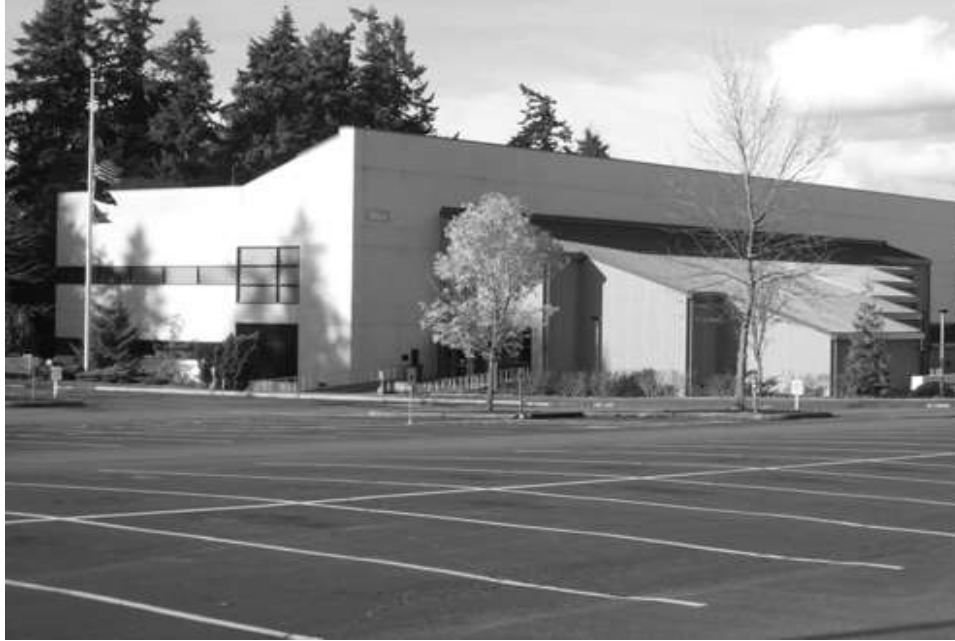
West Building (260-WES) STATE UFI: A09481 Main Campus (260A)
AREA: 89,967 SF BUILT: 1992 REMODELED: No PREDOMINANT USE: Mixed Use
CONSTRUCTION TYPE: Heavy CRV/SF: \$395 REPLACEMENT VALUE: \$35,536,965

Primary Systems			
COMPONENT:	Structure	RATING: 1 x WEIGHT: 8 =	SCORE: 8
No signs of settlement or cracking, no abrupt vertical changes Columns, bearing walls and roof structure appears sound/free of defects			
COMMENTS:	Concrete		
COMPONENT:	Exterior Closure	RATING: 2 x WEIGHT: 8 =	SCORE: 16
Weatherproof exterior, but finish appears poorly maintained			
COMMENTS:	EIFS cladding system; metal panels; minor cracking throughout EIFS		
COMPONENT:	Roofing	RATING: 1 x WEIGHT: 10 =	SCORE: 10
Flashing and penetrations appear sound and membrane appears water- tight; drainage is positive and there are overflow scuppers			
COMMENTS:	Single-ply PVC; recondition oldest portion funded for reconditioning 21-23

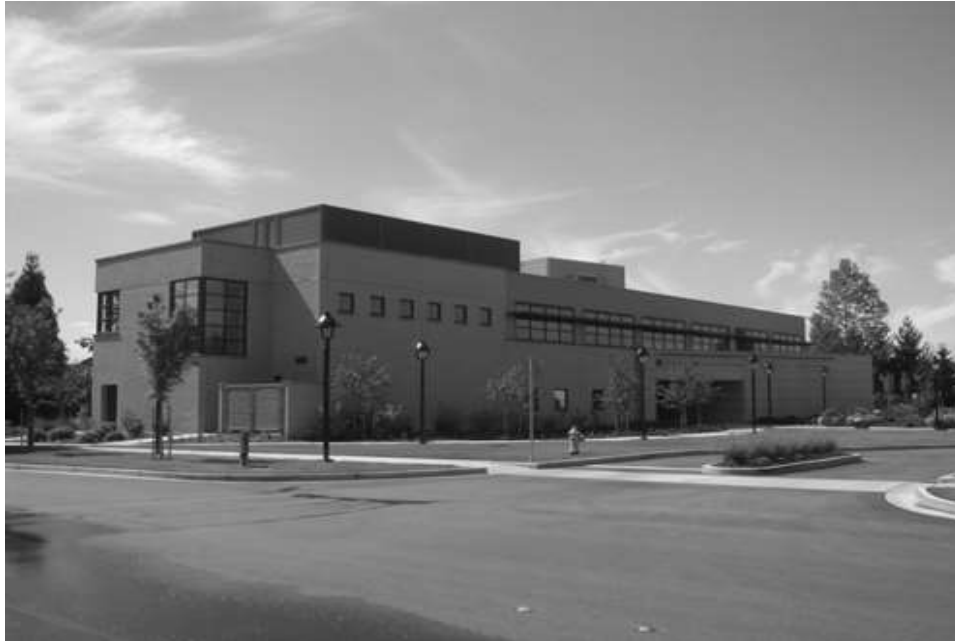
Redmond Campus (260-RED) STATE UFI: A01108 Marymoor Campus (260B)
 AREA: 20,000 SF BUILT: 2005 REMODELED: No PREDOMINANT USE: Mixed Use
 CONSTRUCTION TYPE: Medium CRV/SF: \$395 REPLACEMENT VALUE: \$7,900,000

Primary Systems			
COMPONENT:	Structure	RATING: 1 x WEIGHT: 8 =	SCORE: 8
No signs of settlement or cracking, no abrupt vertical changes Columns, bearing walls and roof structure appears sound/free of defects			
COMMENTS:	Steel; brick; concrete slab		
COMPONENT:	Exterior Closure	RATING: 2 x WEIGHT: 8 =	SCORE: 16
Weatherproof exterior, but finish appears poorly maintained			
COMMENTS:	Brick; metal architectural panels; stucco; window walls		
COMPONENT:	Roofing	RATING: 1 x WEIGHT: 10 =	SCORE: 10
Flashing and penetrations appear sound and membrane appears water- tight; drainage is positive and there are overflow scuppers			
COMMENTS:	PVC single-ply membrane; standing seam metal panels
