# **2023** FACILITY CONDITION SURVEY

Lower Columbia College

SURVEY CONDUCTED BY:  
Steve Lewandowski  
State Board for Community  
and Technical Colleges

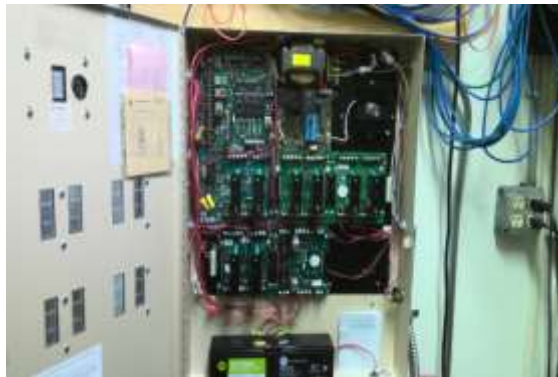
The fire alarm panel is at the end of its useful life and has been identified for required replacement by the city fire marshal. The panel should be replaced.

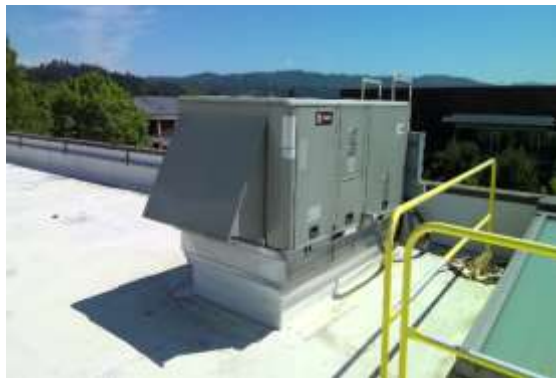
**Deficiency F02**

The unit has failed and should be replaced.

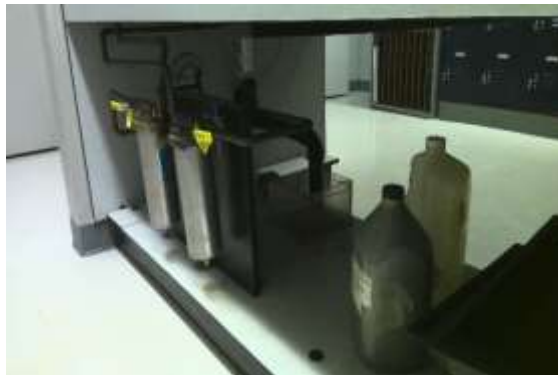
**Deficiency F03**

There are several sections of piping throughout the building that have become brittle and are failing (Photo Lab, Mechanical Room, Clay Lab). These sections of pipe should be replaced.

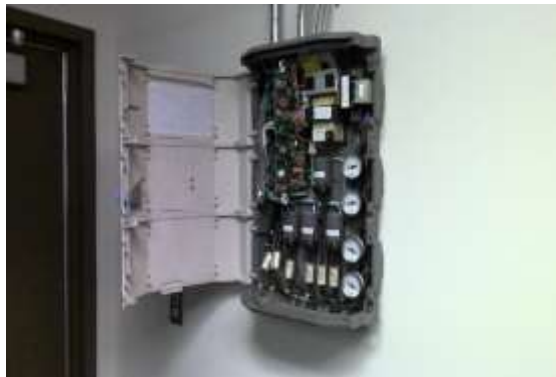
**Deficiency F04**

Several buildings have obsolete HVAC control systems. Many systems are obsolete pneumatic systems. These systems are located in the Student Center, Library, Applied Arts and Admissions buildings. There are also many obsolete pneumatic components that are failing and no longer repairable. These failing HVAC controls and components should be replaced.

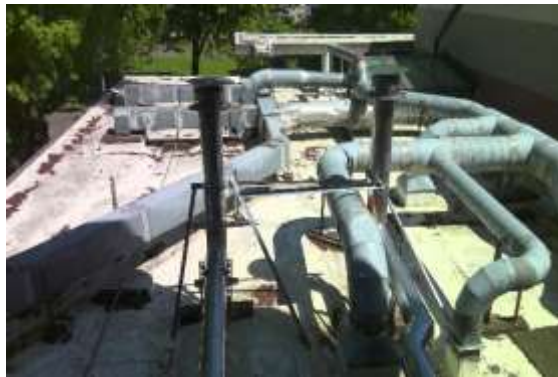
**Deficiency R01**

The lower section of roofing has deteriorated and is at the end of its useful life. The roofing should be replaced.
