# **2023** FACILITY CONDITION SURVEY

Olympic College

SURVEY CONDUCTED BY:  
Steve Lewandowski  
State Board for Community  
and Technical Colleges

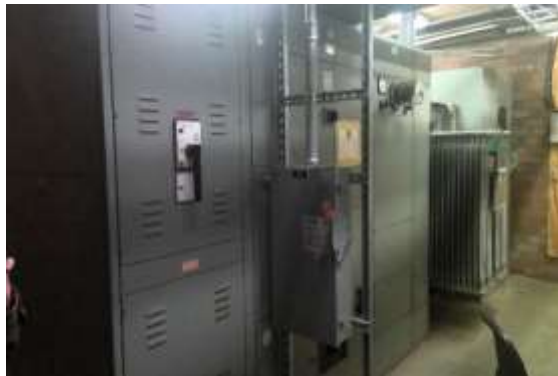
**Deficiency F02**

The college is concerned about the age of the primary disconnect, transformer, secondary distribution and motor control components. The college provided an equipment report that described the age concern, but specific condition was not evaluated. The equipment is still functioning as designed. Additional information and testing is required to justify replacement. Also, the components should be evaluated individually in order to focus on the item(s) in the worst condition. The equipment should continue to be monitored and be replaced in the future.

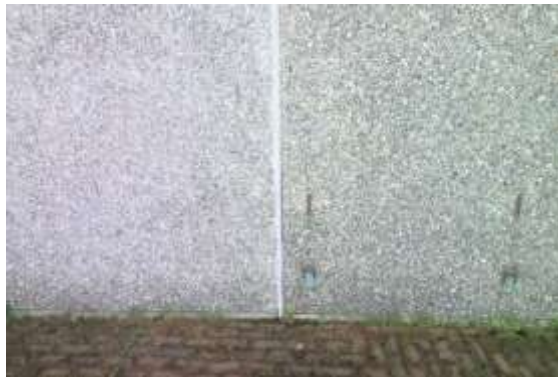
**Deficiency F03**

During the demolition of the Shop Building we discovered that the joints between the tilt up panels was severely degraded. Many of the joints are rusted out and daylight can be seen through them. The college will need to investigate the extent of the problem before the solution can be correctly scoped. Additional information is required to determine the appropriate scope of work required to address any failing components.

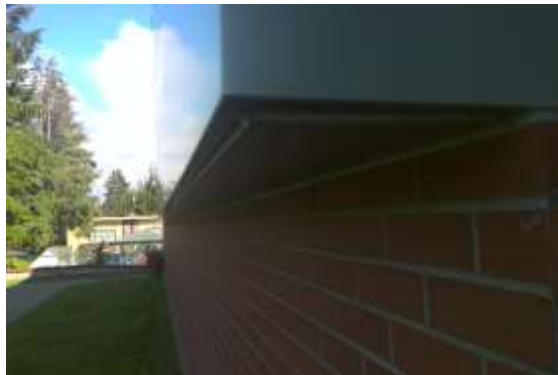
**Deficiency F04**

The exterior panel system is failing at soffit and window locations. The panel system should be repaired.

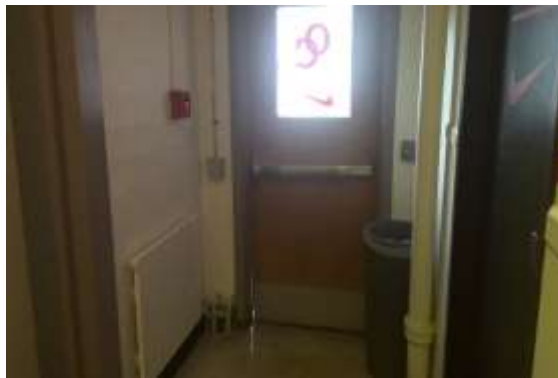
**Deficiency F05**

The exterior entrance doors have degraded and should be replaced.

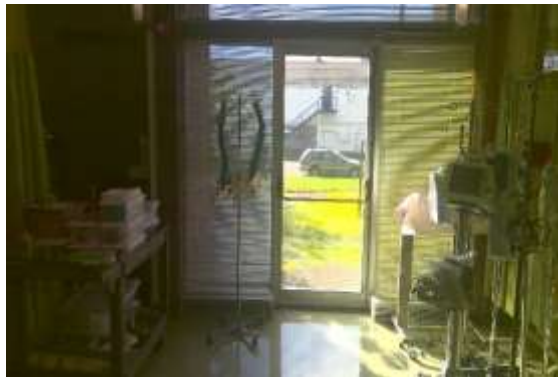
**Deficiency F06**

The exterior doors near the nursing area and conference room have degraded and should be replace.

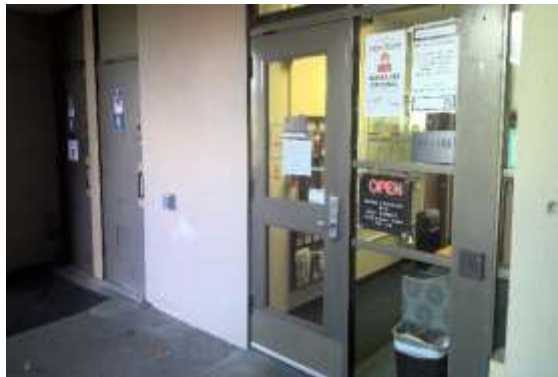
**Deficiency F07**

The college was concerned about the age of the exterior doors, however, the doors appeared to function appropriately during the survey. The doors should continue to be monitored for repairs.

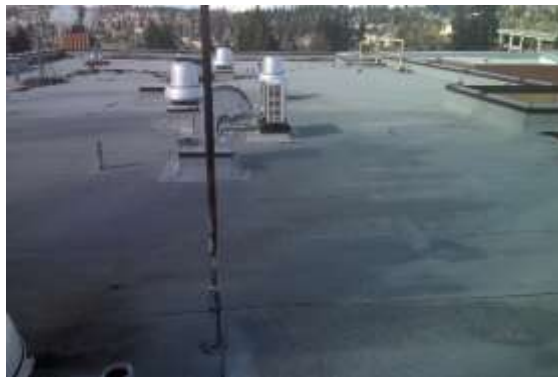
**Deficiency R01**

The college is concerned about the condition of the roof. The roof has required a few repairs in the past, however, leaks were no longer active. The roofing appeared to be in good condition and should continue to be monitored for repairs.

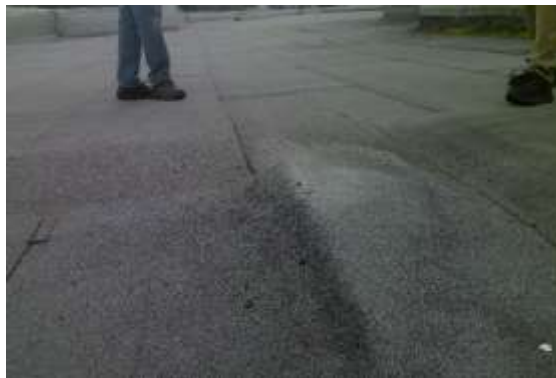
**Deficiency R02**

The roof has minor areas of blistering. These areas should be repaired.

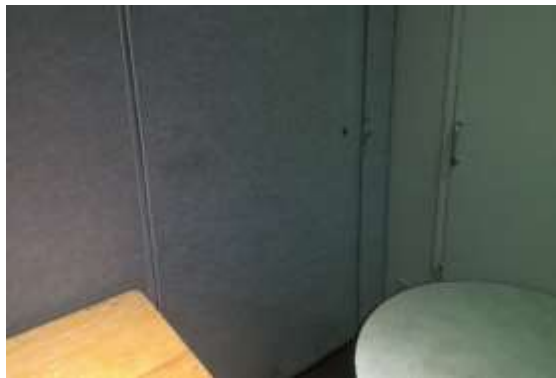
**Deficiency F08**

The movable partition walls have failed and should be replaced.

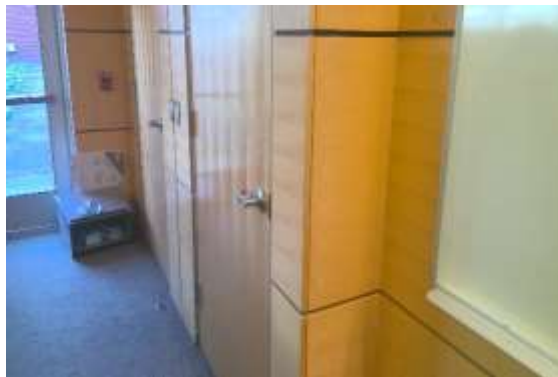
**Deficiency F09**

Some wood paneling in the tiered assembly room have begun to separate from the wall. The panels have been re-fastened by the college, but it appears that the panels were not properly fastened. The panels should continue to be monitored for repairs.

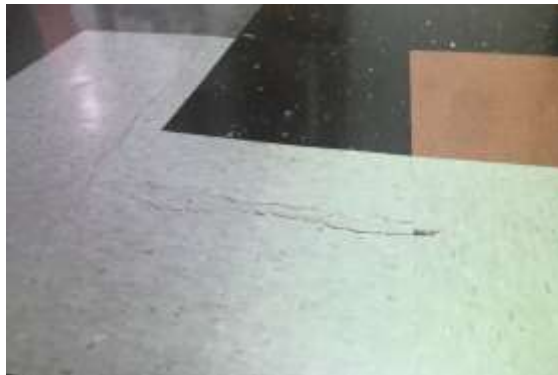
**Deficiency F10**

The VCT and other vinyl tile flooring has failed in several areas where the sub-floor has settled. The flooring in these areas should be replaced and the sub-flooring should be repaired.

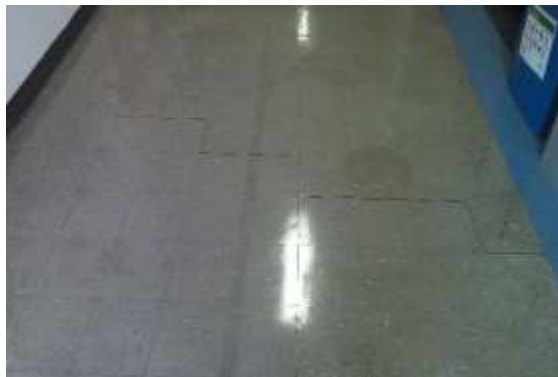
**Deficiency F11**

The college is concerned about the condition of the tile flooring. The flooring appeared to require minor repair in small areas, but was in fairly good condition. The flooring should continue to be monitored for replacement.

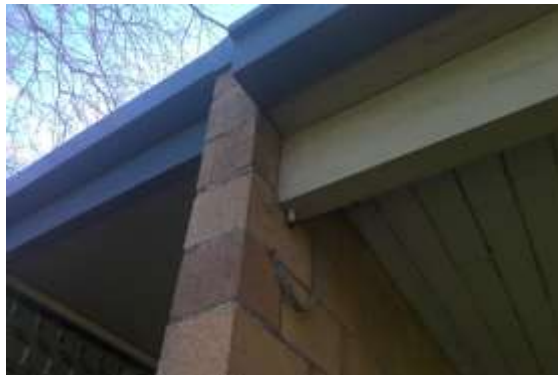
**Deficiency F12**

In a few locations the masonry has cracked where it supports roof beams. These cracked areas should be repaired.

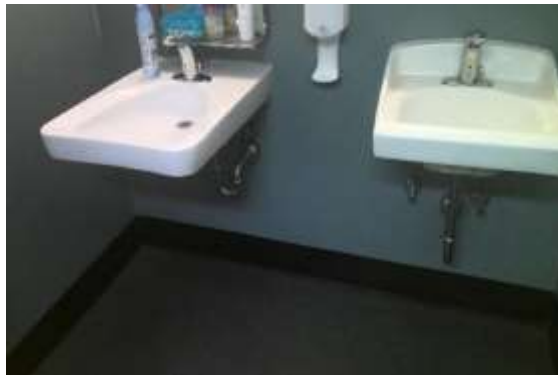
**Deficiency F13**

a. City pressure 70 – 80 lbs., 05 - CSC upper floor bathrooms have low pressure. Additional information is required to determine the appropriate scope of repair required.

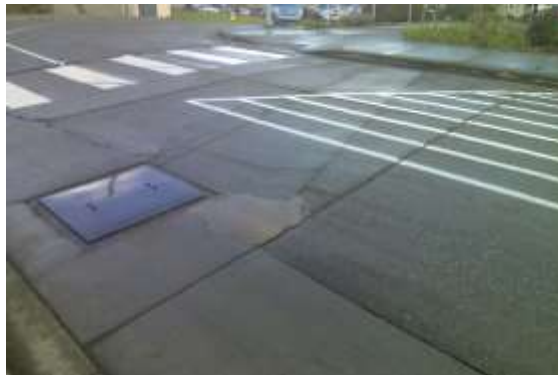
**Deficiency S01**

The college was concerned about the surface over the utility utilidor. Vehicular traffic had caused some damage, but repairs have been made. The utilidor lid should continue to be monitored for repairs.

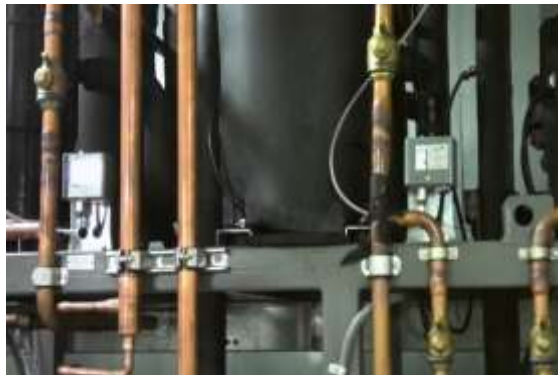
**Deficiency F14**

05, 11, 12, 10, 09 – copper piping needs to be replaced. Additional information is required to determine the extent of the issue.

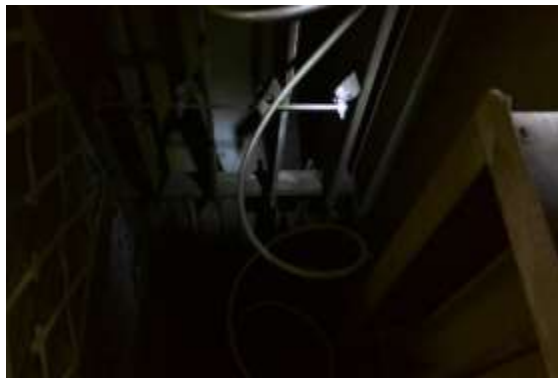
**Deficiency F15**

The dining hall air handler dampers no longer function and need to be replaced or rebuilt.

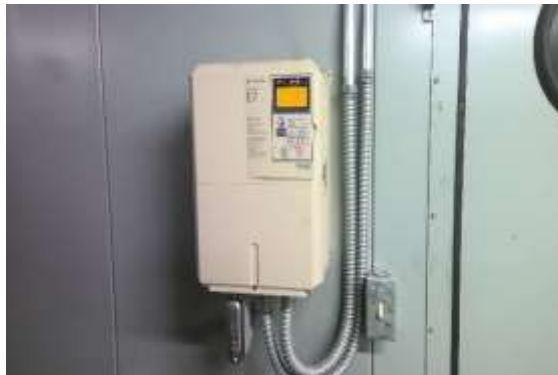
**Deficiency F16**

The supply fan variable frequency drives have begun to fail and are no longer controllable. The drives and associated controls should be replaced.

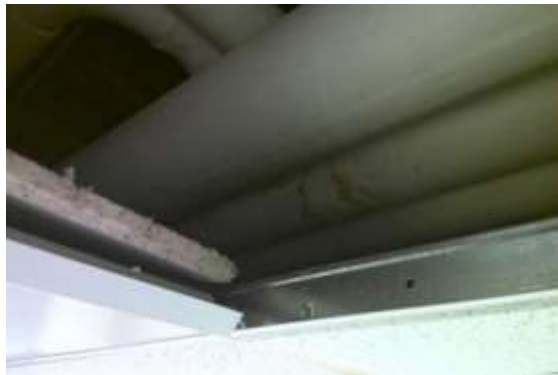
**Deficiency F17**

Many of the Victaulic joints have failed. Boilers must be kept running during the summer to avoid leaking joints. The failing joints should be replaced.
