# **2023** FACILITY CONDITION SURVEY

Peninsula College

SURVEY CONDUCTED BY:  
Steve Lewandowski  
State Board for Community  
and Technical Colleges

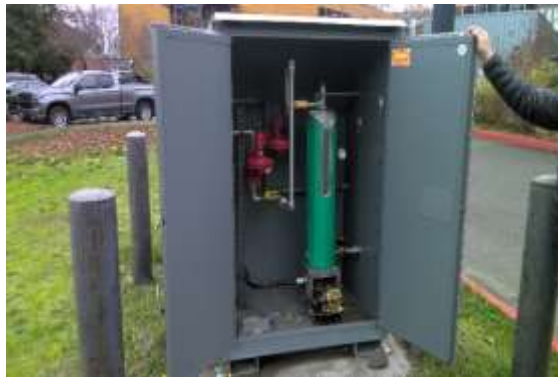
The propane vaporizer that supports the propane delivery system has failed and should be replaced.

Category 2 percentage : 0 %
Project construction estimate (MACC): \$25,000
Total project estimate (including soft costs): \$35,000
Additional points based on building condition: 0
Deficiency score : $4 \times (15 \times 100\%) + 0 = 60$

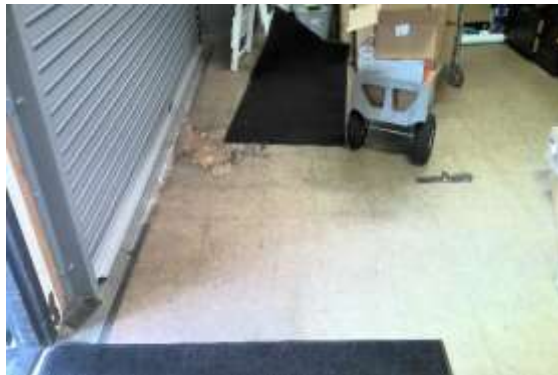
**Deficiency F02**

The flooring and subflooring near the delivery bay has degraded and due to heavy use. The damaged subflooring and flooring should be replaced.

Category 1 percentage : 90 %
Scoring priority category 2 : Quality of Use (scoring weight=5)
Category 2 percentage : 10 %
Project construction estimate (MACC): \$20,000
Total project estimate (including soft costs): \$28,000
Additional points based on building condition: 2
Deficiency score : $4 \times ((12 \times 90\%) + (5 \times 10\%)) + 2 = 47.2$

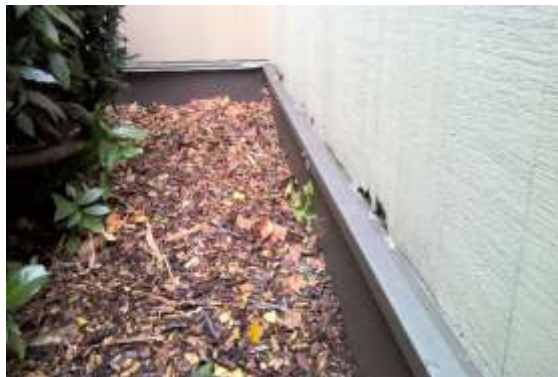
**Deficiency F03**

The college is concerned about the cedar siding and trim that exhibits rot in some areas. The college also indicated that there is rot found in structural components. The siding should be replaced and the structural rot damage should be repaired to ensure a water-tight building.

Estimated remaining life (years) : 7
Estimated average life expectancy (years) : 20
Scoring priority category 1 : High Repair/Repl. Cost (scoring weight=12)
Category 1 percentage : 50 %
Scoring priority category 2 : System Use (scoring weight=15)
Category 2 percentage : 50 %
Project construction estimate (MACC): \$60,000
Total project estimate (including soft costs): \$84,000
Additional points based on building condition: 1
Deficiency score : $4 \times ((12 \times 50\%) + (15 \times 50\%)) + 1 = 55$

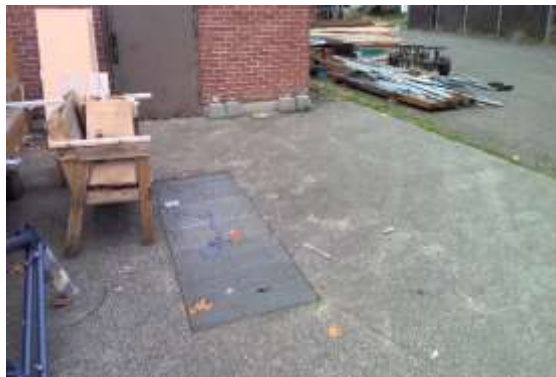
**Deficiency F04**

The oil separator serving the auto repair program has failed. The college is not certain why the system has failed, but water regularly backs up into the auto yard during storm events. Additional information is required to determine the source of the blockage in order to properly identify the scope of repairs required.

Project construction estimate (MACC): \$150,000
Total project estimate (including soft costs): \$210,000
Additional points based on building condition: 5
Deficiency score : Needs study

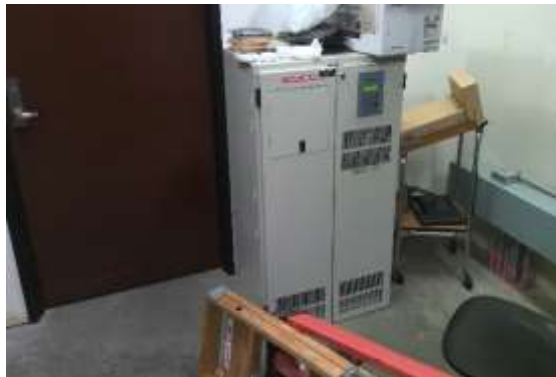
**Deficiency F05**

The college believes that the UPS backup system has exceeded its expected life, based on a vendor report. These units serve emergency and technical system components. The college did not indicate that these units have become unreliable yet, so they appear to have a longer life than presented by the vendor. These should be replaced in the near future to ensure that the systems remain reliable.

Recommended funding schedule : Fund in Next Biennium (scoring weight=2.5)
Estimated remaining life (years) : 5
Estimated average life expectancy (years) : 15
Scoring priority category 1 : System Use (scoring weight=15)
Category 1 percentage : 60 %
Scoring priority category 2 : Health/Safety (scoring weight=25)
Category 2 percentage : 40 %
Project construction estimate (MACC): \$88,000
Total project estimate (including soft costs): \$123,000
Additional points based on building condition: 0
Deficiency score : $2.5 \times ((15 \times 60\%) + (25 \times 40\%)) + 0 = 47.5$

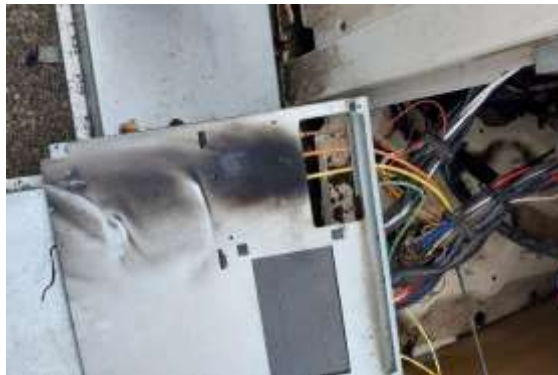
**Deficiency F06**

The heat pumps have exceeded their useful life. One of the units has failed. These units had consistent, premature repair needs. Both units should be replaced.

Category 1 percentage : 50 %
Scoring priority category 2 : System Use (scoring weight=15)
Category 2 percentage : 50 %
Project construction estimate (MACC): \$80,000
Total project estimate (including soft costs): \$112,000
Additional points based on building condition: 0
Deficiency score : $4 \times ((12 \times 50\%) + (15 \times 50\%)) + 0 = 54$

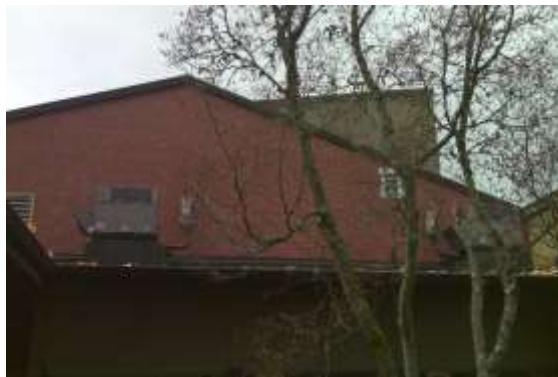
**Deficiency F07**

The college is concerned about the age of the two-ton HVAC units that serve the veteran center and office space. Two similar units were recently replaced. These two remaining units have exceeded their expected life and should be replaced.

Estimated average life expectancy (years) : 25
Scoring priority category 1 : System Use (scoring weight=15)
Category 1 percentage : 60 %
Scoring priority category 2 : High Repair/Repl. Cost (scoring weight=12)
Category 2 percentage : 40 %
Project construction estimate (MACC): \$60,000
Total project estimate (including soft costs): \$84,000
Additional points based on building condition: 2
Deficiency score : $4 \times ((15 \times 60\%) + (12 \times 40\%)) + 2 = 57.2$

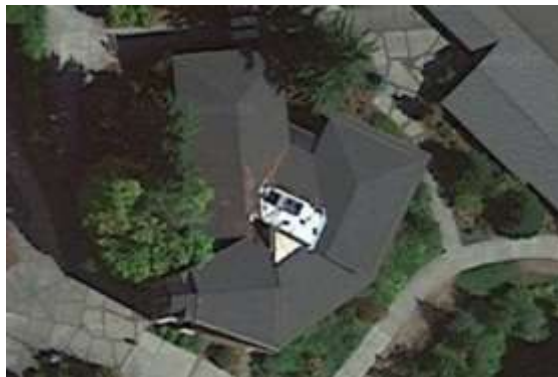
**Deficiency R01**

The flat section of roofing near the mechanical units has reached the end of its useful life and should be replaced. Also, the composition roofing has degraded and should be repaired in various spot locations to extend the life of the roofing system.

Estimated average life expectancy (years) : 25
Scoring priority category 1 : High Repair/Repl. Cost (scoring weight=12)
Category 1 percentage : 60 %
Scoring priority category 2 : System Use (scoring weight=15)
Category 2 percentage : 40 %
Project construction estimate (MACC): \$110,000
Total project estimate (including soft costs): \$154,000
Additional points based on building condition: 1
Deficiency score : $4 \times ((12 \times 60\%) + (15 \times 40\%)) + 1 = 53.8$

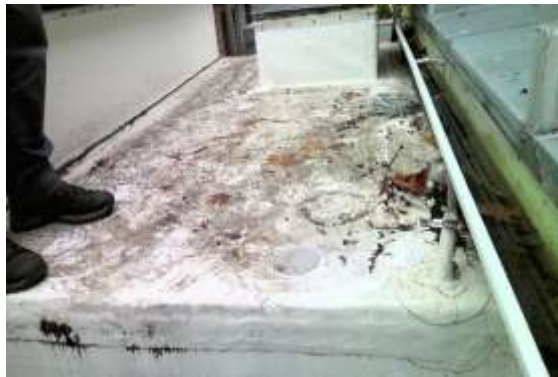
**Deficiency R02**

The roofing leaks near the HVAC units on the north side of the building. The roofing should be repaired to maintain a water-tight condition.

Category 1 percentage : 50 %
Scoring priority category 2 : High Repair/Repl. Cost (scoring weight=12)
Category 2 percentage : 50 %
Project construction estimate (MACC): \$20,000
Total project estimate (including soft costs): \$28,000
Additional points based on building condition: 2
Deficiency score : $4 \times ((10 \times 50\%) + (12 \times 50\%)) + 2 = 46$

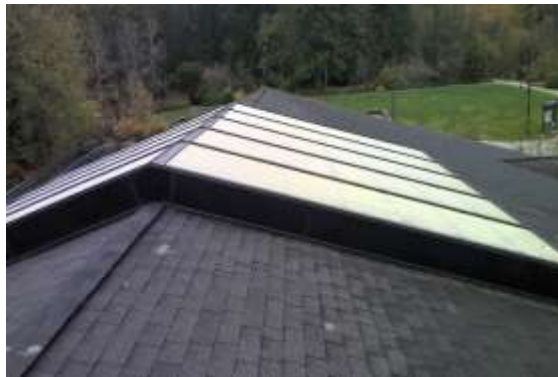
**Deficiency R03**

The skylight Kalwall panel material has degraded due to weather and sun exposure. The skylights panel material should be replaced.

Category 1 percentage : 70 %
Scoring priority category 2 : High Repair/Repl. Cost (scoring weight=12)
Category 2 percentage : 30 %
Project construction estimate (MACC): \$52,000
Total project estimate (including soft costs): \$73,000
Additional points based on building condition: 2
Deficiency score : $2.5 \times ((15 \times 70\%) + (12 \times 30\%)) + 2 = 37.3$

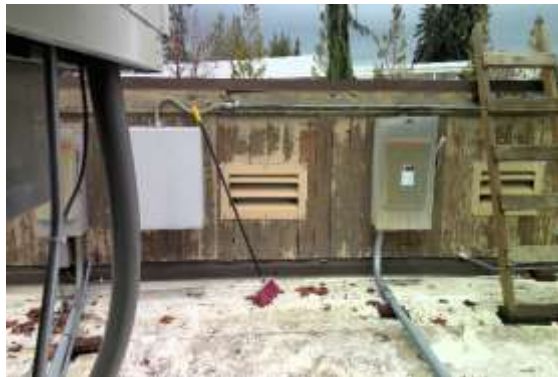
**Deficiency R04**

The parapet wall has degraded and is well beyond its useful life. The parapet wall siding should be replaced.

Scoring priority category 2 : High Repair/Repl. Cost (scoring weight=12)
Category 2 percentage : 50 %
Project construction estimate (MACC): \$20,000
Total project estimate (including soft costs): \$28,000
Additional points based on building condition: 2
Deficiency score : $4 \times ((15 \times 50\%) + (12 \times 50\%)) + 2 = 56$

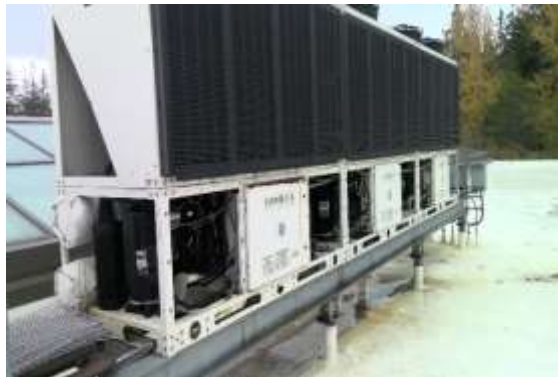
**Deficiency F08**

The college has been required to replace several HVAC unit compressors in recent years even though the unit is fairly new. The unit appears to be a lemon product because of the premature failure of components. The replaced compressors have functioned as expected. The unit still generally functions as designed and should continue to be monitored for future repairs.

Recommended funding schedule : Deferred Backlog (scoring weight=1)
Estimated remaining life (years) : 7
Estimated average life expectancy (years) : 25
Scoring priority category 1 : High Repair/Repl. Cost (scoring weight=12)
Category 1 percentage : 80 %
Scoring priority category 2 : System Use (scoring weight=15)
Category 2 percentage : 20 %
Project construction estimate (MACC): \$150,000
Total project estimate (including soft costs): \$210,000
Additional points based on building condition: 0
Deficiency score : $1 \times ((12 \times 80\%) + (15 \times 20\%)) + 0 = 12.6$

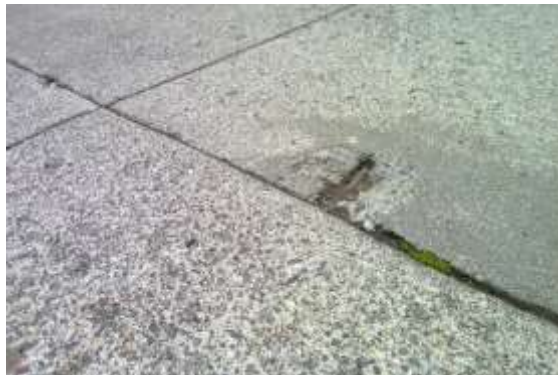
**Deficiency S01**

Several areas of concrete and asphalt pedestrian access paths have failed. These areas should be replaced.

Category 2 percentage : 20 %
Project construction estimate (MACC): \$24,000
Total project estimate (including soft costs): \$33,000
Additional points based on building condition: 0
Deficiency score : $4 \times ((12 \times 80\%) + (20 \times 20\%)) + 0 = 54.4$

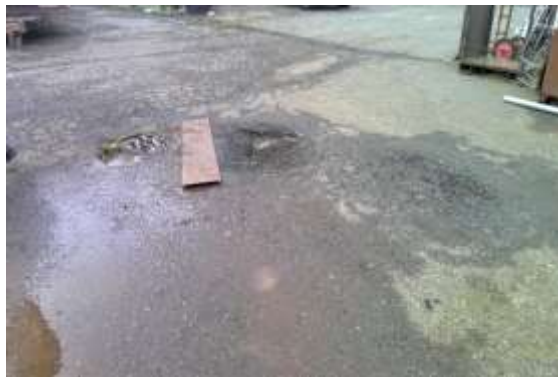
**Deficiency S02**

The catch basin and adjacent asphalt has settled due to soil migration. The catch basin should be replaced or be raised. The soils should be stabilized and the asphalt should be replaced to return the surface condition to the original level.

Scoring priority category 1 : System Use (scoring weight=15)
Category 1 percentage : 90 %
Scoring priority category 2 : High Repair/Repl. Cost (scoring weight=12)
Category 2 percentage : 10 %
Project construction estimate (MACC): \$30,000
Total project estimate (including soft costs): \$42,000
Additional points based on building condition: 0
Deficiency score : $4 \times ((15 \times 90\%) + (12 \times 10\%)) + 0 = 58.8$
