# **2023** FACILITY CONDITION SURVEY

Renton Technical College

SURVEY CONDUCTED BY:  
Steve Lewandowski  
State Board for Community  
and Technical Colleges

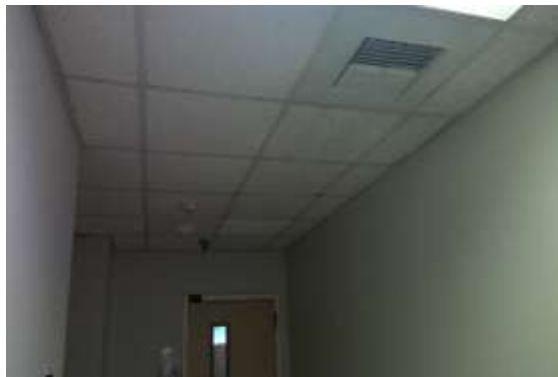
The college is concerned about the condition of the variable air volume units in the central corridor. The unit dampers are not consistently functioning and the motors are failing. There are three units in this area. The units are near the end of their useful life and should be replaced.

| Deficiency score : $4 \times (15 \times 100\%) + 5 = 65$ |

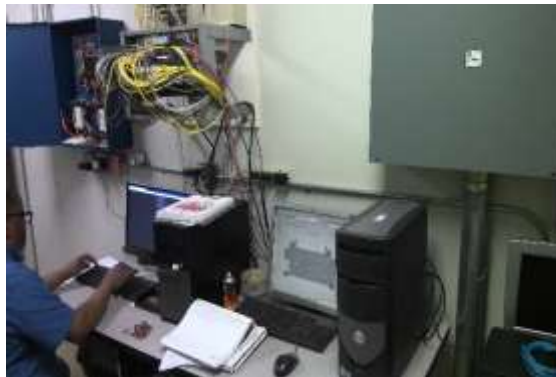
**Deficiency F02**

There are three distinct digital controls systems used to support the main campus buildings. The college is concerned about the unsupported "Lonworks" system in buildings C and H. The college needs to provide some documentation from the vendor that describes the level of support for the system components. If the controls are no longer supported, then they should be replaced.

| Deficiency score : $4 \times (15 \times 100\%) + 0 = 60$ |

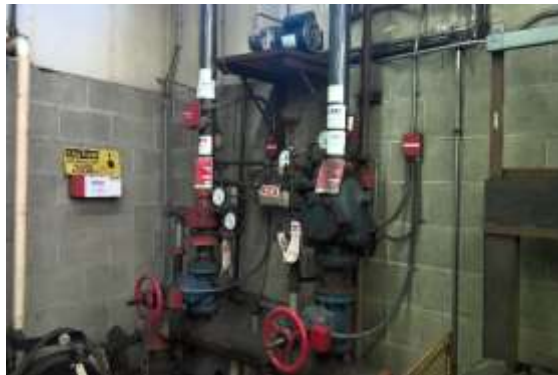
**Deficiency F03**

The sprinkler piping has been subject to frequent failures, resulting in loss of pressure and tripping of the fire alarm panel. The degraded pipe should be replaced.

| Deficiency score : $4 \times ((12 \times 70\%) + (25 \times 30\%)) + 5 = 68.6$ |

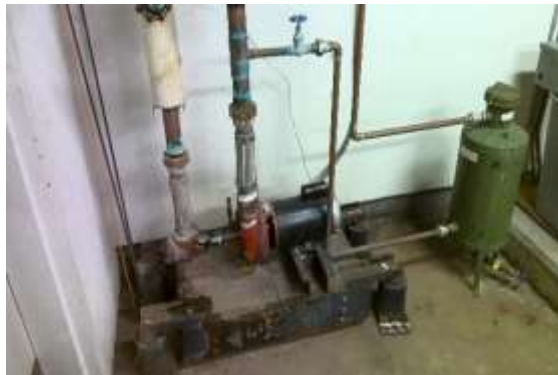
**Deficiency F04**

The circulation pumps in the Dental Area and the Pool area are failing and are unusually noisy while in operation. The pumps are beyond their expected life and should be replaced.

| Deficiency score : $4 \times ((15 \times 60\%) + (12 \times 40\%)) + 5 = 60.2$ |

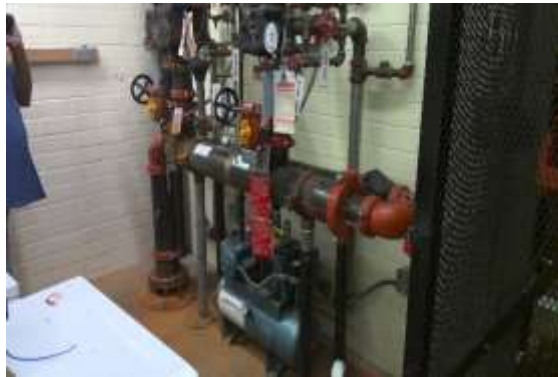
**Deficiency F05**

The dry sprinkler system slowly leaks. The leaks pressurize the system and triggers alarms. Several repairs to the system have been necessary. The degraded pipe should be repaired to extend its useful life and stop false alarms.

| Deficiency score : $4 \times ((12 \times 80\%) + (25 \times 20\%)) + 2 = 60.4$ |

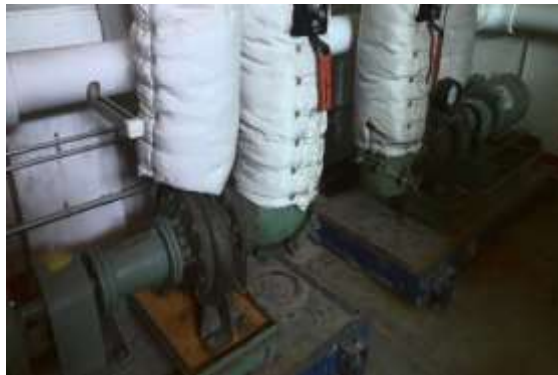
**Deficiency F06**

The circulation pumps serving the Chiller are failing and are unusually noisy while in operation. The pumps are beyond their expected life and should be replaced.

| Deficiency score : $4 \times (15 \times 100\%) + 1 = 61$ |

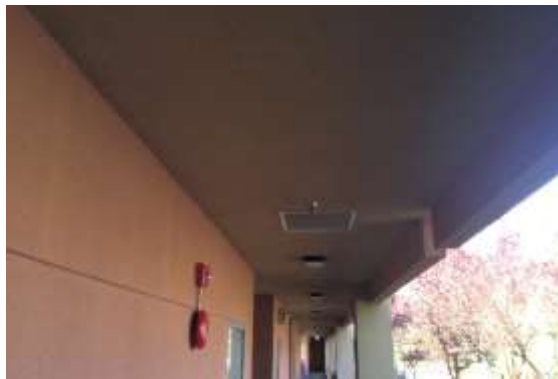
**Deficiency F07**

The dry sprinkler system slowly leaks. The leaks pressurize the system and triggers alarms. Several repairs to the system have been necessary. The degraded pipe should be repaired to extend its useful life and stop false alarms.

| Deficiency score : $4 \times ((12 \times 70\%) + (25 \times 30\%)) + 1 = 64.6$ |

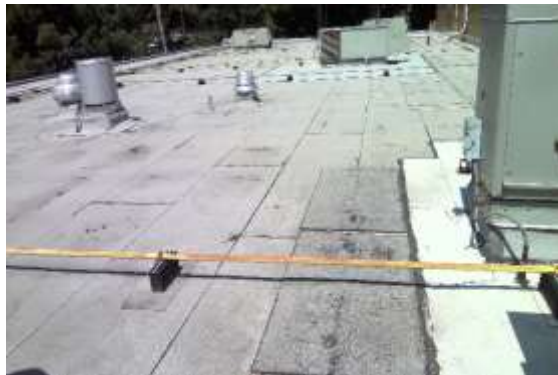
**Deficiency R01**

The roof has degraded and several leaks have recently been repaired. The roofing should be reconditioned to extend its useful life.

| Deficiency score : $4 \times ((12 \times 50\%) + (15 \times 50\%)) + 2 = 56$ |

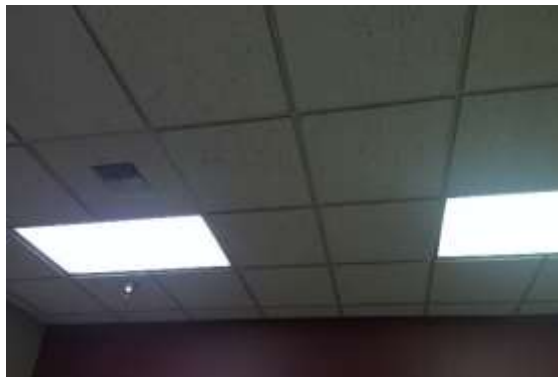
**Deficiency F08**

The fan coil units and Variable Air Volume Units are prone to failure and require frequent troubleshooting. The 11 units in the worst condition should be replaced. The remaining units should continue to be monitored for replacement.

| Deficiency score : $4 \times ((12 \times 60\%) + (15 \times 40\%)) + 1 = 53.8$ |

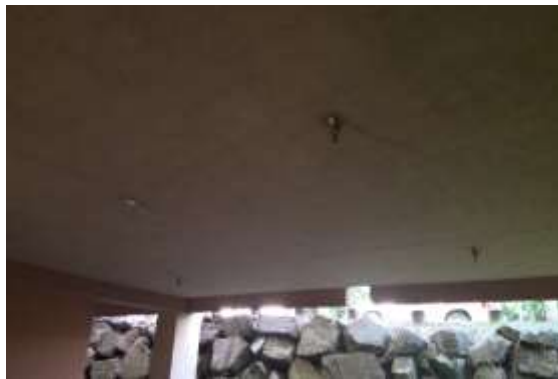
**Deficiency F09**

The dry sprinkler system has leaked in several locations. The leaks pressurize the system and triggers alarms. Several repairs to the system have been necessary and the system did not appear to leak at the time of the survey. The degraded pipe should continue to be monitored and be replaced in the next biennium.

| Deficiency score : $2.5 \times ((12 \times 70\%) + (25 \times 30\%)) + 1 = 40.8$ |

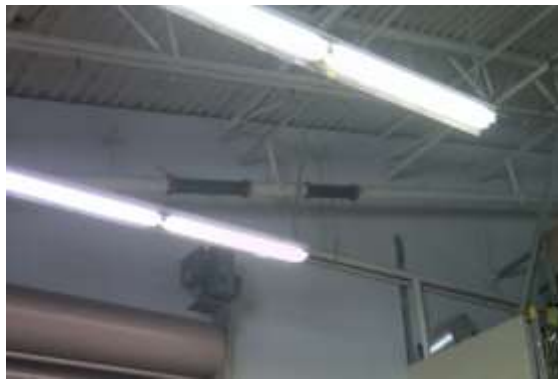
**Deficiency F10**

The dry sprinkler system slowly leaks in several locations. The leaks pressurize the system and triggers alarms. Several repairs to the system have been necessary and they appear to be systemic. The degraded pipe should be replaced.

| Deficiency score : $4 \times ((12 \times 70\%) + (25 \times 30\%)) + 1 = 64.6$ |

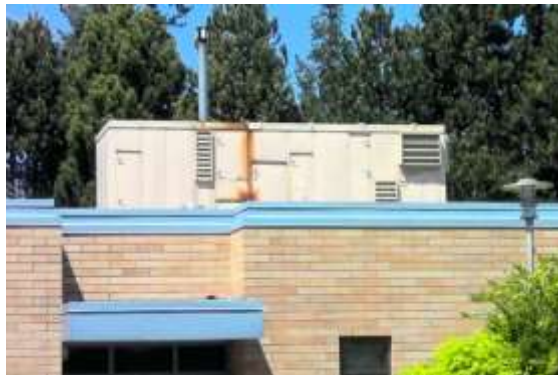
**Deficiency F11**

The multi-zone unit is unreliable and requires a high level of maintenance. The unit is well beyond its expected life and should be replaced.

| Deficiency score : $4 \times (15 \times 100\%) + 1 = 61$ |
