2023 FACILITY CONDITION SURVEY

Seattle Central College

SURVEY CONDUCTED BY:
Steve Lewandowski
State Board for Community
and Technical Colleges

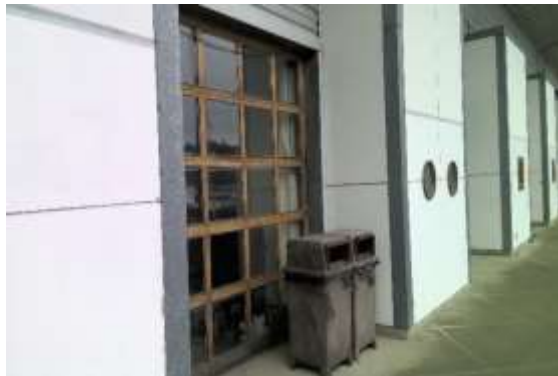
The wood-framed overhead sectional doors as well as the west window are deteriorating due to age and weather exposure. The building was not being used at the time of the survey and the college did not have specific plans for use in the future. The doors may no longer be required for a new use, when the college decides to use the building in the future. These doors should be considered for replacement when the building is used for instruction in the future.

Recommended funding schedule : Deferred Backlog (score = 1)
Estimated remaining life (years) : 3
Estimated average life expectancy (years) : 30
Scoring priority category 1 : High Repair/Repl. Cost (score = 12)
Category 1 percentage : 90 %
Scoring priority category 2 : System Use (score = 15)
Category 2 percentage : 10 %
Project construction estimate (MACC): \$150,000
Total project estimate (including soft costs): \$212,000
Additional points based on building condition: 2
Deficiency score : $1 \times ((12 \times 90\%) + (15 \times 10\%)) + 2 = 14.3$

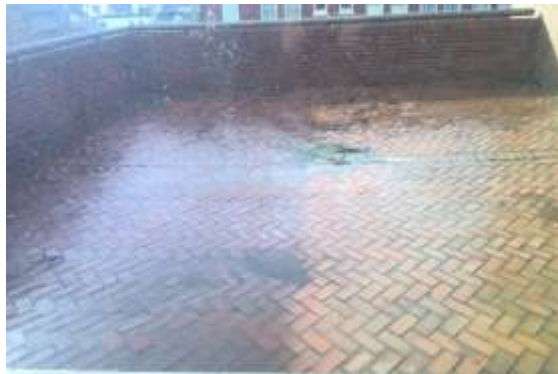
Deficiency F02

The college believes that there are three rooftop patios that leak and allow water to penetrate the building envelope. One patio has been funded for repair in prior biennium. The water is damaging the soffits in some areas. A study detailed the damage to both the mortar bed and waterproof membrane. Several decks are constructed using the same materials, but have varying levels of degradation. The failing deck systems in the worst condition should be replaced. The remaining decks should continue to be monitored for future replacement.

Carryover from prior survey (not yet funded) : Yes
Location : Main Campus (062A)
Building name : Broadway/Edison (062-Be)
Unique Facility Identifier (UFI) : A02501
Funding category in capital budget : Minor Works Facility appropriation
Unifomat category : B20-Exterior Enclosure
Assessment : Asset is near or at the end of its useful life and should be replaced
Quantity : 2
Unit of measurement : EA
Component : Rooftop patios
Location within building or site : Patios
Issue clarity : Adequate information was provided to assess deficiency
Main cause of asset degradation or failure : Weather
Detailed description : The college believes that there are three rooftop patios that leak and allow water to penetrate the building envelope. One patio has been funded for repair in prior biennium. The water is damaging the soffits in some areas. A study detailed the damage to both the mortar bed and waterproof membrane. Several decks are constructed using the same materials, but have varying levels of degradation. The failing deck systems in the worst condition should be replaced. The remaining decks should continue to be monitored for future replacement.

Recommended funding schedule : Immediate (scoring weight=4)
Estimated remaining life (years) : 3
Estimated average life expectancy (years) : 40
Scoring priority category 1 : High Repair/Repl. Cost (scoring weight=12)
Category 1 percentage : 70 %
Scoring priority category 2 : System Use (scoring weight=15)
Category 2 percentage : 30 %
Project construction estimate (MACC): \$260,000
Total project estimate (including soft costs): \$369,000
Additional points based on building condition: 2
Deficiency score : $4 \times ((12 \times 70\%) + (15 \times 30\%)) + 2 = 53.6$

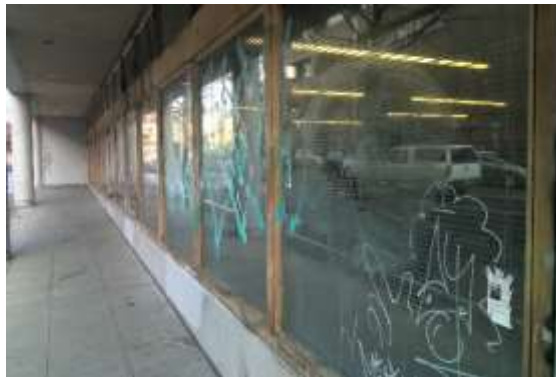
Deficiency F03

The existing wood framed windows location along the first floor of the Broadway side of the MAC are deteriorating and starting to leak, damaging the interior finishes and carpet. The windows should be replaced. The building has 20% instructional use and can be supported by capital funds, so 80% of the project funding must come from local funds.

Recommended funding schedule : Immediate (scoring weight=4)
Estimated remaining life (years) : (No Data)
Estimated average life expectancy (years) : 25
Scoring priority category 1 : System Use (scoring weight=15)
Category 1 percentage : 90 %
Scoring priority category 2 : Quality of Use (scoring weight=5)
Category 2 percentage : 10 %
Project construction estimate (MACC): \$20,000
Total project estimate (including soft costs): \$28,000
Additional points based on building condition: 1
Deficiency score : $4 \times ((15 \times 90\%) + (5 \times 10\%)) + 1 = 57$

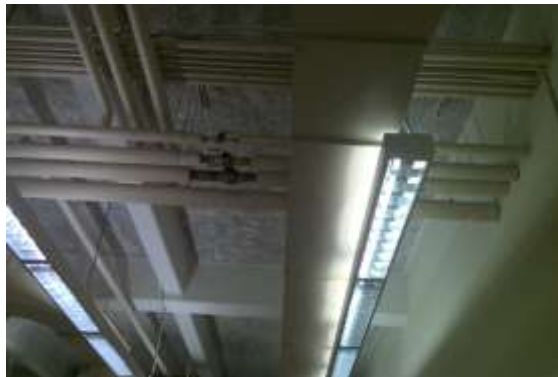
Deficiency F04

The college has found that some copper pipes have begun to form pits due to high flow circulation pumps. Pipe bursts require repairs almost annually. Leaks were not visible during the survey, but prior repairs were visible. The extent of the problem was not clear and did not appear to be systemic during the survey. Some testing in various areas would provide a clearer perspective. Additional information is required to establish an appropriate scope of repair.

Recommended funding schedule : Fund in Next Biennium (scoring weight=2.5)
Estimated remaining life (years) : 5
Estimated average life expectancy (years) : 40
Scoring priority category 1 : High Repair/Repl. Cost (scoring weight=12)
Category 1 percentage : 90 %
Scoring priority category 2 : High Operating Cost (scoring weight=10)
Category 2 percentage : 10 %
Project construction estimate (MACC): \$66,000
Total project estimate (including soft costs): \$93,000
Additional points based on building condition: 2
Deficiency score : Needs study

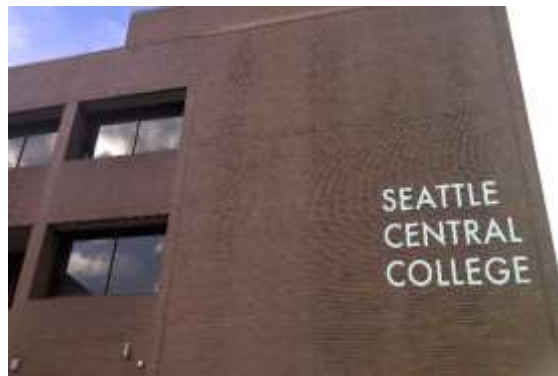
Deficiency F05

The masonry envelope in the older sections of the phased building have deteriorated. The mortar has failed. The lintels have rusted. The flashing has failed in many locations. The perimeter masonry has varying levels of decay. Some areas still function as designed. The areas in the worst condition should be repaired and be reconditioned to ensure a water-tight envelope.

Recommended funding schedule : Immediate (scoring weight=4)
Estimated remaining life (years) : 3
Estimated average life expectancy (years) : 50
Scoring priority category 1 : High Repair/Repl. Cost (scoring weight=12)
Category 1 percentage : 60 %
Scoring priority category 2 : System Use (scoring weight=15)
Category 2 percentage : 40 %
Project construction estimate (MACC): \$1,070,000
Total project estimate (including soft costs): \$1,519,000
Additional points based on building condition: 2
Deficiency score : $4 \times ((12 \times 60\%) + (15 \times 40\%)) + 2 = 54.8$

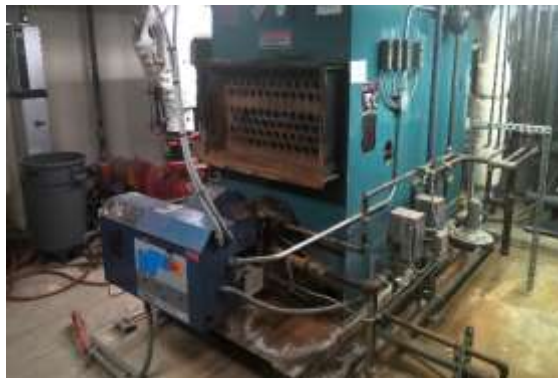
Deficiency F07

One of the gas boilers has failed and should be replaced.

Category 2 percentage : 0 %
Project construction estimate (MACC): \$90,000
Total project estimate (including soft costs): \$127,000
Additional points based on building condition: 1
Deficiency score : $4 \times (15 \times 100\%) + 1 = 61$

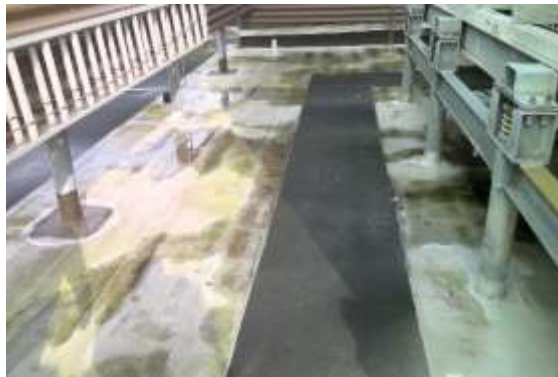
Deficiency R01

The college was concerned about the condition of the roof. A few minor repairs have been completed at structural penetrations. The roof is in good condition and should be monitored for future repair needs.

Scoring priority category 1 : System Use (scoring weight=15)
Category 1 percentage : 100 %
Scoring priority category 2 : None
Category 2 percentage : 0 %
Project construction estimate (MACC): \$750,000
Total project estimate (including soft costs): \$1,064,000
Additional points based on building condition: 1
Deficiency score : $1 \times (15 \times 100\%) + 1 = 16$

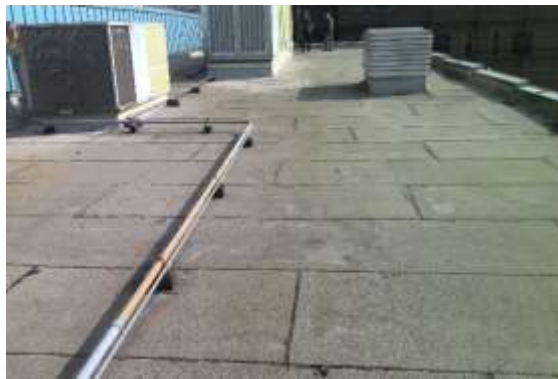
Deficiency R02

The college is concerned about the condition of the roofing. The roofing appeared to be in good condition in general. Small areas should be patched through regular maintenance. The roof should continue to be monitored for repair or reconditioning in the future.

Estimated remaining life (years) : 5
Estimated average life expectancy (years) : 20
Scoring priority category 1 : System Use (scoring weight=15)
Category 1 percentage : 80 %
Scoring priority category 2 : High Repair/Repl. Cost (scoring weight=12)
Category 2 percentage : 20 %
Project construction estimate (MACC): \$900,000
Total project estimate (including soft costs): \$1,277,000
Additional points based on building condition: 1
Deficiency score : $1 \times ((15 \times 80\%) + (12 \times 20\%)) + 1 = 15.4$

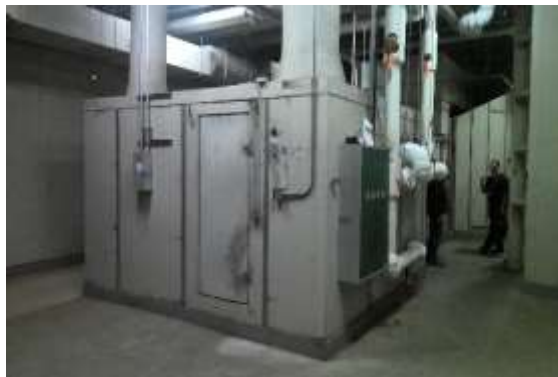
Deficiency F08

The air handler (AHU-3) in the Broadway Edison Phase 2 building has begun to be less reliable. The main components still function as designed. The failing components of the unit should be reconditioned or replaced to extend its useful life.

Scoring priority category 1 : System Use (scoring weight=15)
Category 1 percentage : 70 %
Scoring priority category 2 : High Repair/Repl. Cost (scoring weight=12)
Category 2 percentage : 30 %
Project construction estimate (MACC): \$540,000
Total project estimate (including soft costs): \$766,000
Additional points based on building condition: 2
Deficiency score : $4 \times ((15 \times 70\%) + (12 \times 30\%)) + 2 = 58.4$

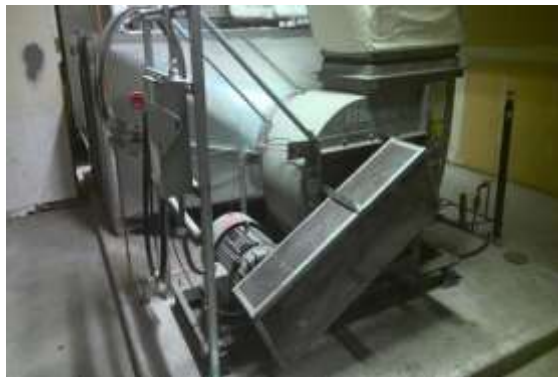
Deficiency F09

The college has concerns about the age of air handler units in the phase 1 portion of the building. The units are reliable and still function as designed. These units should continue to be monitored for repair or replacement.

Scoring priority category 1 : High Operating Cost (scoring weight=10)
Category 1 percentage : 80 %
Scoring priority category 2 : High Repair/Repl. Cost (scoring weight=12)
Category 2 percentage : 20 %
Project construction estimate (MACC): \$520,000
Total project estimate (including soft costs): \$738,000
Additional points based on building condition: 2
Deficiency score : $1 \times ((10 \times 80\%) + (12 \times 20\%)) + 2 = 12.4$

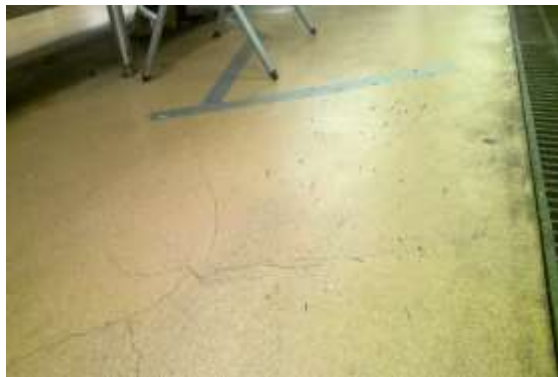
Deficiency F10

Kitchen Floors: The kitchen floor is a hardened surface installed over the concrete slab. The epoxy surface exhibits some fine cracking in most areas. Some areas have deeper cracks and have begun to spawl. The floor surface should be reconditioned to meet health requirements.

Estimated remaining life (years) : 3
Estimated average life expectancy (years) : 25
Scoring priority category 1 : System Use (scoring weight=15)
Category 1 percentage : 70 %
Scoring priority category 2 : High Repair/Repl. Cost (scoring weight=12)
Category 2 percentage : 30 %
Project construction estimate (MACC): \$50,000
Total project estimate (including soft costs): \$70,000
Additional points based on building condition: 2
Deficiency score : $4 \times ((15 \times 70\%) + (12 \times 30\%)) + 2 = 58.4$

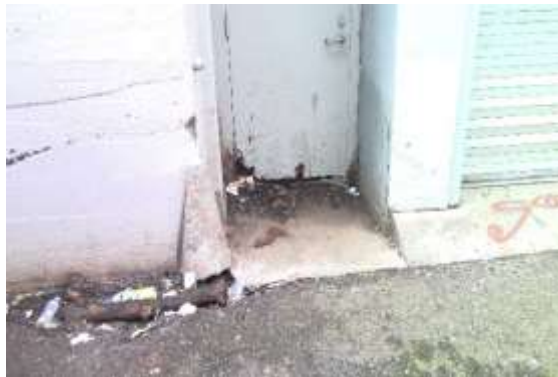
Deficiency F13

Exterior doors on the east side of Siegal Center Building are deteriorated due to exposure to urine and forced entry. These doors should be replaced.

Category 1 percentage : 100 %
Scoring priority category 2 : None
Category 2 percentage : 0 %
Project construction estimate (MACC): \$20,000
Total project estimate (including soft costs): \$28,000
Additional points based on building condition: 1
Deficiency score : $4 \times (15 \times 100\%) + 1 = 61$
