2023 FACILITY CONDITION SURVEY

Shoreline Community College

SURVEY CONDUCTED BY:
Steve Lewandowski
State Board for Community
and Technical Colleges

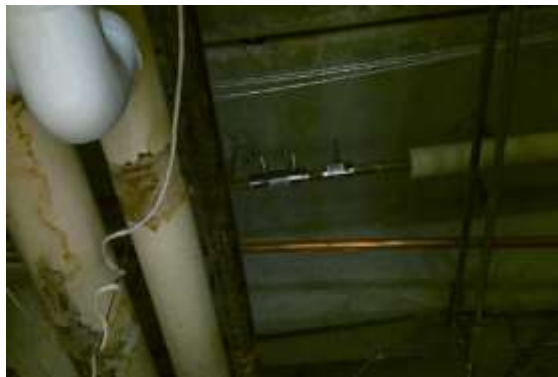
Deficiency F02

Estimated remaining life (years) : 3
Estimated average life expectancy (years) : 40
Scoring priority category 1 : High Repair/Repl. Cost (scoring weight=12)
Category 1 percentage : 50 %
Scoring priority category 2 : System Use (scoring weight=15)
Category 2 percentage : 50 %
Project construction estimate (MACC): \$200,000
Total project estimate (including soft costs): \$284,000
Additional points based on building condition: 2
Deficiency score : $4 \times ((12 \times 50\%) + (15 \times 50\%)) + 2 = 56$

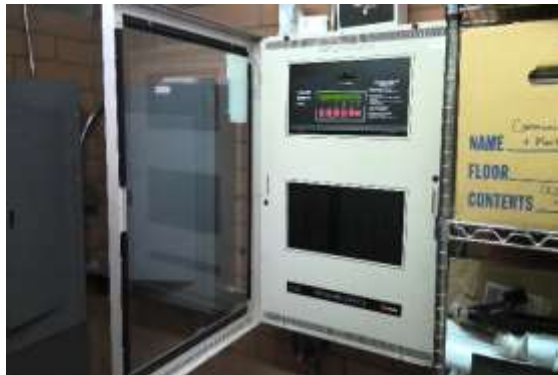
Deficiency F03

Total project estimate (including soft costs): \$426,000
Additional points based on building condition: 0
Deficiency score : Needs study

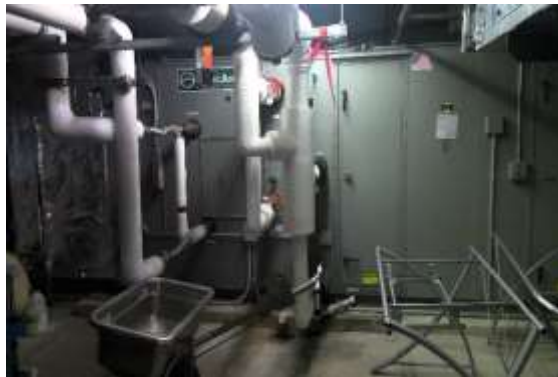
Deficiency F04

Category 1 percentage : 70 %
Scoring priority category 2 : High Repair/Repl. Cost (scoring weight=12)
Category 2 percentage : 30 %
Project construction estimate (MACC): \$150,000
Total project estimate (including soft costs): \$213,000
Additional points based on building condition: 1
Deficiency score : $2.5 \times ((15 \times 70\%) + (12 \times 30\%)) + 1 = 36.3$

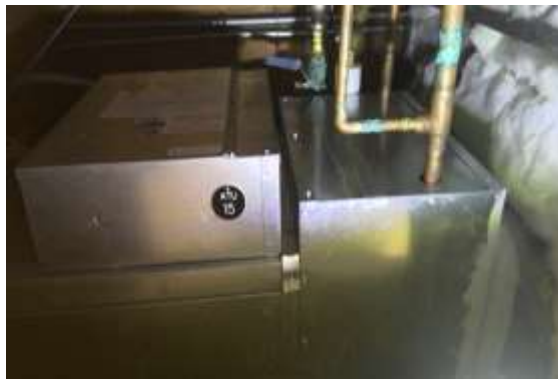
Deficiency F05

Estimated average life expectancy (years) : 25
Scoring priority category 1 : High Repair/Repl. Cost (scoring weight=12)
Category 1 percentage : 60 %
Scoring priority category 2 : System Use (scoring weight=15)
Category 2 percentage : 40 %
Project construction estimate (MACC): \$90,000
Total project estimate (including soft costs): \$127,000
Additional points based on building condition: 1
Deficiency score : $4 \times ((12 \times 60\%) + (15 \times 40\%)) + 1 = 53.8$

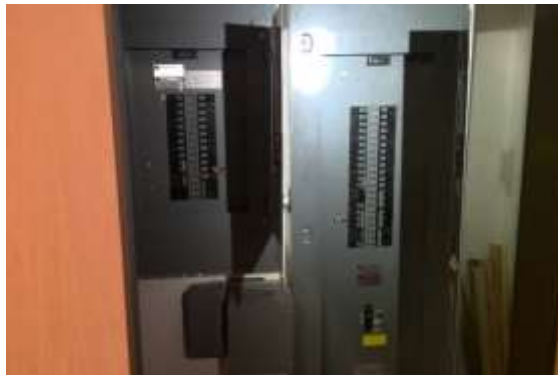
Deficiency F06

Deficiency score : Needs study

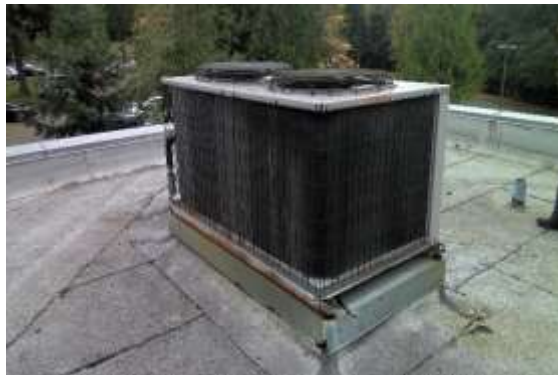
Deficiency F07

Category 1 percentage : 70 %
Scoring priority category 2 : System Use (scoring weight=15)
Category 2 percentage : 30 %
Project construction estimate (MACC): \$50,000
Total project estimate (including soft costs): \$71,000
Additional points based on building condition: 1
Deficiency score : $4 \times ((12 \times 70\%) + (15 \times 30\%)) + 1 = 52.6$

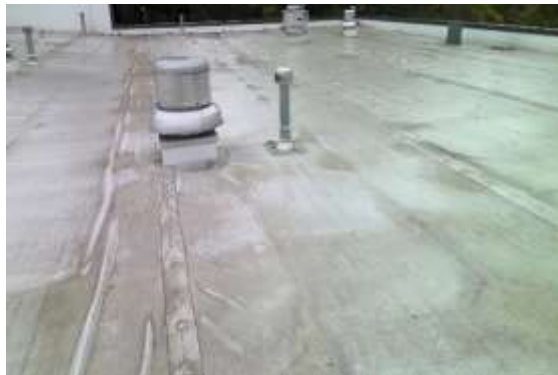
Deficiency R01

Category 1 percentage : 60 %
Scoring priority category 2 : High Repair/Repl. Cost (scoring weight=12)
Category 2 percentage : 40 %
Project construction estimate (MACC): \$228,000
Total project estimate (including soft costs): \$323,000
Additional points based on building condition: 1
Deficiency score : $4 \times ((15 \times 60\%) + (12 \times 40\%)) + 1 = 56.2$

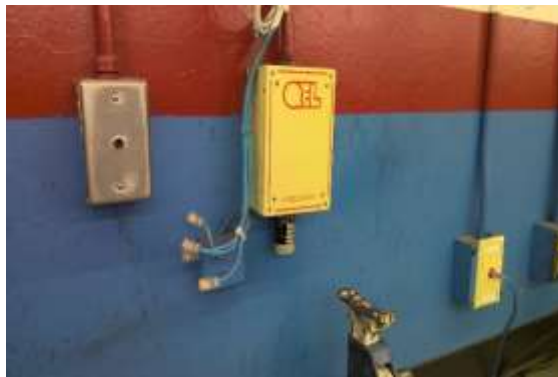
Deficiency F08

Estimated average life expectancy (years) : 20
Scoring priority category 1 : System Use (scoring weight=15)
Category 1 percentage : 80 %
Scoring priority category 2 : Health/Safety (scoring weight=25)
Category 2 percentage : 20 %
Project construction estimate (MACC): \$50,000
Total project estimate (including soft costs): \$71,000
Additional points based on building condition: 1
Deficiency score : Needs study

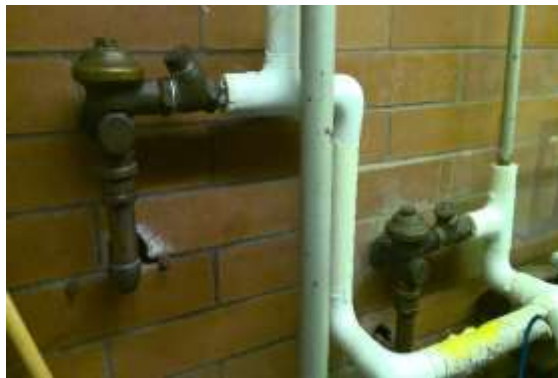
Deficiency F09

Category 2 percentage : 30 %
Project construction estimate (MACC): \$24,000
Total project estimate (including soft costs): \$34,000
Additional points based on building condition: 2
Deficiency score : $4 \times ((12 \times 70\%) + (15 \times 30\%)) + 2 = 53.6$

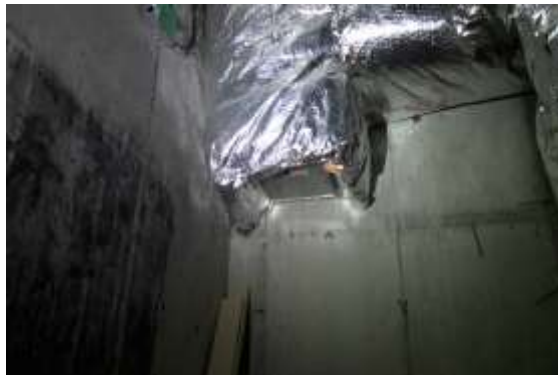
Deficiency F10

Category 1 percentage : 70 %
Scoring priority category 2 : Health/Safety (scoring weight=25)
Category 2 percentage : 30 %
Project construction estimate (MACC): \$60,000
Total project estimate (including soft costs): \$85,000
Additional points based on building condition: 1
Deficiency score : $4 \times ((15 \times 70\%) + (25 \times 30\%)) + 1 = 73$

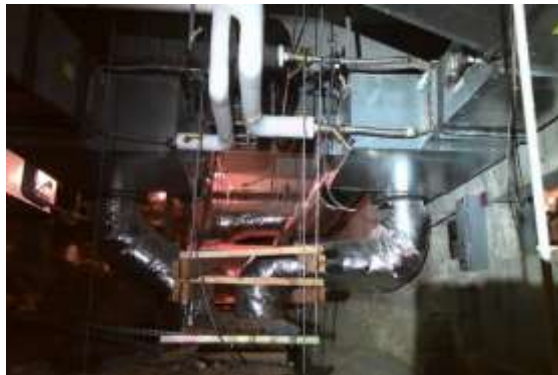
Deficiency F11

Category 1 percentage : 60 %
Scoring priority category 2 : System Use (scoring weight=15)
Category 2 percentage : 40 %
Project construction estimate (MACC): \$80,000
Total project estimate (including soft costs): \$113,000
Additional points based on building condition: 1
Deficiency score : $2.5 \times ((12 \times 60\%) + (15 \times 40\%)) + 1 = 34$

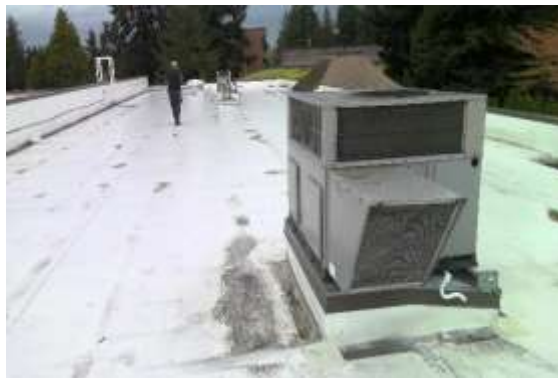
Deficiency F12

Category 2 percentage : 40 %
Project construction estimate (MACC): \$80,000
Total project estimate (including soft costs): \$113,000
Additional points based on building condition: 1
Deficiency score : $4 \times ((12 \times 60\%) + (15 \times 40\%)) + 1 = 53.8$

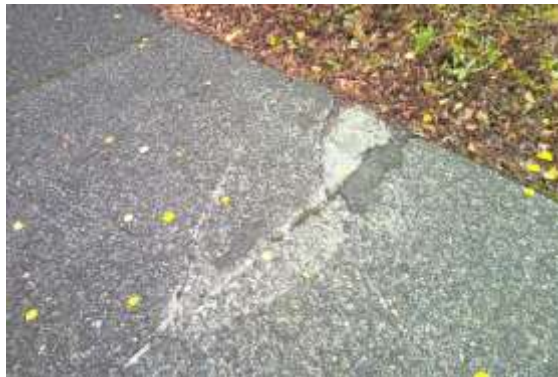
Deficiency S01

Scoring priority category 2 : Facility Use/ Civil Rights Violation (scoring weight=20)
Category 2 percentage : 20 %
Project construction estimate (MACC): \$20,000
Total project estimate (including soft costs): \$28,000
Additional points based on building condition: 0
Deficiency score : $4 \times ((12 \times 80\%) + (20 \times 20\%)) + 0 = 54.4$
