2023 FACILITY CONDITION SURVEY

Skagit Valley College

SURVEY CONDUCTED BY:
Steve Lewandowski
State Board for Community
and Technical Colleges

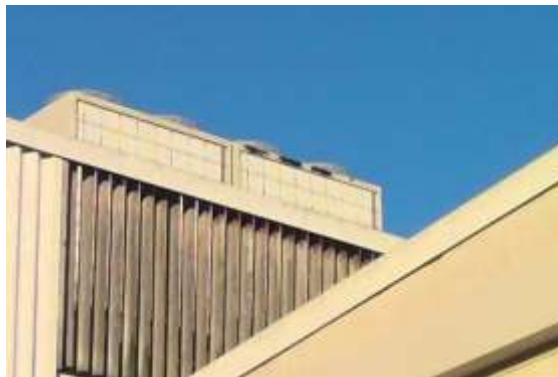
Estimated average life expectancy (years) : 20
Scoring priority category 1 : High Repair/Repl. Cost (score = 12)
Category 1 percentage : 50 %
Scoring priority category 2 : System Use (score = 15)
Category 2 percentage : 50 %
Project construction estimate (MACC): \$212,000
Total project estimate (including soft costs): \$297,000
Additional points based on building condition: 1
Deficiency score : $4 \times ((12 \times 50\%) + (15 \times 50\%)) + 1 = 55$

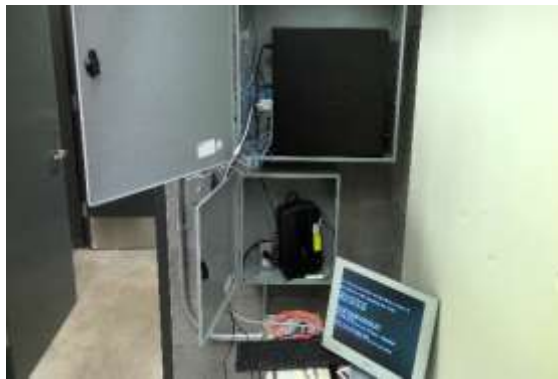
Deficiency F02

Estimated average life expectancy (years) : 20
Scoring priority category 1 : System Use (scoring weight=15)
Category 1 percentage : 80 %
Scoring priority category 2 : High Repair/Repl. Cost (scoring weight=12)
Category 2 percentage : 20 %
Project construction estimate (MACC): \$53,000
Total project estimate (including soft costs): \$74,000
Additional points based on building condition: 0
Deficiency score : $4 \times ((15 \times 80\%) + (12 \times 20\%)) + 0 = 57.6$

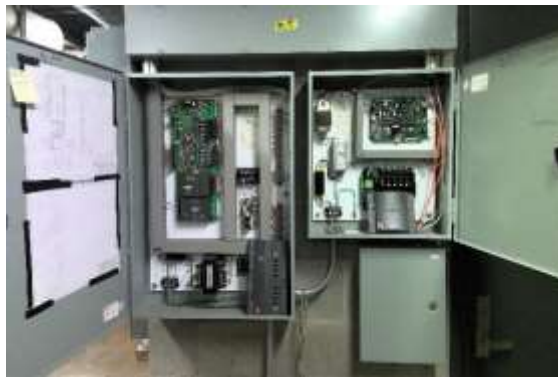
Deficiency F03

Estimated average life expectancy (years) : 20
Scoring priority category 1 : High Repair/Repl. Cost (scoring weight=12)
Category 1 percentage : 50 %
Scoring priority category 2 : System Use (scoring weight=15)
Category 2 percentage : 50 %
Project construction estimate (MACC): \$163,000
Total project estimate (including soft costs): \$228,000
Additional points based on building condition: 0
Deficiency score : $2.5 \times ((12 \times 50\%) + (15 \times 50\%)) + 0 = 33.8$

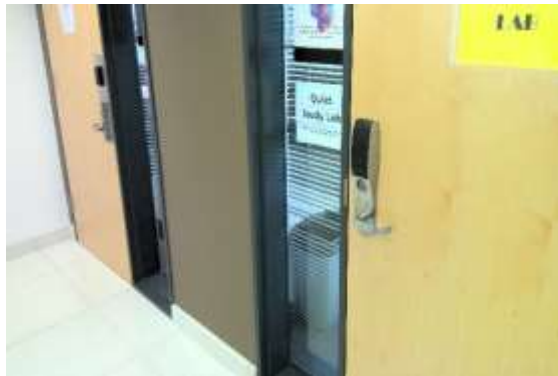
Deficiency F04

Recommended funding schedule : Fund in Next Biennium (scoring weight=2.5)
Estimated remaining life (years) : 5
Estimated average life expectancy (years) : 20
Scoring priority category 1 : High Repair/Repl. Cost (scoring weight=12)
Category 1 percentage : 100 %
Scoring priority category 2 : None
Category 2 percentage : 0 %
Project construction estimate (MACC): \$417,000
Total project estimate (including soft costs): \$584,000
Additional points based on building condition: 0
Deficiency score : $2.5 \times (12 \times 100\%) + 0 = 30$

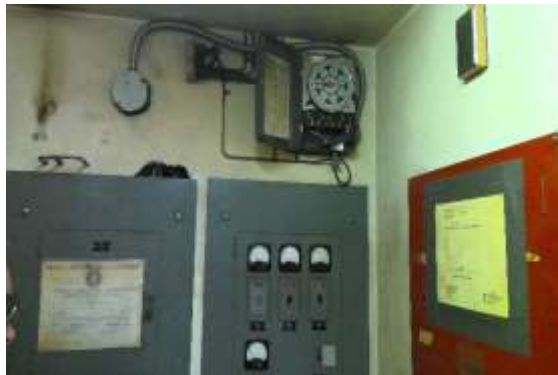
Deficiency F05

Category 1 percentage : 80 %
Scoring priority category 2 : High Repair/Repl. Cost (scoring weight=12)
Category 2 percentage : 20 %
Project construction estimate (MACC): \$285,000
Total project estimate (including soft costs): \$399,000
Additional points based on building condition: 5
Deficiency score : $4 \times ((15 \times 80\%) + (12 \times 20\%)) + 5 = 62.6$

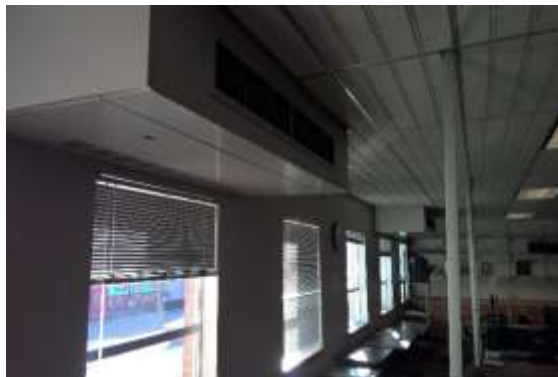
Deficiency F06

Scoring priority category 1 : High Repair/Repl. Cost (scoring weight=12)
Category 1 percentage : 90 %
Scoring priority category 2 : High Operating Cost (scoring weight=10)
Category 2 percentage : 10 %
Project construction estimate (MACC): \$398,000
Total project estimate (including soft costs): \$558,000
Additional points based on building condition: 2
Deficiency score : $4 \times ((12 \times 90\%) + (10 \times 10\%)) + 2 = 49.2$

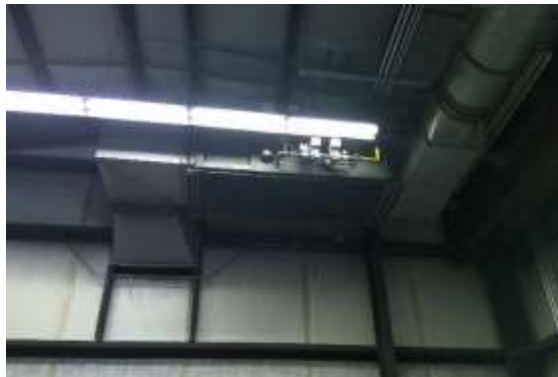
Deficiency F07

Estimated remaining life (years) : 3
Estimated average life expectancy (years) : 30
Scoring priority category 1 : High Repair/Repl. Cost (scoring weight=12)
Category 1 percentage : 70 %
Scoring priority category 2 : System Use (scoring weight=15)
Category 2 percentage : 30 %
Project construction estimate (MACC): \$100,000
Total project estimate (including soft costs): \$140,000
Additional points based on building condition: 0
Deficiency score : $4 \times ((12 \times 70\%) + (15 \times 30\%)) + 0 = 51.6$

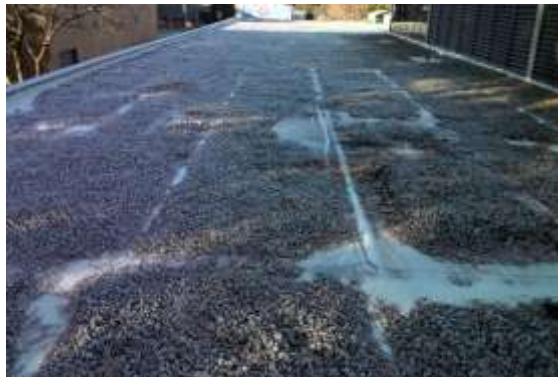
Deficiency R01

Recommended funding schedule : Immediate (scoring weight=4)
Estimated remaining life (years) : 7
Estimated average life expectancy (years) : 15
Scoring priority category 1 : High Repair/Repl. Cost (scoring weight=12)
Category 1 percentage : 60 %
Scoring priority category 2 : System Use (scoring weight=15)
Category 2 percentage : 40 %
Project construction estimate (MACC): \$143,000
Total project estimate (including soft costs): \$200,000
Additional points based on building condition: 2
Deficiency score : $4 \times ((12 \times 60\%) + (15 \times 40\%)) + 2 = 54.8$

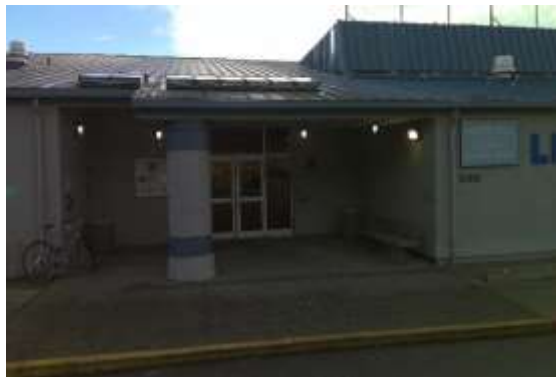
Deficiency R02

Recommended funding schedule : Immediate (scoring weight=4)
Estimated remaining life (years) : 7
Estimated average life expectancy (years) : 40
Scoring priority category 1 : High Repair/Repl. Cost (scoring weight=12)
Category 1 percentage : 80 %
Scoring priority category 2 : Quality of Use (scoring weight=5)
Category 2 percentage : 20 %
Project construction estimate (MACC): \$252,000
Total project estimate (including soft costs): \$353,000
Additional points based on building condition: 1
Deficiency score : $4 \times ((12 \times 80\%) + (5 \times 20\%)) + 1 = 43.4$

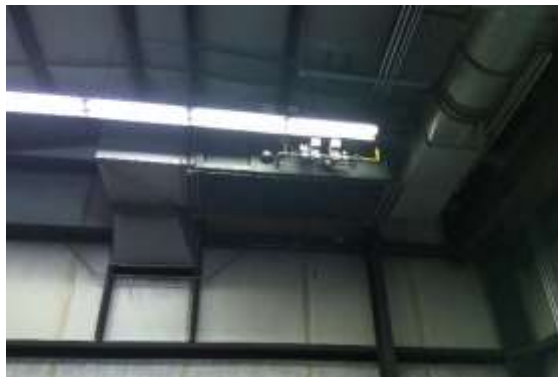
Deficiency F08

Category 1 percentage : 90 %
Scoring priority category 2 : High Repair/Repl. Cost (scoring weight=12)
Category 2 percentage : 10 %
Project construction estimate (MACC): \$180,000
Total project estimate (including soft costs): \$252,000
Additional points based on building condition: 5
Deficiency score : $2.5 \times ((15 \times 90\%) + (12 \times 10\%)) + 5 = 41.8$

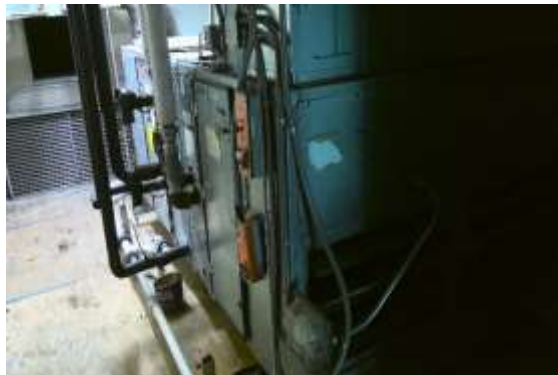
Deficiency F09

Scoring priority category 2 : High Repair/Repl. Cost (scoring weight=12)
Category 2 percentage : 40 %
Project construction estimate (MACC): \$377,000
Total project estimate (including soft costs): \$528,000
Additional points based on building condition: 1
Deficiency score : $4 \times ((15 \times 60\%) + (12 \times 40\%)) + 1 = 56.2$

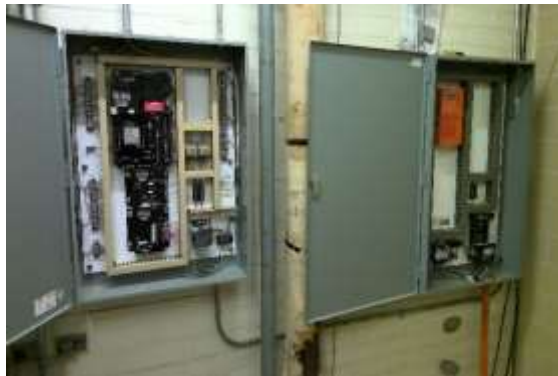
Deficiency F10

Recommended funding schedule : Immediate (scoring weight=4)
Estimated remaining life (years) : 5
Estimated average life expectancy (years) : 25
Scoring priority category 1 : System Use (scoring weight=15)
Category 1 percentage : 60 %
Scoring priority category 2 : High Repair/Repl. Cost (scoring weight=12)
Category 2 percentage : 40 %
Project construction estimate (MACC): \$200,000
Total project estimate (including soft costs): \$280,000
Additional points based on building condition: 0
Deficiency score : $4 \times ((15 \times 60\%) + (12 \times 40\%)) + 0 = 55.2$

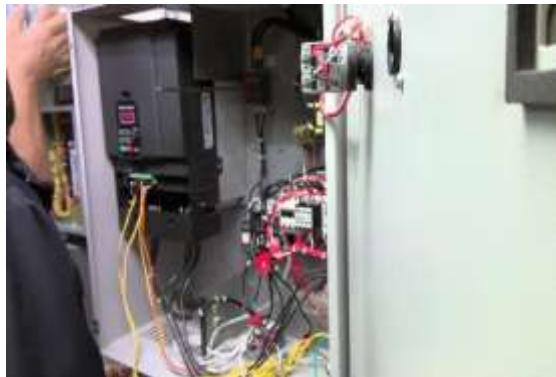
Deficiency F11

Recommended funding schedule : Immediate (scoring weight=4)
Estimated remaining life (years) : 3
Estimated average life expectancy (years) : 20
Scoring priority category 1 : High Repair/Repl. Cost (scoring weight=12)
Category 1 percentage : 90 %
Scoring priority category 2 : System Use (scoring weight=15)
Category 2 percentage : 10 %
Project construction estimate (MACC): \$148,000
Total project estimate (including soft costs): \$207,000
Additional points based on building condition: 1
Deficiency score : $4 \times ((12 \times 90\%) + (15 \times 10\%)) + 1 = 50.2$

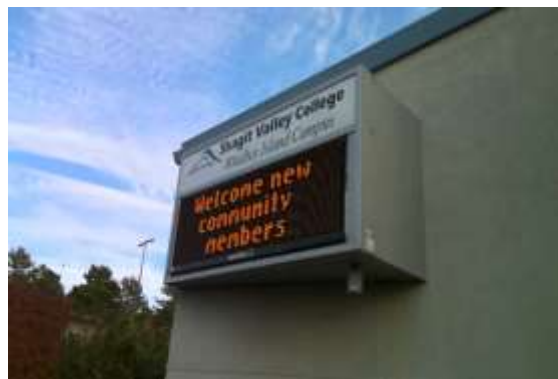
Deficiency F12

Scoring priority category 1 : High Repair/Repl. Cost (scoring weight=12)
Category 1 percentage : 80 %
Scoring priority category 2 : Quality of Use (scoring weight=5)
Category 2 percentage : 20 %
Project construction estimate (MACC): \$60,000
Total project estimate (including soft costs): \$84,000
Additional points based on building condition: 0
Deficiency score : $4 \times ((12 \times 80\%) + (5 \times 20\%)) + 0 = 42.4$

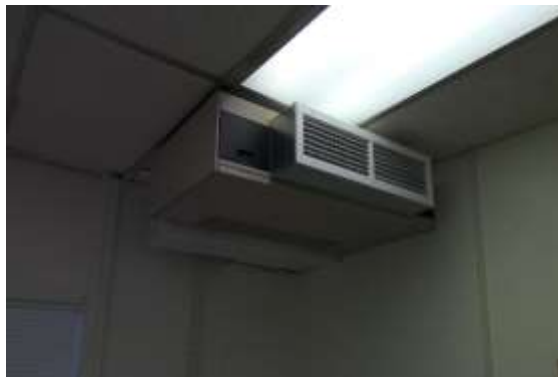
Deficiency F13

Estimated remaining life (years) : 3
Estimated average life expectancy (years) : 20
Scoring priority category 1 : High Repair/Repl. Cost (scoring weight=12)
Category 1 percentage : 60 %
Scoring priority category 2 : High Operating Cost (scoring weight=10)
Category 2 percentage : 40 %
Project construction estimate (MACC): \$319,000
Total project estimate (including soft costs): \$447,000
Additional points based on building condition: 5
Deficiency score : $4 \times ((12 \times 60\%) + (10 \times 40\%)) + 5 = 49.8$

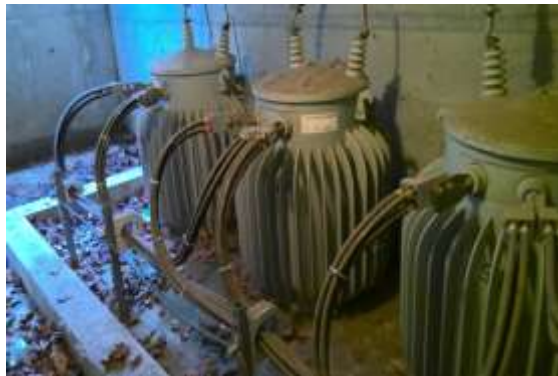
Deficiency S01

Recommended funding schedule : Fund in Next Biennium (scoring weight=2.5)
Estimated remaining life (years) : 5
Estimated average life expectancy (years) : 40
Scoring priority category 1 : Facility Use/ Civil Rights Violation (scoring weight=20)
Category 1 percentage : 50 %
Scoring priority category 2 : System Use (scoring weight=15)
Category 2 percentage : 50 %
Project construction estimate (MACC): \$335,000
Total project estimate (including soft costs): \$469,000
Additional points based on building condition: 0
Deficiency score : $2.5 \times ((20 \times 50\%) + (15 \times 50\%)) + 0 = 43.8$

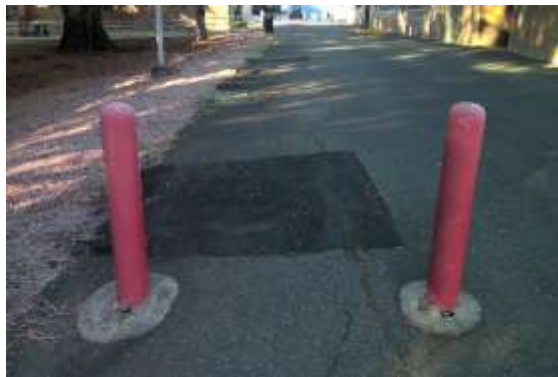
Deficiency S02

Scoring priority category 1 : High Repair/Repl. Cost (scoring weight=12)
Category 1 percentage : 70 %
Scoring priority category 2 : Health/Safety (scoring weight=25)
Category 2 percentage : 30 %
Project construction estimate (MACC): \$103,000
Total project estimate (including soft costs): \$144,000
Additional points based on building condition: 0
Deficiency score : $4 \times ((12 \times 70\%) + (25 \times 30\%)) + 0 = 63.6$

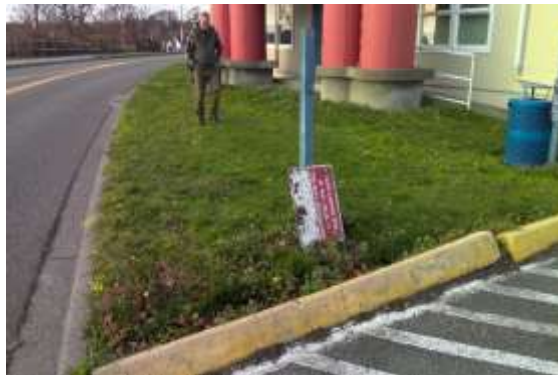
Deficiency S03

Category 1 percentage : 100 %
Scoring priority category 2 : None
Category 2 percentage : 0 %
Project construction estimate (MACC): \$152,000
Total project estimate (including soft costs): \$213,000
Additional points based on building condition: 0
Deficiency score : $4 \times (15 \times 100\%) + 0 = 60$

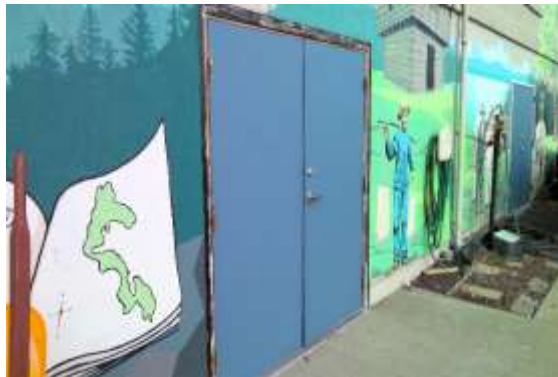
Deficiency F14

Recommended funding schedule : Immediate (scoring weight=4)
Estimated remaining life (years) : 3
Estimated average life expectancy (years) : 30
Scoring priority category 1 : High Repair/Repl. Cost (scoring weight=12)
Category 1 percentage : 70 %
Scoring priority category 2 : System Use (scoring weight=15)
Category 2 percentage : 30 %
Project construction estimate (MACC): \$28,000
Total project estimate (including soft costs): \$39,000
Additional points based on building condition: 0
Deficiency score : $4 \times ((12 \times 70\%) + (15 \times 30\%)) + 0 = 51.6$

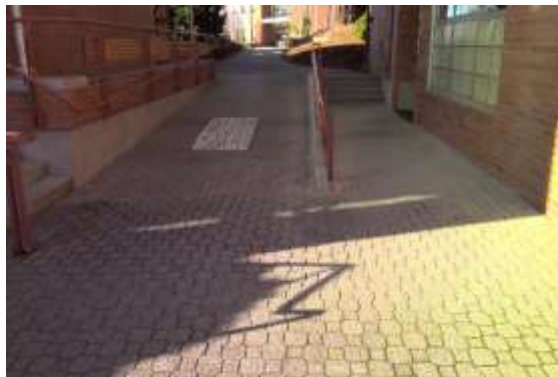
Deficiency S04

Estimated remaining life (years) : 3
Estimated average life expectancy (years) : 30
Scoring priority category 1 : High Repair/Repl. Cost (scoring weight=12)
Category 1 percentage : 70 %
Scoring priority category 2 : Facility Use/ Civil Rights Violation (scoring weight=20)
Category 2 percentage : 30 %
Project construction estimate (MACC): \$20,000
Total project estimate (including soft costs): \$28,000
Additional points based on building condition: 0
Deficiency score : $4 \times ((12 \times 70\%) + (20 \times 30\%)) + 0 = 57.6$
