# **2023** FACILITY CONDITION SURVEY

South Puget Sound  
Community College

SURVEY CONDUCTED BY:  
Steve Lewandowski  
State Board for Community  
and Technical Colleges

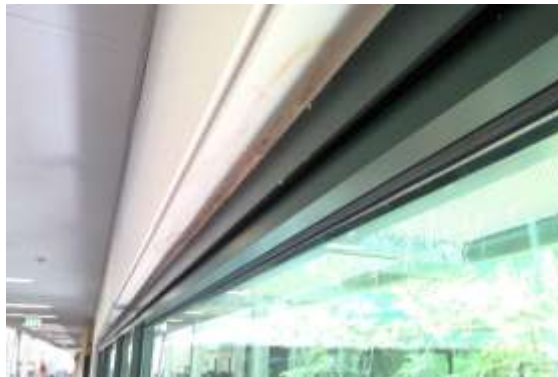
The window headers leak and allow water to infiltrate the building envelope. The windows should be flashed and sealed to provide a water-tight envelope. The interior damage should be repaired.

| Deficiency score : $4 \times ((12 \times 70\%) + (15 \times 30\%)) + 0 = 51.6$ |

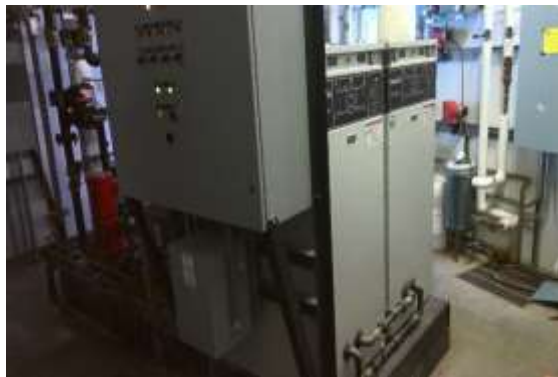
**Deficiency F02**

The two boilers are near the end of their useful life, but still function as designed. There has not been a significant increase in maintenance required to sustain operation of the boilers. The boilers are still maintainable and should be replaced in the next biennium.

| Deficiency score : $2.5 \times ((15 \times 60\%) + (12 \times 40\%)) + 1 = 35.5$ |

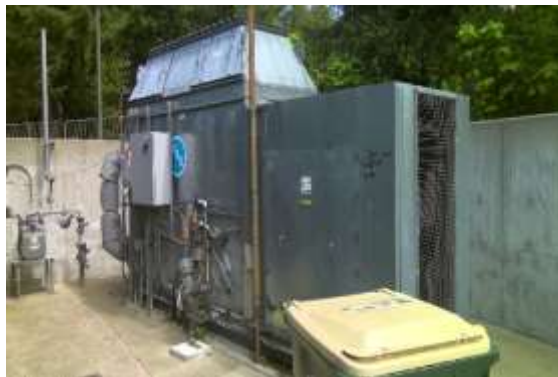
**Deficiency F03**

The college is concerned about the age of the cooling tower. The unit has not required an increased level of maintenance or repair and still functions as designed. The unit should continue to be monitored for future replacement.

| Deficiency score : $2.5 \times ((15 \times 50\%) + (12 \times 50\%)) + 1 = 34.8$ |

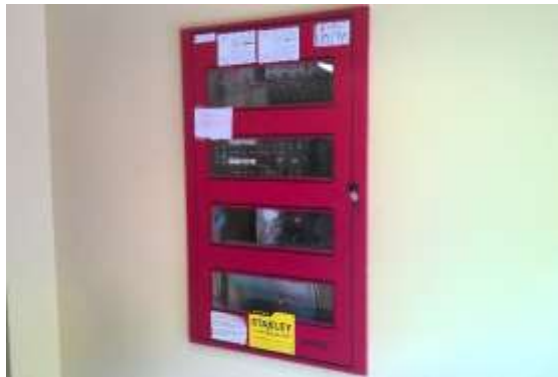
**Deficiency F04**

The college is concerned about the age and reliability of several fire alarm control panels. Additional information is required to determine if the panels still function as designed and if they are still repairable. A vendor memo is required to describe the lack of spare parts and ability to make repairs for each of the nine panels.

| Deficiency score : Needs study |

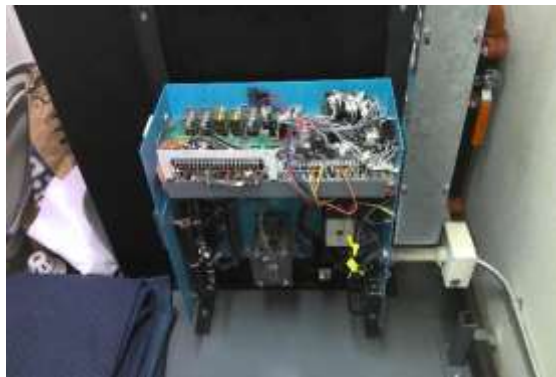
**Deficiency F05**

The college is concerned about the age and reliability of the elevator controls. The college staff indicated that the controls have not required a high level of maintenance or repair calls. The controls are no longer supported by the elevator vendor and components can no longer be easily repaired.

| Deficiency score : $4 \times ((12 \times 70\%) + (20 \times 30\%)) + 1 = 58.6$ |

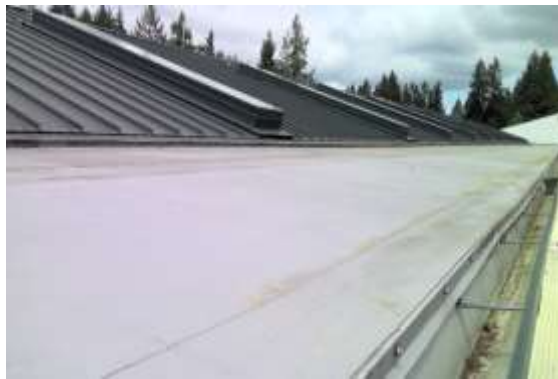
**Deficiency R01**

The roof has been leaking in several locations. The college believes that the building may have shifted. The leaks occur in an area that relies on exposed fasteners that penetrate the roofing. The roof should be reconditioned to extend its useful life.

| Deficiency score : $4 \times ((15 \times 70\%) + (12 \times 30\%)) + 0 = 56.4$ |

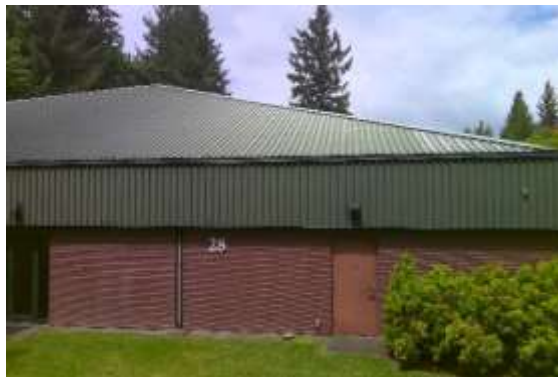
**Deficiency R02**

The roofing ridge cap allows water to penetrate the envelope. This scope of work was included in a prior capital budget, but funds were moved to a higher priority project. The ridge cap should be replaced and flashing should be installed to provide a water-tight roof system.

| Deficiency score : $4 \times ((15 \times 70\%) + (12 \times 30\%)) + 1 = 57.4$ |

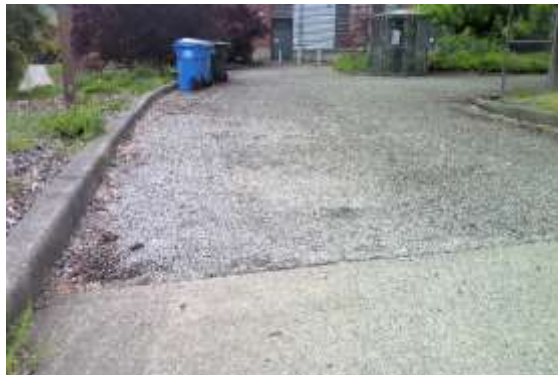
**Deficiency S01**

Campus fire lanes are deteriorated and have likely substrate failures in some areas. The road surface in these areas should be replaced.

| Deficiency score : $4 \times ((25 \times 90\%) + (15 \times 10\%)) + 0 = 96$ |

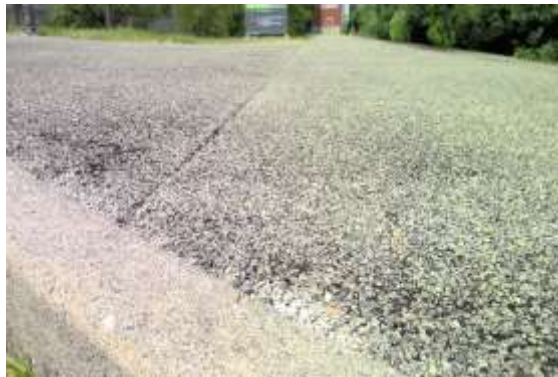
**Deficiency S02**

There are several areas of pervious concrete pedestrian paths that have failed and should be replaced.

| Deficiency score : $4 \times ((12 \times 80\%) + (20 \times 20\%)) + 0 = 54.4$ |
